ANALYSIS OF THE FLOODS EFFECTS IN JUNE 2016 IN THE VORONET RIVER HYDROGRAPHIC BASIN

ABSTRACT

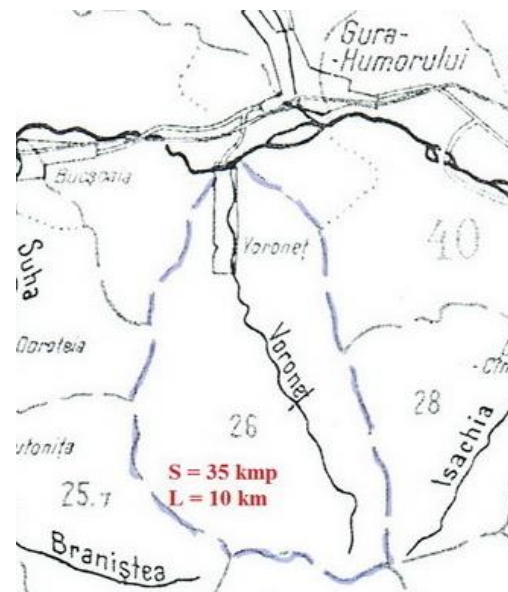
Fig. 4. The Voroneț River Basin [6]

The Voroneț River presents an ellipse-shaped river basin, which allows a rapid concentration of the flow (Figure 4). The erosive action of the water has made a minor bed with variable widths, where erosion, meandering and alluvial deposits occur. The river bed is characterized by intense morphological transformation over time.

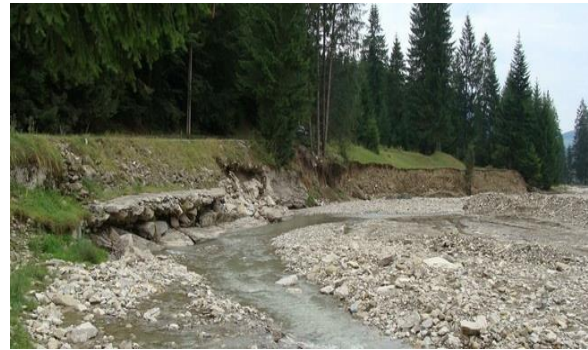
Fig. 5. General view of the Voroneț River shore erosion at the limit of the road DJ 177D in the downstream area after the flood of June 2016 (photo Aug. 2016 [4])

The river banks were eroded (2600 m of shore) and the bed was morphologically transformed (Figure 5) [4, 9].

The reduced dimensions of the Voroneț River flow section in the degradation area, as well as the absence of shore defense works, were the factors that allowed excessive road erosion. Old shore defense works have been degraded and no longer have a functional role in the transit of floods (Figure 5). The hydrodynamic erosion phenomenon of the bed has led to the lowering of the foundation quota of the shore defense constructions. The absence of rehabilitation works has led to a decrease in the protective capacity of shore defense works [3].

The reconstruction of the county road must be correlated with the design and execution of shore defense works on the affected river sector.

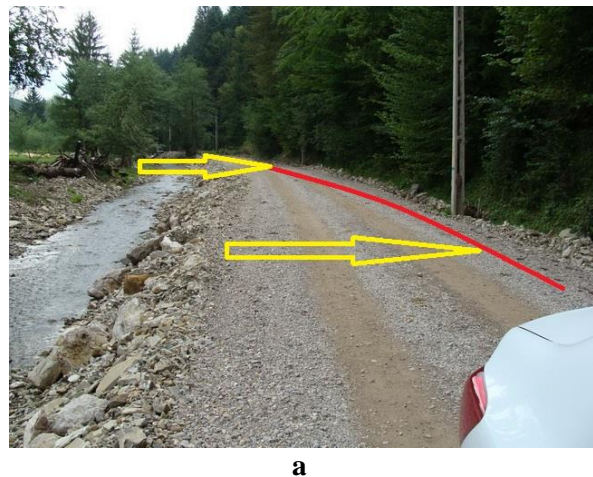
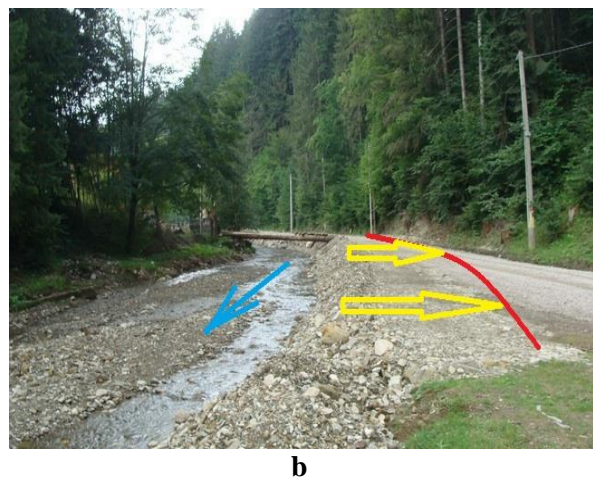
Fig. 6. Details of the Voroneț River's erosive action on the left bank and the road DJ 177D: a - the beginning of the deforestation degradation and the erosion of the road (downstream "Camp Cristea"); b - the end zone of the eroded road section to the slope (upstream of the Brusturosu Brook) [4]

- structural degradation of the county road DJ 177D on a length of 1500 m and breaking it on a length of 400 m (Figure 5 and 6);
- partial and total degradation of the bridges (5 bridges), of the footbridges (17 footbridges) and of the pedestrian bridges along the river's length affected by the flood;
- the degradation of shore defense works in urban and out-of-town areas;
- the erosion of the bank in urban and out-of-town areas, a situation that affected individual riverine properties;
- the morphological modification of the river bed by sectors, with the change of flow paths;
- material and human losses.

The county road DJ 177D was degraded on a route from the Voroneț district to the "Camp Cristea" area. The county road is parallel to the Voroneț riverbed on this route at distances of 1.0-45 m. The degradation forms are represented by the erosion of the marshalling with the entrance to the structure and its breaking on the differentiated length [4].

The county road was degraded to a length of 1500 m. High intensity hydrodynamic erosion led to the degradation of the road 177 177D, until its total destruction over a length of 400 m (Figure 6). This situation caused the interruption of traffic over a period of time. The river advanced to the shore, then into the road until it touched the slope (Figure 6.a). The phenomenon has been accelerated by the river's curvature area, the absence of shore defense and the geotechnical constitution of the land.

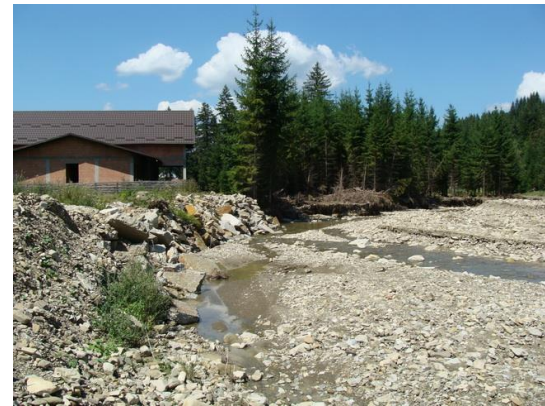
Fig. 8. Details of Voroneț erosive action on the riverbed and its impact on the riparian area: a - bank erosion and damage to a dwelling construction; b - morphological modification of the bedrock with excessive erosion of the left bank [4]

The alluvial material (large stone, ballast, forest waste, etc.) driven by floods degraded the individual properties located in the river area (tourist hostels, dwellings, pedestrian bridges, agricultural land, etc.).

The degradation of the properties was favored by the non-observance of the law on the distances and the location of the constructions in the riparian area (Figure 8) [4].
