## STRUCTURE EFFECTS OVER BEHAVIOR OF GRAPHITE GRAY IRON IN RUNNING

*The work aims at emphasizing the structure changes of graphite gray iron, as a result of make-casting conditions and their effects over behavior in running of several cast items. Researches consisted of complex characterization of several gray iron specimens sampled from damaged items comparatively to other suitable ones. Chemical composition, crack aspect, tensile strength, structure, kind, micro hardness of structural constituent were analyzed. Laboratory researches made by optical and electronic microscopy emphasized the showing up of some unsuitable structures with fragile structural constituents and areas unpurified by exogenous inclusions as well as degenerated graphite. All of these steady structural changes had a powerful fragility effect over the material. This fact was confirmed by mechanical characteristics and analysis of cracking area.*

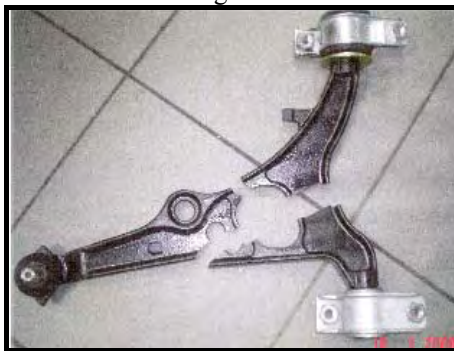
Fig.1. „Arm – wheel support” - cracked piece.

Based on the theoretical considerations submitted, the herewith work intends to investigate three nodular graphite gray irons, apparently identical, but which stated a different behavior of cast items (fig. 1). From those specimens code 1, 2 and 3 tension specimens and metallography micro sections sampled. In case of damaged items code 2 and 3 the specimens were sampled from the cracking areas.

Unsuitable structures and mechanical characteristics found in nodular graphite gray iron codes 2 and 3, resulted because of the deficient technological make-casting management, neglected and incomplete heating treatment. They caused the items cracking even during assembly.

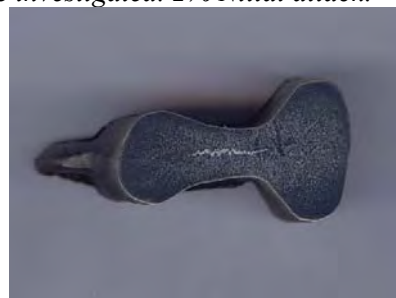
**Fig. 5. Specimen code 3- 2% macro Nital attack.**

For example (fig. 5) the macrostructure analysis of one sample from the damaged area was shown. In the thickness average of sample code 3, a powerful unpurified area, which caused the material fragilizing (fact confirmed by values of yielding and elongation limits) was found and constituted prime propagation of crakes during erection.

- bubbling and unsuitable protection of metallic bath during elaboration, as well as the incompletely slag exhausting, explain the oxides and exogenous existence in the iron;
- the too large speed when parts solidifying in mold allowed the secondary cementite precipitating;
