A Study of the Effects Caused by Freezing

Automatic Sprinkler Heads.

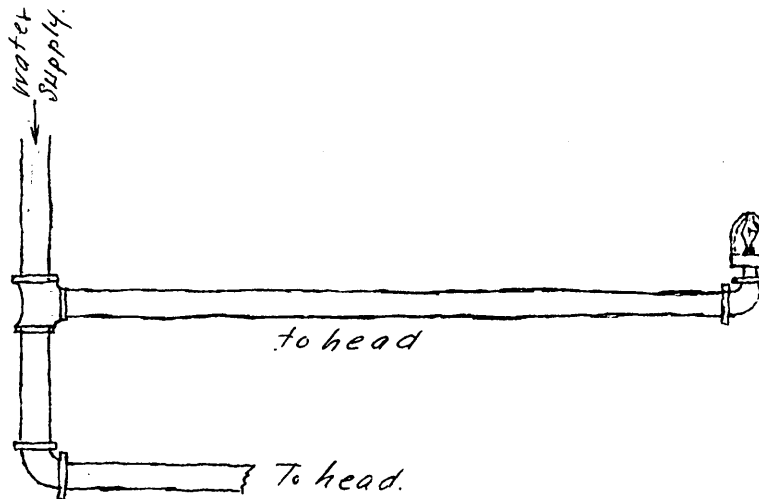
To allow as much expansion of the ice as possible, 6-ft. lengths of $\frac{3}{4}$ -inch pipes were used, connected to a common header. This header was made up of $\frac{3}{4}$ -inch tees and short nipples between the tees as in following sketch.

This arrangement would allow for more expansion of ice than in the regular sprinkler system, and therefore results would be on the safe side, and would apply to the regular installation with worse effects than these tests show. The header was used to keep the ice formed, from backing out of the pipe during the thawing period. The ice could not back out in the practical installation, due to bends and longer pipes to cause greater friction.

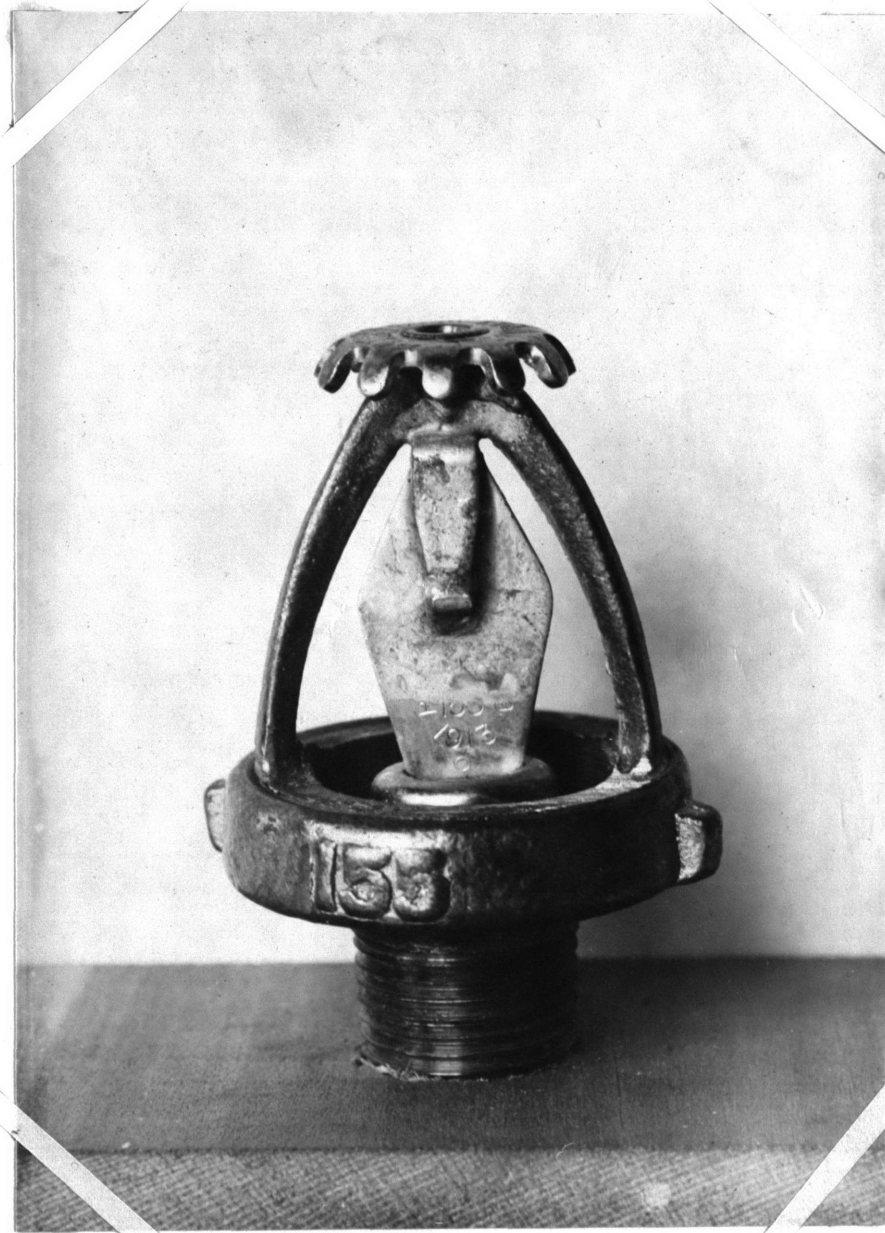
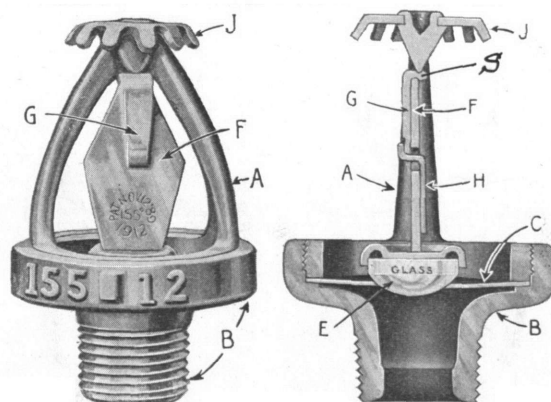
Grinnell, Improved, 1903.

Diaphragm C was thrust out by the ice, and lever G was sheared off at point S. The glass valve E was not broken in any of the tests.

All other five heads failed in a similar manner, viz: by shearing at point S.

When tested for pressure, the lever sheared at a pressure of 400 lbs. per sq. in. These heads failed at a low pressure owing to the large area exposed to the water under the diaphragm.

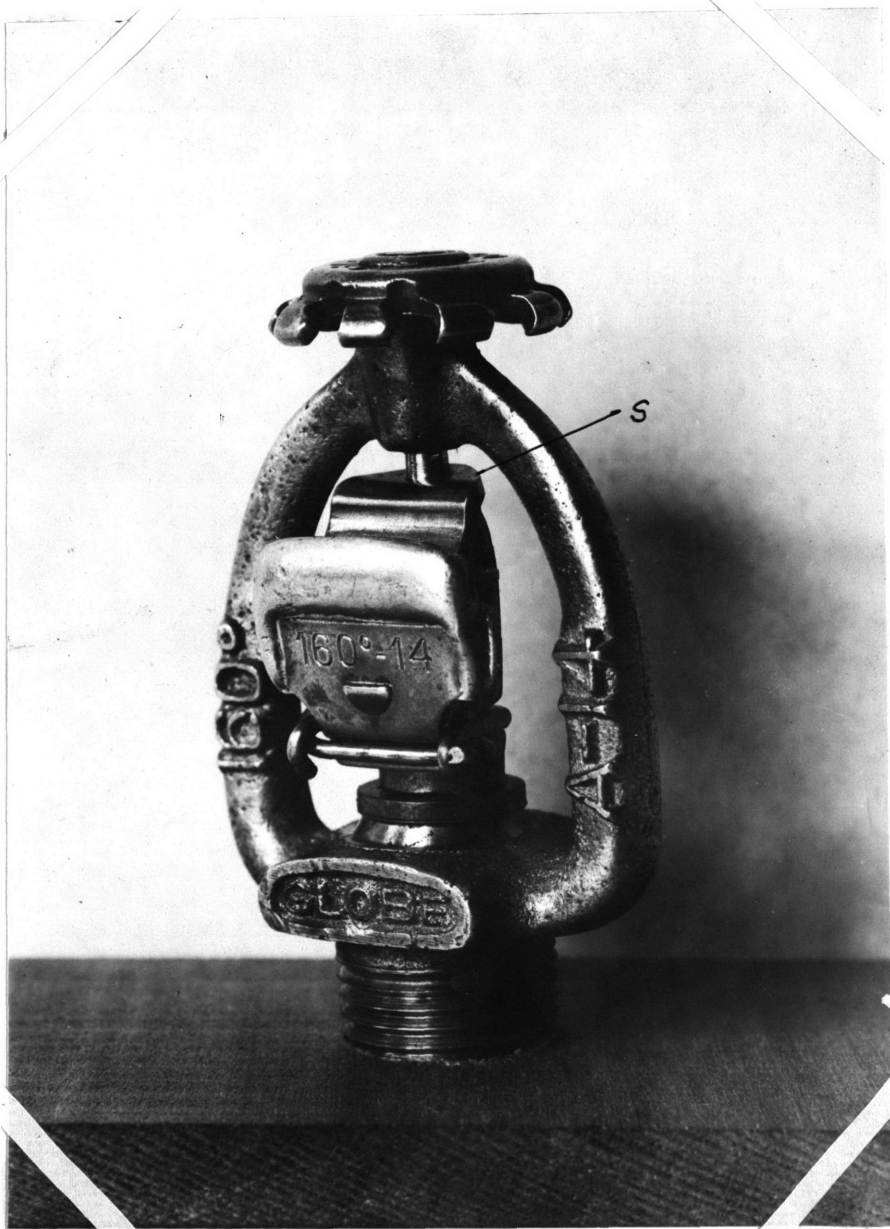
Garrett, Issue A.

Three tests on this type of head resulted in each case in distorting lever S, directly under its supporting seat. This sheared in such a manner that the valve of the head was loose, and could be turned around with the fingers.

In this case the head leaked at a pressure of 2 lbs. per sq. in., and would therefore have to be replaced by a new head.

Two other tests showed no effects in the head, the leakage pressure being as high as 1400 lbs. per sq. in.

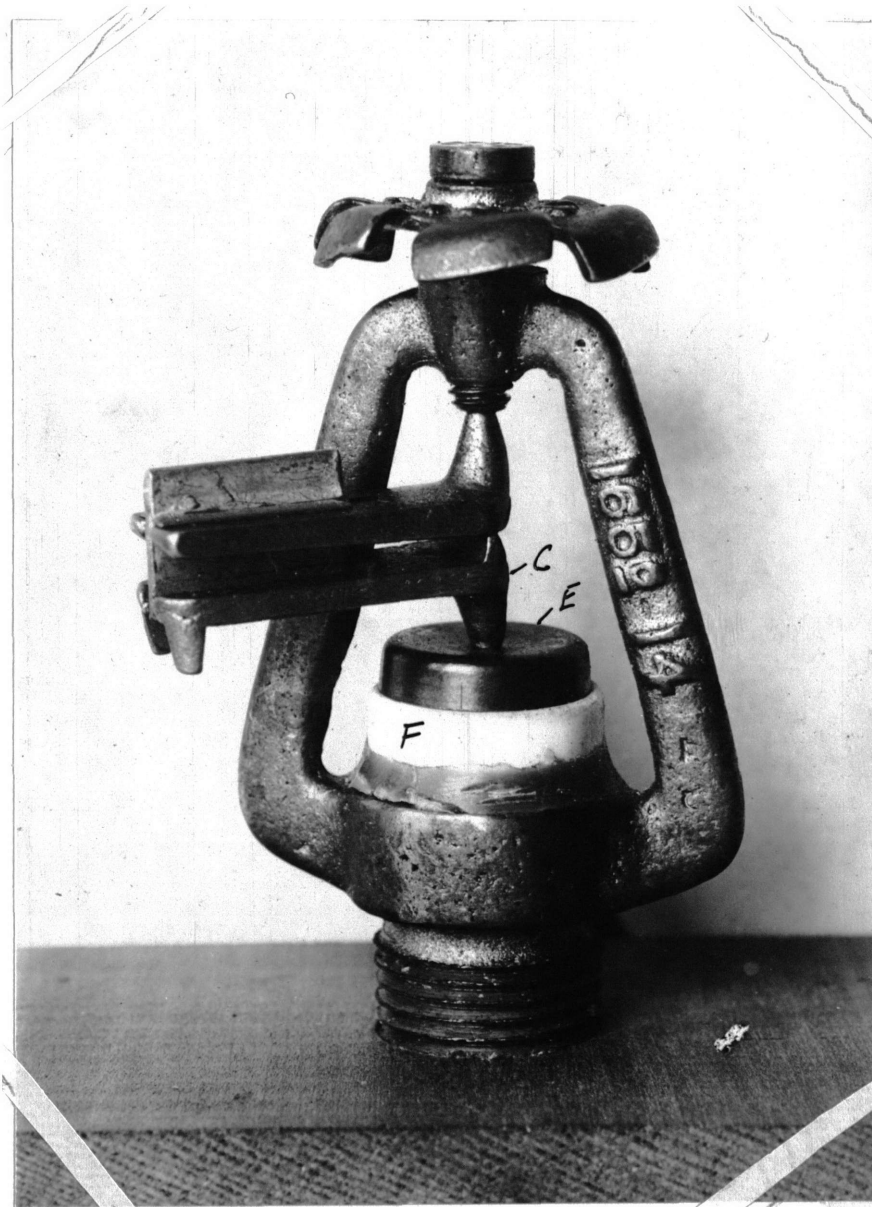
Manufacturers, Issue C.

In four tests made, the thrusts of the ice caused the point of arm C to crush into cap E. This cap is a hollow button which bears on a porcelain valve F. By crushing cap E, the ice thrust the valve off its seat entirely, and allowed full flow.

One other test showed a weakened head, resulting in a leakage pressure of 50 lbs. per sq. in.

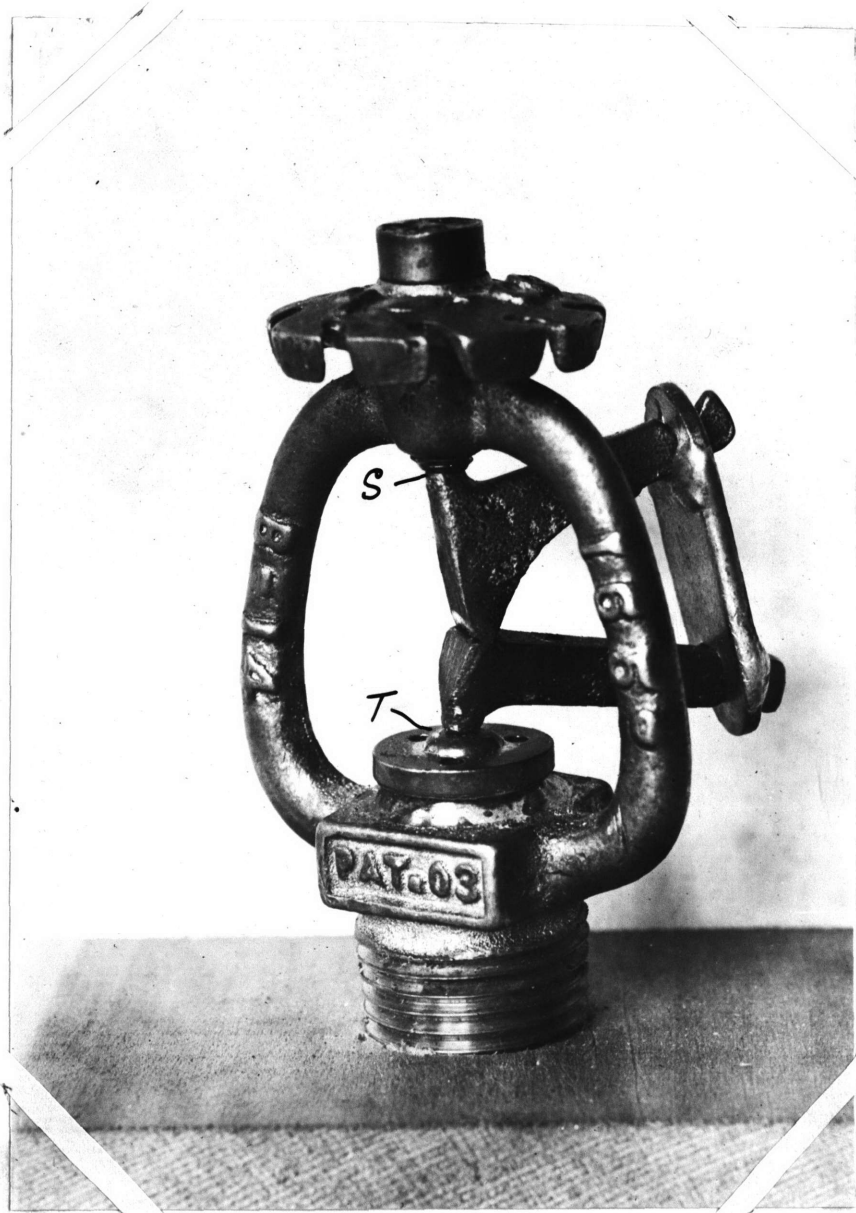
International, Issue B.

As a result of freezing two heads of this type, the thrust was taken on points S and T. The levers at these points were compressed enough to allow the force of the ice to thrust the valve from its seat; thus allowing full flow of water when thawed.

One test showed no effect on the head, and the leakage pressure was 1200 lbs. per sq. in.

Two tests bruised the levers sufficiently to loosen the valve, and leakage pressure, in both cases, was 10 lbs. per sq. in.

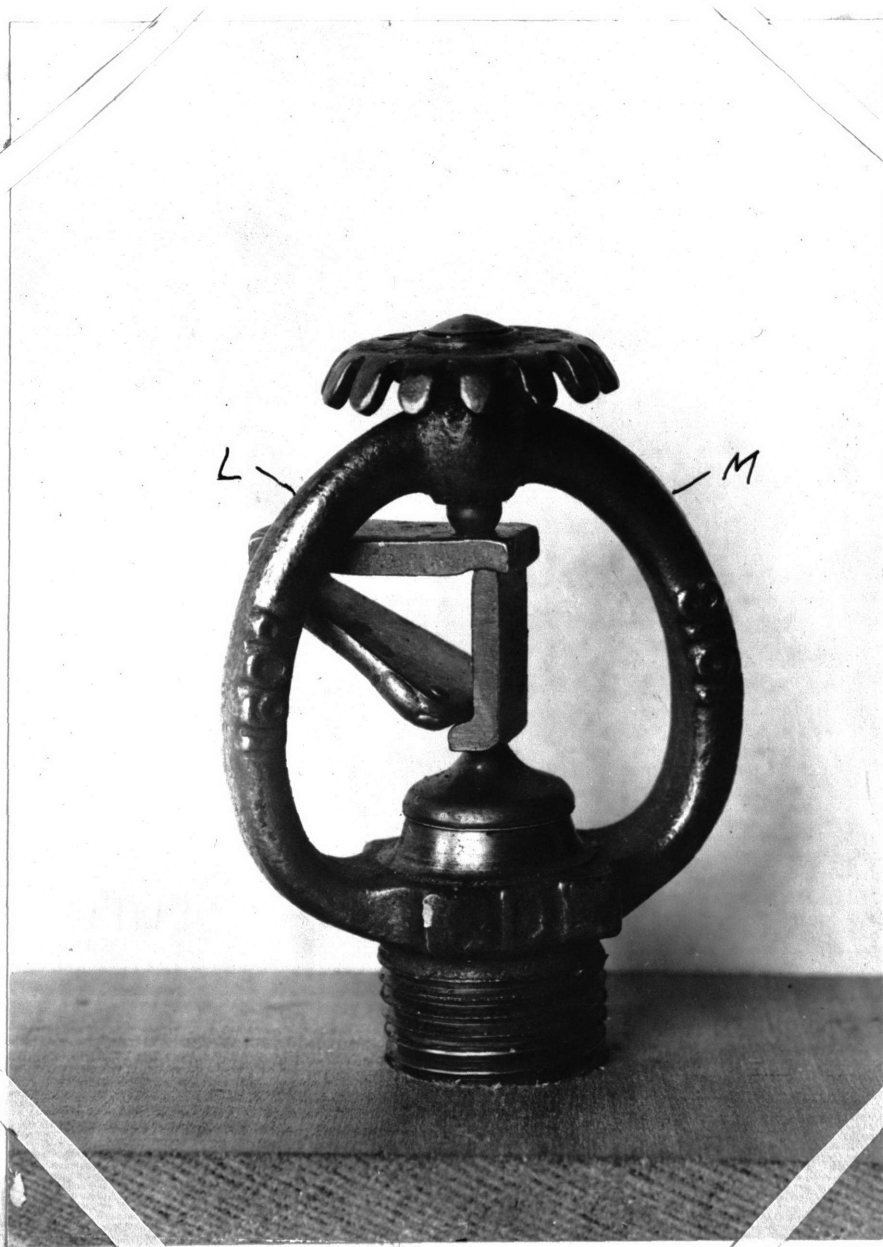
Rockwood, Issue D.

The result of freezing this sprinkler head expands the German Silver diaphragm, placed between the valve and seat, and, as a rule, ruptures this diaphragm.

It is claimed by the Rockwood Company that this diaphragm takes care of any expansion due to freezing. The results of tests show that this was true in two tests out of five.

In the other two tests the parts were picked up, and no marked defects were found on the valves or links. In this case the arms, L and M, must have been elongated enough to allow the valve to fly off its seat. In one case the tee, six feet from the head, was burst; thus relieving the valve of the high ice thrust.

The leakage pressure in the two previous cases was as low as 15 lbs. per sq. in.

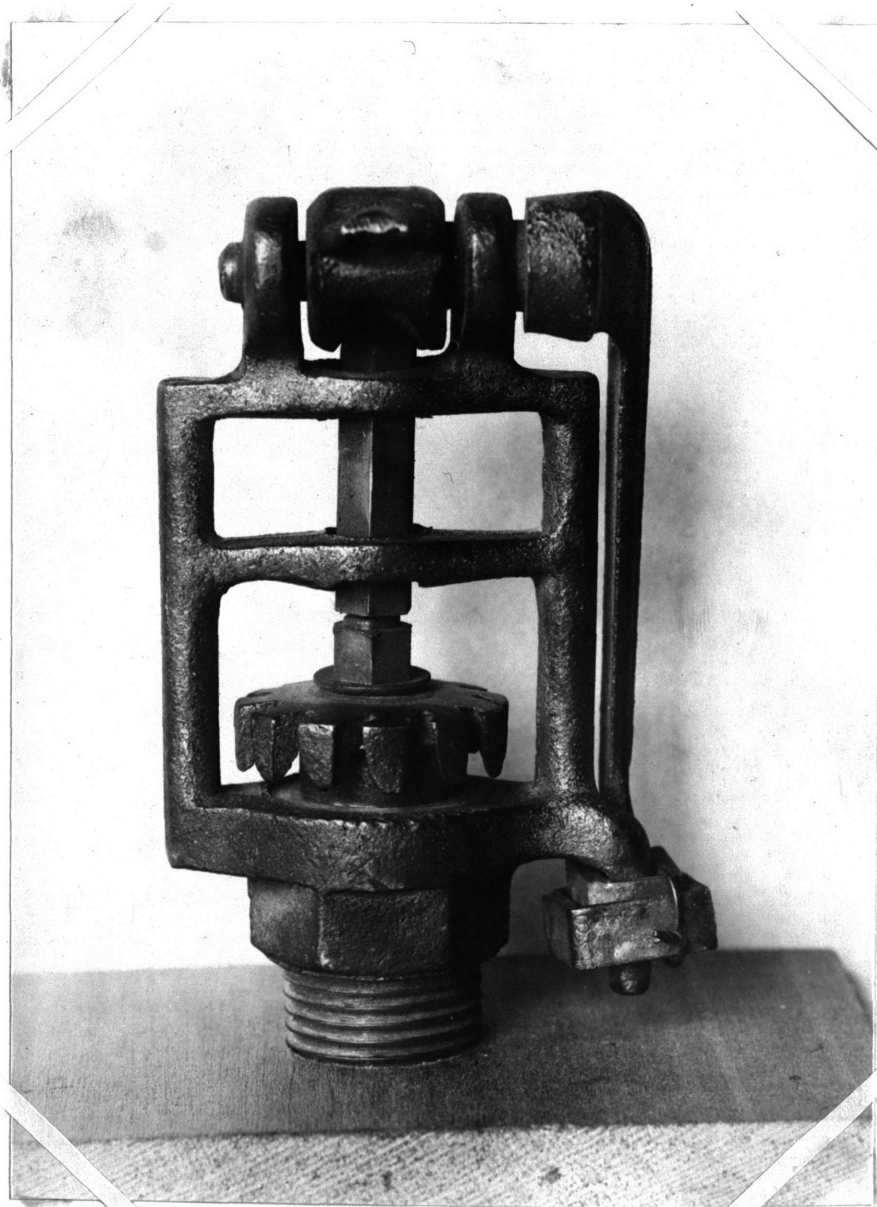
Walworth.

Two heads were all that could be obtained of this type. The freezing seemed to have no marked effects on the head.

This type of head is one of the first manufactured in this country, and at present is not approved by the Underwriter's Inspection Bureau of New England.

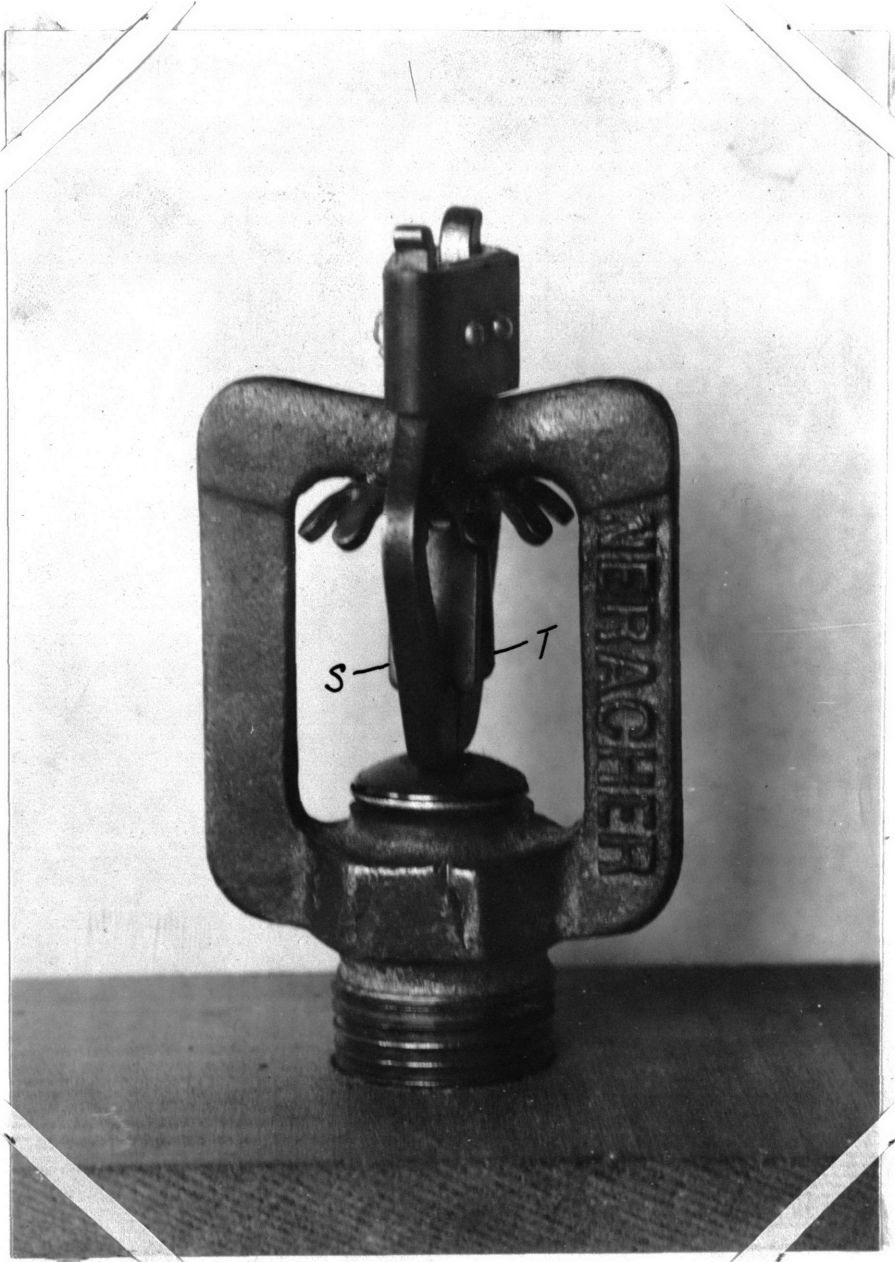
Neracher, Improved, 1902.

Four tests on this head opened the valve completely. The pressure of the ice compressed the struts S and T. One other test resulted in the valve reseating, offset on its seat; thus allowing water to pass freely between the valve and the seat.

When tested for pressure, a perfect head leaked at 750 lbs. per sq. in.

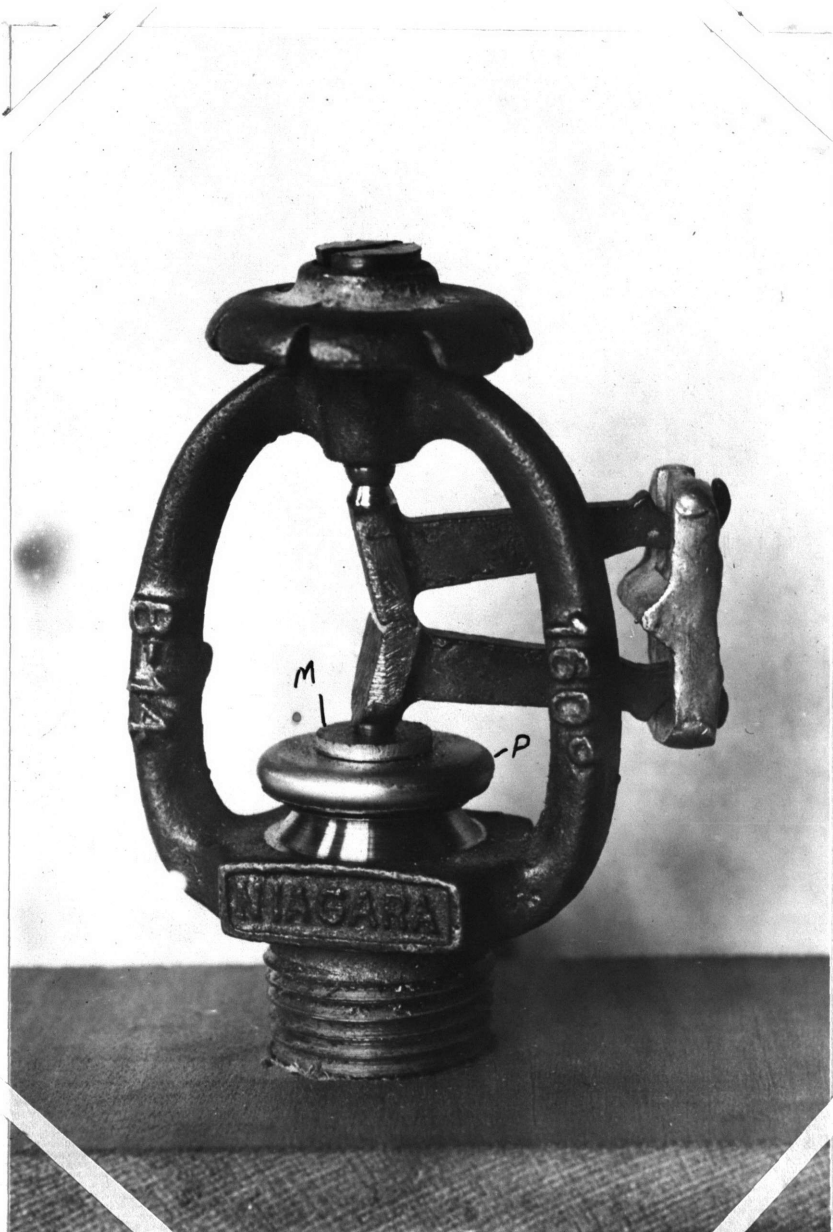
Niagara, Issue B.

The valve of this type of head was completely opened in four tests out of five. The thrust of the ice was taken up by the disk M crushing into the valve P. This valve is a hollow ^{German Silver}~~pressed steel~~ button.

The fifth test weakened the head resulting in a loose valve, with leakage of 5 lbs. per sq. in.

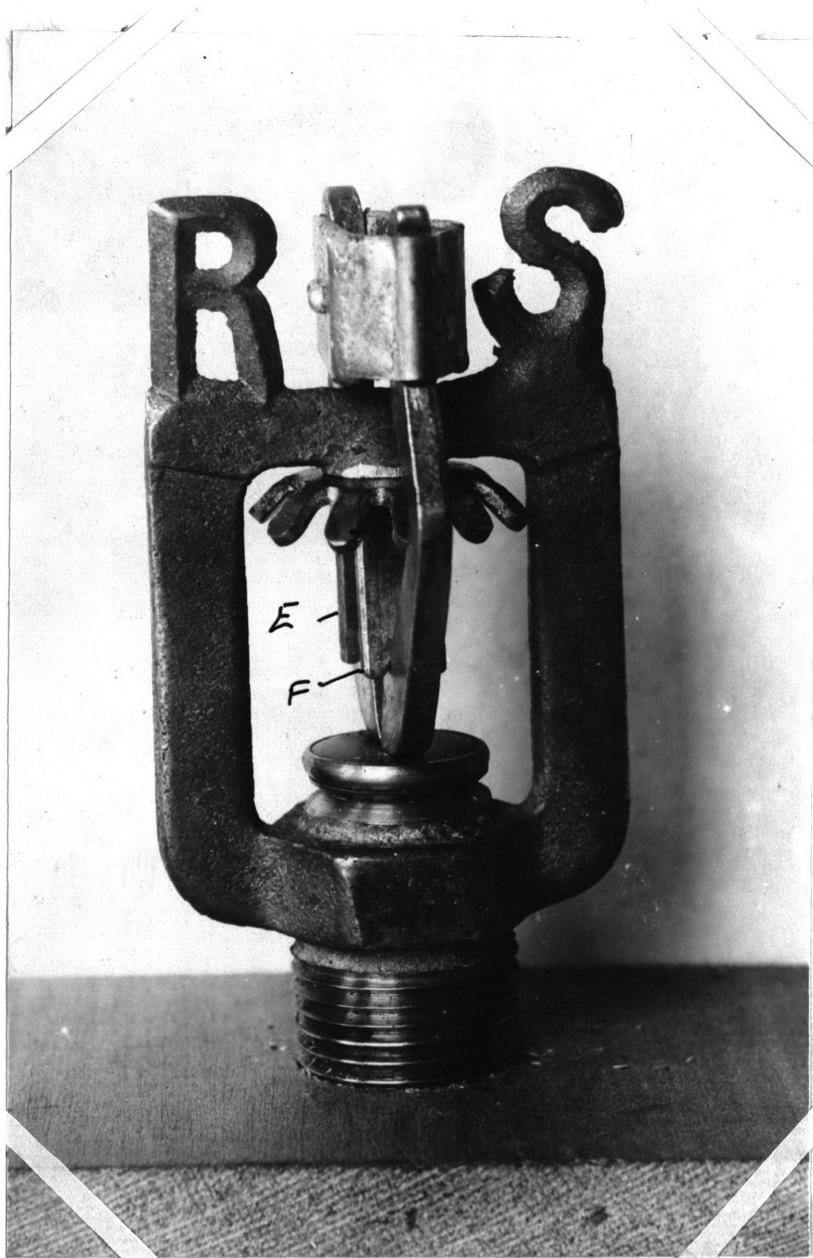
Rundle Spence, Type A.

This head is a copy of the Neracher, and therefore the results of tests made are very similar.

Three tests on this head resulted in the valve opening completely. Struts E and F being compressed into their seats, allowed the valve to shear by its seat.

Two other tests resulted in the valve reseating offset on its seat; and, although this would not be noticed until the ice thawed, it allowed water to pass freely between the valve and the seat.

Leakage pressure of this head was at 700 lbs. per sq. in.

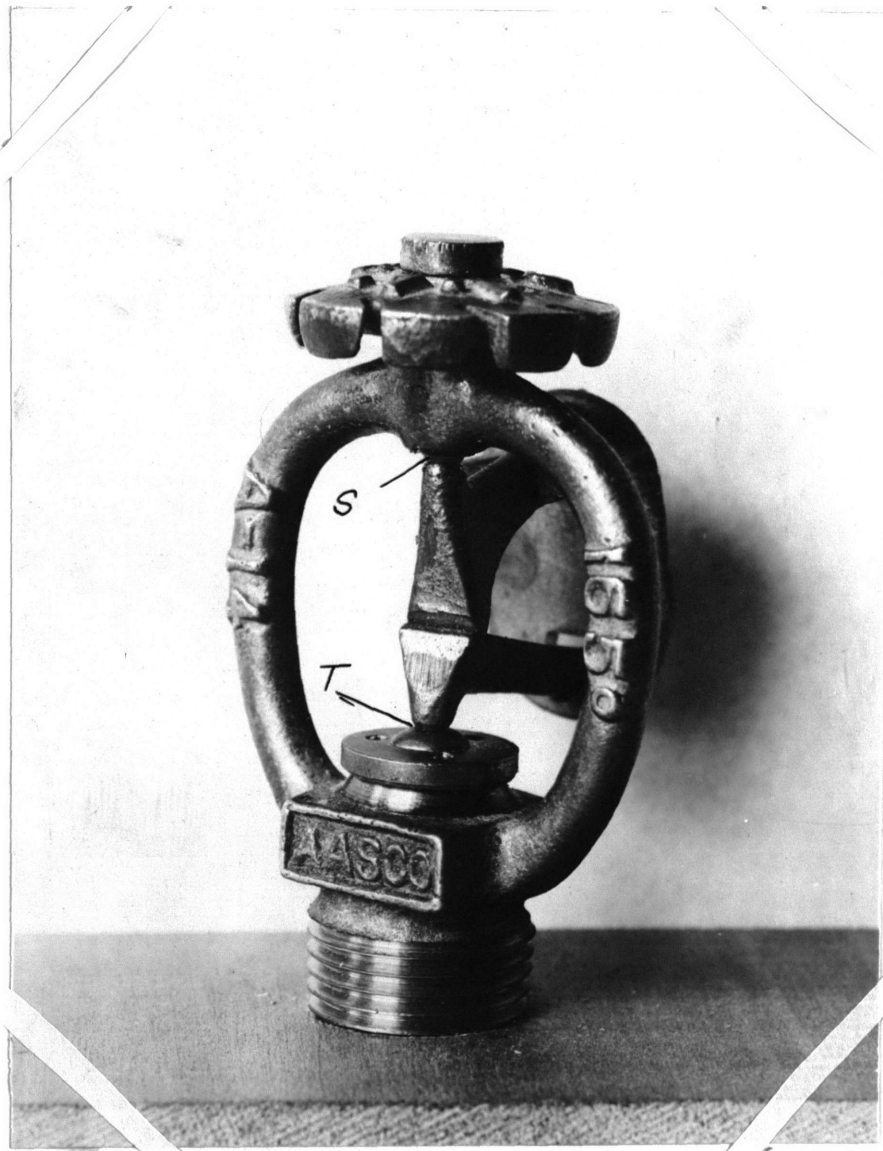
Associated, Type A.

The result of freezing these heads caused defects very similar to those observed in the freezing of the International Sprinkler Heads.

The thrust of the ice was taken on points S and T, in three tests out of five. The arms at these points were crushed sufficiently to allow the force of the ice to shear the valve from its seat, giving full flow. The other two tests showed no effects on the head, although the valve was loose on its seat, allowing a leakage pressure in these cases of 5 lbs. per sq. in.

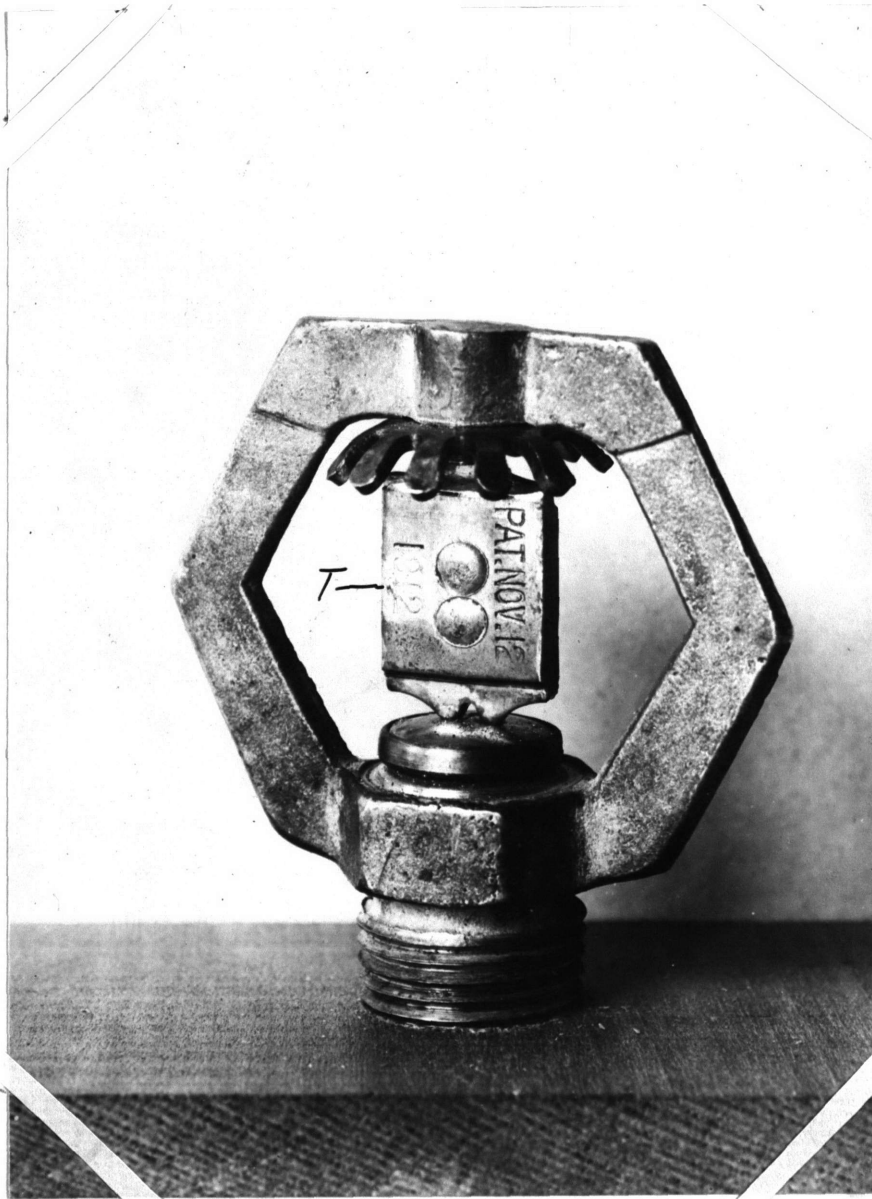
Rundle Spence, Type B.

This appeared to be one of the strongest heads tested. Two cases of freezing resulted in the strut T crushing at the top and bottom, and caused the valve to be loose on its seat. The leakage pressure after freezing was as high as 50 lbs. per sq. in.

Three other freezing tests showed no marked effects, and the water pressure rose to 1200 lbs. per sq. in. before leakage occurred.
