Damage Levels – Comparison of Experiment and Simulation

V. Kain, CERN, Geneva, Switzerland

Abstract

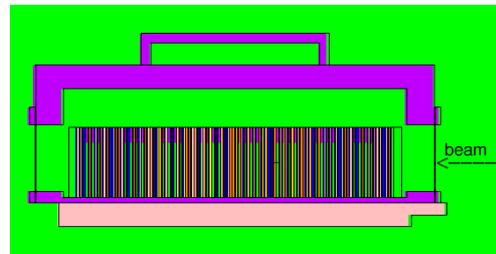
The geometry of the target was implemented in FLUKA including every relevant detail of the double confinement [6], see Fig. 6.

Figure 6: The model of the target implemented in FLUKA.

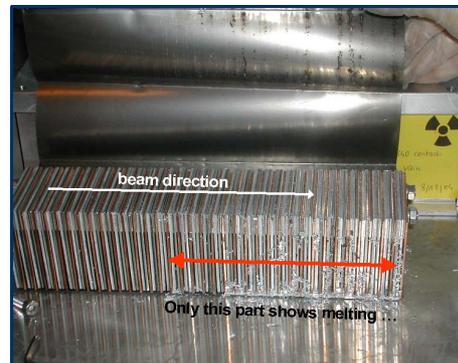
The outer confinement did not show any damage; the downstream part of the inner confinement did not survive. The first observations, after having opened the outer container and having removed the inner confinement, showed that the upstream plates had not been damaged. From package number 6 on more and more damage had occurred, see Fig. 10. These results agree with the simulation. No signs of stress related damage could be found - no cracks, no twisting, no buckling of the plates.

Figure 10: The core of the target after the test. On the more downstream part melted Zn can be seen.
