LHCb-2007-070
11 September 2007

VELO Module Production - Clean Room Layout, Procedures and Monitoring

LHCb Technical Note

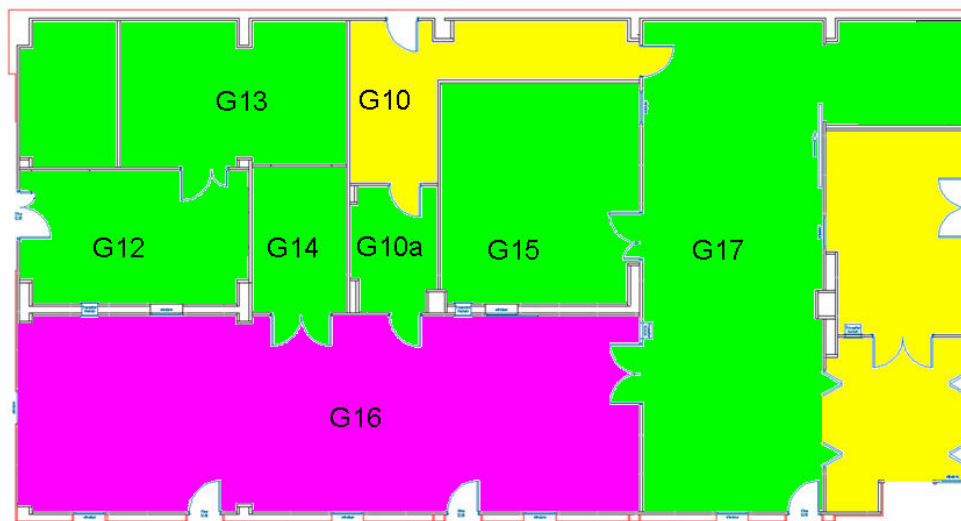
Figure 1: A schematic of the areas used within the LSDC for LHCB VELO module production. The cleanest area was Class 100 and is indicated in purple. The Class 10,000 areas are coloured in green and access areas are in yellow.

A view of the production area is given in Figure 1. The layout is critical to the safe production of modules. We describe in detail the layout of LSDC as arranged for the LHCB production. The cleanest area is the Class 100[1] area (ISO class 5 at present 14644-1 standard) which is maintained at an overpressure (relative to atmospheric) of 75Pa. The Class 10,000 areas (ISO class 7 at present 14644-1 standard) are maintained at 50Pa overpressure and the entry and egress areas are at 25Pa overpressure. (See also 6.1.2). Figure 1 also shows the room numbers (e.g. G10) which will be used in this document.

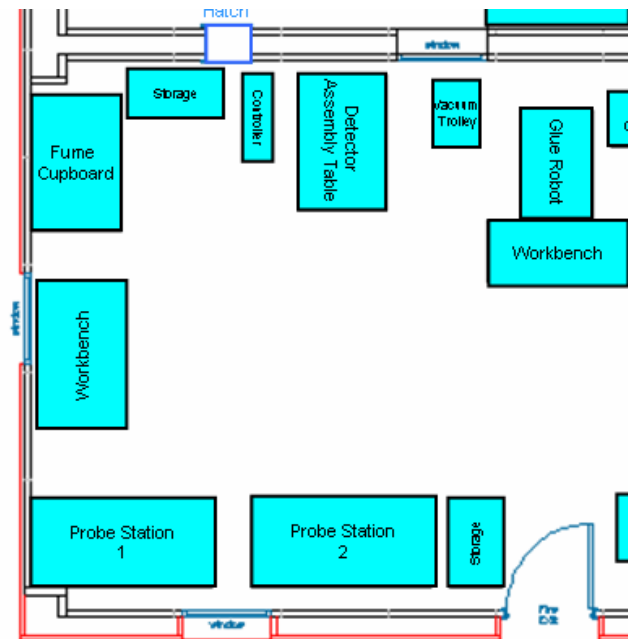
Figure 3: Detail of the Si and pitch adaptor testing zone of G16. Also shown is the gluing zone.

The testing of the silicon wafers and pitch adaptors occurred using the two probe stations (1 and 2) positioned at the lower left of the schematic – in the Class 100 area G16. The pitch adaptors were stored in clean boxes adjacent to Probe Station 2, see Figure 3. The sensors were stored adjacent to the fume cupboard.

The glue for the pitch adaptors and Si sensor and hybrids was applied by a glue robot in the gluing zone in G16. This was immediately adjacent to the assembly zone to allow the double sided gluing of the hybrids to proceed with minimum movement and to preserve the cleanliness of the sensor, see Figure 3.

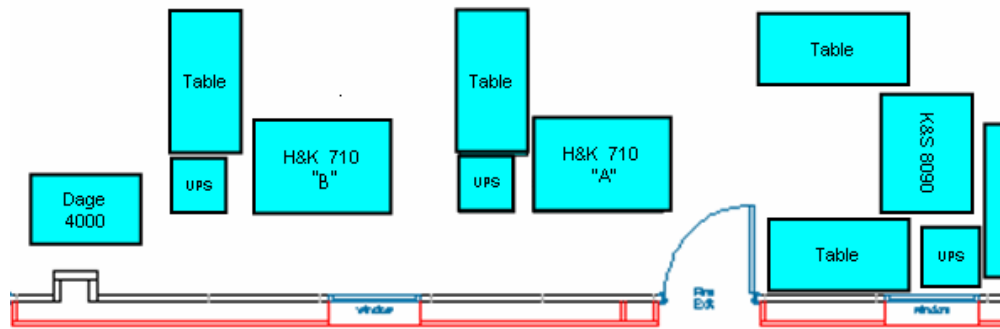
Figure 4: The layout of the bonding zone in G16.

The bonding was performed by two H&K 710 and a K&S 8090.[3-5]. The machines were located in the bonding zone. The zone also contained the Dage 4000 series wire pull tester used for quality control of the bonding process.

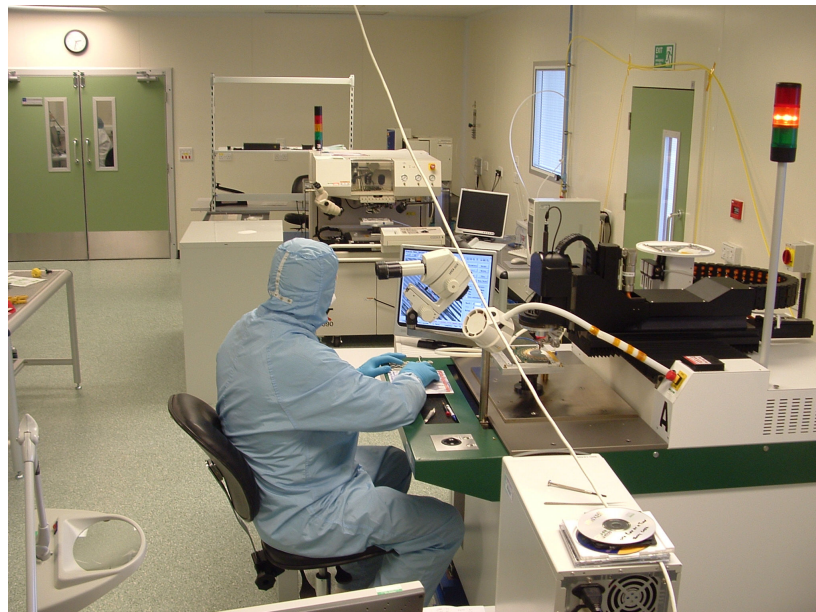
Figure 5: View of bonding zone showing H&K. The K&S 8090 can be seen in the background.

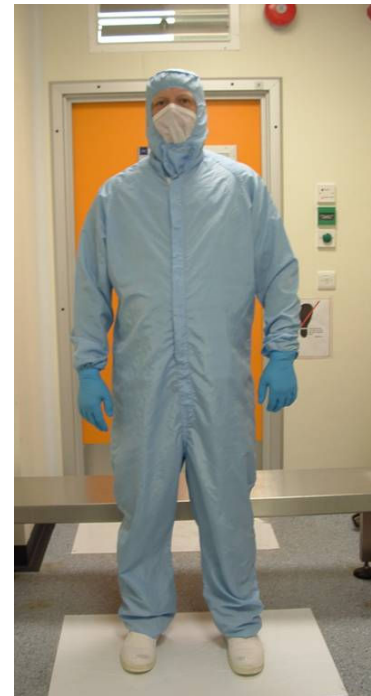
Figure 7: Dress code for Class 100 area.

- 3.2.1. Before entering G10 (lobby) from corridor step on tacky mat ensuring that the soles of both feet come into contact with mat and repeat several times.
- 3.2.2. Proceed from G10 to G10a (class 100 gowning area) again ensuring correct tacky mat procedure as above before entry.
- 3.2.3. G10a is the gowning room for the class 100 area. Firstly remove shoes (including any woollen garments) and locate dedicated coveralls, hood and class 100 ESD shoes from storage cabinet, these are clearly marked with unique

- personal numbers. Garment packaging should be inspected for tears before use.
- 3.2.4. Garments should be put on from top to bottom starting with face mask, veil or beard cover (ensuring nose is covered) and then hood. (use mirror provided to ensure hair is tucked in)

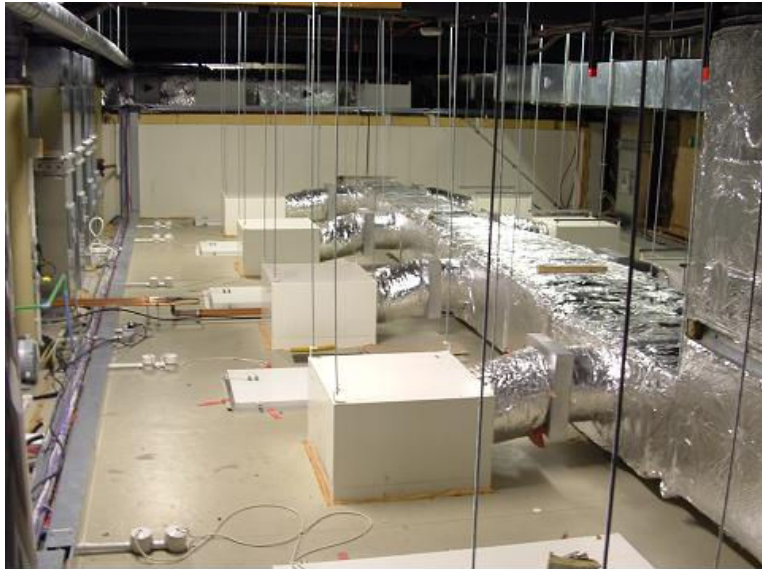
Figure 8: View of some of the plant room above the LHCB. Leaks in this area can damage equipment below.

Each of the three air handler units (AHUs) contains a heater battery, refrigeration unit and humidifier, in order to sustain a controlled environment within the cleanrooms. Any serious leak from this equipment could potentially damage equipment in the cleanrooms below. To safeguard and provide maximum forewarning against such occurrence, extensive bunding of the plant room

area was installed together with a sophisticated leak detection system. If a leak was detected both local and remote alarms to security control would be activated resulting in the cleanroom manager being notified via mobile phone. The system would also render itself safe by dumping all water in the system to waste, in order to minimise any damage.

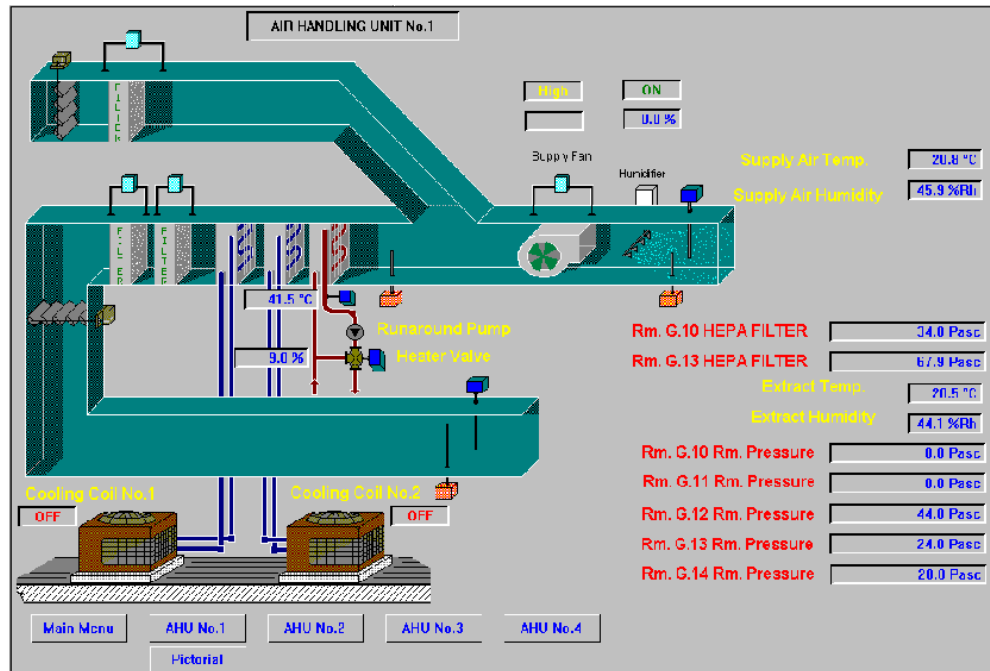
Figure 9: Control screen for the air handling units; this is displayed in G10.

As mentioned in section 2, the air pressure and room temperatures are controlled via a BMS, this being operated from a PC in G10. Alarms are in place for air flow and high room temperatures. A lack of air flow or excessive extract temperatures will trigger both local visual and remote alarms to security control. The cleanroom manager would be automatically notified and work would be halted.

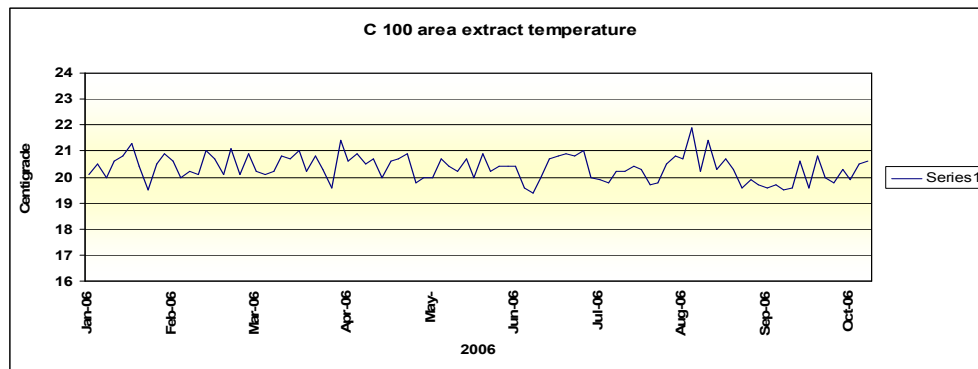
Figure 10: Temperature of the Class 100 area up to Nov 2007.

The temperature and humidity of the clean room were monitored and controlled. The temperature was kept stable to approximately $20 \pm 1^\circ\text{C}$ in the Class 100 area and approximately $21 \pm 1^\circ\text{C}$ in the Class 10000 areas. See Figure 10 and Figure 11.

This was important as precise gluing was required to maintain the precision of the modules. The tooling was predominantly made of aluminium and steel so the mechanical tolerances would be best if the temperatures during production were kept even.

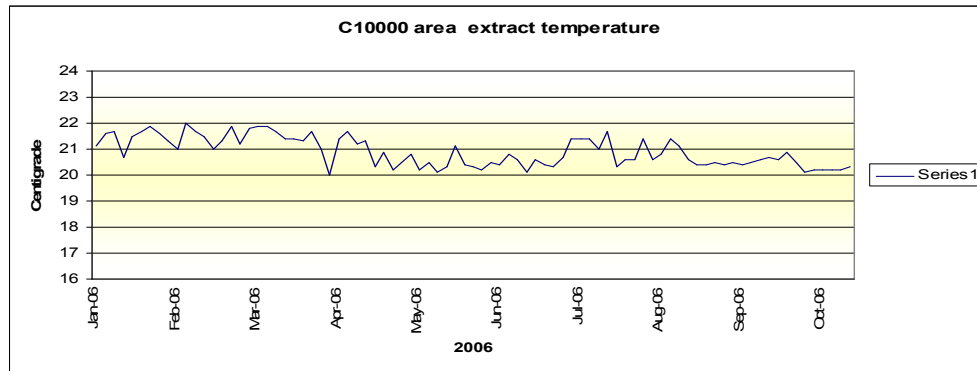
Figure 11: Temperature of the Class 10000 area up to Nov 2007

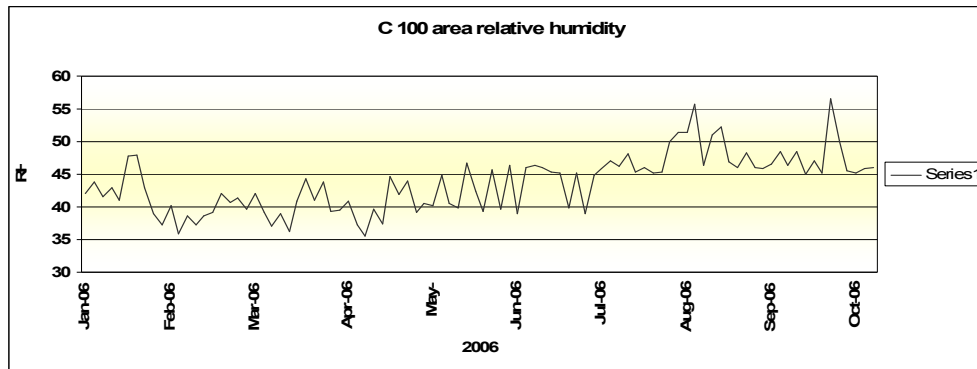
Figure 12 Relative humidity in the Class 100 area.

The humidity was also controlled although not to the same degree. The humidity varied between 35 and 55%. (See Figure 12 and Figure 13.)

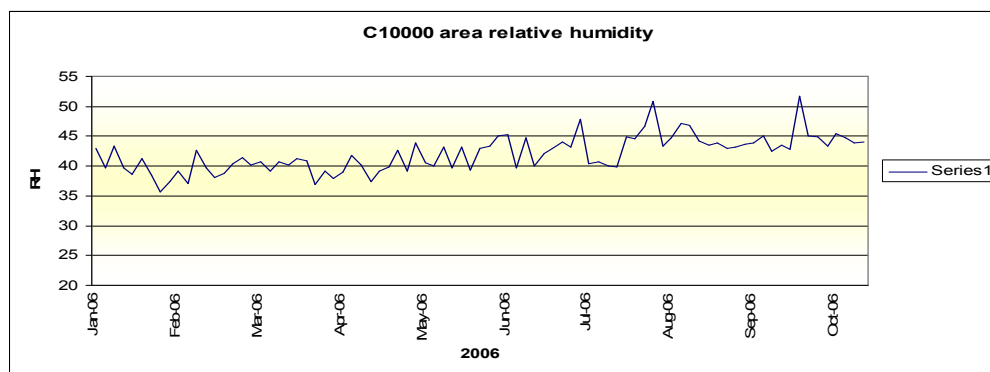
Figure 13: Relative humidity in the Class 10000 area.

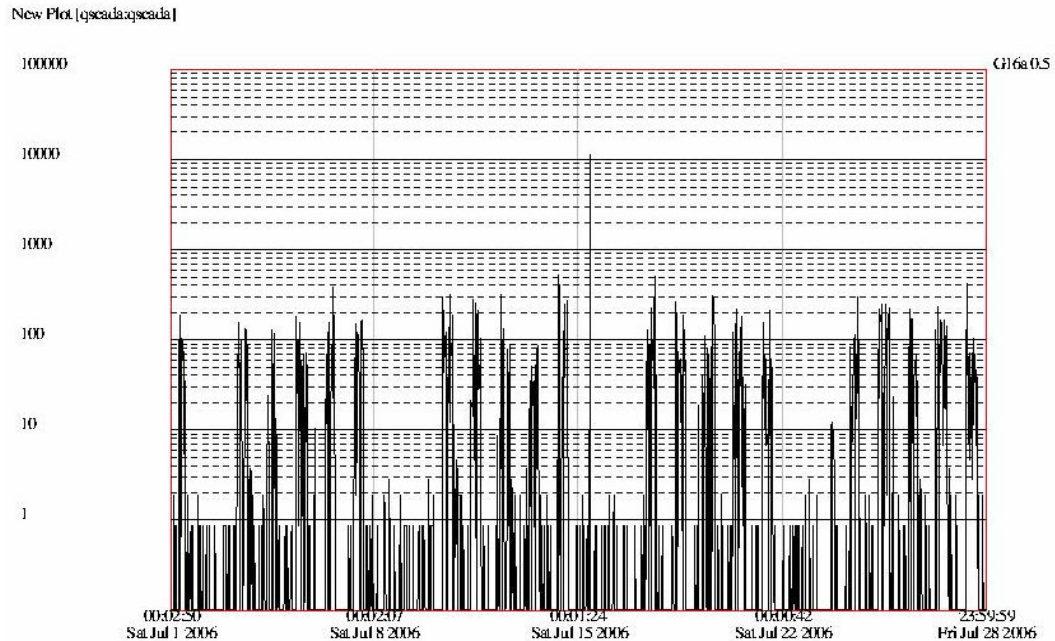
Figure 14: Particulate count in the Class 100 areas.

The clean room cleanliness was monitored through the LSDC. There were 5 sniffers placed in the ceilings and walls around G16 and also in each of the Class 10000 areas. These enabled the airborne particulate count to be measured. This acted as an immediate monitor of the conditions

inside the cleanrooms and warned if non-sanctioned materials were being utilized. Further spot measurements were made using a tripod mounted particulate counter. Results from a typical month (Jul 2006) can be seen in Figure 14. This clearly shows the effects of reduced manpower at weekends (typically either 0 or 2 people working over weekends) compared with 6 people in the Class 100 area during the week. Over the weekends the particulate count drops to Class 1 levels whereas during the working week it reaches approximately 200 0.5 microns particles per Cu ft.

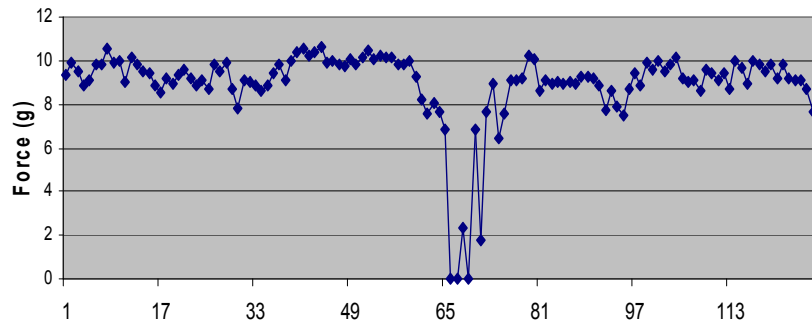
Figure 15: Wire bond strengths on the front-end of one chip. The weak bonds correspond to a period of vibration

An unexpected problem that manifested itself during production was that of vibration. Due to the narrowness of the pads used for bonding the H&K 710 machines were working at the limit of their resolution. Minor vibrations in the floor could cause an enhanced failure of bonds – or of weakened bonds as shown in Figure 15.

During the production period the building opposite the Oliver Lodge was suffering extensive severe renovation that produced large 10µm or greater excursions in the positioning of the bonds.

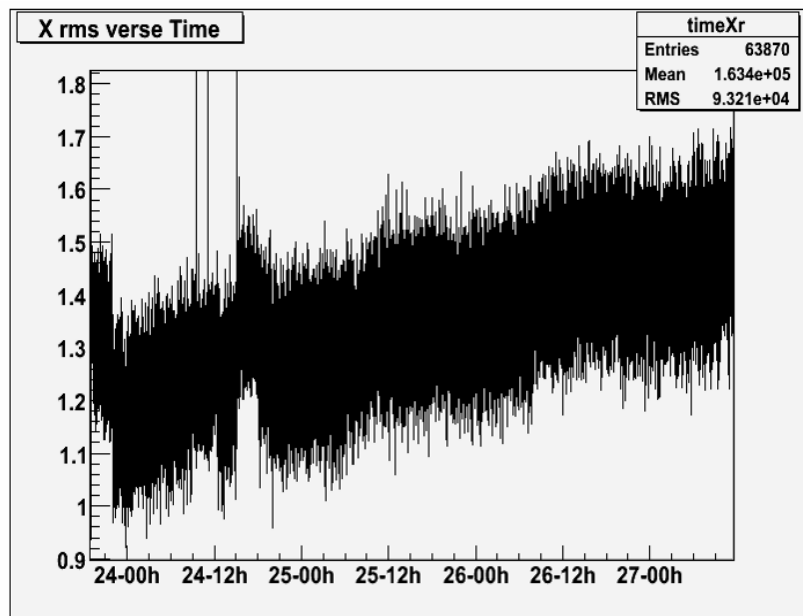
Figure 16: A display from the vibration sensor (Mac Notebook), showing a step which signified a period of vibrations in the clean room.

The cheapest device available was the 3D motion sensor on the Mac notebook, which could also display and record activity, an example is shown in Figure 16. The Mac was placed on the floor of the clean room and was visible to the bonders. In periods of activity (visible at the most sensitive scale of 0.02g) bonding was halted.

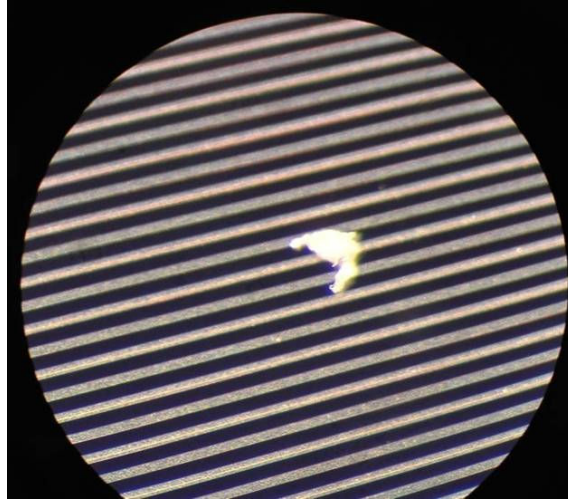
Figure 17: Contamination on a sensor "out of the box"

In particular the sensors were opened and immediately inspected. Many small white specks could be observed (at a rate of $\sim 1\text{cm}^2$) and we would contend that this was contamination from the manufacture. Typical contamination on a sensor is shown in Figure 17 and that on a chip Figure 18. This could not necessarily be blown off using a N₂. These particles have been seen on reception when parts arrive from Stevenage and Hawk On close inspection they appear to be sponge like and some seem to be tacky.

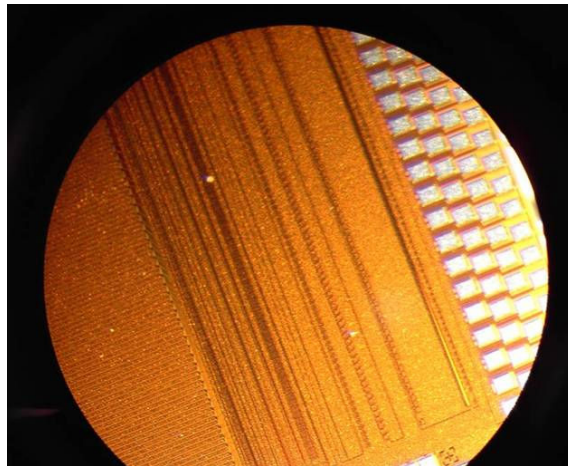
Figure 18: Contamination on a chip out of the box.

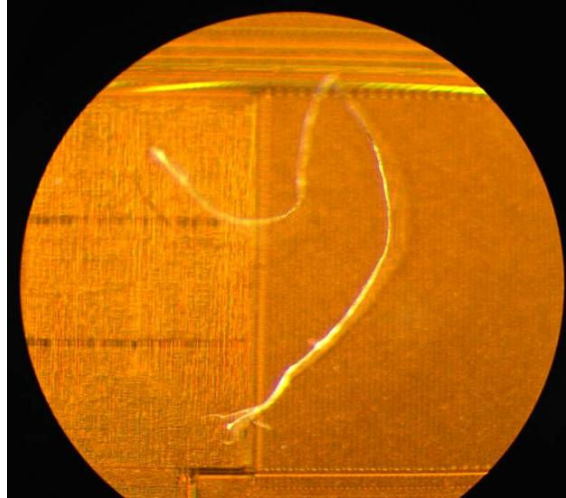
Figure 19: Fibre observed in a chip.

Another class of contaminants manifest themselves as strands, both fibrous (Figure 19) and sometimes translucent (Figure 20). Although it cannot be stated categorically it is believed that these emanate from work in the LSDC.

The strands themselves are peculiar in that close inspections shows them to be neither bond wire nor hair. One postulate is that they could be strands of glue produced during the gluing (or repair) process. Figure 21 shows (an unusual) case where glue has spread over the pads of a pitch adaptors. Bonding is only possible if this is removed. This can give rise to particulates or strands.

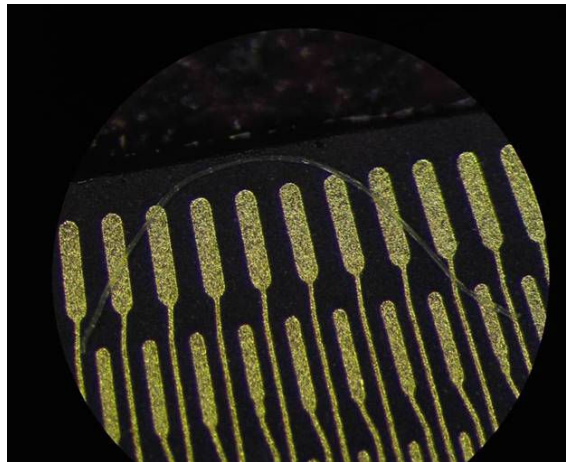
Figure 20: Translucent strand on a pitch adaptor

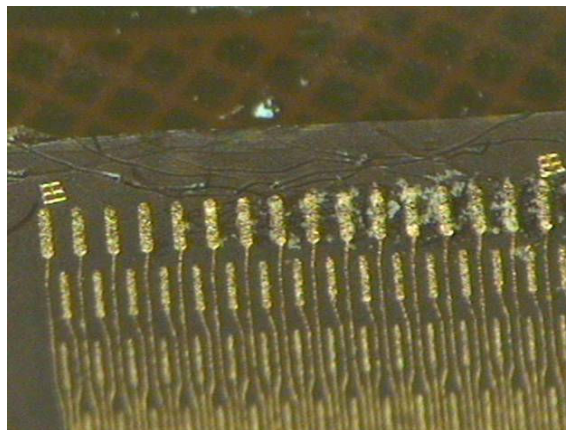
Figure 21: Glue on a pitch adaptor. Removal of the epoxy can lead to contamination.

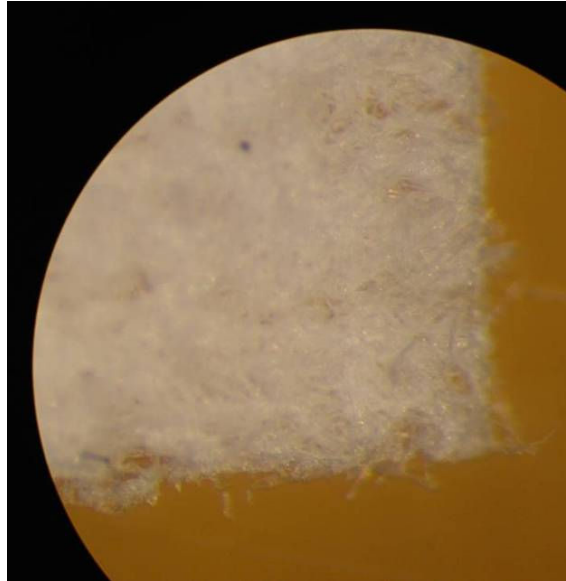
Figure 22: Photograph of original Class 100 wipes. These showed fibres at the edge.

An important source of contamination is believed to have been the original clean room wipes and swabs chosen for the LHCb production. These were all chosen to be Class 100 compatible. However closer inspection of the original wipes (see Figure 22) showed that there were fibres similar to some of those observed on the hybrids present on the wipes. These were non-woven wipes made from cellulose added to a polyester foundation (Cellulose – 55%, Polyester – 45%). These wipes were removed from the Class 100 area and subsequently only used for “pre-cleaning” in the Class 10000.

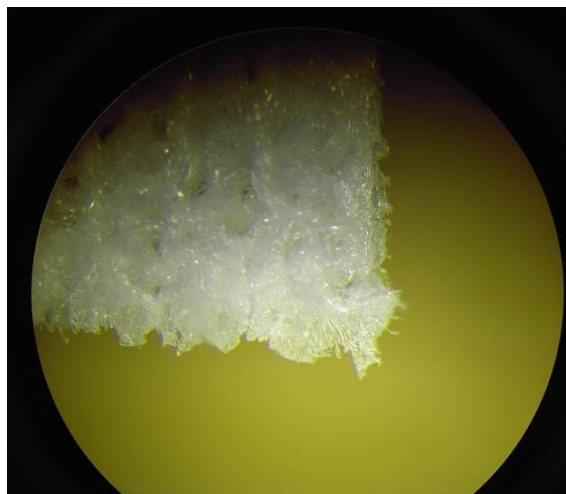
Figure 23: Photograph of the current Class 100 wipes

The wipes were replaced by a new brand of Class 10 compatible wipe which were found to shed substantially less than their predecessors. (See Figure 23) These wipes had their four edges cut and sealed by ultrasonic method, to prevent linting and scratching. They were 100% continuous-

filament double knitted polyester wipe. In addition they were also processed and packaged in double bags in a Class 10 clean room.

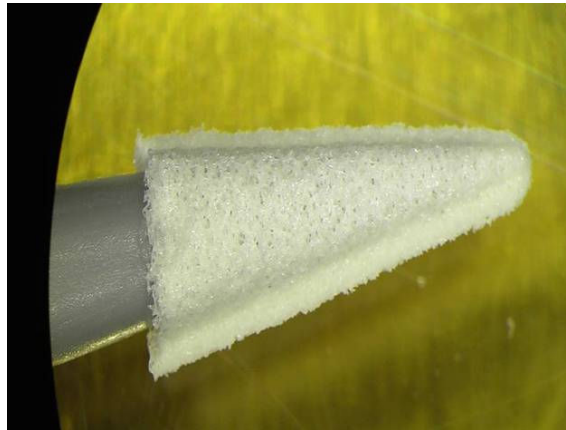
Figure 24: Photograph of TV757B2 swab.

Two types of swabs, the cleanest of their kind were selected; typical use included placing chips and removing contaminants. The first was the “TX757B2” flexible head paddle with a compact handle. See Figure 24. This had a Micro clean foam of 100 pores per inch and was composed of an open cell polyurethane foam. This was observed to only generate very low levels of non volatile residue and particles. The second type of swab also used was the TX741B semi-rigid head paddle, compact handle swab. See Figure 25. On the TX741B the heads are thermally welded on to polypropylene handles without any contaminating adhesives. These are the cleanest foam swabs available.

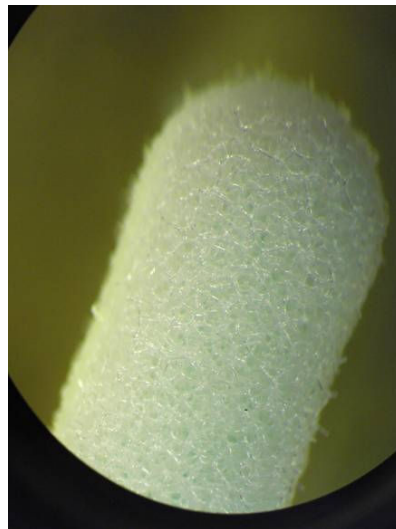
Figure 25: Photograph of the TX741B swab.

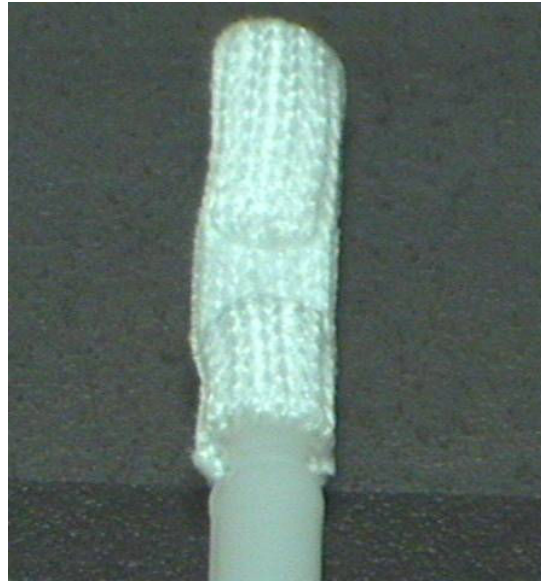
Figure 26: Photograph of the Constix SP-5 swab.

Further research into suitable swabs resulted in a type sourced from the U.S.A. This product being Constix SP-5 shown in Figure 26, the head being constructed from a sealed polynit polyester cleanroom fabric (similar to that used in C10 polyester wipes). These swabs were found to

produce exceptionally low residue and particulate levels, and were ideal for applications of critical contamination sensitivity and use with harsh solvents.
