Aging in the LHCb Outer Tracker

MASTER THESIS

Vrije Universiteit
Faculteit der Exacte Wetenschappen
Particle- and astroparticle physics master
De Boelelaan 1081a
1081 HV Amsterdam

November 2007

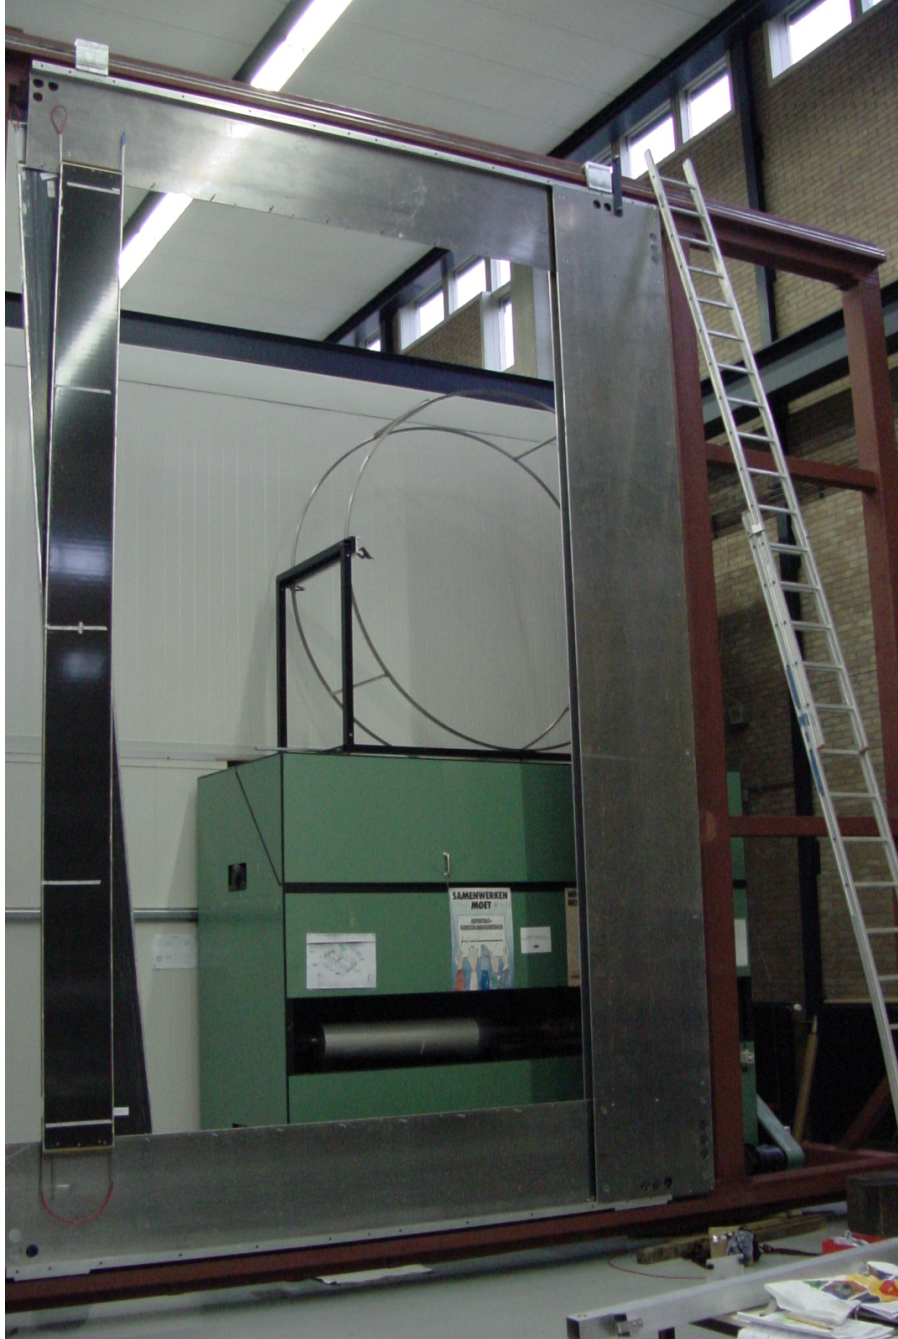
Figure 1.2: *Two LHCb Outer Tracker modules in two different layers in a C-Frame. In the actual LHCb setup, the Outer Tracker will consist of 12 C-frames, six on either side of the beampipe*

Figure 1.2 shows two F modules of the LHCb OT in a so-called C-frame, similar to the frames used in the actual setup. The two modules are placed in different layers in this picture. Two C-frames are placed on either side of the beam pipe, such that one full layer contains 14 F modules, and 8 smaller S modules. More details on the setup can be found in chapter 2.

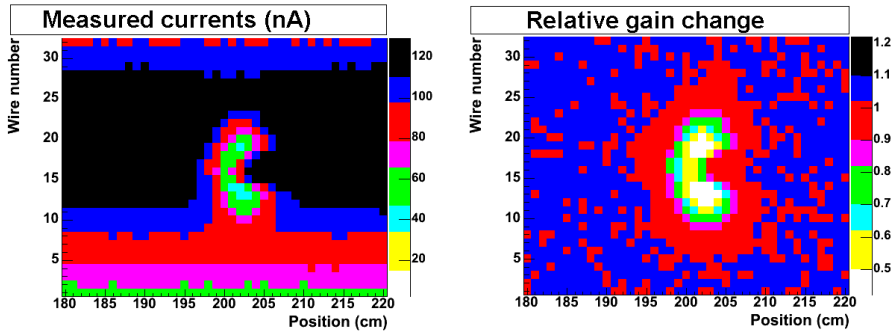
Figure 1.3: An example of the gain loss observed after irradiation with a $2mCi$ ^{90}Sr (spherically symmetric) source. The left graph shows the current in nA (color scale) per wire (Y axis) when the scan source was at a given position (X axis). The right graph shows relative change of the detector response after irradiation. The gas flow goes from left to right. [Module 99, 23/04/2007]

The aging pattern (the area where the currents are lower) has a crescent shape. Surprisingly, the gain loss is not the largest directly below the source, where the intensity is highest. Furthermore, the damage is not symmetric, since most of the damage appears to be left of the source position. Considering the gas flow, which goes from left to right in Fig. 1.3, this means most of the damage is upstream of the source. These two characteristics have been observed in almost all aging tests done with LHCb OT modules. Many other drift chamber detectors also experience aging effects in certain circumstances, but these characteristics have rarely been reported.

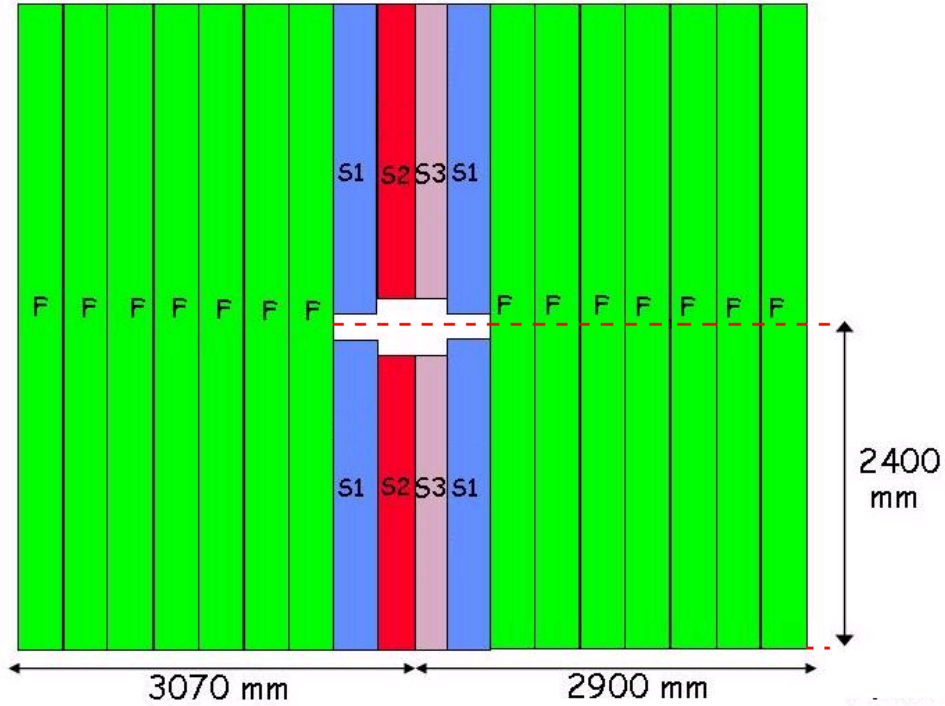
Figure 2.3: *The module arrangement of one layer of the LHCb Outer Tracker. The cross in the middle will be covered by the Inner Tracker detector. The beam pipe traverses the detectors in the center.*

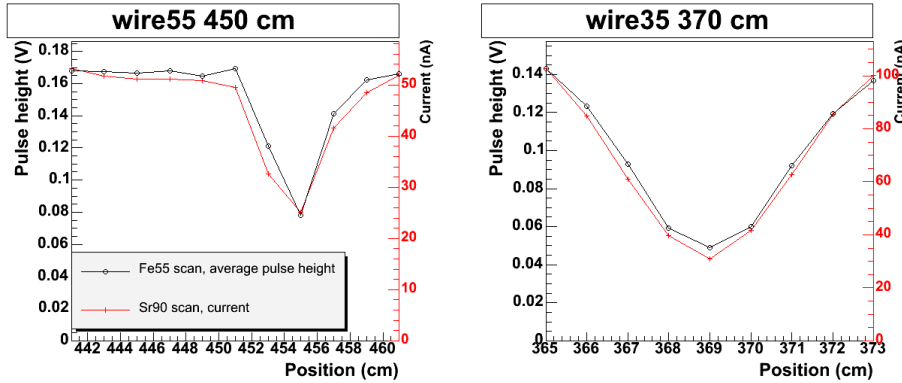
Figure 4.3: *The currents and average pulse heights measured per wire on a module with several areas with gain loss, measured with a ^{90}Sr and a ^{55}Fe scan respectively. [Module 30, 25/04/2007]*

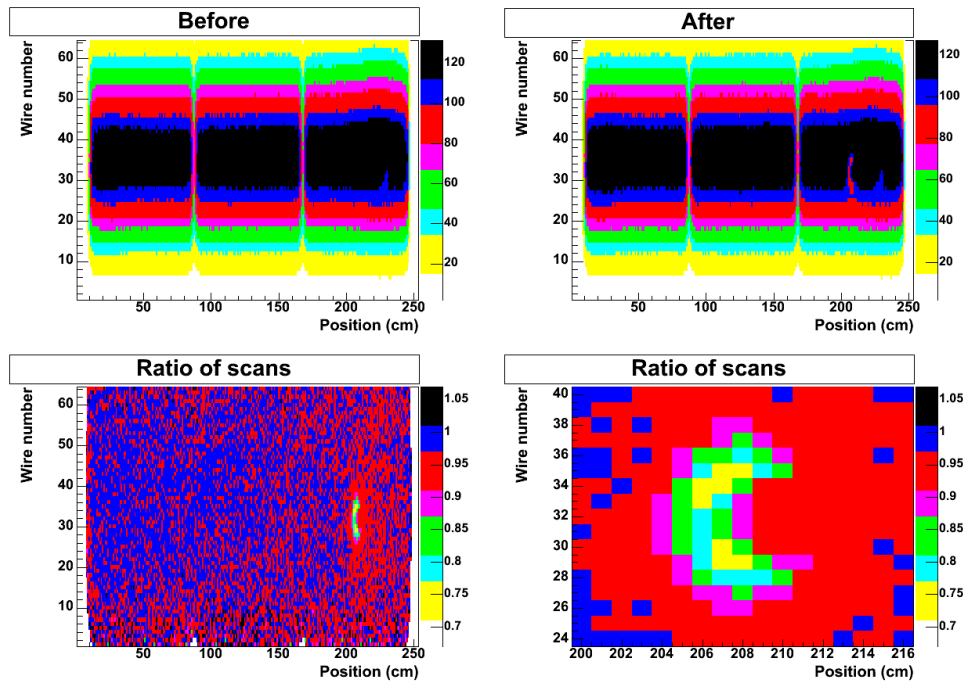
Figure 4.5: *The results of scanning a module before and after an irradiation test with a 2mCi ^{90}Sr source, placed at 208 cm above wire 32. The gas flows from left to right. The results of the scans are shown in the top, where the color scale notes the currents in nA. The lower graphs show the values of the division of the top two graphs. [Module 58, 31/01/2007]*

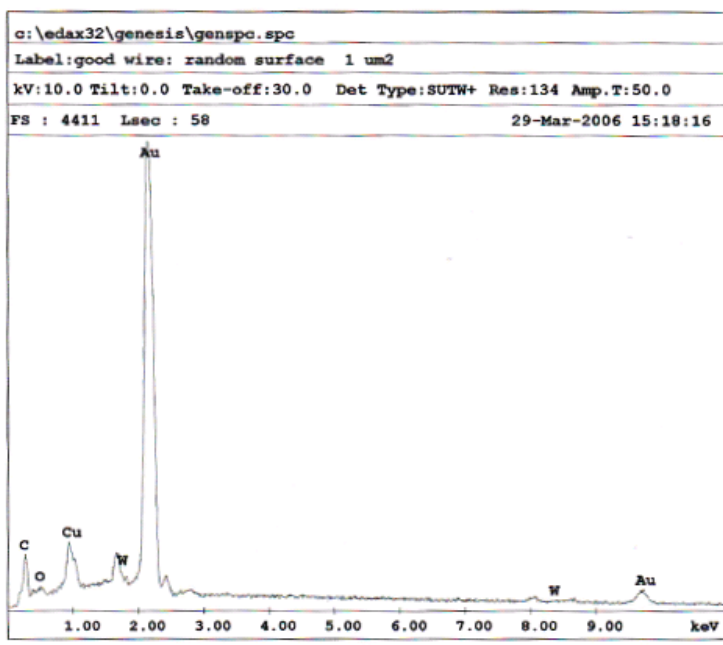
Figure 4.8: *EDX analysis of a normal wire.*

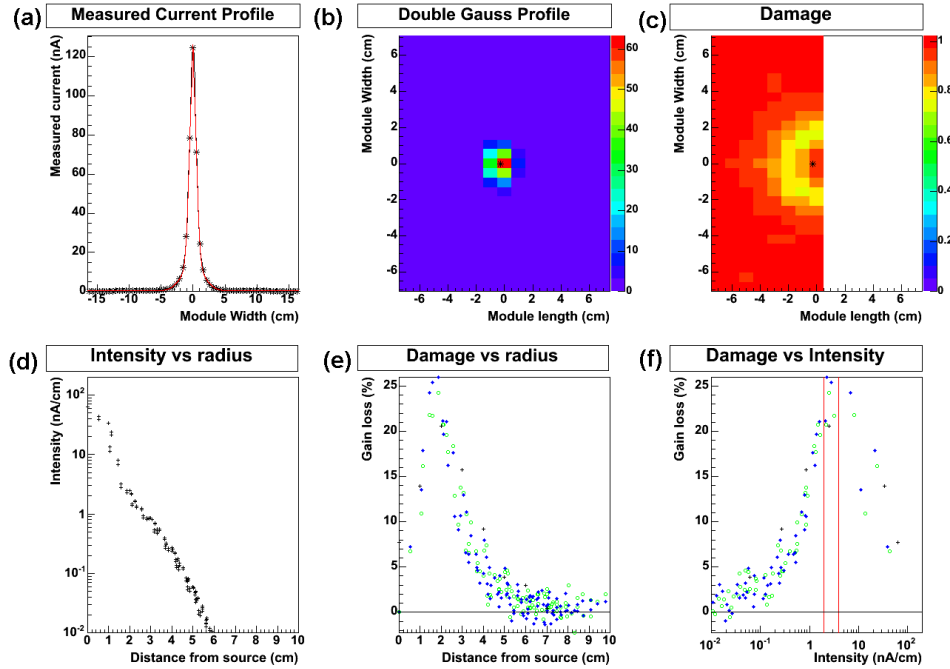
Figure 4.10: *An analysis of a typical 20 hour irradiation with the $2mCi$ ^{90}Sr source. [Module 58, 31/01/2007]*

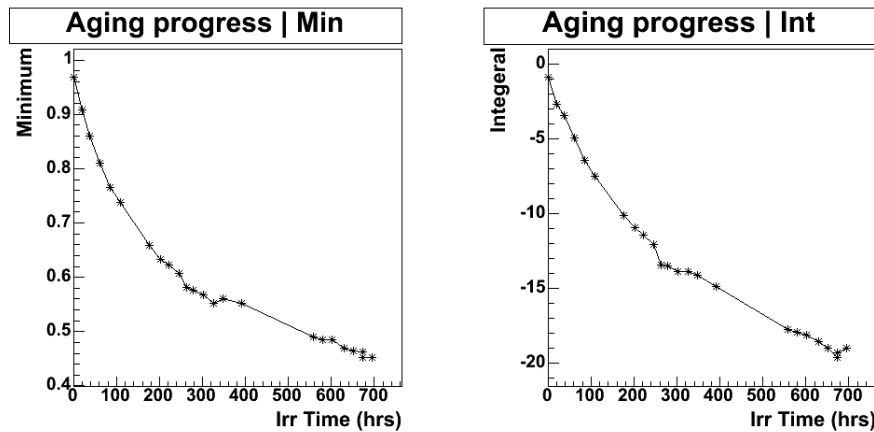
Figure 4.15: The amount of aging, measured with the minimum and the integral method, as a function of irradiation time.

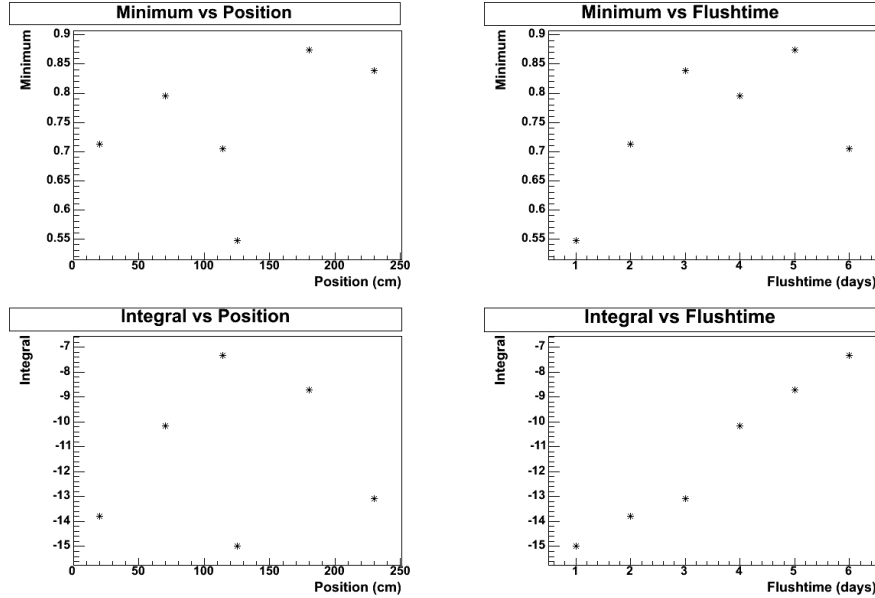
Figure 4.17: Aging as a function of position and flush time, measured with the minimum and integral method. The values are corrected for small differences in irradiation time. [Module 3, 13/04/2006 - 18/04/2006]

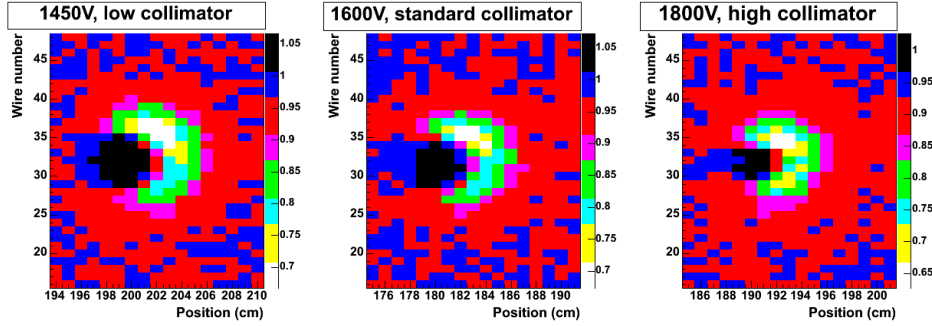
Figure 4.18: Aging measured at various voltages. The different collimators provided comparable source profiles. The chronological order of these irradiations was: 1600V, 1800V, 1450V. [Module 3, 17/04/2006 - 27/04/2006]

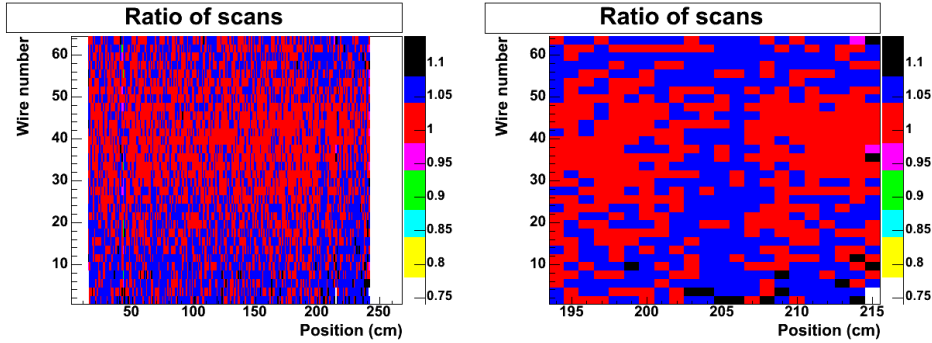
Figure 6.2: *The ratio plots of the openable chamber, after 300 hours of irradiation with the 20 mCi scanning source. The source was placed at 204 cm. The right plot is a zoom of the irradiated area. [Module 501, 18/12/2006 - 02/01/2007]*

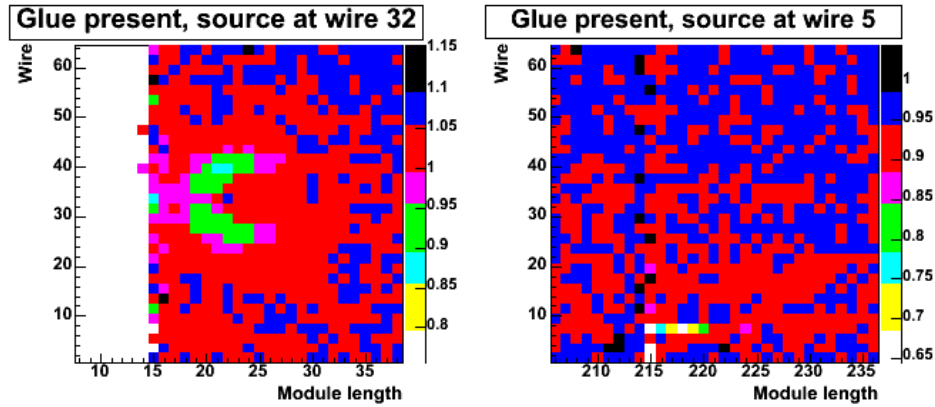
Figure 6.5: Scans after 20 hour irradiations of module 501 with glue inserted. The gas input is on the left of the module, at 0 cm, and the gas flows from left to right. The left irradiation is done at 23 cm, close to the gas input. The right irradiation is done at 221 cm, close to the gas output. [Module 501, 11/06/2007 - 14/06/2007]

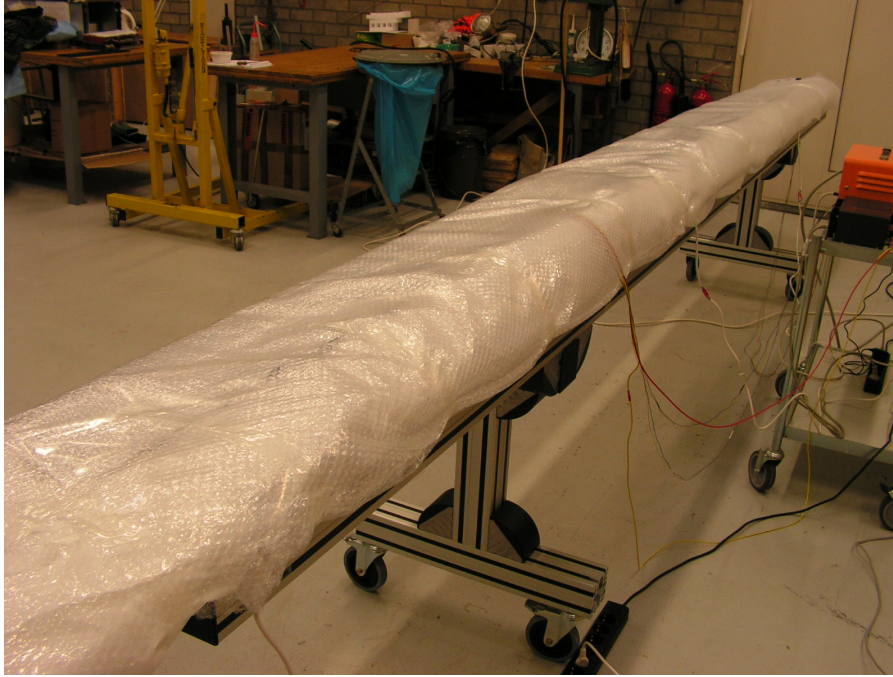
Figure 7.2: *The setup used for heating modules at NIKHEF.*
