ATLAS Pixel Detector System Test

Abstract

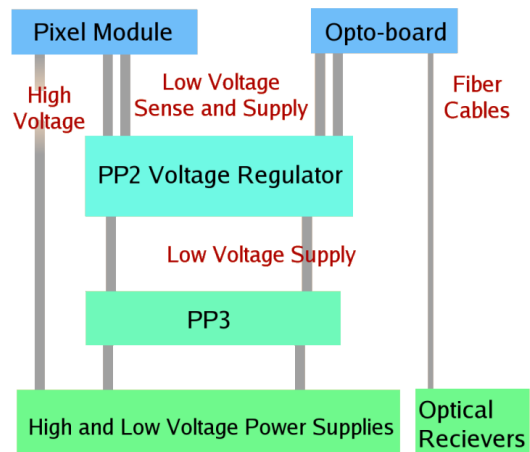
A host of electrical and cooling services are needed for the operation of the pixel detector, and these are shown in Figure 1 for one pixel module. The service cables pass through a series of patch panels between the pixel detector and the counting room. Patch Panel 0 (PP0) is the interface from the pixel modules to pixel services and is integrated into the pixel detector assembly. The interface between the pixel assembly and the rest of the world is Patch Panel 1 (PP1). The low voltage regulators are located at PP2, approximately 10 meters from the detector center. PP3 is a cable interface located on the scaffolding of the atlas cavern. The final step is PP4, in the counting room itself, where the cables are routed to the proper power supplies and interlocks.

Figure 1: Electrical and optical services for one module

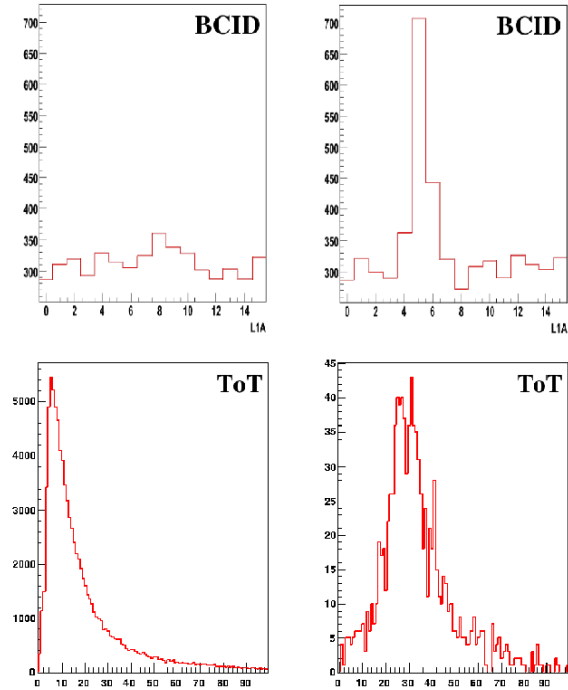
Shortly after the start of cosmic data taking, the first evidence of real reconstructed tracks appeared. This appeared in the form of the module trigger timing and in the ToT distribu-

tion, shown by Figure 2. In both cases, a clear difference could be seen between events with random triggers and events with cosmic triggers. The reconstructed tracks from the cosmic data were then compared with those from the Monte Carlo data as shown in Figure 3. The agreement was good, except for the presence of a few noisy pixels which caused false tracks to appear. Once the dead and noisy pixels were taken into account the data matched the Monte Carlo as expected [4].

Figure 2: Left: noise triggers, Right: Cosmic triggers [2]

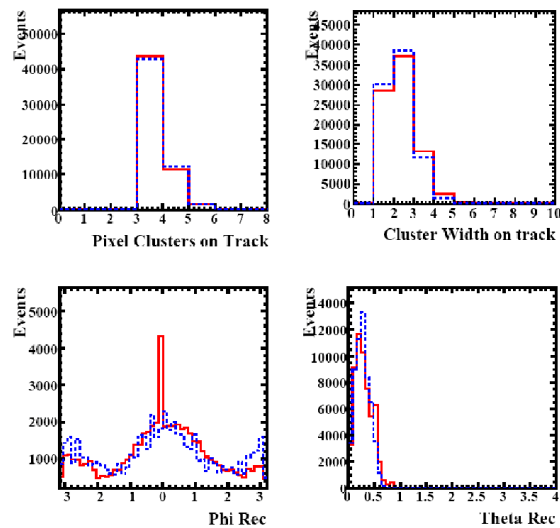
Figure 3: Solid: Cosmic data, Dashed: MC data [4]
