## ENHANCEMENT OF EXTERNAL WALL DECORATION MATERIAL FOR THE BUILDING IN SAFETY INSPECTION METHOD

**Abstract.** As buildings wear out, external wall tiles or attachments will usually fall off, sometimes causing human injuries. At present, the method employed for middle-high rise buildings is mainly the method of visual inspection. The inspection results in using this method are affected by the factors of subjectivity, safety and cost. This study aims to provide a lower-cost and more efficient evaluation method for inspecting the status of buildings' external walls. This proposed method implements Forward Looking Infrared (FLIR) technology and high-resolution photographic equipment on Unmanned Aerial Vehicle (UAV) which can improve the image recording of the detection process, as well as the overall visual detection technology, and solve the existing visual detection problem of inspectors. Also, the images detected by visual inspection and UAV high-resolution video are used to develop a suitable visual evaluation process and test table for external walls. Through the test results of several cases, the deterioration status and needs for maintenance are taken into account according to

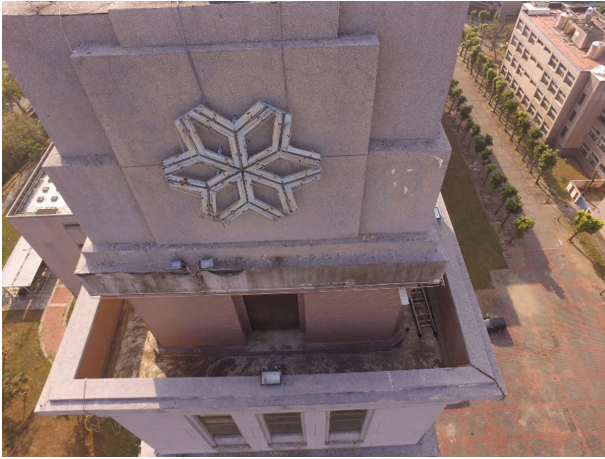
Figure 5. Overhead photography by UAV's camera

Regarding the discussion of the effective visible inspection height, currently all cases chosen are over eight floors high. The fuselage remains stably controlled and the sampled images can be taken through head-up photography and overhead photography. In Figure 5, the remote and timely inspection method added with the high-resolution image can be used to obtain and magnify images, as shown in Figure 6. In addition, by comparing the side-shooting and the real-time UAV inspection, as shown in Figure 7, the proposed detection method can also use the infrared thermal imager to detect the difference in the image, as shown in Figure 8, and then use the UAV image to increase the accuracy of detection position, as shown in Figure 9. By means of real case detection, images are obtained by the image transmission system and information screen-

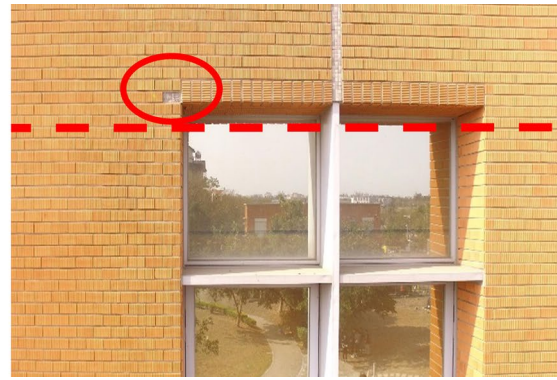
ages, annotation method in the CAD is adopted to serves as a basis for estimating the size and range of the damaged area and subsequently improving the accuracy and completeness of detection results, as shown in Figures 11(a) and 11(b).

Figure 11(a). The sample of the original CAD

Figure 11(b). The sample image by aerial photography

degrees, as shown in Table 3. In this study, the deteriorated area of exterior walls is estimated by comparing the CAD layer with the images of exterior wall verification, which contributes to evaluating the deteriorated area. This study also provides a comprehensive evaluation method to estimate the deterioration status of exterior walls based on the grading scores of degree and impact given in the evaluation.

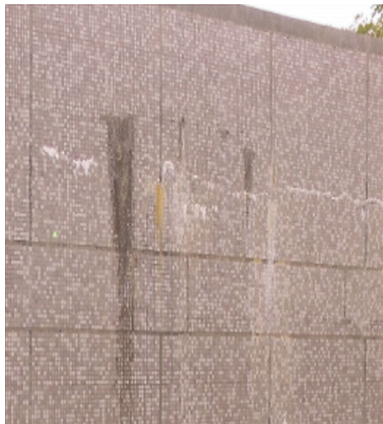
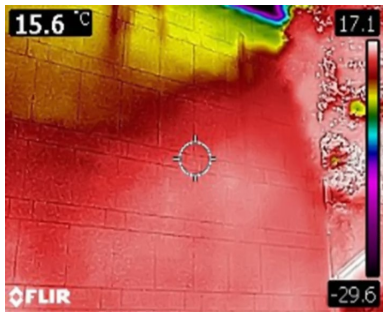
Figure 12. The web interface output of case A

According to the test results of Case A, the external wall deterioration is mainly caused by cracks in the magnetic tiles. The obvious temperature difference can be detected by an infrared thermal imager and the inspection images can be obtained by UAV at close range shooting.

<p>UAV shooting images</p>

<p>Infrared shooting image</p>
Structures items	Exterior wall	
Structures material	Mosaic tile	
Inspection Tool	UAV and Infrared	
Deteriorating state	Efflorescence and crack	
Degree of deterioration	A	
Date of inspection	2017-03-18	
Remarks	Length range is about 3 m	
Maintenance method description	Regular inspection

In Case A, the image rating reveals that the structure has not been seriously affected. Given that mosaic tiles are small magnetic tiles, regular detection is recommended.

This study implements web interface to display the test results of the cases chosen. The information in the proposed web interface contains case ID, test date, the decoration materials’ description and detection methods, abnormal description and the evaluations of degree (D) and impact (R). The picture information includes FLIR thermal imager detection images and UAV close-up images, as shown in Figure 12.

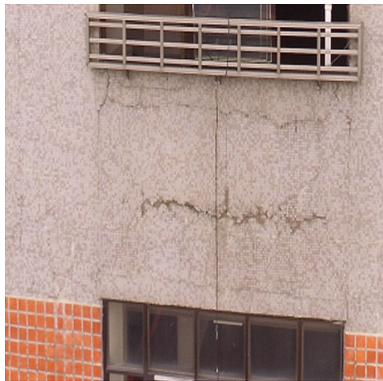
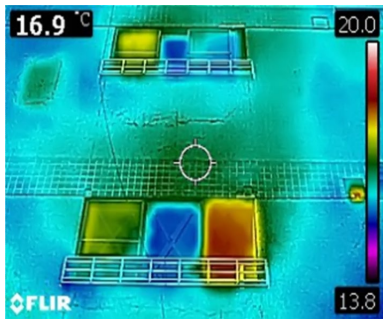
Figure 13. The web interface output of the case B

<p>UAV shooting images</p>

<p>Infrared shooting image</p>
Structures items	Exterior wall	
Structures material	Mosaic tile	
Inspection Tool	UAV and Infrared	
Deteriorating state	Crack and peeling	
Degree of deterioration	B	
Date of inspection	2017-03-18	
Remarks	Length range is about 1.5 m	
Maintenance method description	The degree of structural deterioration is safe. It is recommended to take regular inspections and repair and repair the peeling.

The test results of Case B show there are some cracks and some of the tiles fall off. Using an infrared camera to obtain images, the results reveal that a significant temperature difference around the hunting wind and the crack range can be clearly seen, shown in Figure 13. Then using UAV for close-range flat-view images, we can find that a small number of tiles have fallen off, the crack distribution is at least two, and compound deterioration is occurring. Therefore, the grading result can be B. It means that regular inspection and repair of spalling should be carried out.
