**Évaluation du comportement cinétique et du risque
associé aux glissements de terrain rocheux actifs à
l'aide de mesures de surveillance
Le cas du glissement de Gascons, Gaspésie, Canada**

Thèse

**Doctorat interuniversitaire en sciences de la Terre
Philosophiae Doctor (Ph.D.)**

Québec, Canada
© Catherine Cloutier, 2014

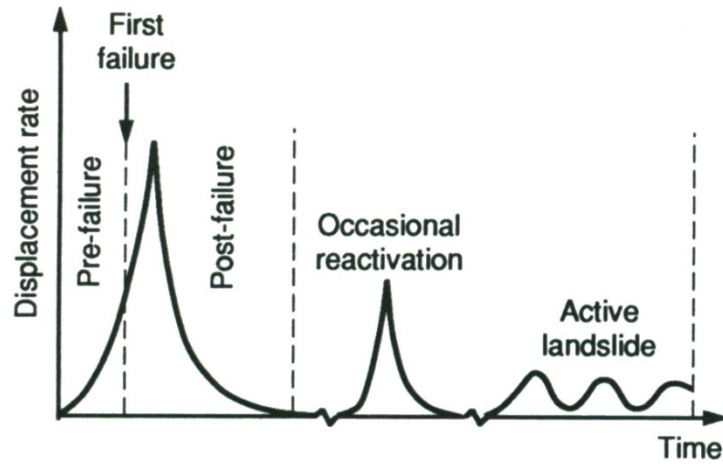
Figure 1-1 Les différents stades des mouvements de terrain tel qu'illustré par Leroueil *et al.* (1996). Le glissement de Gascons se situe dans le domaine de la post-rupture et est actif. Il correspond au cas identifié *active slide* dans la figure.

Lorsqu'un glissement actif est reconnu, il est possible de suivre ses déplacements pour documenter son comportement post-rupture (tel que défini par Leroueil *et al.* (1996) et illustré à la figure 1-1) et pour prédire son évolution. Des exemples de suivis de glissements rocheux jusqu'à la rupture sont décrits dans la littérature (Cruden et Masoumzadeh 1987; Gigli *et al.* 2011; Mufundirwa *et al.* 2010; Rose et Hungr 2007; Froude 2011; Oppikofer *et al.* 2008; Helmstetter *et al.* 2004; Zvelebil et Moser 2001). Toutes ces études montrent une accélération non-linéaire des déplacements précédant une rupture rapide. L'accélération des déplacements est donc un signe précurseur des ruptures rapides.

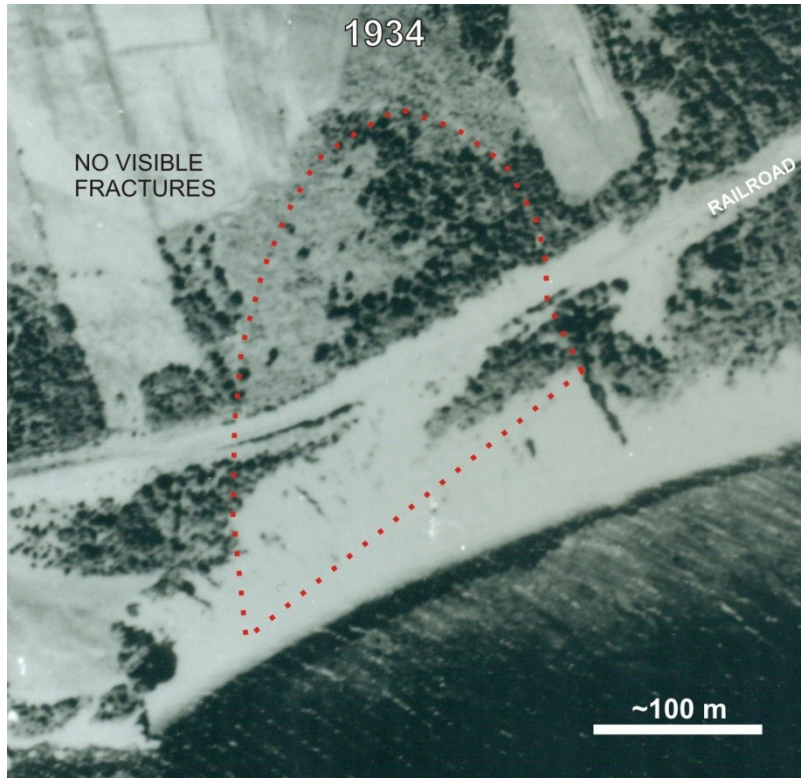
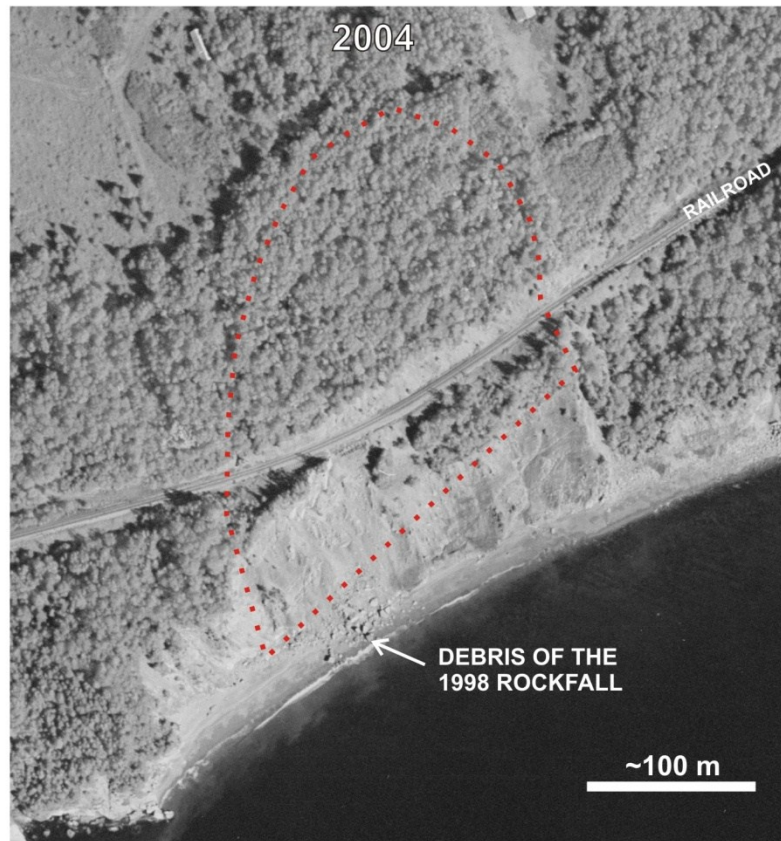
Figure 2-3 Evolution of the Gascons rockslide as seen on aerial photographs of 1934 (top) and 2004 (bottom).

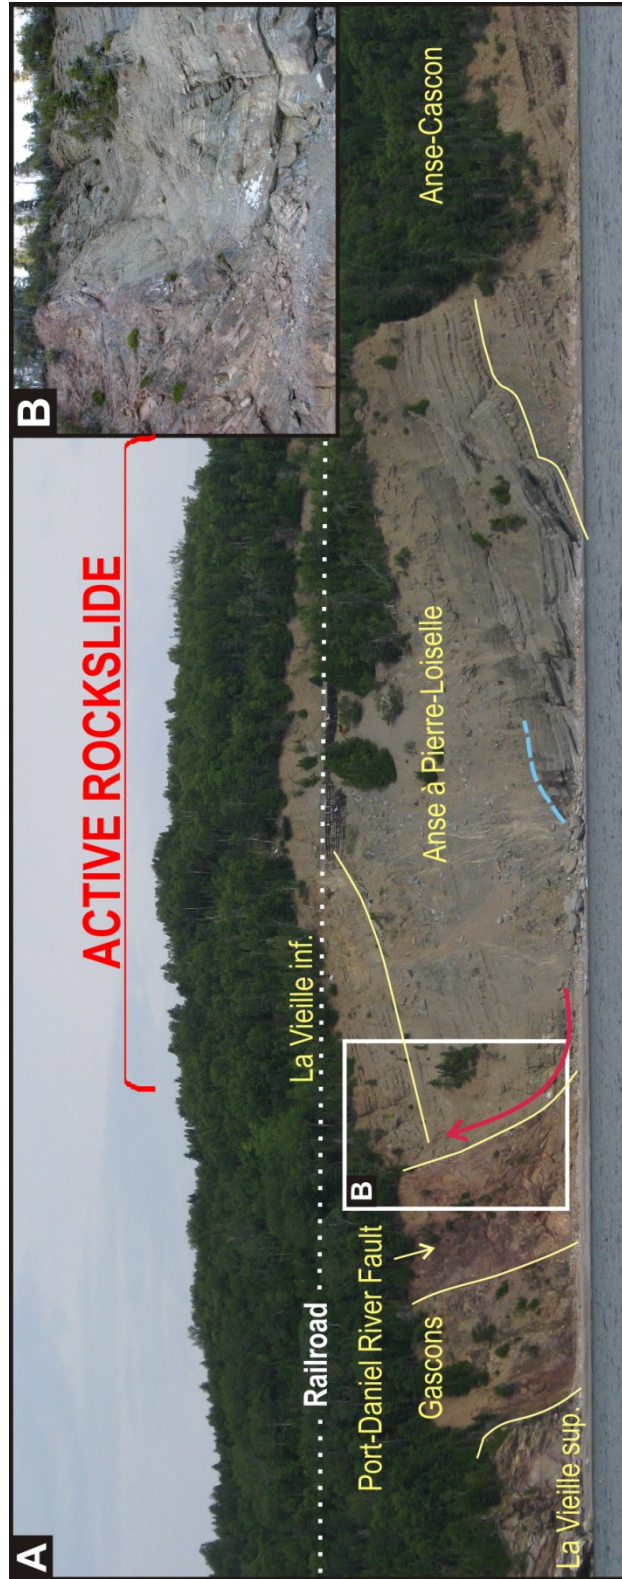
Figure 2-6 A) Cliff as viewed from the Chaleurs Bay showing the limits of the geological formations. The blue line indicates a zone that is always wet indicating the water table position. B) Photo of the fold taken from the beach.

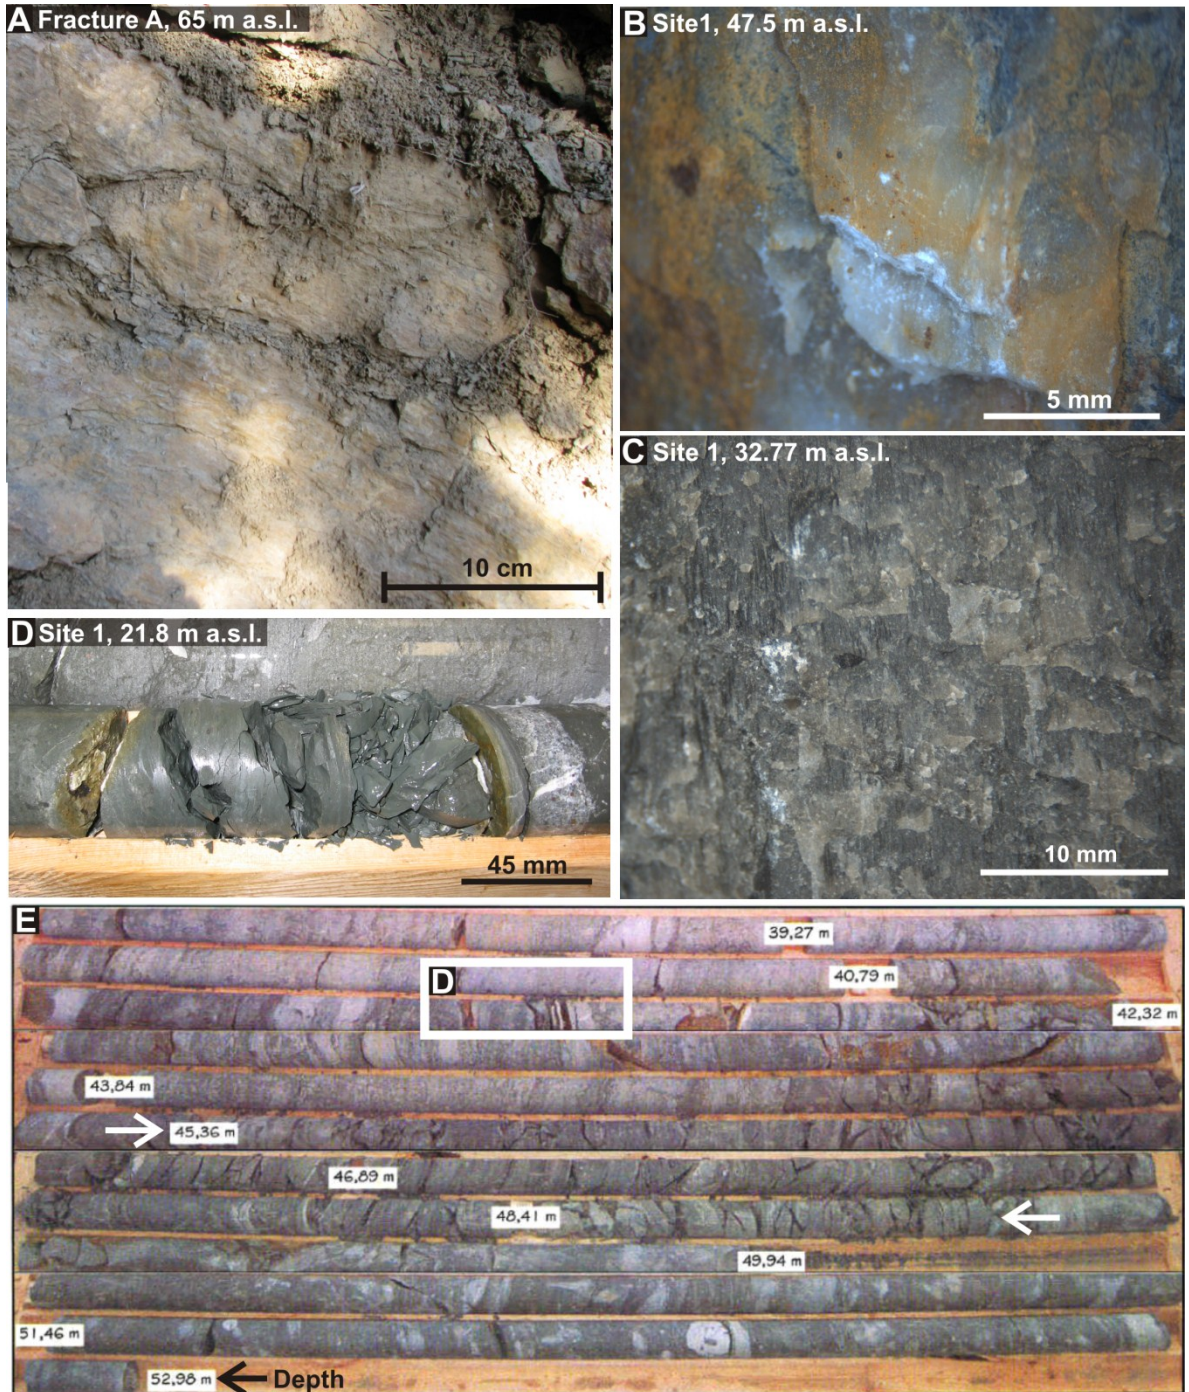
Figure 2-7 Rock specimens with slickensided surfaces. A) Photography taken in fracture A (Figure 2-2) showing limestone beds with slickenlines alternated with weathered mudstones. B) Fracture covered with calcite and iron oxide observed in the borehole core of Site 1 (Figure 2-2) and photographed with a binocular. C) Binocular photography of a fracture in the APL Formation taken from Site 1. D, E) Pictures of the APL Formation in the core of Site 1. Figure 2-8 shows SEM images of a sample coming from the unit shown in D.

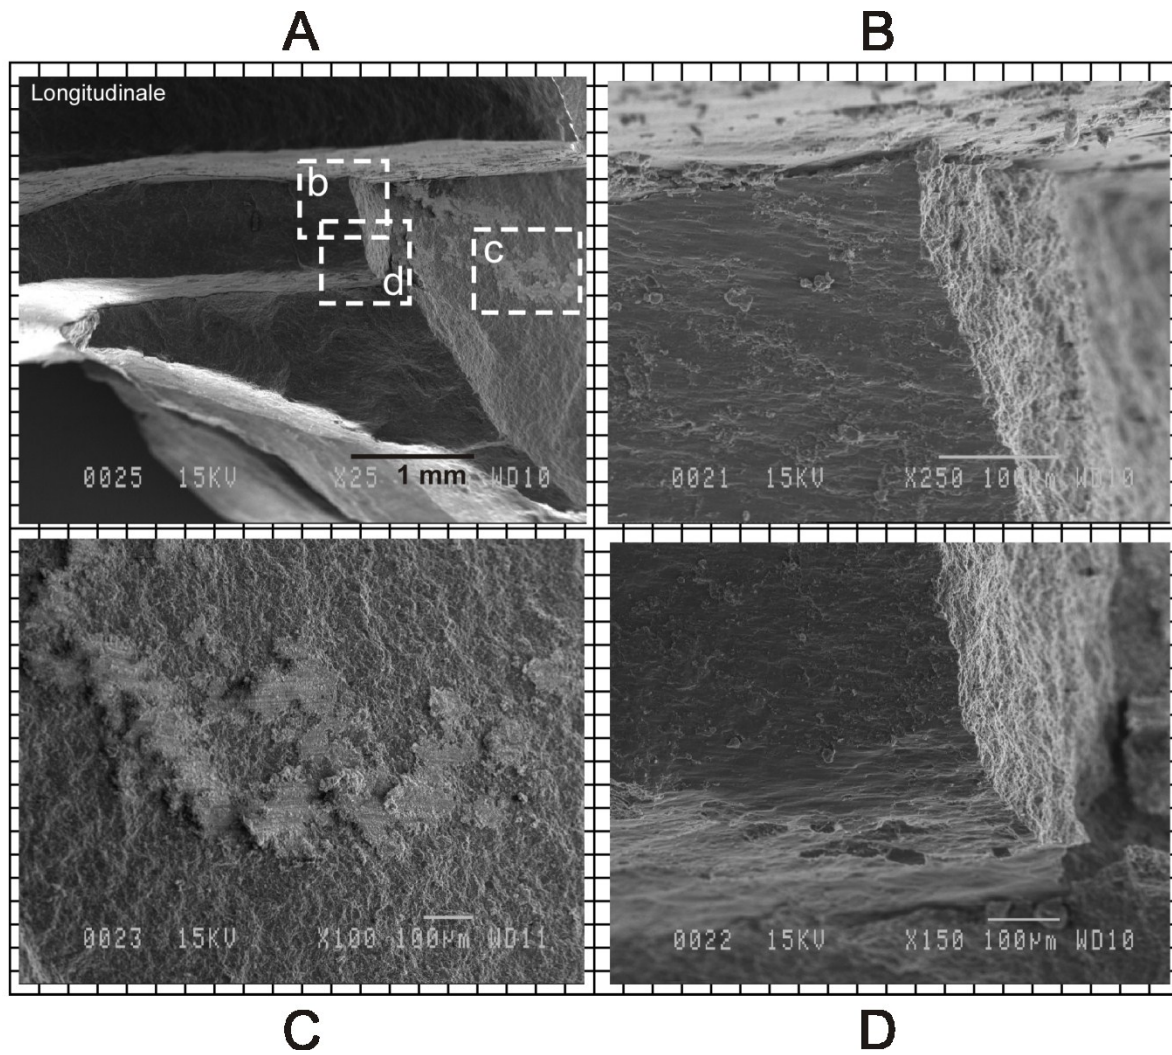
Figure 2-8 SEM images from a longitudinal cut in the shale sample shown in Figure 2-7D taken at 21.8 m a.s.l. in the core of Site 1 in the APL Formation. The positions of images B,C, and D are shown in A.

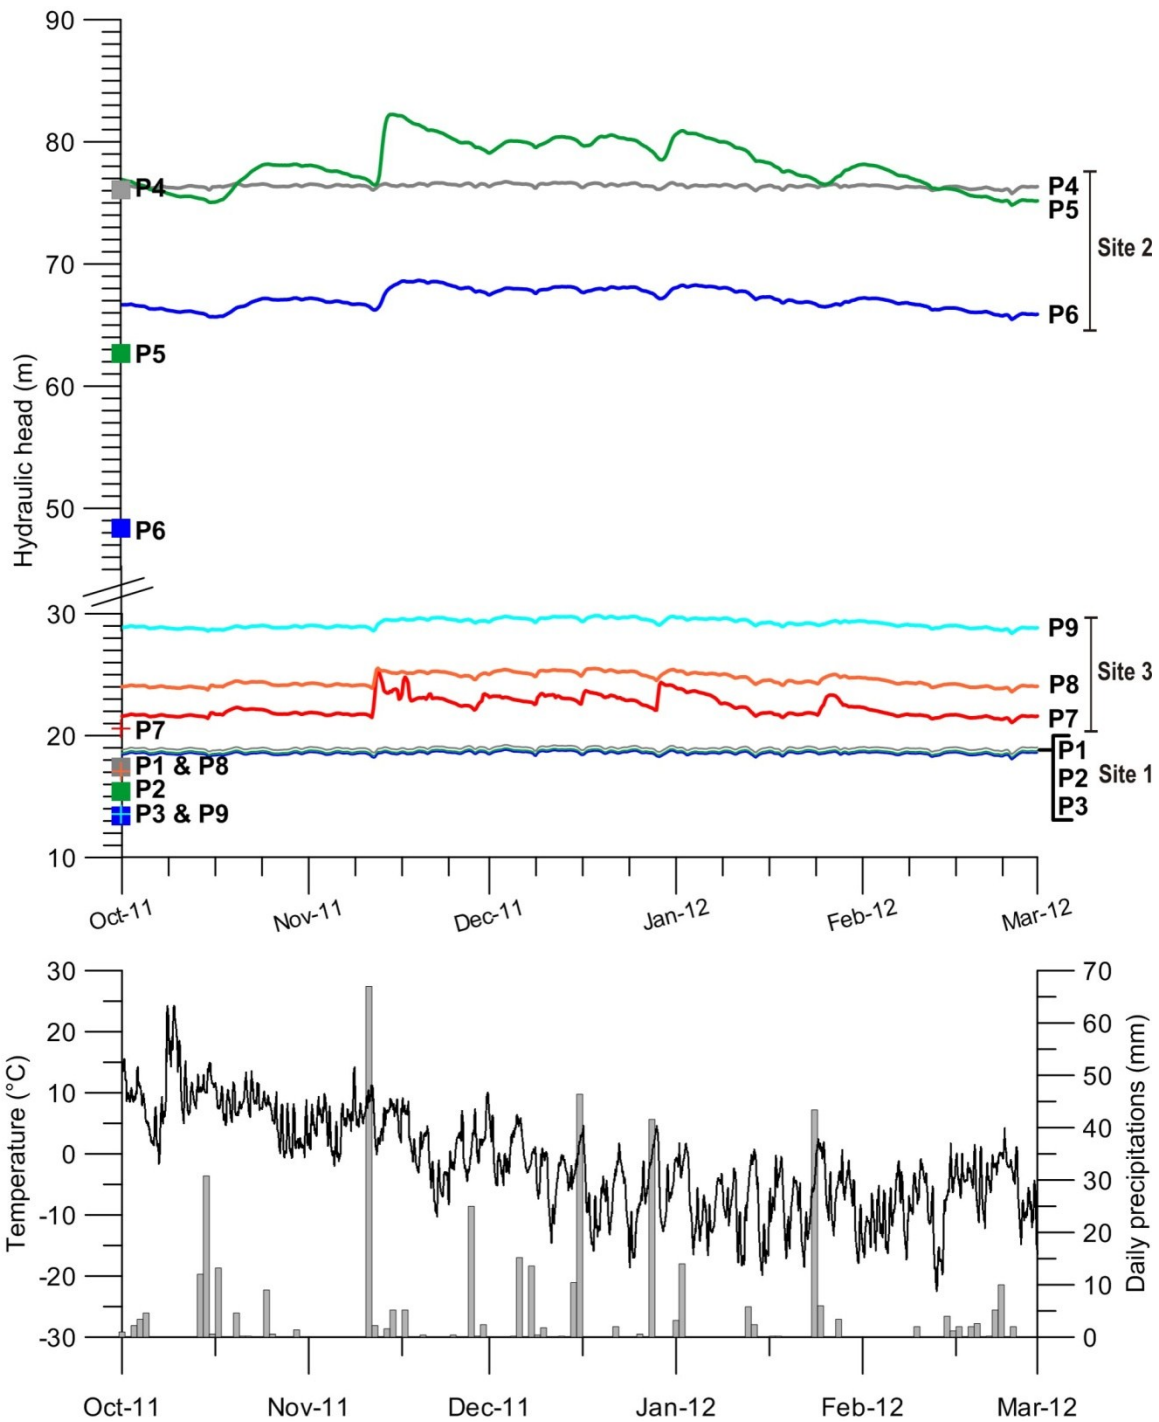
Figure 2-15 Hydraulic head of the nine piezometers installed in the three boreholes, for the time span between October 2011 and March 2012. The altitudes of the sensors are indicated on the Y-axis. Below, temperatures and daily precipitations are presented.

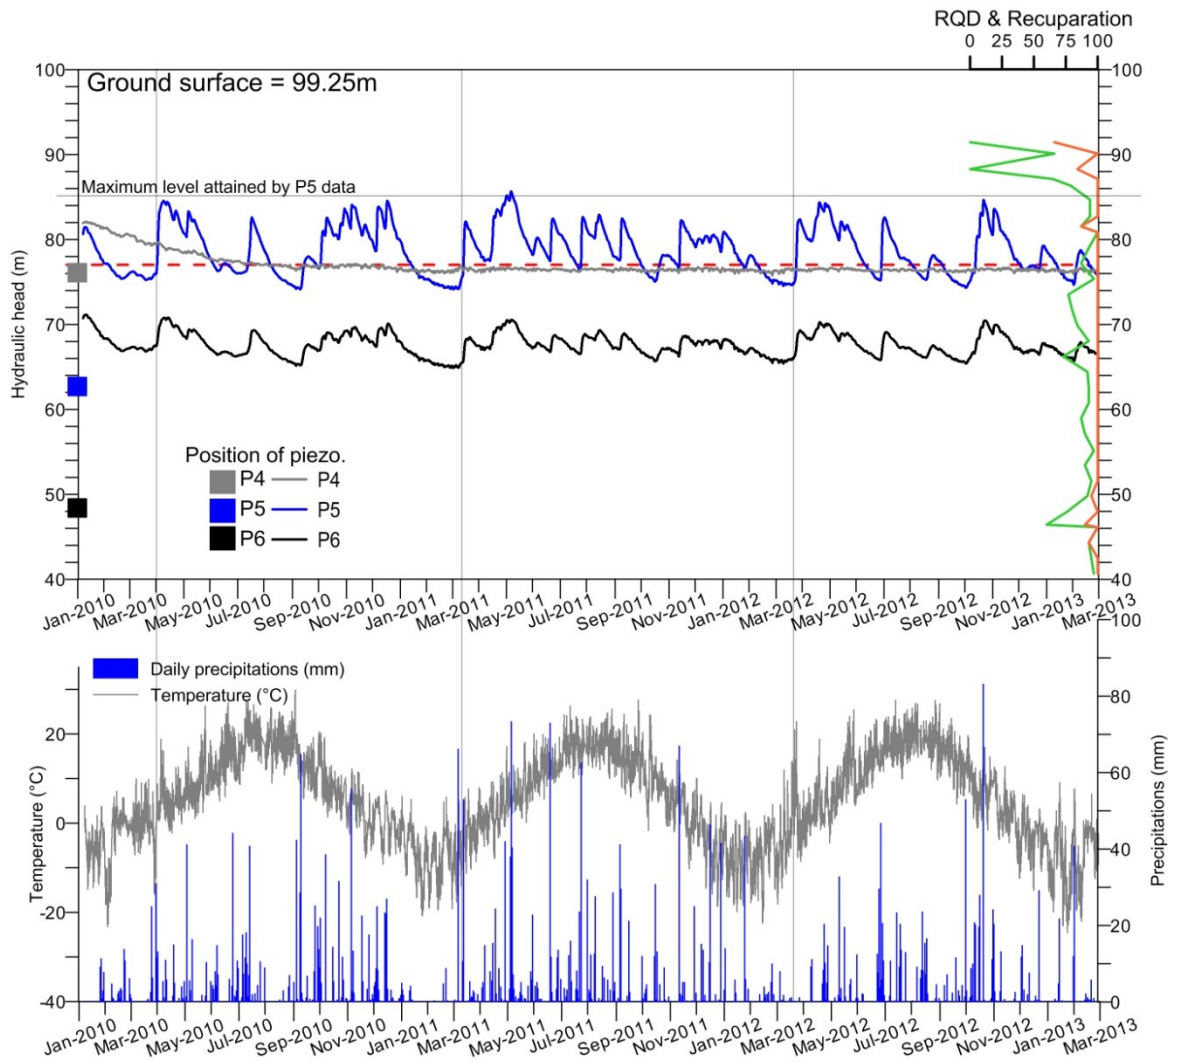
Figure 2-16 Hydraulic head of the three piezometers installed at Site 2 and their installation elevations. Rock Quality designation (green) and recuperation data of the core (orange) are indicated in % on the right. Below, temperatures and daily precipitations are graphed. The vertical lines indicate the start of yearly snow melt.

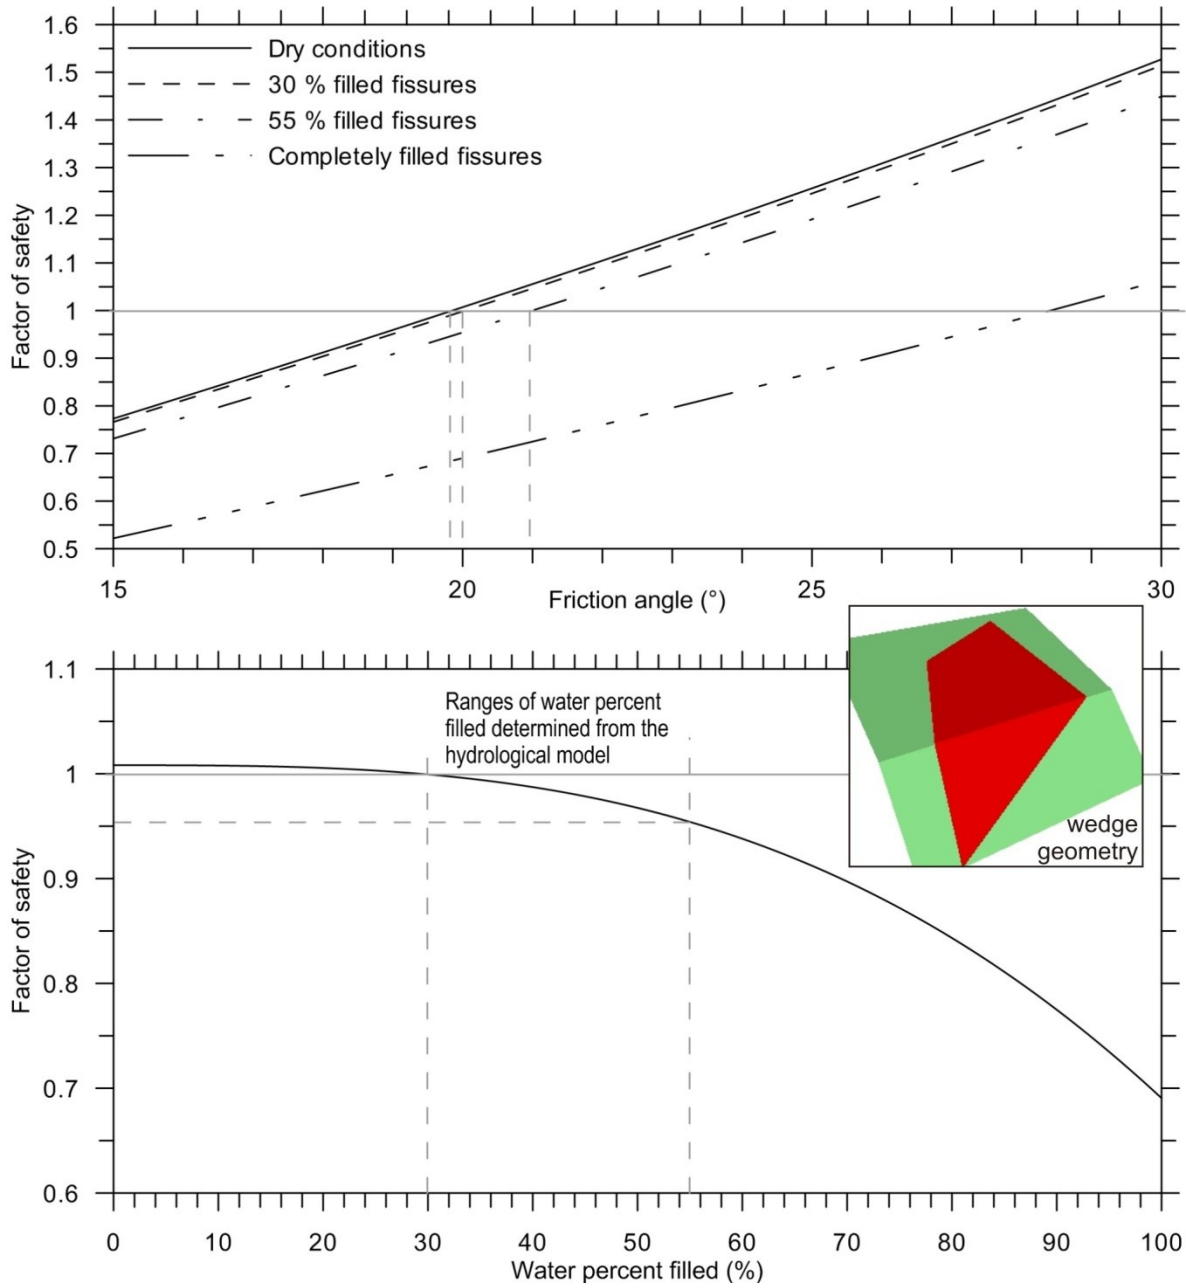
Figure 2-17 Limit equilibrium sensitivity analyses results. Above the Factor of Safety is computed for changing friction angle for four different water pressures. Below: The factor of safety is computed for changing fissures water percent filled.

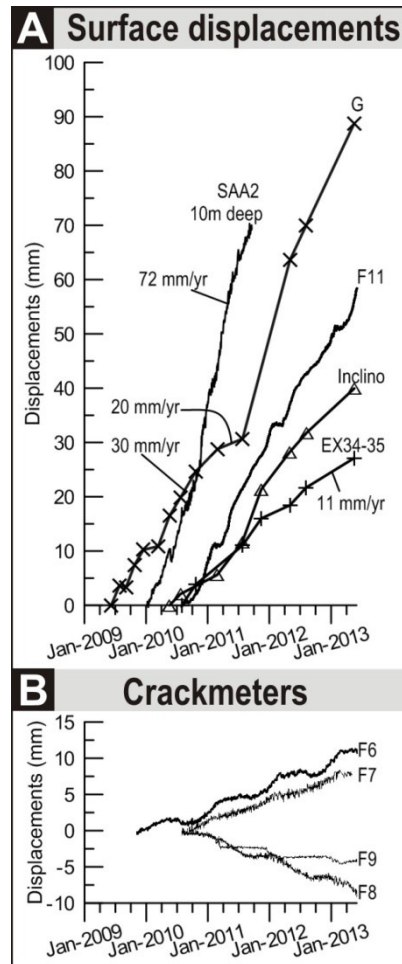
Figure 2-18 A) Displacement-time plots from SAA2, inclinometer, crackmeter F11, and extensometers (G and EX34-35). Instruments locations are indicated in Figure 2-2. B) Displacement-time plots of four crackmeters.

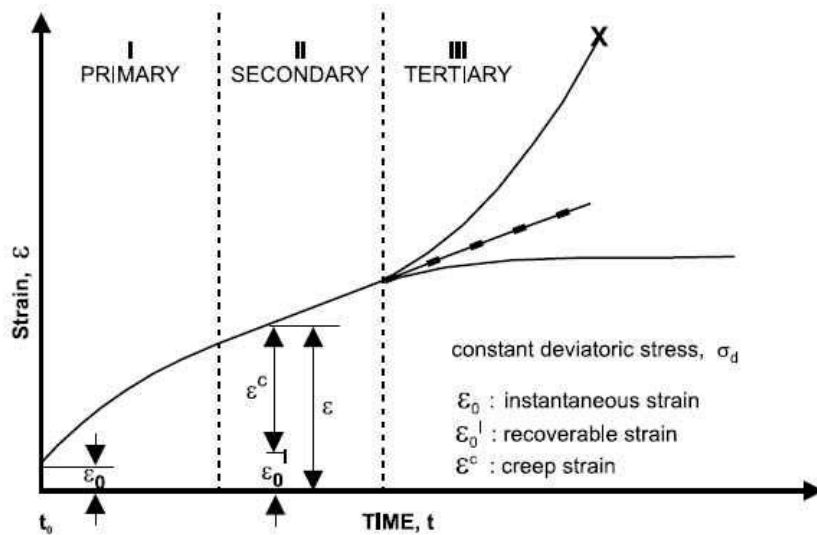
3-2 Idealized creep behaviour where the three phases are identified (taken from Crosta and Agliardi, 2003).

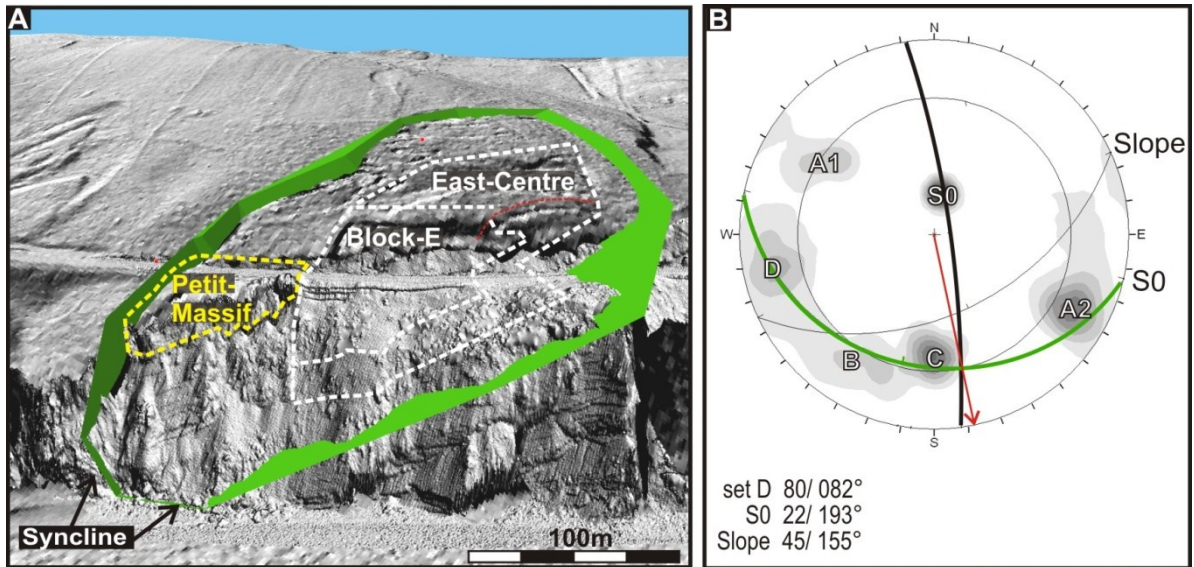
Figure 3-4 A) Oblique view of the elevation model and in green the sliding surface of the rockslide. Key sectors are identified: Petit-massif, Block-E and East-Centre B) Stereographic representation of the discontinuity sets. The planes forming the wedge sliding surface are indicated in bold. The red arrow represents the intersection line of the discontinuity pair forming the wedge.

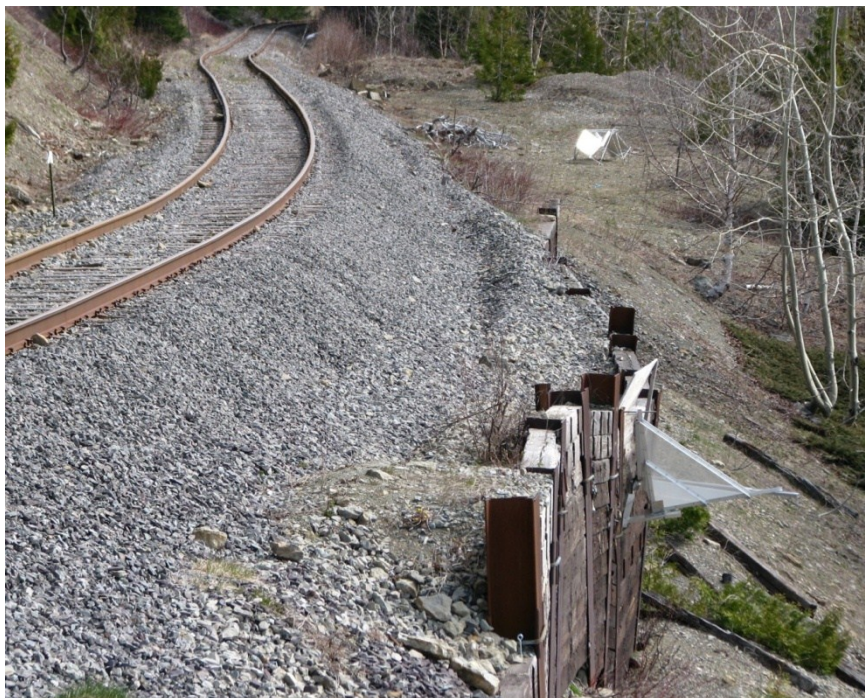
Figure 3-5 View towards the east showing deformation of the railroad with a clear departure from a straight line at the eastern limit of the rockslide. The horizontal displacement from the initial alignment is estimated to be about 1 m from the observation of aerial photographs and DEM.

Horizontal displacement rates in the centre part of the slide are between 80 and 111 mm/yr (CR12, CR13, HB1, and HB8). In the Petit-massif sector, the inclinometer, SAA3, and CR11 average displacement rates are 14, 14, and 22 mm/yr respectively. In the upper part of the slide (Site 2), vertical SAA2 shows a clear sliding surface at 23 m deep (Figure 3-15A), which corresponds to the green surface in Figure 3-4A with an average displacement rates of 48 mm/yr at 12 m deep. It corresponds also to the deepest sliding surface identified at Site 1 at 43 m deep (Figure 3-12), where the average displacement rate is much lower and is 4 mm/yr. The rockslide does not move as a monolithic wedge.

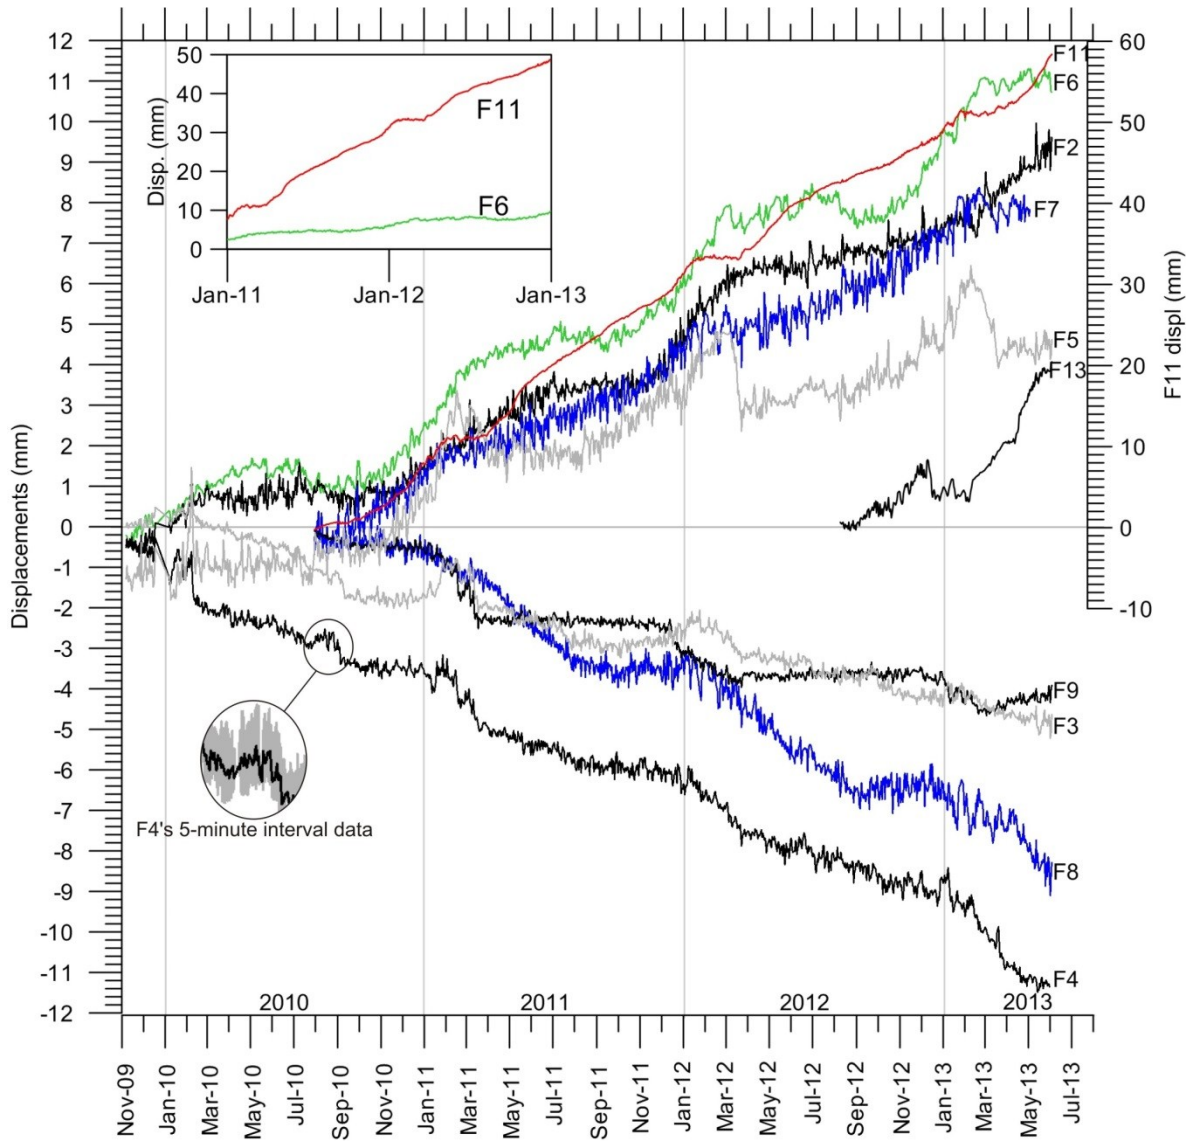
Figure 3-10 Crackmeters displacement curves. F11 curve uses the y-axis to the right, the other are plot using the left y-axis. The inset in the left top corner traces F11 and F6 using the same y-axis to show how displacements of F11 are more important than other crackmeters.

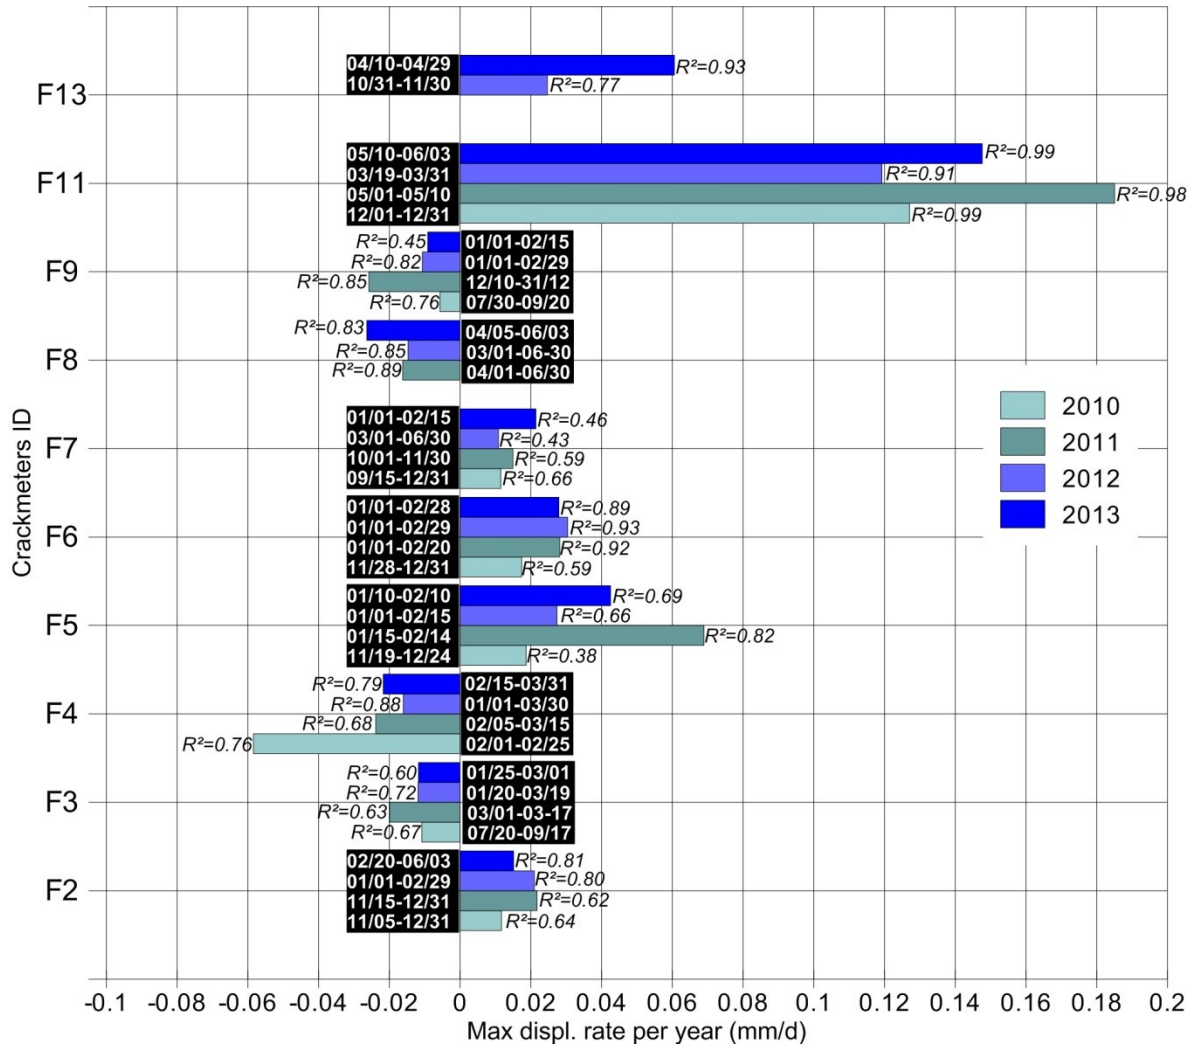
Figure 3-11 Maximum displacement rates measured on a period longer than 10 days for the crackmeters installed on pre-existing fractures. The rates are calculated by a linear regression. The coefficient of determination (R²) and the time period on which they are calculated are indicated.

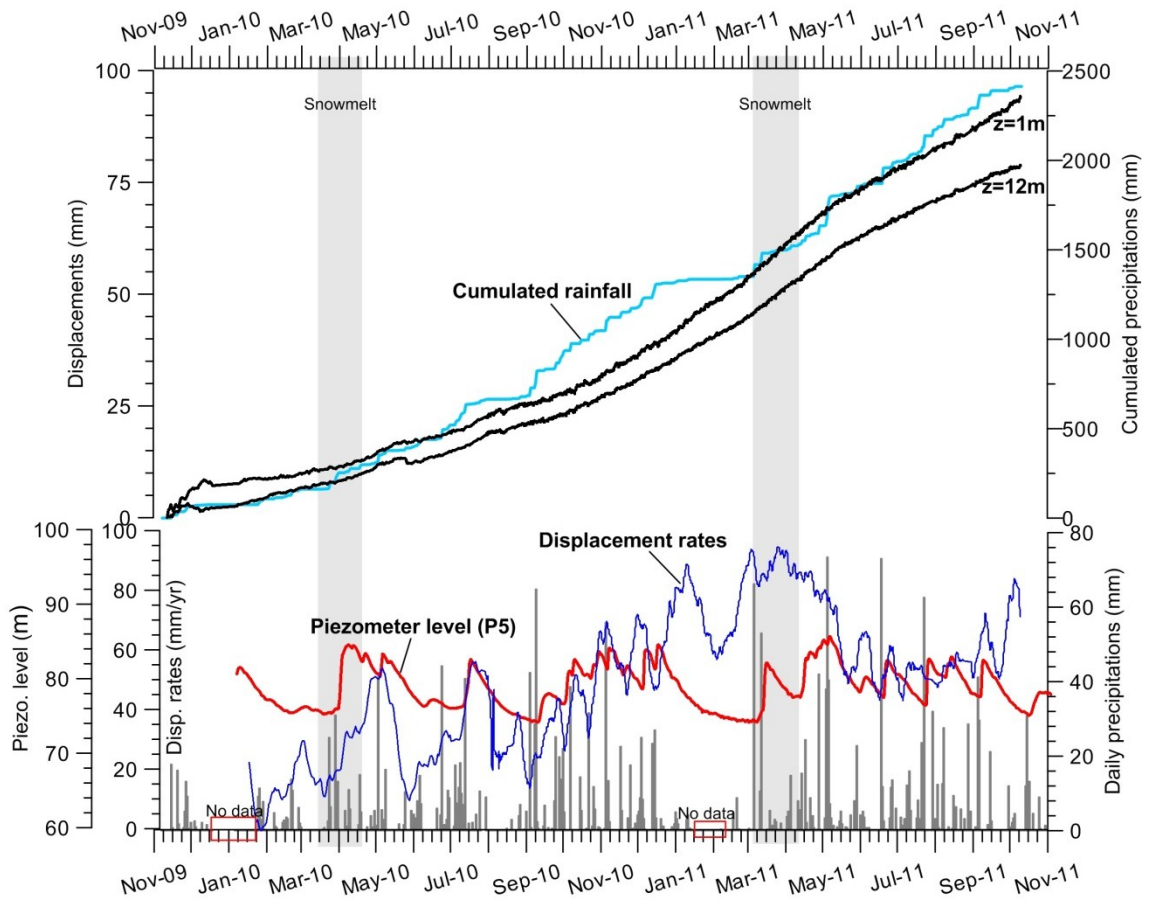
Figure 3-16 In black are displacement versus time curves of SAA2 at three different depths: 1, 12, and 27.4 m (elevation of 98.25, 87.25, and 71.85 m). In red is the piezometer equivalent elevation of water level measured at a depth of 36.6 m (elevation of 62.65m), which is under the sliding surface. In blue are the displacement rates measured on a 20 day period. The bar chart presents the daily precipitations. The pale blue line is the cumulated precipitation.

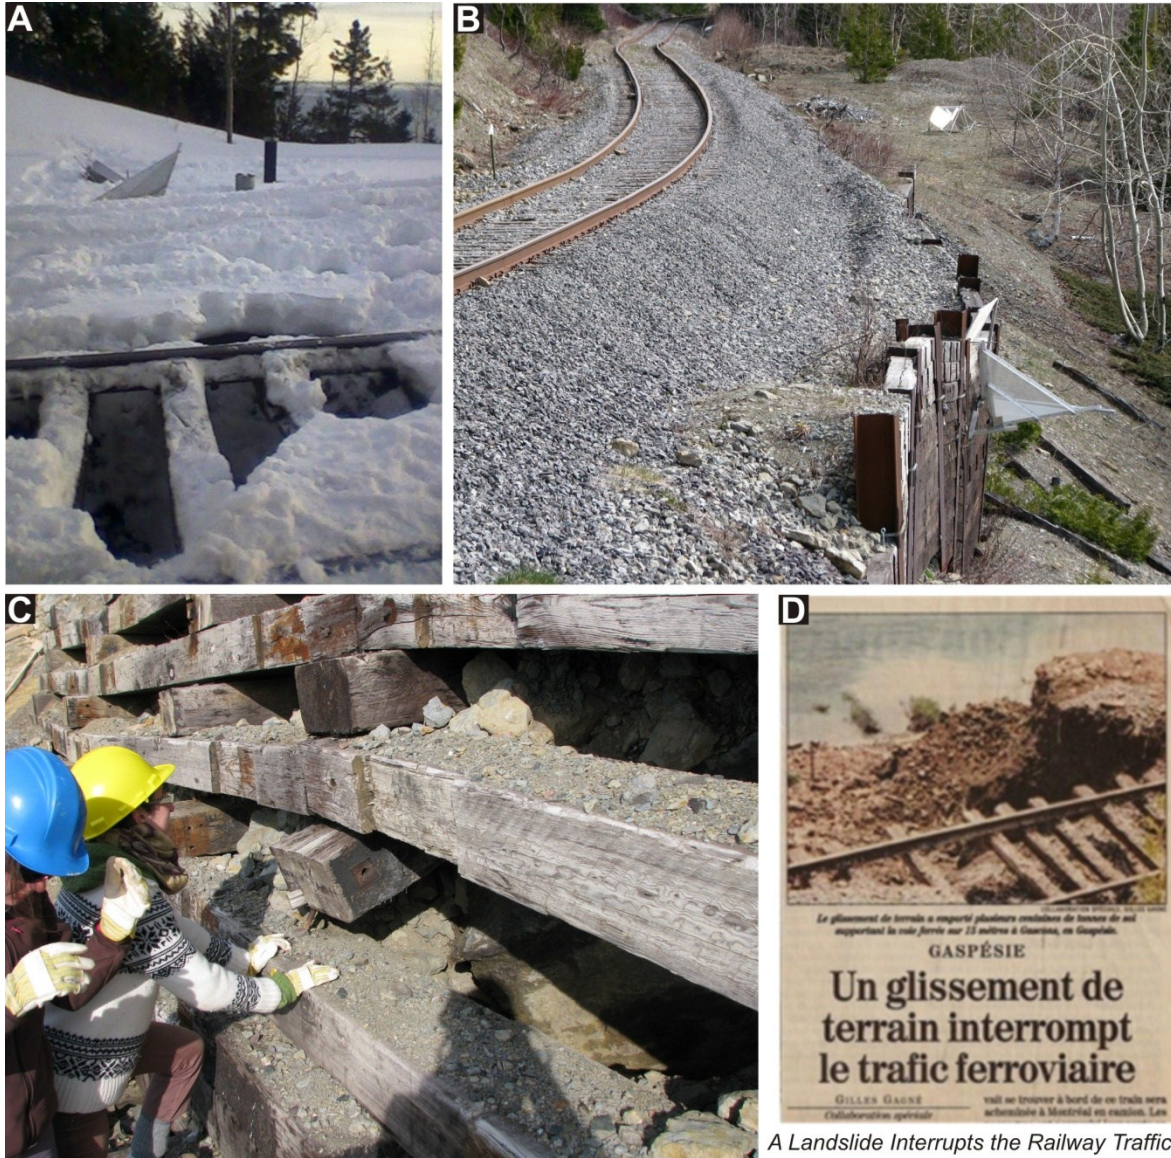
Figure 4-7 Examples of damage caused by the accumulation of displacements on the infrastructures and of the 1998 collapse event. A) Undermining of the railway ballast in an underlying fissure in February 2011. B) Deformation of the retaining wall and of the railway. C) Deformation in the retaining wall built in 1998 D) Newspaper cut showing the damaged railroad after the 1998 slide event (Le Soleil, 1998).

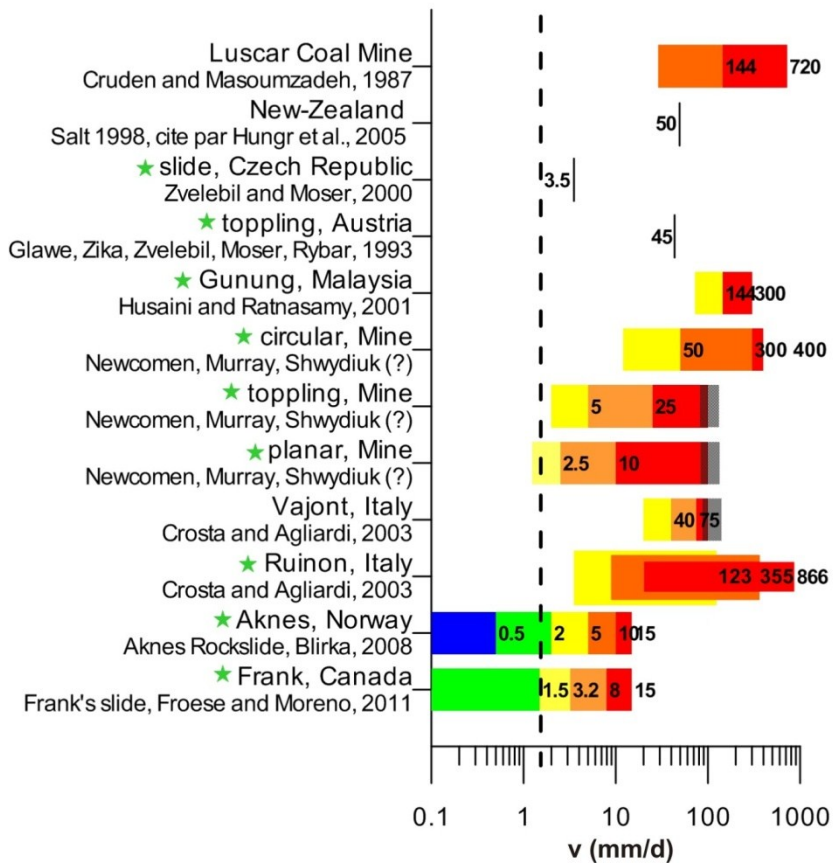
Figure 4-12 Proposed velocity based warning criteria found in the literature. The green stars show the criteria that were defined prior to brutal failure. In the vast majority of cases, the authors proposed intervals associated with different alert levels. The author associated colors to the values, even though some authors have not. Green and blue colors are used to represent situations considered normal, yellow is use for an increase activity, orange is a preoccupying situation and must be evaluated by an expert while red is the superior alert level associated with immediate actions. The red warning criteria were generally presented as “more than”. In the figure, the maximum values have been limited to facilitate presentation.

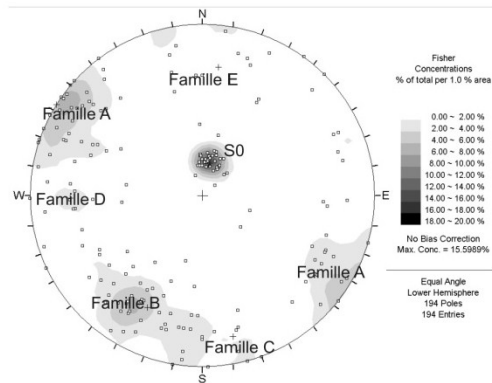
Figure 3. Stéréogramme des pôles des familles de discontinuités (hémisphère sud)

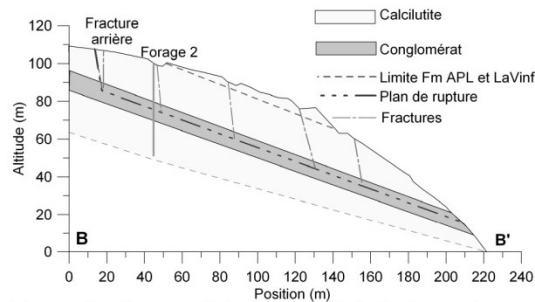
Figure 5. Coupe géologique BB' (voir figure 1 pour localisation). Les fissures observées en surface ont été prolongées jusqu'au plan de rupture estimé.

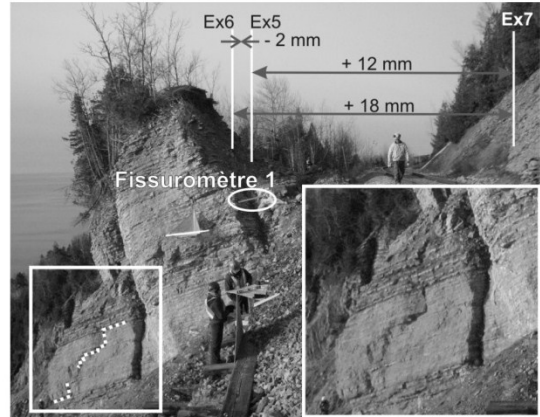
Figure 6. Formes en échelons (traits pointillés). Le fissuromètre 1 se referme depuis son installation. Les flèches indiquent les déplacements mesurés sur les tiges extensométriques, EX5, 6 et 7 (vue vers l'ouest).

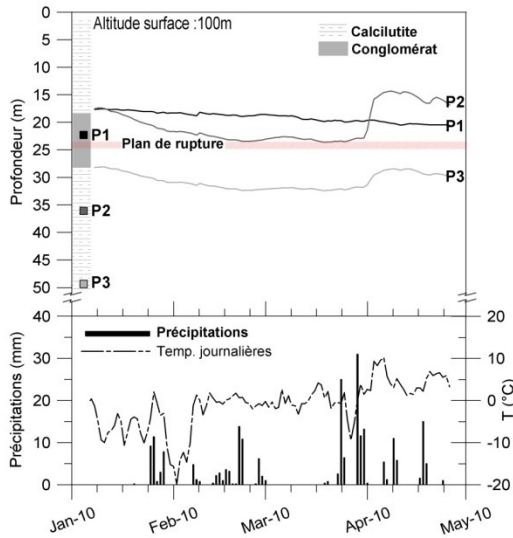
Figure 7. Niveaux piézométriques des piézomètres 1, 2 et 3 du site de forages 2 et précipitations (cumulées sur 24 heures) et températures (moyenne 24 heures). La position de la surface de rupture est déduite des résultats du chapelet SAA dans un forage voisin.

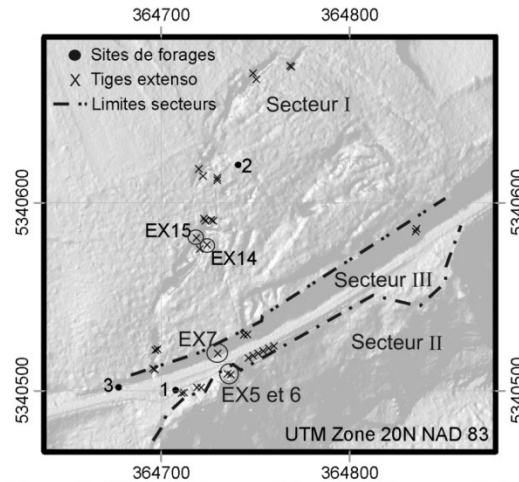
Figure 8. Réseau extensométrique, positionnement des sites de forages et délimitation des secteurs décrits à la section 4.1.

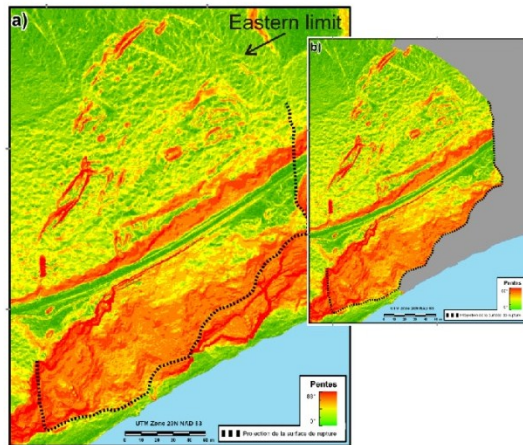
Figure 4. A) Delimitation of the unstable area in black determined by the grey plane in B) In grey, plane with direction and dip direction of bedding fitted to the eastern limit of the rockslide.

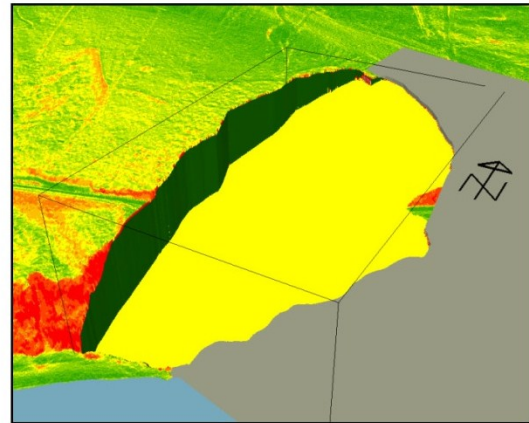
Figure 5. Morphology of the rockslide sector, if the unstable mass determined by the plane fitting technique is removed.

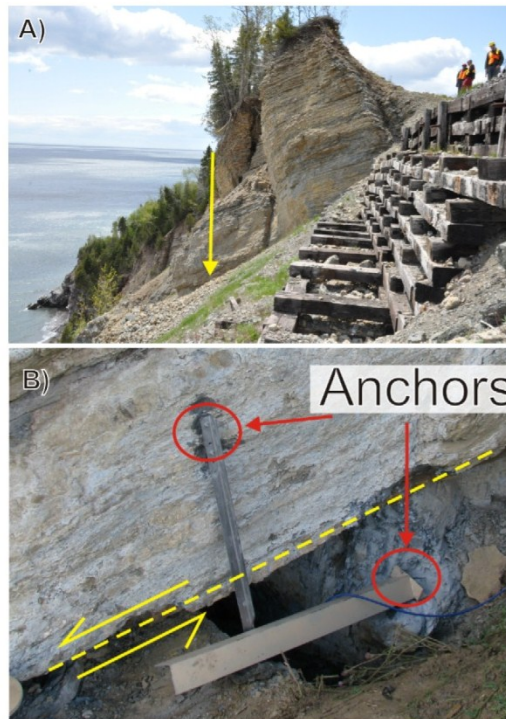
Figure 9. A) Position of the crackmeter F12 and looking west at the Petit-massif B) F12 is installed to monitor a translational movement of the upper block relative to the lower block. F11 is measuring the opening of the crack below F12.

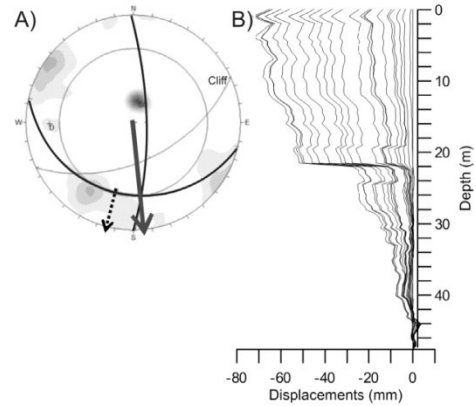
Figure 3. a) The grand circles of the bedding (S0) and the discontinuity set (D) defining the wedge are in a bold on the stereonet (lower hemisphere). The longer arrow is the wedge's direction of movement; the other arrow is planar sliding direction. b) Monthly displacement profiles of SAA at borehole site 2, from January 2010 to September 2011.

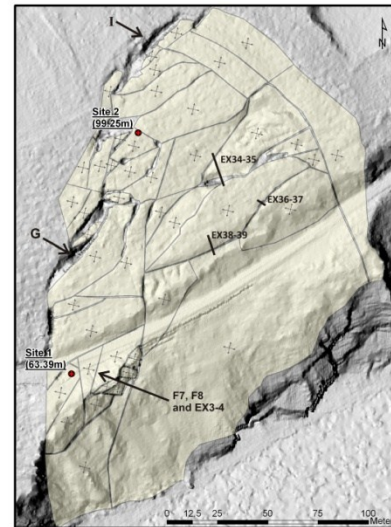
Figure 4. First block model of the Gascons rockslide. The axes in the blocks center are oriented with the bedding structure. The fissure measured by F7, F8, and EX3-4 is pointed as well as fissures G and I.

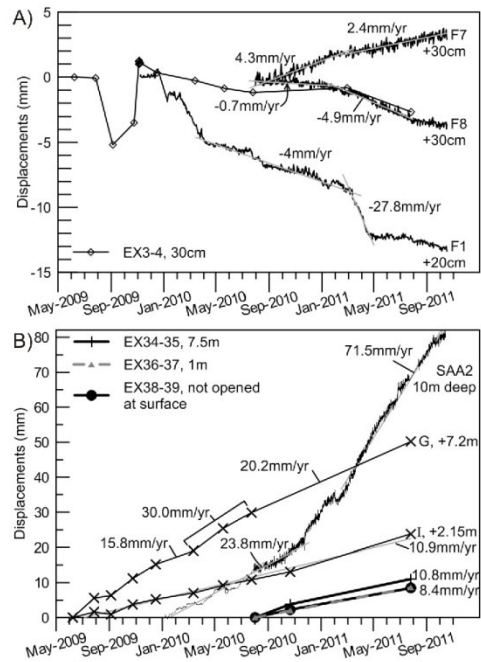
Figure 5. Displacement vs time curves of certain crackmeters, extensometer pairs, and SAA at borehole site 2. a) South of the rails b) North of the rails.

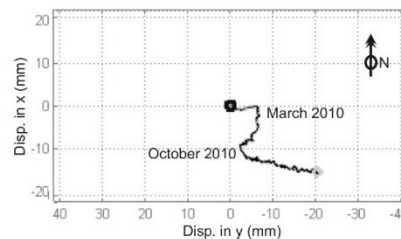
Figure 6. Displacement in the horizontal plane of the SAA at borehole site 1, south of the railroad, at 24m deep, from January 2010 to September 2011.
