**Évaluation du comportement cinétique et du risque
associé aux glissements de terrain rocheux actifs à
l'aide de mesures de surveillance
Le cas du glissement de Gascons, Gaspésie, Canada**

Thèse

**Doctorat interuniversitaire en sciences de la Terre
Philosophiae Doctor (Ph.D.)**

Québec, Canada
© Catherine Cloutier, 2014

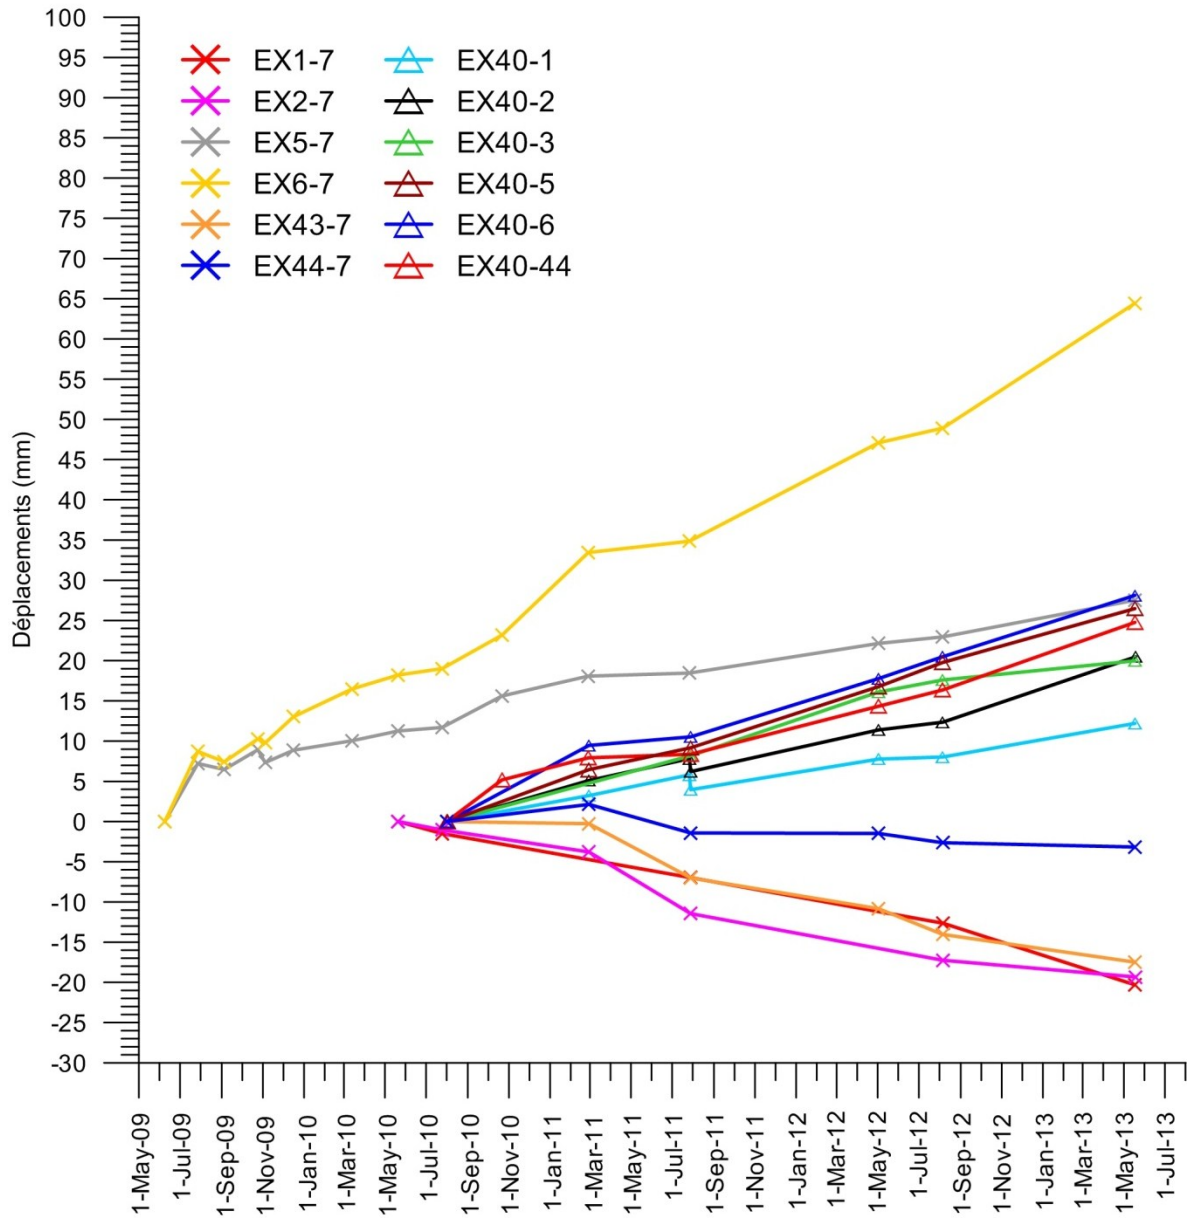
Déplacements obtenus à partir de mesures de distance réalisées à l'aide du ruban extensométrique, pour les tiges dans le secteur du Petit-massif.

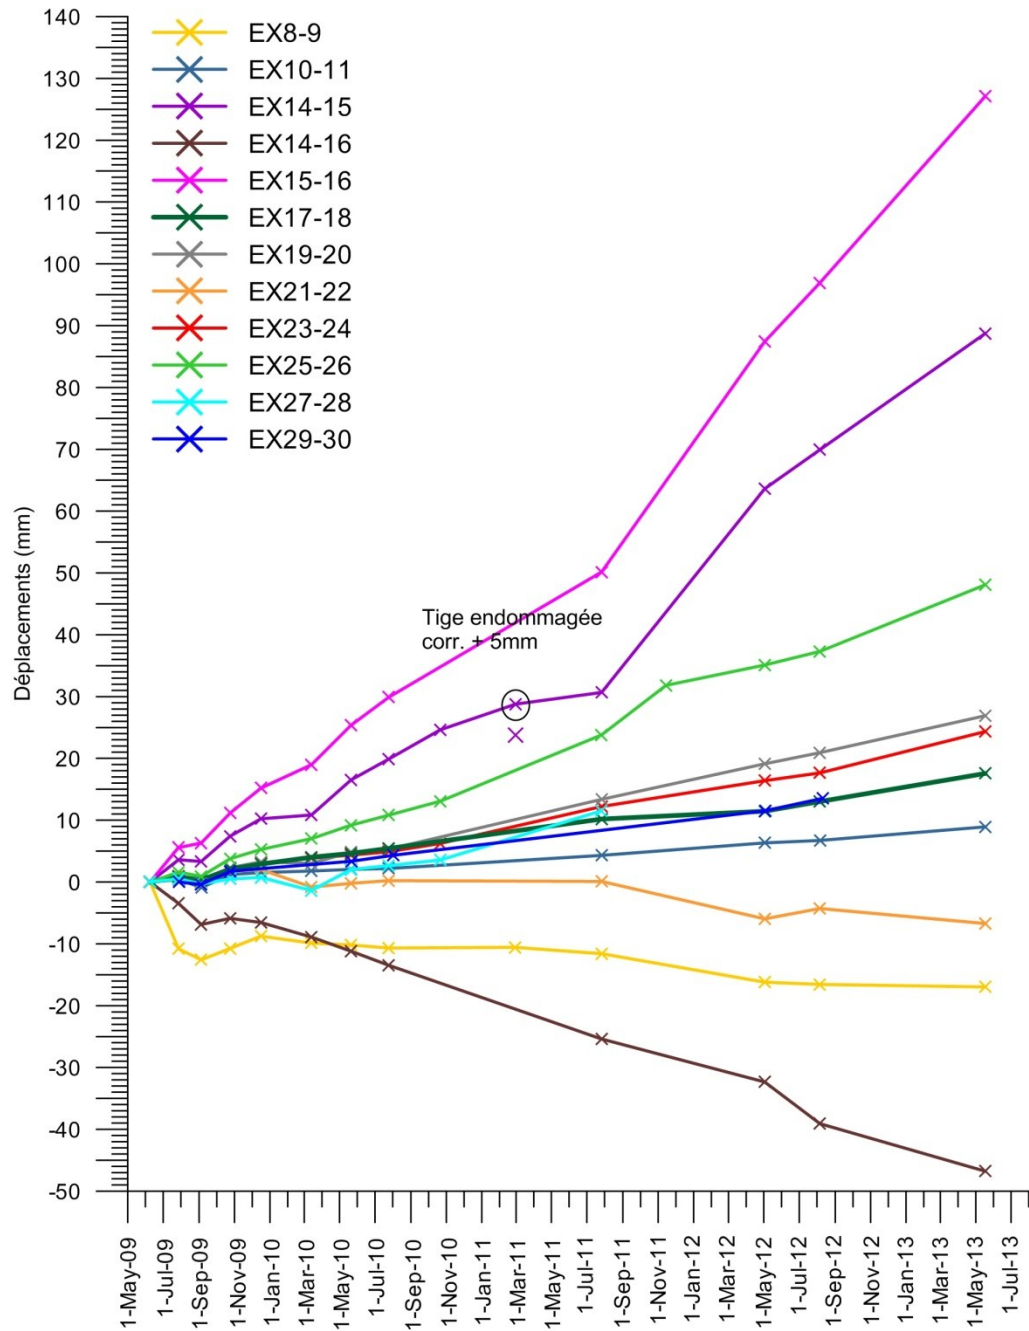
Déplacements obtenus à partir de mesures de distance réalisées à l'aide du ruban extensométrique, pour les tiges dans le secteur en amont du Petit-massif.
