EUROSTEEL 2017, September 13–15, 2017, Copenhagen, Denmark

Asymmetrical cross sections in historic riveted bridges

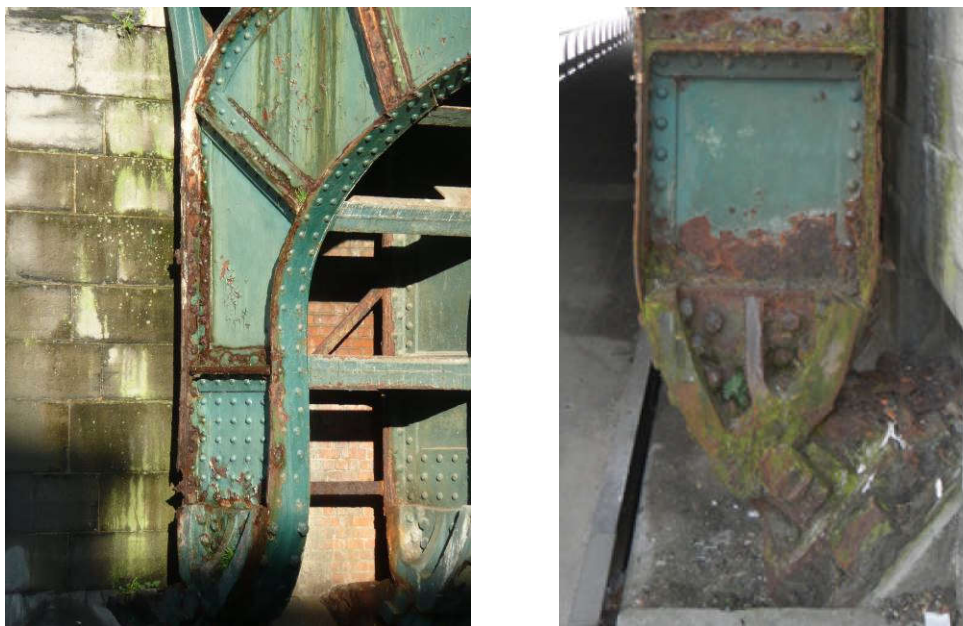
Both bridges have recently been inspected. The general aspect of both bridges is worrying and corrosion is seen in every detail. However, it is more important to find out whether the steel sections show considerable reduction and to quantify this. Although modern riverside walkways have been installed below both bridges, the corrosion protection has not been renewed since 30 years. For both bridges especially the outside frames are corroded, either the angle profiles or the lower flanges or the top plate of the upper flange. In a single case of a vertical frame post, the complete upper flange is corroded. This can be seen in *Fig. 2 (left)*.

Fig. 2. Left : reduction of flange section Right : Corrosion of hinges

These observations have been supplemented at the most critical locations by grinding to blank metal and by measuring the exact length of the main corrosion areas. This enabled to derive exact data of the remaining profile and plate sections and to assemble characteristics of an alternative damaged structure. Superficial deterioration has not been considered in this alternative.

The hinged supports were inspected more in particular. Already *Fig. 2 (right)* shows a rather bad condition. However, after manual brushing, hammering and subsequent local grinding, the corrosion of these parts appeared equally superficial and limited to less than 1 mm. Most probably the hinge is not functioning sufficiently and will require serious refurbishment.

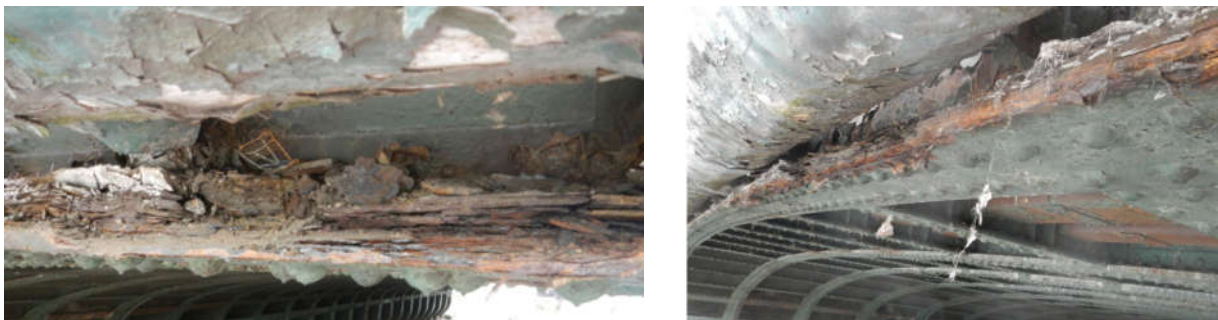
In the 3 portal frame bridges, especially in the corroded ones, the upper rivet heads have completely corroded. However the rivets are still in place and did not fall out from the steel members. This further supports the assumption that the remaining parts of the shaft is fitting the hole.

Fig. 8. Corroded rivets

Fortunately the rivets on the opposite side of this connection are in good condition. Since shear is moderate in this area, the connection remains effective, although near to the posts the unity-check of rivets results in a value of 0.897.
