Considerations of Pull-Plug Sedimentation Basin for Dairy Manure Management

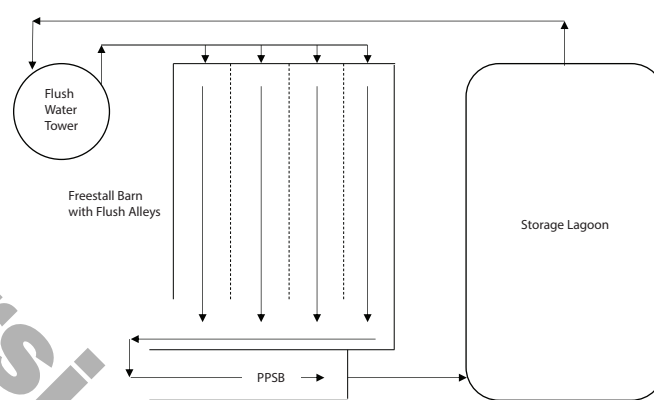
The PPSB is installed between the flushed freestall barn and the lagoon, as seen in Figure 1. Figure 1 shows one of several possible arrangements of a PPSB

Figure 1. Placement of a PPSB within the flush system on a dairy farm (drawing not to scale).

relative to the overall facility. Various configurations are discussed in the Design Considerations section. A sand settling lane can be integrated into the design between the freestall barn and the PPSB if needed.

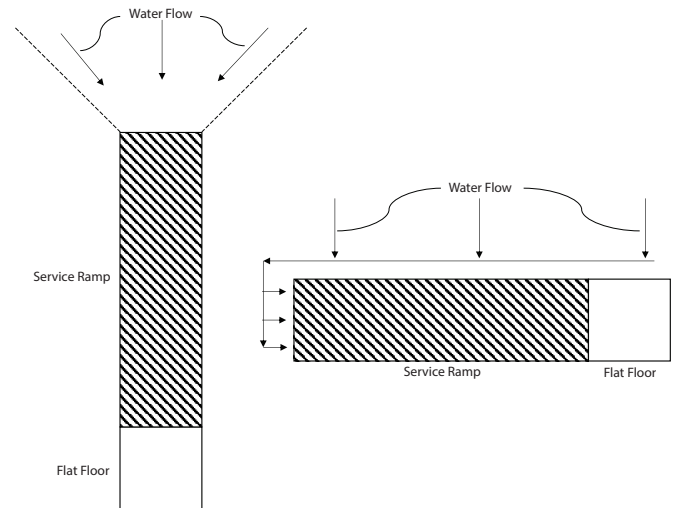
The PPSB can be orientated parallel or perpendicular to the flush water flow, as seen in Figure 2. Site restrictions and relative cost will dictate the best option. Flush water that is loaded parallel to the flush flow

direction (left diagram, Figure 2) will require grading to create a funnel in order to guide the water to the service ramp. A perpendicular orientation (right diagram, Figure 2) will require the curb height to be sufficient to prevent the flush water from cascading over the side of the PPSB.

Figure 2. Flow loading and orientation of PPSB to achieve desired flow down the service ramp.

The location of the pull-plug within the PPSB is very important. It should be located as far from the entrance ramp as possible. For example, the perpendicular orientation (right diagram, Figure 2) is likely to see the highest amount of turbulence on the side of the PPSB closest to the flush curb (unless measures are taken to distribute the water along the service ramp). Therefore, the pull-plug should be located in the far corner on the opposite side of the freestalls being flushed.

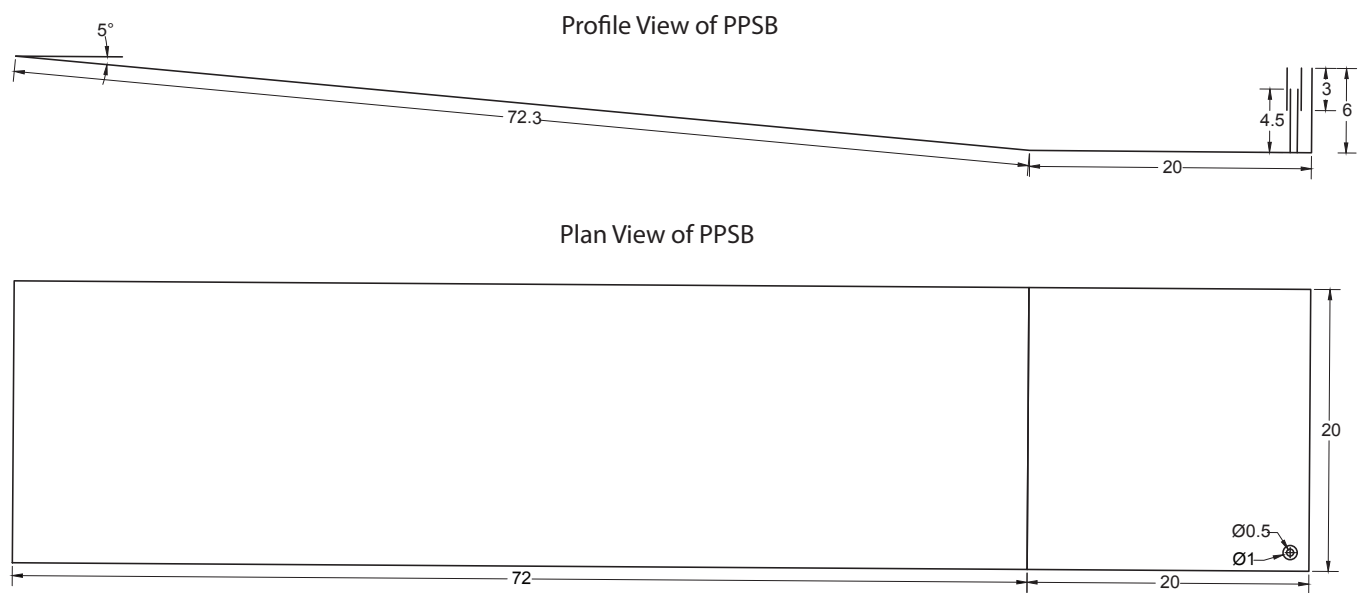
The concrete entry ramp into the PPSB should have a maximum slope of 12-to-1 (or 5 degrees), as seen in the profile view of Figure 3, to minimize wheel slippage and the potential for equipment overturns. A 12-to-1 slope was chosen because it was the steepest slope possible (minimizes construction cost) that would allow for sufficient traction when hauling solids from the basin (i.e., safety/operability).

The example provided in the profile view of Figure 3 is of a typical PPSB design that serves a herd of about 150 milking cows with a single-flush volume of about 7,000 gallons, but also represents the smallest recommended size of the system. (Note: This size system can be used for smaller herds, but the size may need to be increased for larger herds or fiber bedding.) A minimum operational depth of 4.5 feet is needed allow solids to settle.

Figure 3. Profile and plan views of typical PPSB (dimensions in feet).

Figure 3 also shows a plan view of a typical PPSB. The maintenance ramp has a horizontal length of 72 feet. The flat floor dimensions of 20 feet by 20 feet are recommended for equipment maneuverability when cleaning the basin. Either dimension (length or width) can be adjusted to increase capacity, with the decision generally based on overall cost. Flush water is dispersed along the width of the maintenance ramp and down into the basin. Water is decanted out of the basin through the pull-plug that is located as far from the influent location as possible.

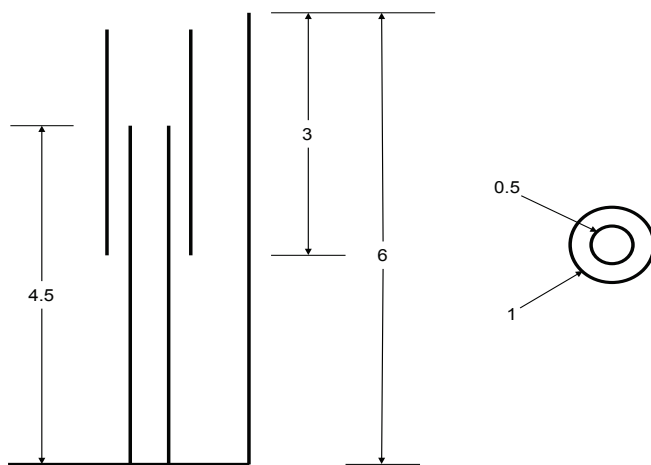
The pull-plug typically consists of a 6-inch diameter PVC pipe, fitted into a floor slip-joint that has a height of approximately 4.5 feet. The top of the pull-plug pipe is protected from debris by a 12-inch diameter pipe that encircles the pull-plug and extends approximately 1.5 feet above and below the top of the pull-plug. The outer pipe can be mounted to the inner pipe by using 1-inch galvanized steel strapping such that the outer pipe “hangs” from the inner pipe. A nylon or polypropylene retrieval rope, not less than 1/2-inch in diameter, should be attached to the top of the inner pipe. Removal will be easier if the retrieval rope is made to run through both

sides of the pipe, so that pulling on the rope will pull the pipe directly upward. Detail of the pull-plug is shown in Figure 4.

Figure 4. Profile and plan views of a pull-plug. Dimensions given in feet.

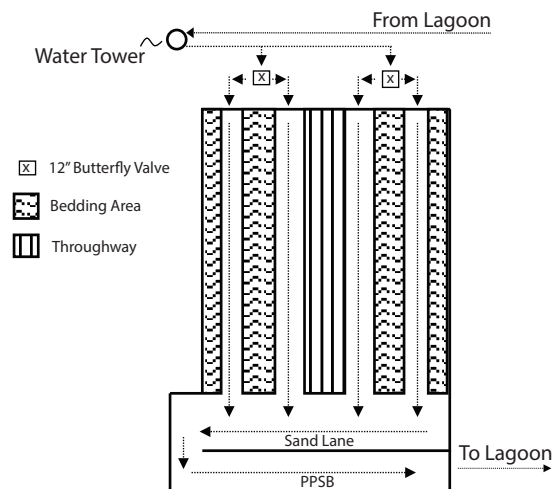
The system at BR Dairy now consists of a 128 foot-wide by 144 foot-long freestall barn, a passive sand-settling lane, the PPSB, and storage lagoon. The dairy is located on a hilltop with little topsoil above bedrock. The location and geology of the site contributed to the most difficult aspects of the design and construction of the system. Figure 5 provides a plan view of the integrated freestall barn, sand settling lane, PPSB, and lagoon.

Figure 5. Plan view of BR Dairy freestall barn and closed-loop manure flushing system.

The barn is separated into two sections by a 21.3 foot-wide feeding throughway in the center. Each side features three rows of sand-bedded freestalls and two flush lanes. The flush lanes are 14.6 feet and 12 feet-wide, for a total width of 26.6 feet per side. The flush lane slope was 2.6 percent as measured but calculated to be 2.1 percent based on elevations and dimensions provided by the design engineer. The sand lane slopes at a 0.4 percent grade until it reaches the end of the wall that separates it from the PPSB. The slope around the corner to the PPSB is 0.6 percent.

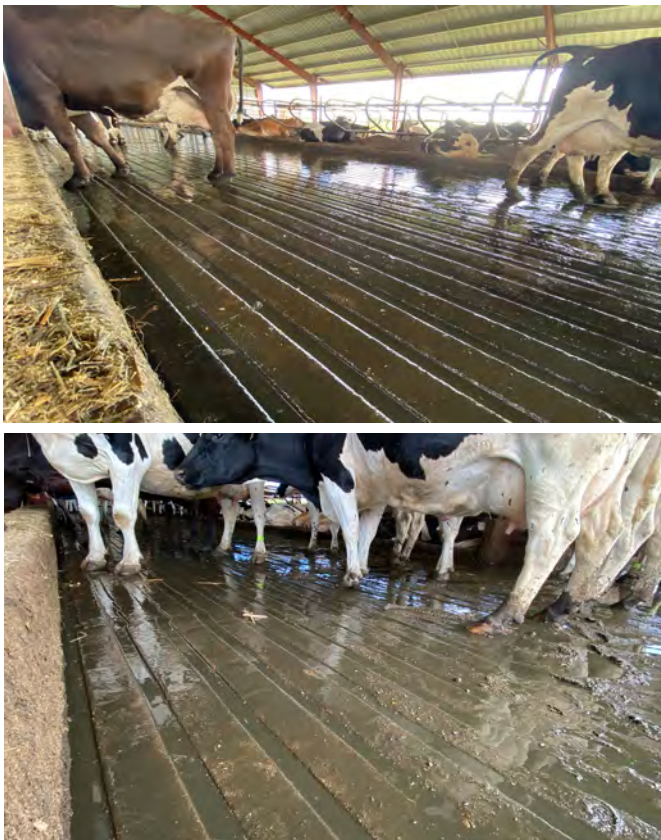
Figure 6a and 6b. Upslope (top) and downslope (bottom) of flush alley.

It takes approximately 22 seconds for the flush water to traverse the 144-foot lane length from the 12-inch butterfly valve to the end of the barn (i.e., the beginning of the sand lane). The depth of the flush was measured to be greater than 3 inches for approximately 10 seconds and reached a maximum depth of 4 inches. Manning's equation for open channels is adequate for calculating velocity in flush alleys.

The calculated velocities for the 14.6-foot and 12-foot flush alleys are 4.7 feet per second and 4.6 feet per second, respectively, for a 10-second flush at a flow height of 3 inches. Both alleys reach velocities of essentially 5.6 feet per second at a flush depth of 4 inches. The flushing system cleans the front (upslope) portions of the alleys well (Figure 6a). However, owners have reported some residual bedding sand in the alleys after flushing, generally from the midpoint to the downslope end of the alley (Figure 6b). Based on the calculations above, it seems likely that the recommended velocity of 5 feet per second at a duration of 10 seconds for alleys less than 150 feet with grades less than 3 percent is either inadequate or not quite achieved.

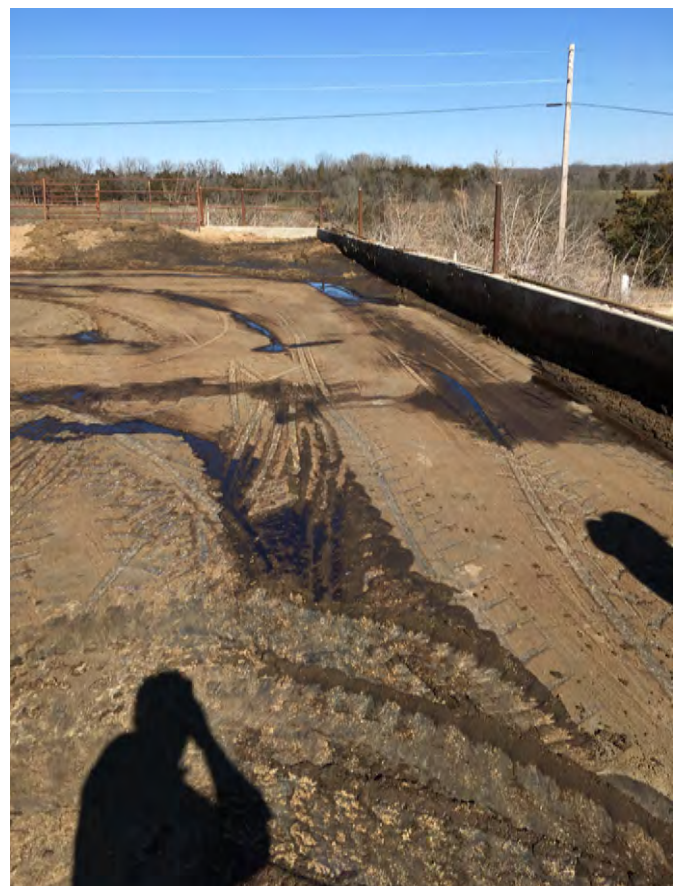
Figure 7a. Upslope view of sand lane.

The sand lane is 20 feet-wide with a 0.4 percent slope to allow the heavier sand particles to settle while keeping manure slurry in suspension (velocity approximately 1.2 feet per second). Figure 7a shows an image of the sand lane from the downslope end. The sand lane provides a means of retaining the heavier particles prior to the PPSB. BR Dairy allows the reclaimed sand to dry prior to reuse. The sand lane designed for BR Dairy seems to retain most of the sand prior to the PPSB service ramp. The operator believed that 60 to 70 percent of sand is retained in the sand lane when the sand is removed from the lane once per week.

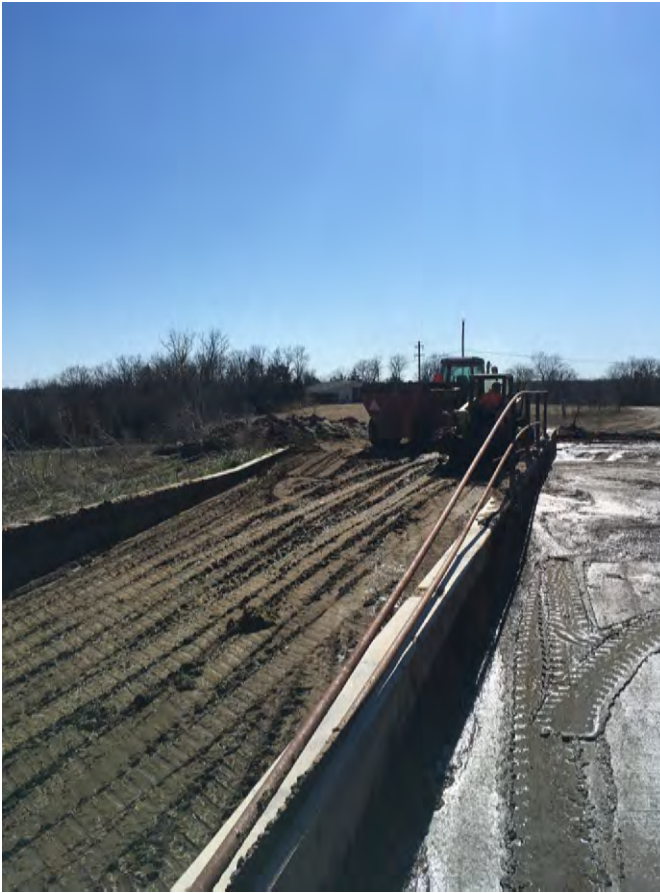
Figure 7b. PPSB ramp and adjoining sand lane.

The flush water makes a 180 degree (hairpin) turn at the downstream end of the sand lane and spreads across the width of the PPSB as it flows into the PPSB. The brown pole on the curb to the right in Figure 7a marks the approximate end of the PPSB, which is on the other side of the stem wall. Figure 7b displays an image of the PPSB ramp and adjoining sand lane near the hairpin turn. It should be noted that the photos in Figures 7a and 7b were taken during a cleanout operation of the PPSB. Figure 7c shows the sand lane and PPSB while in operation.

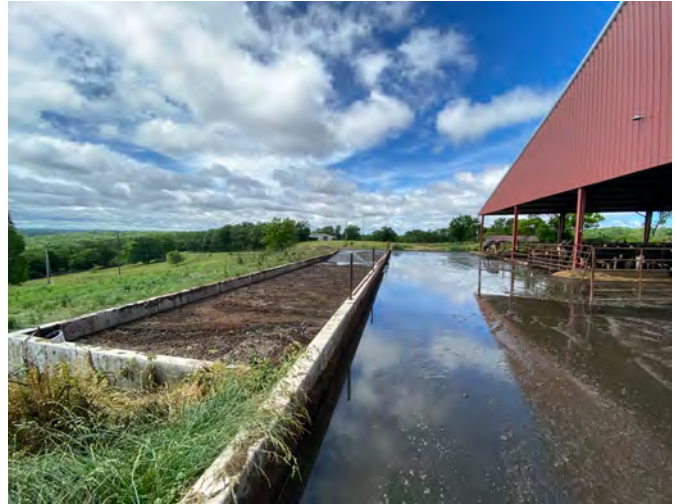
Figure 7c. PPSB and sand lane in operation.

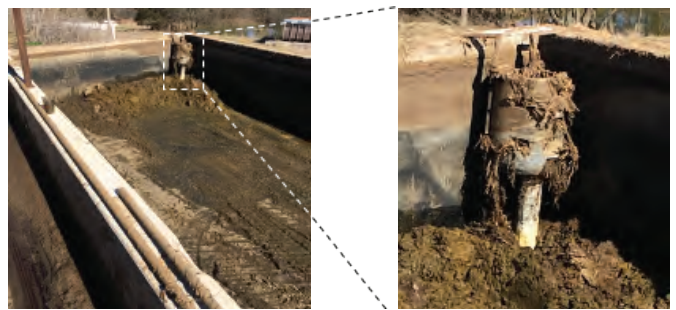
Figure 8a and 8b. PPSB with liquid discharge pipe (left) and discharge pipe (right).

NCRS generally recommends the discharge pipe (Figure 8b) be pulled from the slip joint prior to cleaning the basin so that the water will completely drain and minimize the moisture content of the solids in the basin. However, the operator at BR Dairy was discouraged by the recommended procedure when plugging occurred in the pipe between the PPSB and lagoon during the first cleaning attempt. Now the operator carefully monitors the bottom/top layer interface and cleans the basin without removing the discharge pipe. He simply waits for all the fluid to drain through the discharge pipe and begins transferring the solids out of the PPSB. This revised cleaning procedure results in solids that, even though heavier due to a higher moisture content, are still stackable. It takes the operator approximately 33 loads using a Gehl 312 spreader (300-bushel rating; 7–8 tons per load) and Gehl 6635 skid steer loader. The solids are land applied between one and two miles from the site. The entire cleaning procedure takes a single operator ten hours to complete.

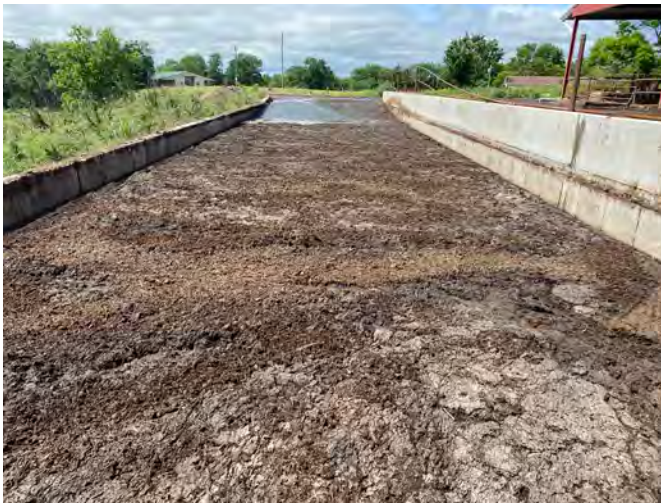
Figure 8c. Mat development on the PPSB.

Although referred to as a sedimentation basin, the PPSB also acts as a filter during operation. Fibrous material from the manure slurry (or bedding, if applicable) collects on the surface of the water in the PPSB and congeals to form a semi-solid mat. It is important that the incoming flow is allowed to spread out across the 20' width to disturb the mat as little as possible. The manure-laden water flows down the access ramp and under the mat. Over time, the height of the mat rises to the level of the orifices in the discharge pipe (Figures 8a and b). It is at this point that filtration begins to occur. As water flows into the basin it tries to raise the mat, but the weight of the mat causes water to flow up through the mat and into the collection pipe. Operation continues in this manner until the mat rises above the basin wall. Figure 8c (following page) shows

development of the mat during operation and Figure 8d shows the filtering action and discharge of the PPSB through the pull-plug.

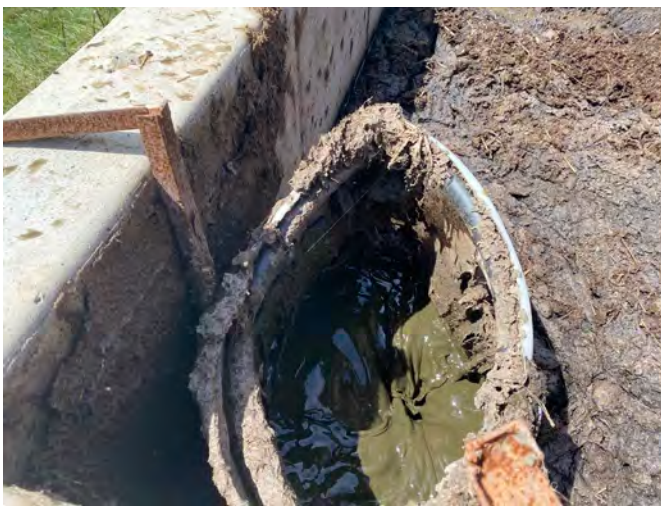
Figure 8d. Water discharging from the PPSB.

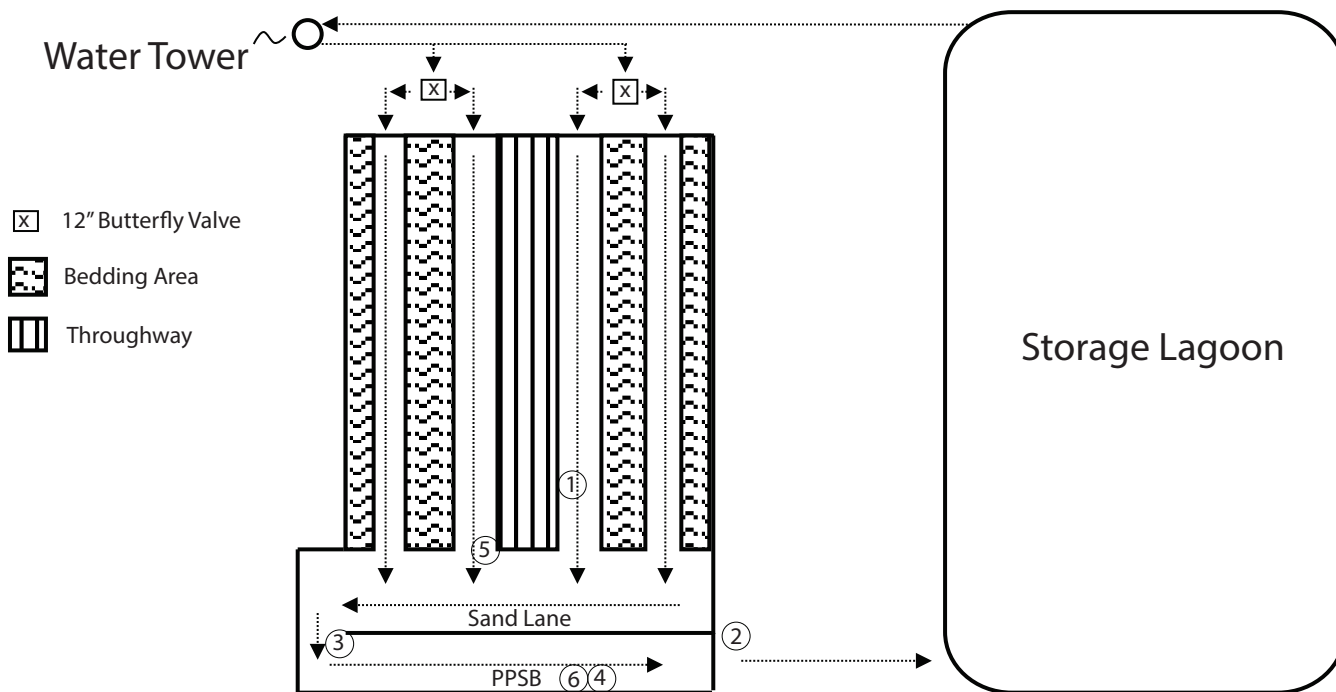
shows the sampling locations superimposed on a sketch of the freestall barn, sand lane, and PPSB at BR Dairy.

Figure 9. Illustration showing sample locations in flush water handling system.

The sand lane effluent sample (3) was taken at the entrance of the PPSB where both sand and organic solids are present, and the flush discharge sample (5) was taken as the end of the flushing lane as indicated in Figure 8. It should be noted that the operator flushed the system outside of normal flushing time so that samples 1, 3, and 5 could be collected. Samples taken between normal flushing cycles could return results that underestimate the solids and nutrient concentrations normally in the flush water and, therefore, underestimate the mass load on the PPSB.

Samples of the settled solids (bottom, Loc. 4) and mat (top, Loc. 6) of the PPSB are useful in evaluating the solids and nutrient retained in the settling basin. The floating materials at the top and the sediment at the bottom had a higher nutrient and solids content than the effluent, confirming significant solids and nutrient retention by the PPSB. The operator at BR Dairy noted that, upon cleanout, there was no liquid middle layer; the top layer and the bottom layer comprises 2 feet and 4 feet, respectively, out of the overall 6-foot basin
