Post-Occupancy Evaluation of State Schools in 5 Climatic Zones of Chile

This paper presents the results of a study, commissioned by the Chilean Ministry of Education and UNESCO, of hygro-thermal comfort, visual comfort, acoustics and indoor air quality, as experienced in selected classrooms of 8 state schools located in distinct climatic zones in Chile.

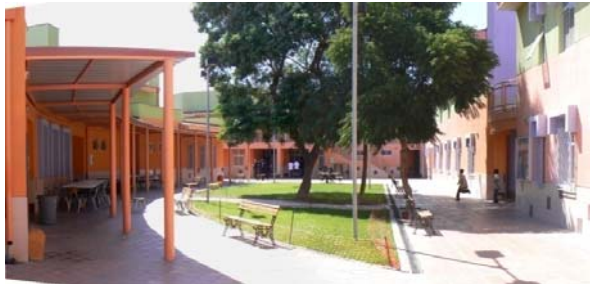
Figure 2. School A, External view

The school is situated with the main road to the north and a side road to the east. The classroom is on the ground floor, facing east. The construction is reinforced concrete, of 250mm overall thickness with a pale green painted plaster internal finish and external un-insulated render. The room is 2.9m high with 17.8% of the wall surface glazed, principally towards the east. No external solar protection is provided with only internal curtains. The artificial lighting consists of 16 fluorescent tubes, which are all switched on.

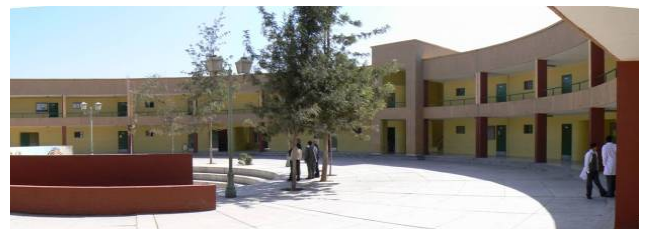
Figure 6. School B, External view

The school is situated within its own grounds. To the west, the direction of the predominant wind (SW), is located a bare earth football pitch. The classroom is situated on the ground floor, facing north. The construction is reinforced concrete, of 270mm overall thickness with a pale yellow painted plaster internal finish and external un-insulated render. The room is 2.7m high with 17% of the wall surface glazed, principally towards the North. No external solar protection is provided with only internal curtains. The artificial lighting consists of 14 fluorescent tubes, which are all switched off.

Teachers interviewed reported that the location of the bare earth football pitch causes problems with dust and prohibits the opening of windows. The simplest solution would be to surface the pitch or create a windbreak with trees and shrubs.

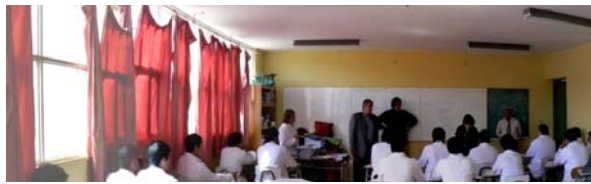
Figure 7. School B, Internal view of study classroom

A third of teachers interviewed experienced discomfort from glare arising from the lack of external solar protection. In turn this leads to internal curtains often being closed, thus reducing natural daylighting and augmenting the reliance on artificial illumination.

Horizontal shading, perhaps in the form of a light shelf could reduce glare and provide more homogeneous daylighting.

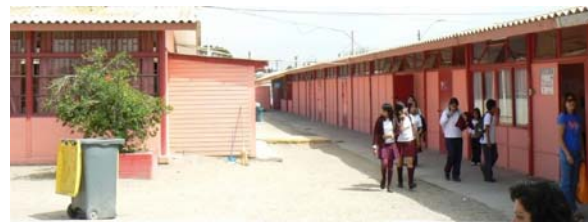
Figure 9. School C, External view

The school occupies an entire urban block in the town centre. The classroom is situated on the ground floor, facing west. The construction is a steel frame with un-insulated 90mm brick, or 40mm solid panel infill. The internal finish is apricot painted plaster. The room is 2.7m high with 17% of the wall surface glazed, principally towards the west. Planting provides limited external solar protection, supplemented by internal curtains. The artificial lighting consists of 4 low energy pendant bulbs, which are all switched on.

School C again suffers similar problems regarding noise pollution, leading to poor ventilation, in addition to lack of solar protection.

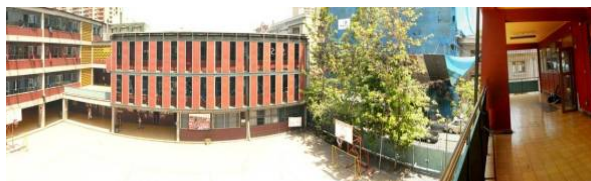
Figure 12. School D, External view

The school is situated in the city centre, occupying the corner of a city block. Two classrooms were studied both situated on the top floor of a three story block, one facing east, the other west. The construction is reinforced concrete, of 200mm overall thickness with a yellow painted plaster internal finish and external un-insulated render. The rooms are 3.5m high. The east facing room has 20% glazing distributed both east and west walls with no external shading and internal curtains. The west facing room has 12.5% of the wall surface glazed, principally towards the west. External vertical panels provide solar protection, supplemented by internal curtains. In both classrooms the artificial lighting consists of 14 fluorescent tubes, which are all switched on.

Once again, due to the schools city centre location, noise pollution is the principal problem faced by school D. Of the teachers interviewed all reported that background noise levels interfere with their work. They confirmed a constant conflict between external noise when windows are open and poor indoor air quality and serious overheating when windows remain closed.

The complexity of the inner-city location would make urban transport control an unlikely solution, therefore hermetic high performance glazing with mechanical ventilation could perhaps be the most appropriate solution. This could be coupled with the use of night purging to take advantage of the low nocturnal temperatures experienced in Santiago, and the high thermal mass inherent in the buildings construction, to help reduce summer peak temperatures.

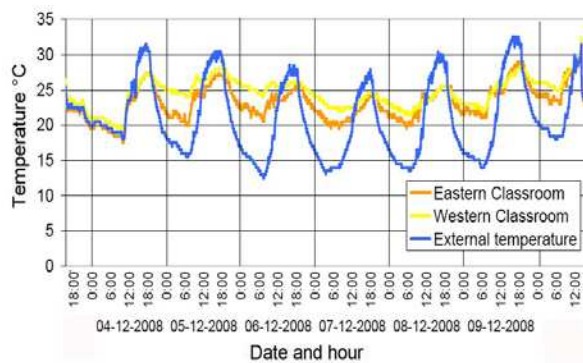
Figure 16. School D, Internal and external temperatures over a 6 day period

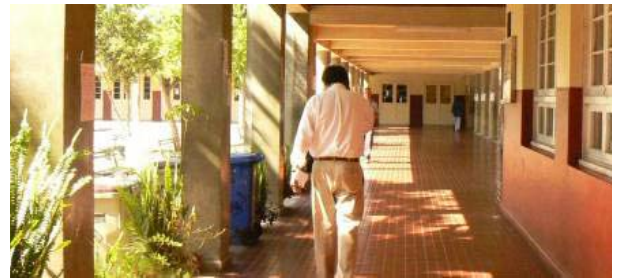
Figure 17. School E, External view

The school is situated in a quiet residential neighbourhood fronting onto a square. The classroom is situated on the ground floor facing north. The construction is solid brick, of 250mm overall thickness with an apricot painted plaster internal finish and external un-insulated render. The room is 3.2m high and has 17% of wall surface glazed, distributed equally between external wall and that to the internal patio. No external solar protection is provided with only internal curtains. The artificial lighting consists of 6 fluorescent tubes, the lights are all switched on.

Due to its location in a quiet residential neighbourhood noise pollution an issue and so natural ventilation via opening windows is possible. The high levels of thermal mass provided by construction help regulate temperatures during the summer months; however it is likely that the lack of insulation leads to discomfort from the cold in winter and problems with condensation. Due to a reluctance of teachers to participate in the proposed interviews it is not possible to confirm this.

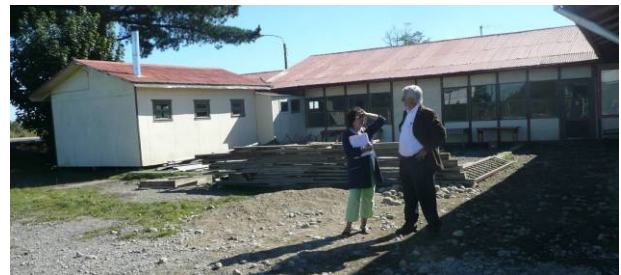
Figure 20. School F, External view

The school is situated in a rural location but is adjacent to the cities airport. The classroom is situated on the ground floor, facing north. The construction is timber framed with un-insulated timber panel infill painted pale yellow internally. The windows are fixed shut due to noise pollution from adjacent airport. No external solar protection is provided with only internal curtains. The artificial lighting consists of fluorescent tubes, which are all switched off.

At school F the problem of external noise pollution is taken to its extreme due to the schools inappropriate location besides the airport. All teachers interviewed confirmed that it was necessary to interrupt their classes each time a plane lands or takes off. They also confirmed that with the windows fixed shut the classroom is stuffy with insufficient ventilation and high humidity. Whilst there exists possible new-build solutions to this problem the most effective and affordable solution would be to relocate the school, a solution that the local authorities are currently pursuing.

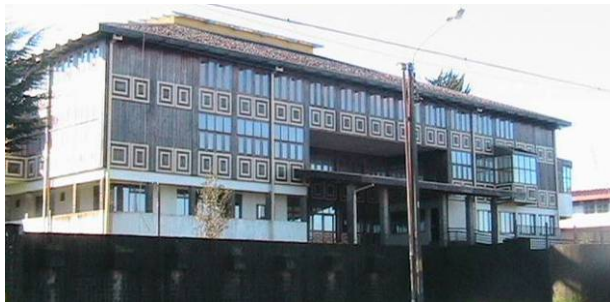
Figure 22. School G, External view

The school is situated near the seafront close to centre of town, with a central atrium with translucent roof. The classroom is situated on the second floor, facing east. The construction is reinforced concrete with pale yellow painted plaster internally. No external solar protection or internal curtains are provided. The artificial lighting consists of 8 fluorescent tubes, which are all switched off.

In interviews the teachers' most common complaint was that of the cold, 80% wear outdoor coats for winter classes. The problem is aggravated by problems with the under floor heating system. It is unclear if this is a mechanical or economic problem, but it is clear that the lack of insulation in the building envelope clearly does not help. Inadequate ventilation was also once again highlighted, this time due to low outdoor air temperatures and associated draughts. The insulation of the building envelope and mechanical ventilation with heat recovery should be considered.

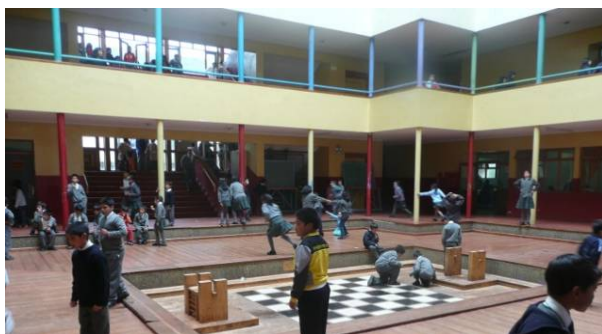
Figure 23. School G, Internal atrium

The central atrium provides a vibrant centre to the school and provides a well-lit protected space for recreation throughout the year. However the lack of acoustically absorbent materials in this space leads to poor acoustics and complaints by teachers.

The introduction of absorbent materials, such as acoustic wall or ceiling panels would help reduce the reverberation time of the space.

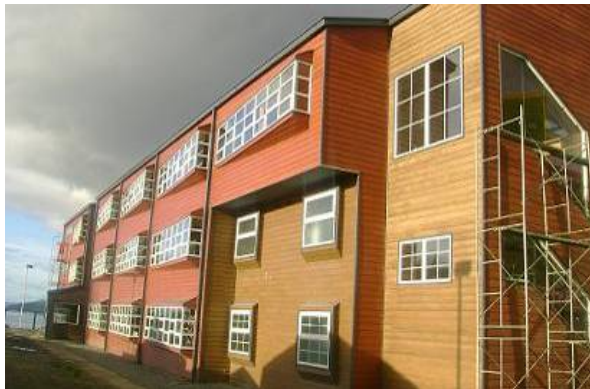
Figure 24. School H, External view

The school is recently constructed and is the only school studied with thermal insulation. It is situated in the upper part of the village overlooking the bay, with a central atrium. The classroom is situated first floor, facing east. The construction is timber framed with 100mm of insulation, clad internally and externally in timber. The room has glazing to the east and south. No external solar protection is provided with only internal curtains. The artificial lighting consists of 6 fittings each with 3 fluorescent tubes, which are all switched on.

The central atrium suffers similar acoustic problems as those encountered at school G. In addition the space suffers from complete lack of ventilation with no opening windows or mechanical ventilation, a problem also experienced in the kitchen and dining room of the school.

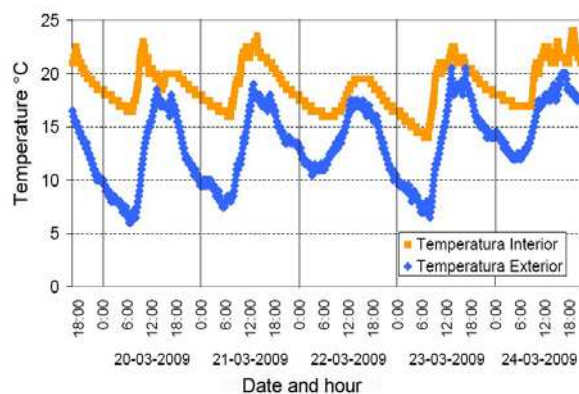
Figure 26. School H, Internal and external temperatures over a 6 day period

Being the only school in the study with an insulated building envelope it is not surprising to see that the indoor air temperature stays constantly above the external. Due to its recent completion the building manager and teachers have not yet experienced a winter in the building, however it is possible that the natural ventilation strategy of simple opening windows may prove problematic given the local climatic conditions.
