Proceedings of the Geologists' Association

Geological and geomorphological influences on a recent debris flow event in the Ice-scoured Mountain Quaternary domain, western Scotland

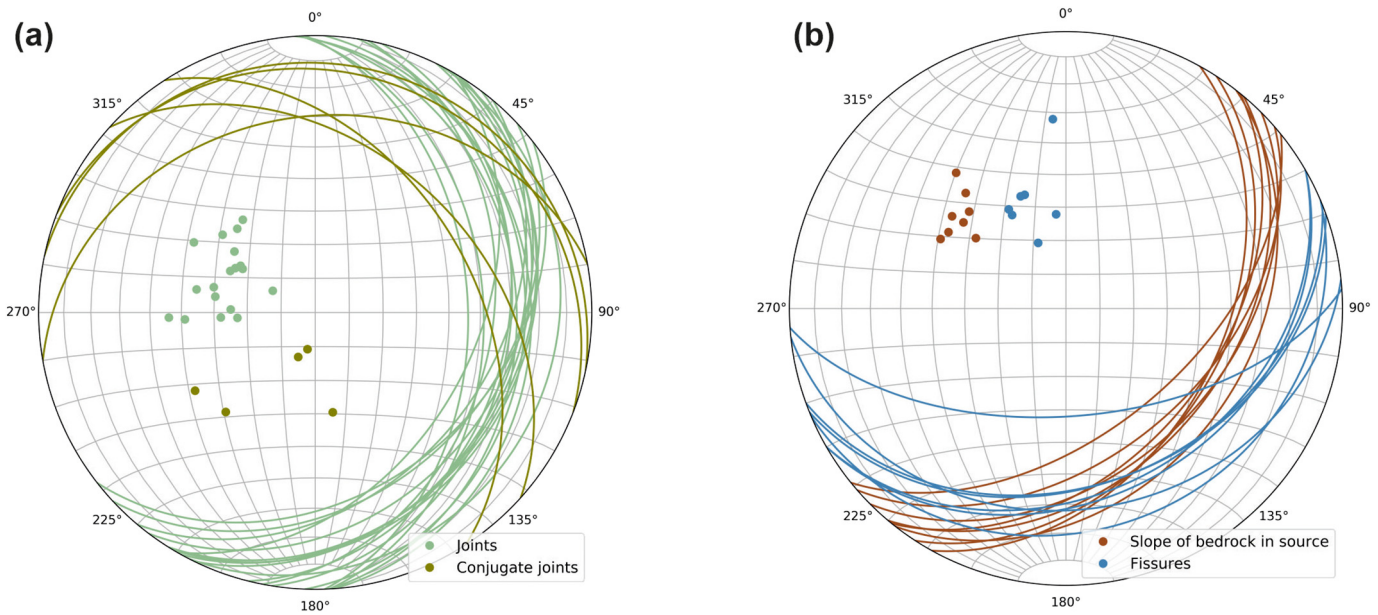
Fig. 5. Stereonets of (a) orientation data from the exposed bedrock slopes; and (b) fissures in deposits from both source areas.

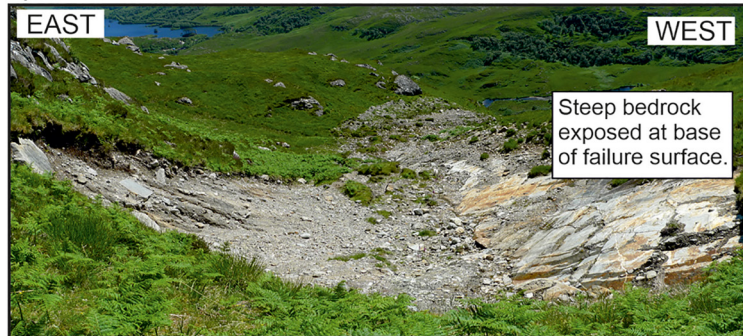
a) Western source area overview

b) Eastern source area overview

Fig. 6. Photographs of (a–b) western and eastern source areas; and (c–d) photographs showing types of deposits in both source areas.

developed set of joints that dip at approximately 40 degrees towards the north-east. The south-western edge of the western bowl is bounded by a grassy slope with a large proportion of exposed bedrock, which forms a continuous rock surface dipping at 30–40 degrees towards the south-east (Fig. 6a–b).

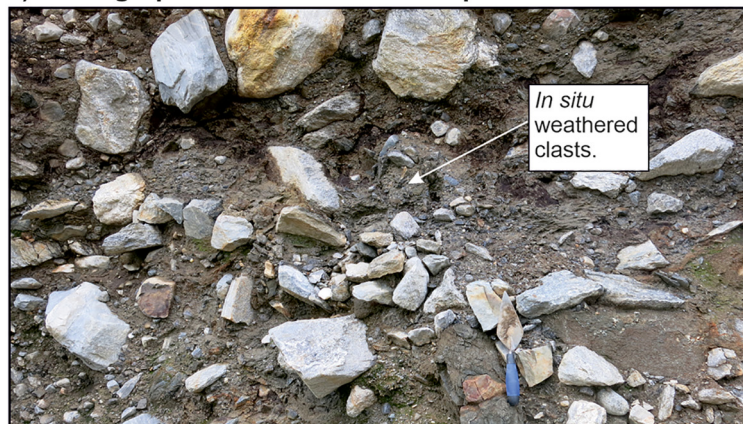
d) Photograph of eastern source deposit

The sediments exposed in the eastern landslide scarp comprise a single unit of very dense, poorly-sorted, very gravelly sand, with frequent cobbles and boulders (Figs. 6d, 8b). The larger clasts are angular and composed of psammite, pelite and mafic material (Fig. 6d). The deposit is predominately clast-supported but isolated patches of matrix-supported material also occur. Short (<1 m), discontinuous, clay-filled fissures are also present in the matrix-supported sections. A number of the mafic clasts were observed to be heavily-weathered and

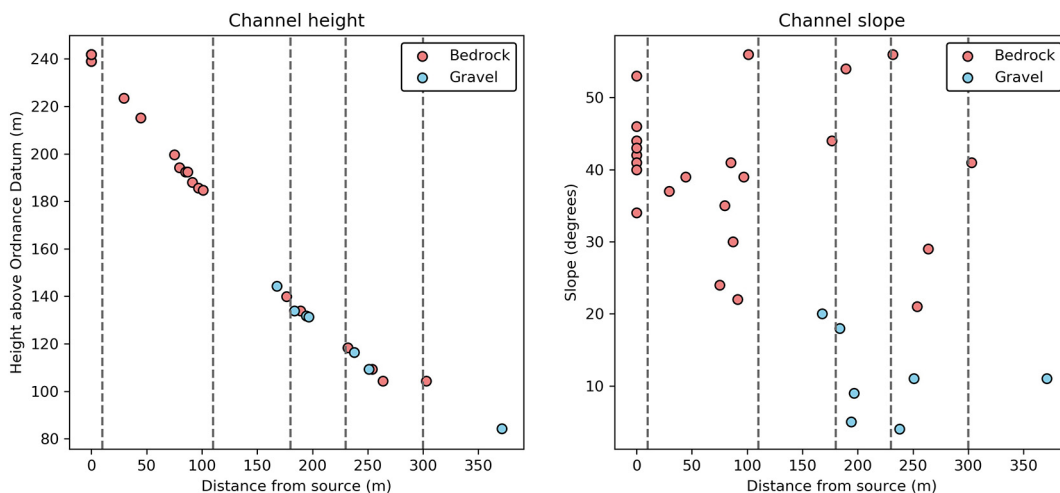
Fig. 10. Field measurements of topographic height and slope angle along the western channel. The points are coloured to show if the channel either has bedrock or gravel exposed. Dashed vertical line show the points where cliffs intersect the channel. (For interpretation of the references to colour in this figure legend, the reader is referred to the web version of this article.)

The angle of the slope is highly variable from the source areas at 250 m OD to the base of the hillside (Fig. 10). A series of small psammite cliffs run perpendicular to the channels and vary in height from 2 m to nearly 10 m . The cliffs are regularly spaced down slope and are intersected by the channels every 50 to 100 m (Fig. 4). The uppermost part of the western channel, immediately below the source, has bedrock exposed in the channel base for a distance of approximately 100 m through the first set of bedrock cliffs. In general, the shape of the
