# Experimental assessment of a wireless communications platform for the built and natural heritage

M.I. Martínez-Garrido<sup>a,b,c,†</sup>, R. Fort<sup>a,b</sup>

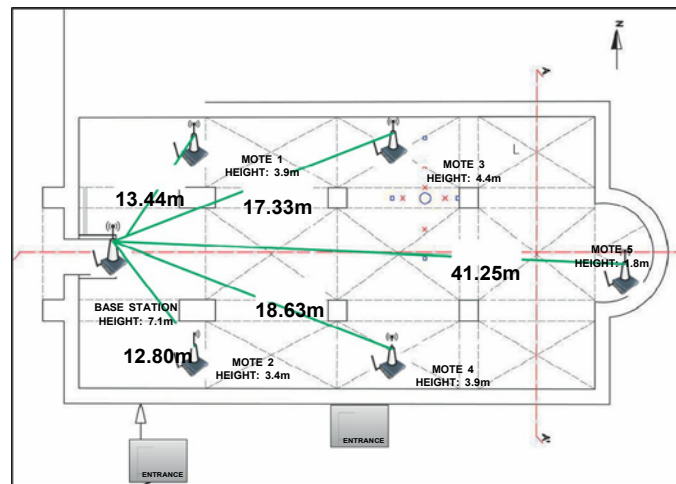
Fig. 6. Mote distribution in Santo Domingo de Silos Church at Pinto, Madrid, Spain.

When the study of parameters RSSI and CORR was based on the distance to the base station (Table 3), two distinct areas were observed: the RSSI was higher for the motes close to the receiver (motes 1 and 2) and lower in the intermediate zones (motes 3 and 4) and in the node farthest away, in the apse (mote 5), for which the lowest CORR value was also recorded.

The link quality denoted by the correlation (CORR) value was practically the same for links 1/BS and 2/BS, whereas the difference in their received signal strength indicators (RSSI), a measure of the degree of partial obstruction in the first Fresnel clearance zone, was

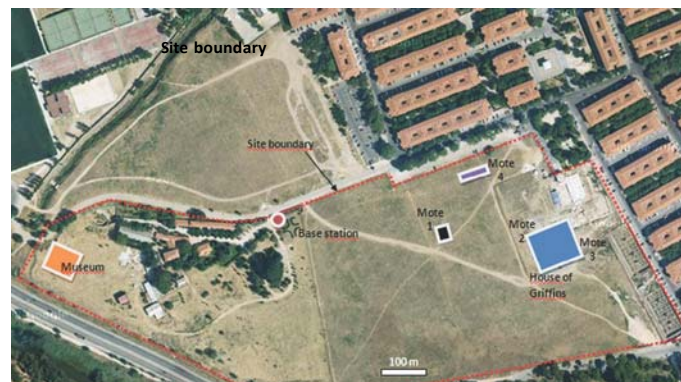
Fig. 7. Mote positions at the Complutum archaeological site, Alcalá de Henares, Madrid, Spain.

antenna in the line of sight between it and the receiver, the link had no line of sight (NLoS, 60% of  $r_1 = 0.74$  m), as shown in Fig. 7. In other words, the lower RSSI (27.43 dBm) and CORR (88) values were due to the interference of construction elements as well as metals that caused absorption-induced strength losses in the signal transmitted [32], leading to a loss in the number of messages received. In link 5/BS, despite the considerable difference in the distance to the base station, the RSSI value was excellent thanks to the existence of a line of sight (LoS).

Two of the monitoring points were positioned on the House of Griffins (motes 2 and 3, Fig. 7) [15], one of the compound's largest (around 1000 m<sup>2</sup>, including house and courtyard) and most comfortable homes and the site's central element. It was in use until the fourth century when it was destroyed by fire. A third was placed on the information booth alongside the entrance (mote 1, Fig. 7) and a fourth in an area with replicas of Roman building foundations (mote 4, Fig. 7) [15].

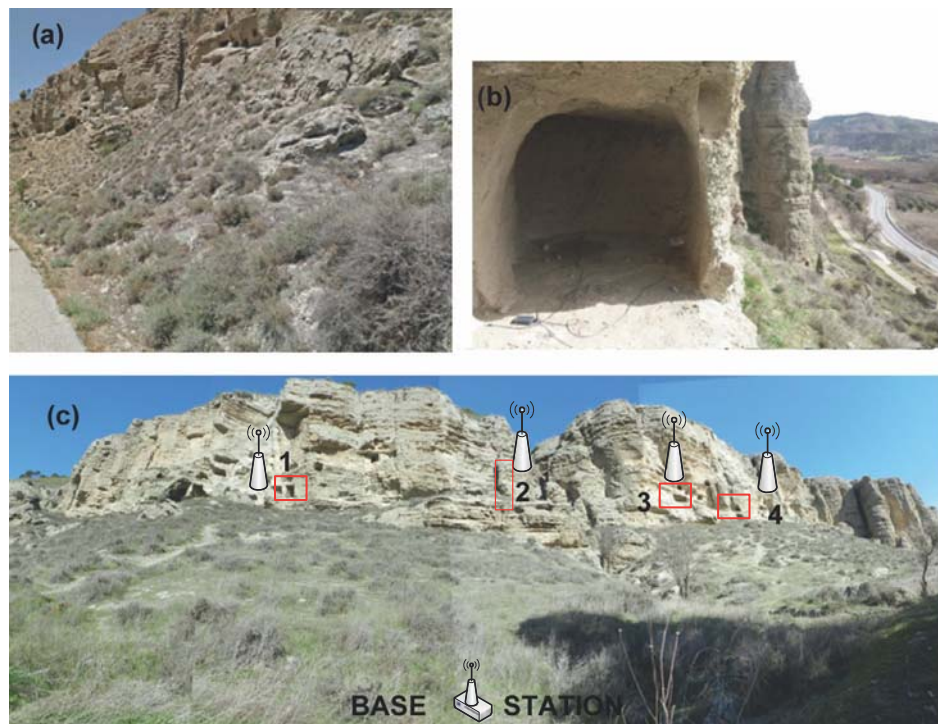
Fig. 8. Network installation at Risco de las Cuevas, Perales de Tajuña, Madrid, Spain: (a) grade on terrain between the base station and caves; (b) sensor installation in mote 3 cave; (c) overview of Risco de las Cuevas showing the positions of the wireless sensor network measuring points.

Risco de las Cuevas is a gypsum escarpment where caves were excavated in the solid rock between the late Neolithic and much more recent times (Fig. 8). It is located at Perales de Tajuña, Madrid, Spain ( $40^{\circ}14'0.83''N$ ,  $3^{\circ}19'55.85''W$ ), where it rises to a height of 70 m and runs SW–NE for a total of 500 m. The carved dwellings were listed as a historic-artistic monument in 1931 and as a cultural

Despite the difficulties posed by the enclave, in three of the four caves monitored, 100% of the data were received. The exception was mote 1, where 20% of the information was lost, even though the RSSI and CORR parameters were indicative of stable communications. In this case, in addition to the 50 grade to the base station, the inside of the cave was likewise sloped. As a result, the mote had to be scotched with a piece of gypsum from the cave itself to prevent it from sliding out of position. The position of the scotch close to the antenna and cave characteristics were therefore the factors that induced the decline in the percentage of data received. A small percentage of duplicated messages, albeit larger than for the remaining caves, was received for caves 3 and 4 (Fig. 8).

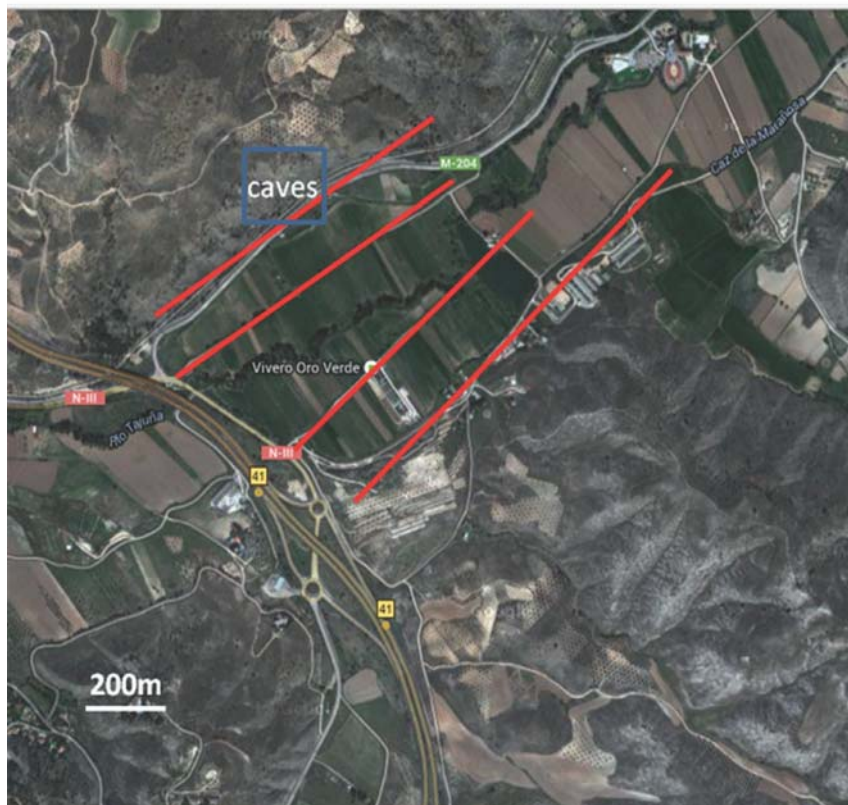
Fig. 9. Range tests for the installation at Risco de las Cuevas, Perales de Tajuña, Madrid, Spain: aerial photograph of the zone, showing range test lines (in red). (For interpretation of the references to color in this figure legend, the reader is referred to the web version of this article.)

A series of tests were run at distances of nearly 1 km as shown in Fig. 9 to check network performance in an open area flanked with trees (Fig. 9, rectangle between lines 2 and 3) and similar elements in such enclaves.

The mote positions were not varied, while the base station was shifted for 5 min to check reception. The mote numbers in green in the figure mean satisfactory reception, blue intermittent reception and red no reception from the mote at the point in question.

The distances shown in Fig. 9, measured with Google Earth, were taken from the midpoint between caves 2 and 3 to the midpoint between the lines assessed. The
