## EVALUATION OF COLORIMETRIC CHANGES IN THE ITAQUERA GRANITE OF THE RAMOS DE AZEVEDO MONUMENT, SÃO PAULO, BRAZIL

### Abstract

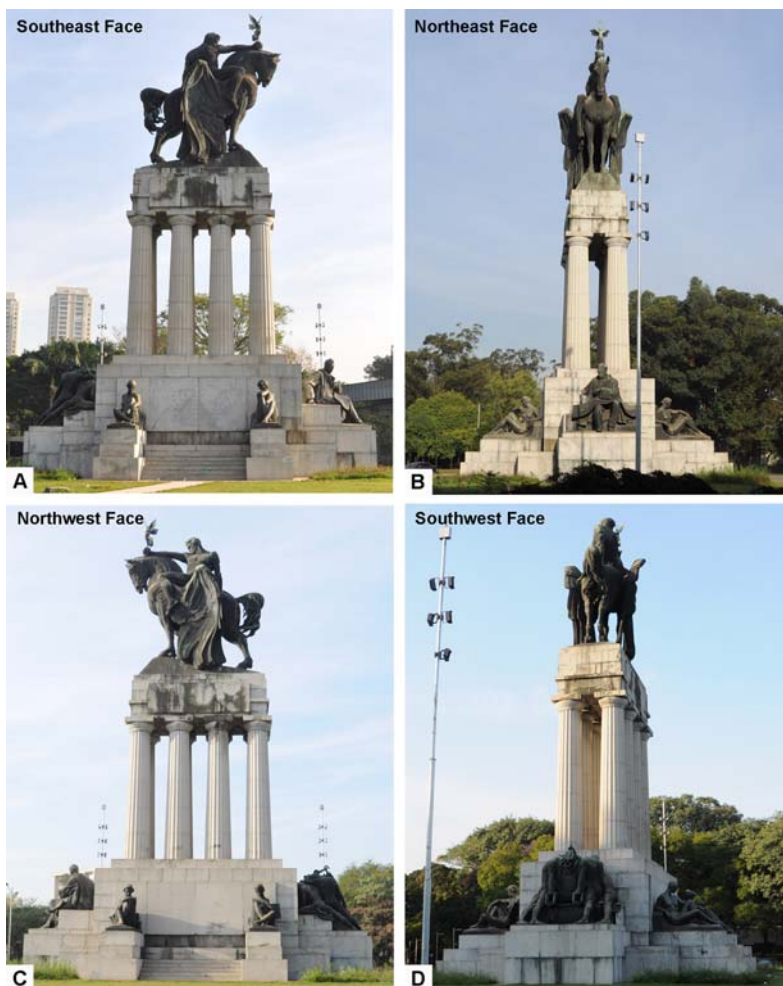
**Fig. 1.** Monument to Ramos de Azevedo. Face 1 (A); Face 2 (B); Face 3 (C) and Face 4 (D)

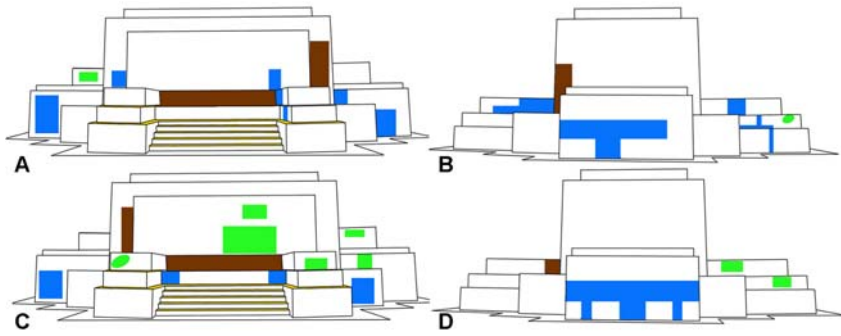
There are 4 colorimetric standards for the pathologies observed (Table 1 and Fig. 4). The first one has a bluish-greenish color and is associated with leaching of bronze statues situated above (Fig. 5A). In fact, SEM (scanning electron microscopy) analysis pointed out that the statues are made of brass and not bronze as Cu and Zn were detected.

Fig. 4. Schematic mapping of the pathologies observed in the lower part of the monument. Blue - pathology 1; brown - pathology 2; green - pathology 3; yellow - pathology 4. See Table 1 for the meaning of each pathology.

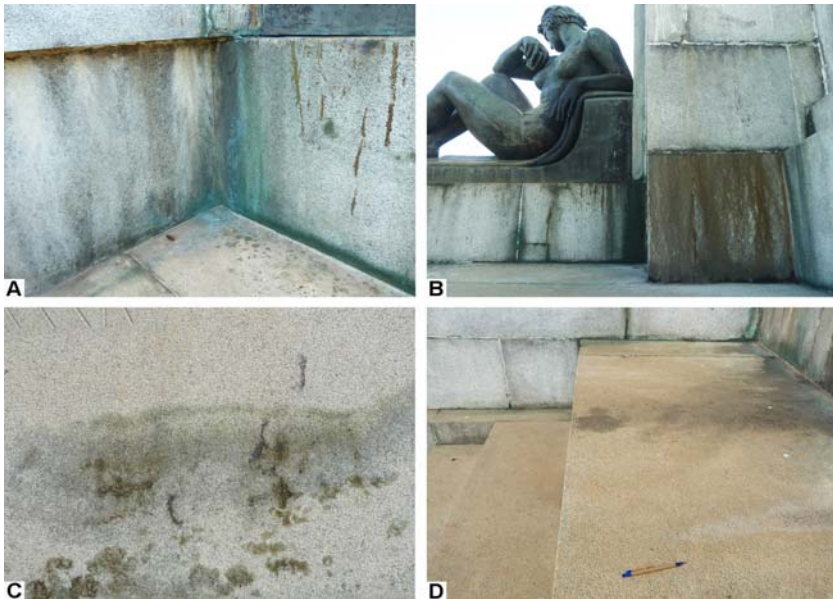
The second soiling standard is the deposition of leachate from the mortar and is associated with the deposition of soot yielding a brown color (Fig. 5B).

The third standard is due to the presence of biological colonization mainly fungi yielding a green color (Fig. 5C).

The fourth standard is characterized by the yellowing of granite (Fig. 5D) caused by deposition of ozone and/or oxidation of iron-rich minerals. *P. Brimblecombe* [23] explains the yellowing of the stone by sulfur dioxide attack or deposition of atmospheric urban pollutants (i.e. ozone). There is no high emission of  $SO_2$  next to the monument, but the  $O_3$  rate is *cca.*  $200\mu\text{g}/\text{m}^3$ , which is considered a very bad air quality index [34].

Fig. 5. Standards for the soiling found on the Monument to Ramos de Azevedo.

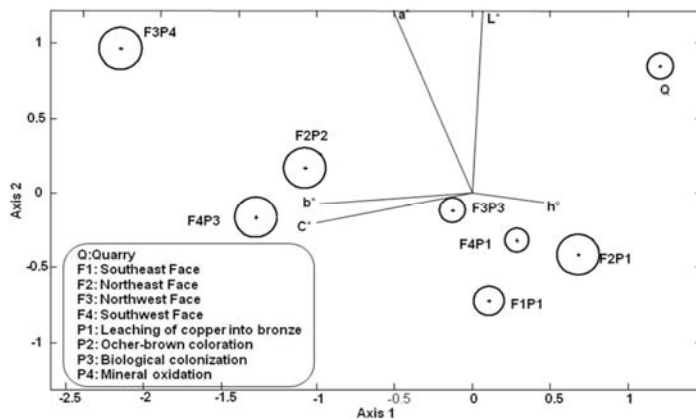
Figure 6 shows the data obtained from the statistical analysis.

With respect to the parameter  $L^*$ , we noticed a darkening of all samples with pathologies, with the exception of sample F3P4 (Northwest face and oxidation of iron-rich minerals). In this case, the data for the color parameter  $L^*$  are at the same level as for the quarry granite (Q), with the conclusion that this sample shows no modification for the parameter  $L^*$ .

Fig. 6. Graphical representation of statistical analysis of the 2013 data for quarry granite (Q) and granites with pathologies on the four faces of the monument.

There was a reddening of F3P4 with respect to Q, since the value of the parameter  $a^*$  is greater for the sample of the monument with pathology P4 than for the sample from the quarry. Samples of the monument with P1 pathology on faces F1, F2 and F4 are more greenish than for that from the quarry, with a decrease in the parameter  $a^*$ . Samples of the monument with P2 and P3 pathologies on different faces showed no differences in parameter  $a^*$  relative to the values of the quarry granite.

The parameter  $b^*$  increased for all the altered samples, with a notable yellowing of the samples with respect to the quarry granite, except for the samples presenting pathology P1 on faces F1, F2, and F4, where a reduction in parameter  $b^*$  was seen, indicating the acquisition of a bluish tint.
