Nepal earthquake of April 25, 2015

INVITED COMMENTARY

Nepal Earthquake of April 25, 2015

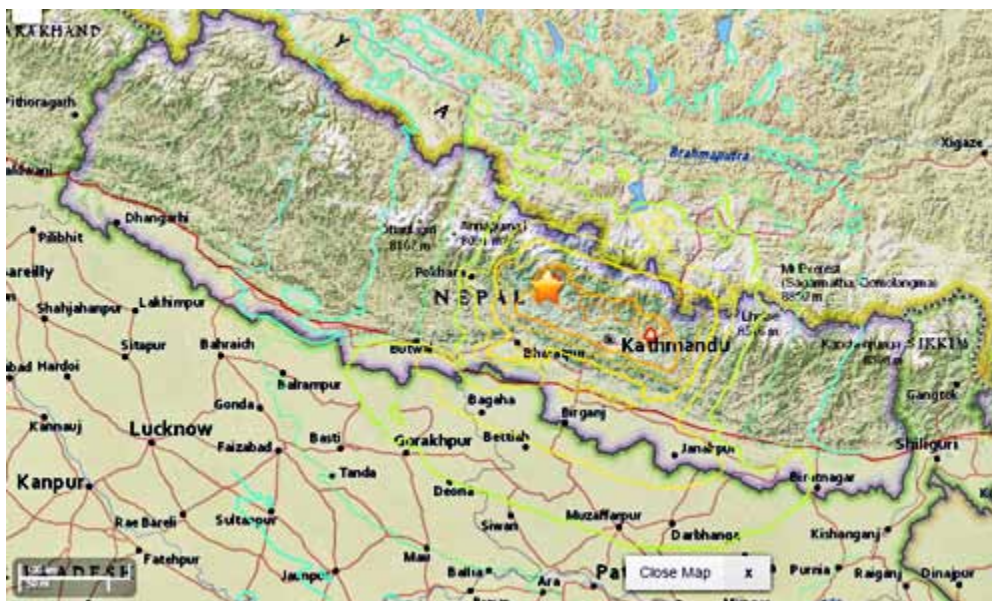
Figure 3. Map showing the location of Nepal earthquake of 25/04/2015 (after USGS)

The 2015 April 25th Nepal earthquake of M_w 7.8 occurred within the eastern region of the central seismic gap of Himalaya (Figure 3). The central seismic gap of Himalaya is considered to be the most vulnerable segment in the Himalaya plate boundary (Rajendran and Rajendran 2005). The epicentral location: 28.15° N 84.71° E (60 to 70km north to Gorkha) and the earthquake had a focal depth of 10-15km. Studies have shown that the thrusting mechanism on a shallow dipping fault of 7° dip is responsible for the 2015 Nepal earthquake of M_w 7.8. The maximum slip was estimated to be around 4.3 m with the eastward rupture propagation.

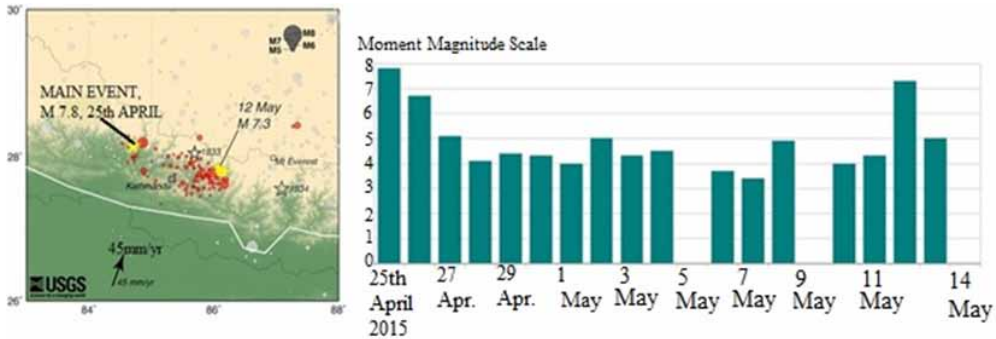
Figure 5. Aftershocks of the main event in Nepal (After USGS, Data shown in the Figure excludes the values <2.5)

The 25th April 2015 Nepal earthquake main event has more than 100 of aftershocks (Figure 5). Out of these aftershocks, the aftershocks on May 12th 2015, M 7.3 and M 6.3 are significant. The following Figure give a detail view of the aftershocks from 25th April 2015 to 14th May 2015.

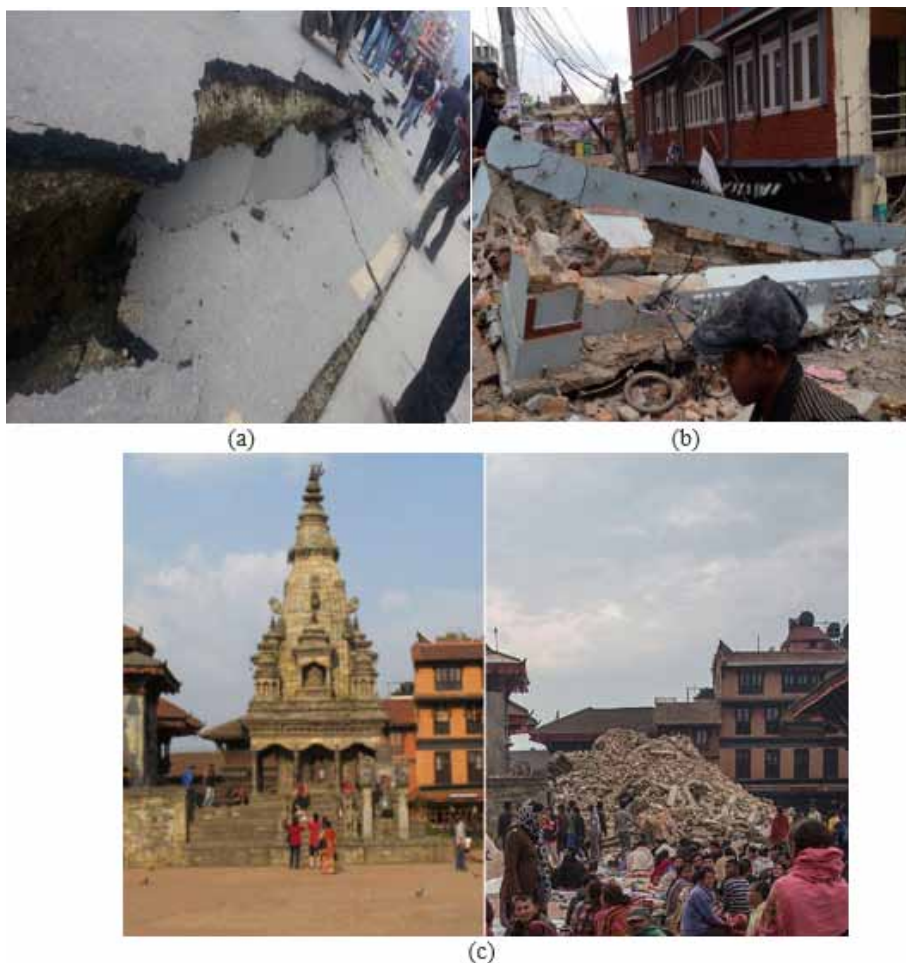
Sindhupalchowk, Kavre were mainly affected, where significant damages occurred to houses, hospitals power stations, transmission towers and other infrastructures. As being most densely populated city in the country, Kathmandu also sustained heavy infrastructural damages (Figure 6) and human casualties during the earthquake. Due to the devastating effect of the earthquake, Nepal also lost many monasteries and historical monuments among which the Dharahara (or Bhimsen) tower (Figure 7) and Durbar square (Figure 8) of Kathmandu are significant.

Figure 6. Some structural damages in Kathmandu during 2015 Nepal earthquake of Mw 7.8 (after <https://images.google.com>) (a) Collapse road (b) collapsed building (c) Collapsed temple

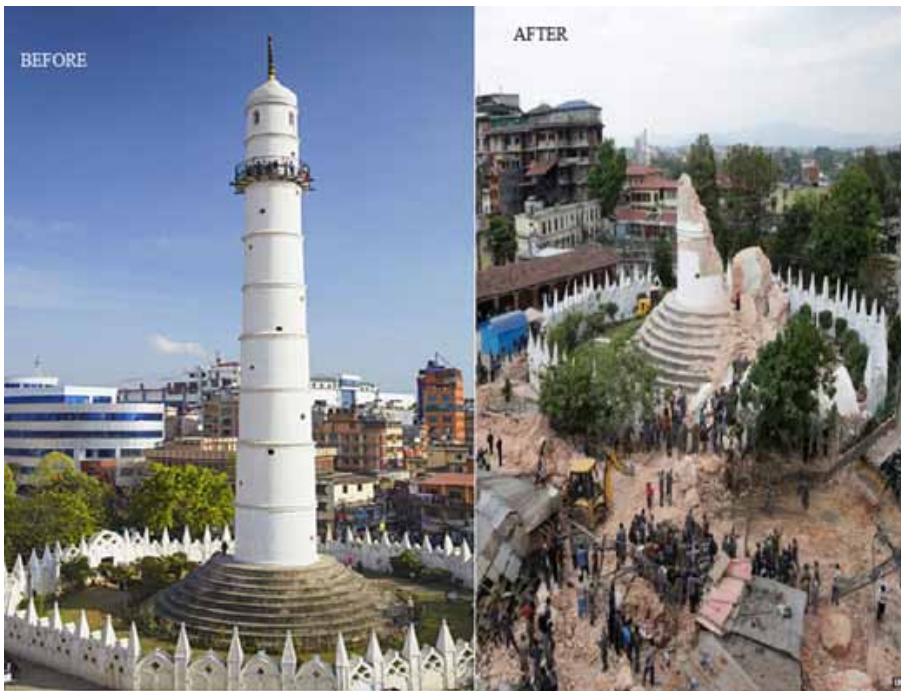
Figure 7. Dharahara Tower Before and After the Earthquake (after <https://images.google.com>)

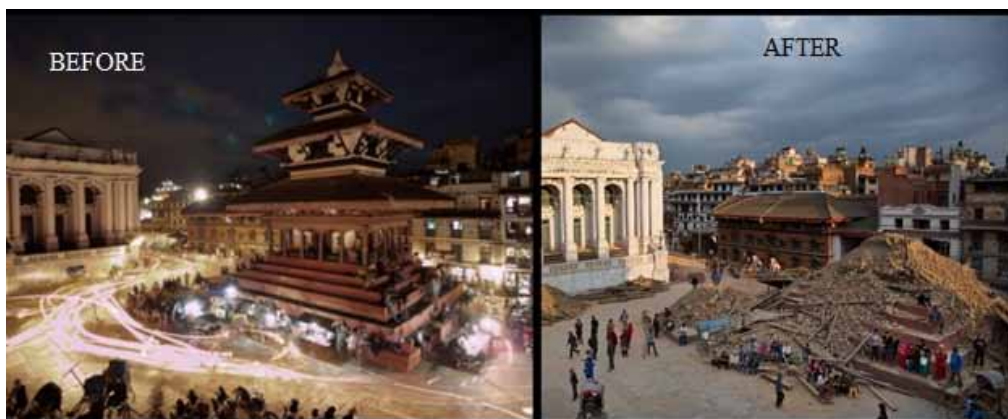
Figure 8. Durbar Square Before and After the Earthquake (after <https://images.google.com>)

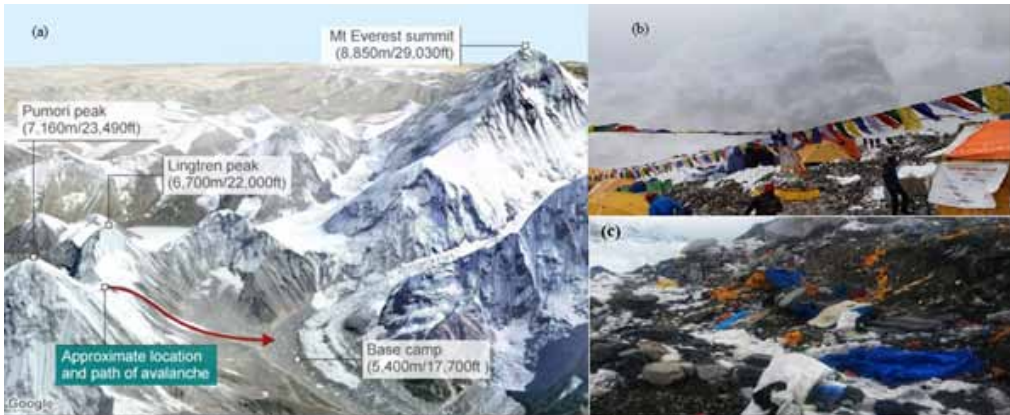
The massive earthquake has triggered several large and small avalanches on and around mountains. A major aftershock of magnitude 6.7 M_w occurred on 26 April 2015 in the same region caused fresh avalanche on Mount Everest and was felt in many parts of northern India. The avalanche was originated on the nearby peak Pumori and swept into south base camp (Figure 9). The base camp got completely destroyed and after the quake the Indian Army mountaineering team recovered 19 bodies of mountaineers from south base camp and also rescued at least 61 stranded climbers from the mountain. The Nepal earthquake of 2015 Mw 7.8 has also triggered landslides in various part of Nepal-China border (Figure 10 and Figure 11) and Sikkim, India.

Figure 9. Triggered avalanche on Mount Everest (after <https://images.google.com>)

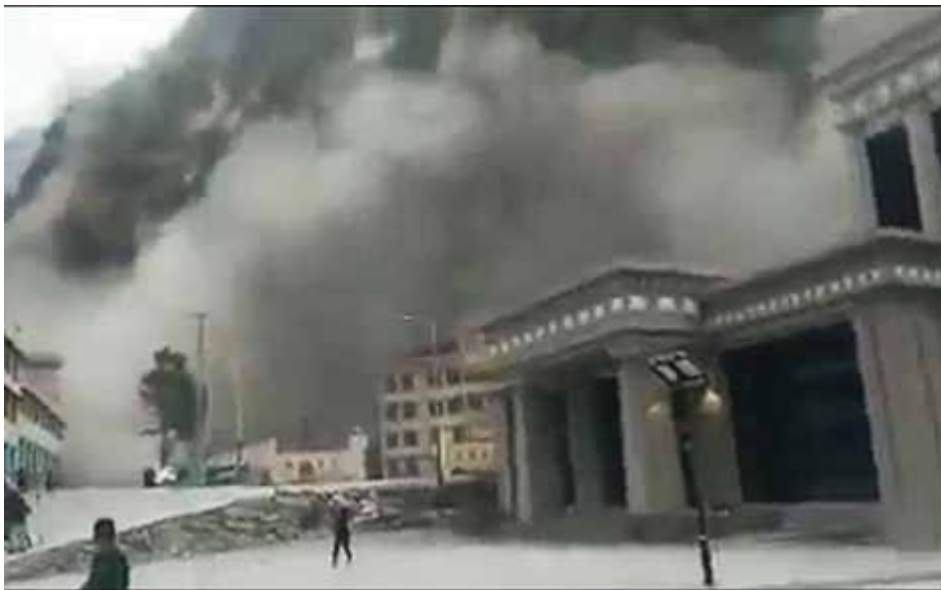
Figure 10. Landslide in Gyirong, close to the Nepal-Tibet border (www.thetelegraph.co.uk)

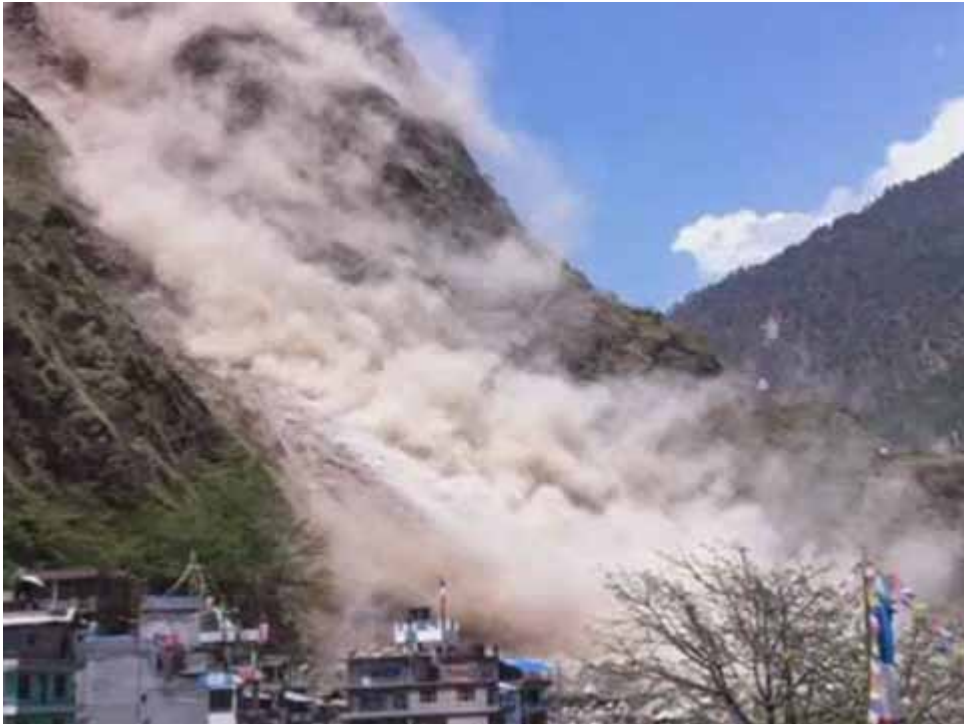
Figure 11. Massive landslide hits the area near the town of Dhunche (www.independent.co.uk)
