6th International Building Physics Conference, IBPC 2015

Relationship between Environmental Conditions and Algal Growth on the Exterior Walls of the Ninna-ji Temple, Kyoto

Makiko Nakajima^a, Shuichi Hokoi^a, Daisuke Ogura^a, Chiemi IBA^{a,*}

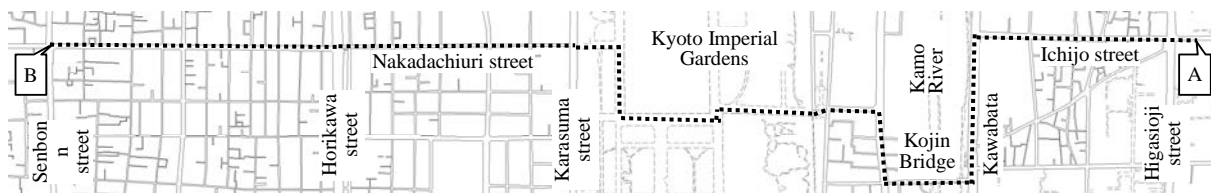
Fig. 1. Survey area.

The survey in Kyoto City was conducted to identify on which parts of the building walls the algae grow and which environmental factors affect algal growth. To study the effects of the local environment, a route passing through water areas (river and pond), green areas and urban areas was chosen. The surveyed area is along the east-west corridor of Ichijo street and Nakadachiuri street running from Kyoto University on the east to Senbon street on the west (Fig. 1). Surveys were conducted in October and November of 2008 and May of 2013. Photographs of exterior walls were taken with a digital camera in order to compare soiled and unsoiled areas. The surrounding environment, materials and the status of walls were documented. On the basis of a review and analysis of the photographs, the extent of soiling on the walls and causes of algal growth were estimated.

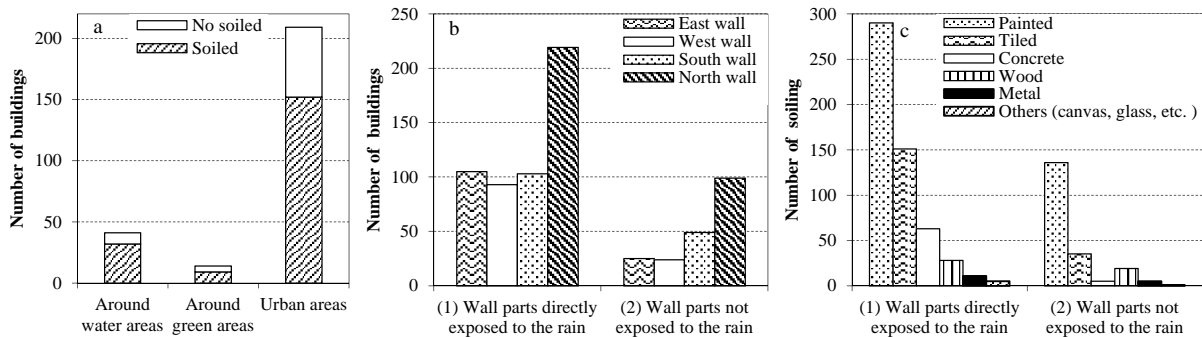
Fig. 2. (a) occurrence of algal soiling by type of local environment; (b) direction of surveyed building walls; (c) materials of surveyed building walls

relatively wide streets running in an east-west direction. East and west walls were frequently shaded by the adjacent buildings. The status of algal soiling was documented on buildings within 50 m of water areas, those within 50 m of green areas, and those in the urban area from Senbon street to Karasuma street (Fig. 1). Based on a comparison of algal soiling on these areas, the effect of the regional environment on algal growth appears to be very slight (Fig. 2a).

The relationship between the number of soiled buildings, the soiled areas and the directions is shown in Fig. 2b. About 70% of the buildings with algal soiling had areas directly exposed to rainwater, whereas 30% has areas that rarely received rainwater. In both cases, the largest number of soiled areas occurred on north walls, at a frequency of approximately two times that of south walls. Materials surveyed building walls are shown in Fig 2c. In both cases, the soiling occurred the most frequency on painted walls, followed by tiles walls.

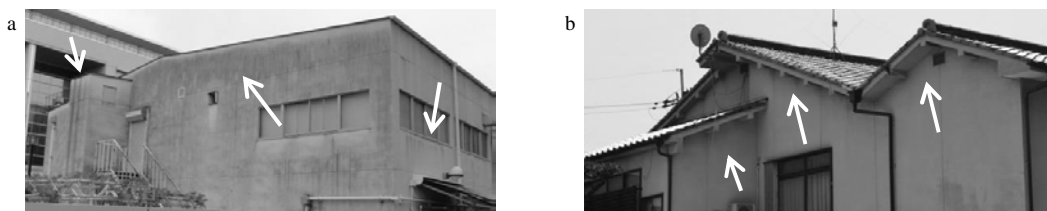
Fig. 3. (a) Walls directly exposed to rainwater; (b) walls rarely receiving rainwater.

- (1) Wall parts directly exposed to rain (where rainwater hits, flows or is stored) (Fig. 3a). Soiled areas extending down from the roof or the lower frame of windows was often observed. The amount of the rainwater impacting a horizontal plane or window frame was more than that on vertical planes (walls). Algae growth appeared to be concentrated along the course of running rainwater. Soiling was also observed on the lower parts of the walls near the horizontal plane (ground or horizontal eaves). Rainwater does not dry quickly, splashes against the wall and is absorbed by the existing algae. Soiling was also observed around and under clacks, where rainwater can be absorbed and stored there.

- (2) Wall parts that rarely receive rainwater (Fig 3b). In these areas, soiling was observed under eaves that were not exposed to rain and where the water flow was not apparent. In some cases, an entire wall was discoloured. The source of moisture for algal growth in these areas appeared to be water vapour in the atmosphere or moisture absorbed by the wall.

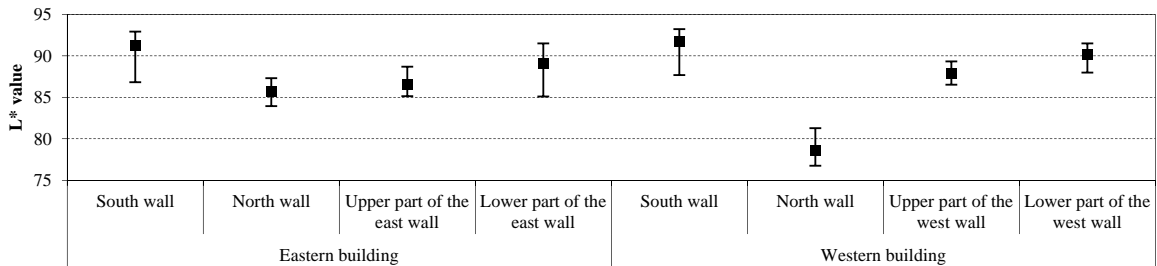
Fig. 5. L^* values of each part of the walls.

the central building only the gabled walls were discoloured. The mean L^* values averaged from west walls of the central building only the gabled walls were discoloured. The mean L^* values averaged from August 6 2013 to December 18 2014 are shown in Fig. 5. The L^* values of the south walls were the highest at approximately 90. The L^* values of the north walls were the lowest, and that of the western building was lower than that of the eastern building. The L^* values of the upper part of the walls were lower than those of the lower parts on the east wall of the eastern building and the west wall of the western building. The visual evaluation of discolouration agreed well with the L^* value, and thus visual inspection using photographs can be a simple and effective method for evaluating discolouration due to algal soiling.
