Made from Mud: Functional Categorization and Analyses of Bronze Age Earthen Materials from Western Turkey

Jana Mokrišová – Christopher H. Roosevelt – Christina Luke – Caitilin R. O’Grady

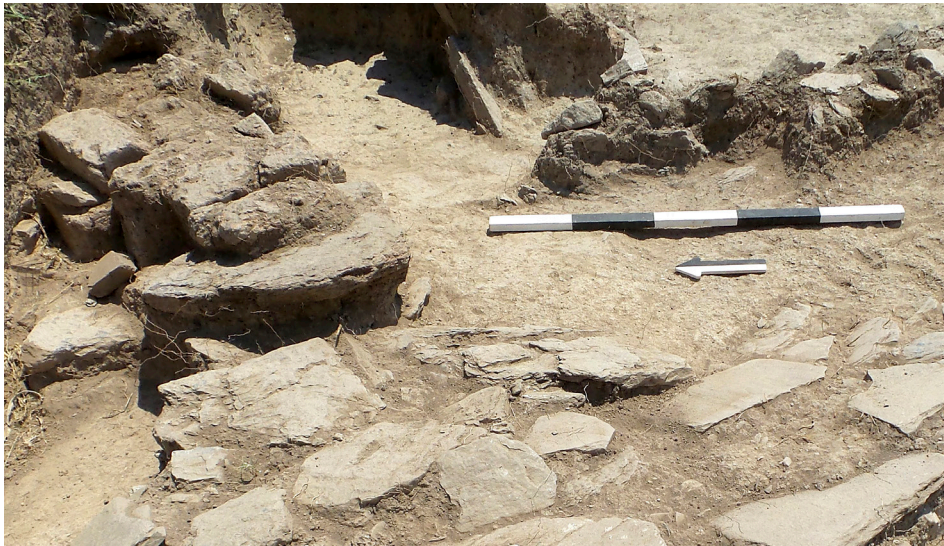
Fig. 3: In situ stone socle with lower courses of mudbrick superstructure in area 97.541 (© Gygaia Projects).

During excavations at Kaymakçı, the 'architecture - mudbrick' category was applied to earthen brick-shaped objects found associated with wall construction. The excavated architectural remains are characterized by the use of stone socles with mudbrick superstructures, so far revealed *in situ* in only a few rare cases. The best-preserved evidence for mudbrick superstructure consists of two courses set seemingly atop stone foundations in area 97,541, sheltered from weather and degradation by the collapse of a larger wall located immediately north of it (Fig. 3).

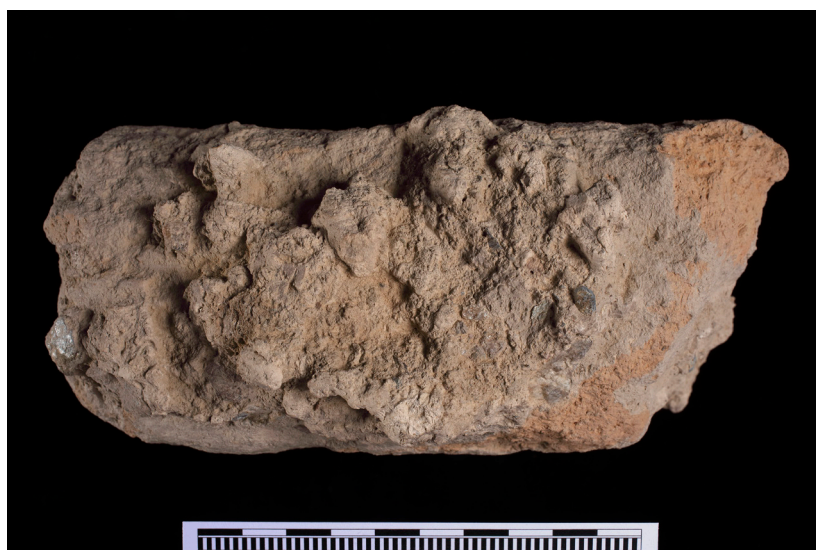
Fig. 5: Mudbrick bearing traces of mud mortar (93.545.294.1). The coarse aggregate of the mortar, rich in micaceous and calcium carbonate aggregate, is visible on the vertical interstice of the brick (N. Gail; © Gygaia Projects).

between horizontal courses of bricks has not been documented so far. A very coarse mortar on a vertical interstice, however, has been observed on a single mudbrick (93.545.294.1). The mortar was rich in micaceous and calcium carbonate aggregate (**Fig. 5**).

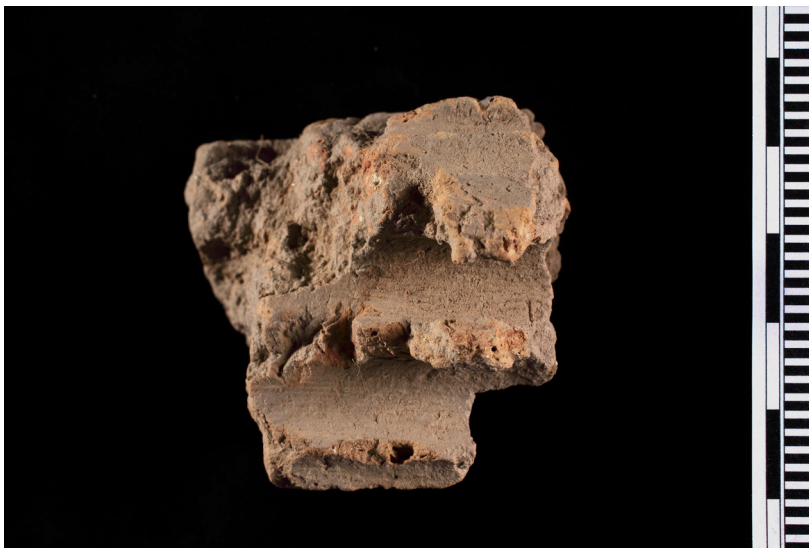
Fig. 6: Example of an impressed architectural fragment (93.545.204.5) (N. Gail; © Gygaia Projects).

Overall, 28 fragments of impressed earthen material have been identified. They are hardened, and their fabrics and inclusions are visually similar to those of mudbricks (calcium carbonate, micas, and limestone), although they rarely contain chaff and straw. Inclusions are well sorted, and fabric is usually medium to coarse. They tend to be preserved by contact with intense heat in reducing conditions, as fabrics range from dark grayish brown (10YR 4/2) to light brownish gray (10YR 6/2) or pinkish gray (7.5YR 6/2). In fragments with reed impressions, reed diameters vary significantly, from 0.9 to 3.3 cm (**Fig. 6**).

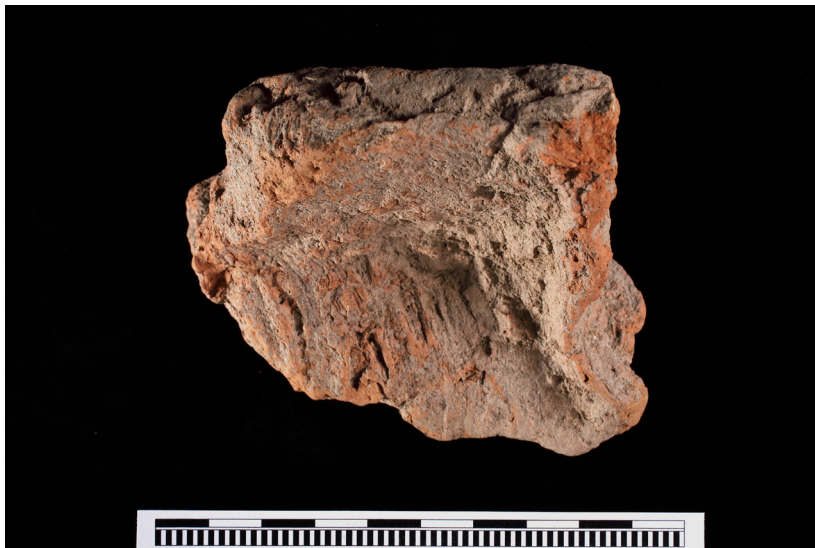
Fig. 7: Example of an impressed architectural fragment with straight edges. The fragment would have been impressed into flat wooden planks, as indicated by parallel impressions visible in the lower part of the fragment (93.545.286.43) (N. Gail; © Gygaia Projects).

Some fragments seem to have been pressed into the corners of perishable structures and are irregular in shape as a result. They bear linear impressions on one of their surfaces, while the opposite surface tends to be irregular, either rough or smoothed. Other fragments seem to have been pressed between wooden planks or straight-edged items, such as flat rocks (**Fig. 7**).

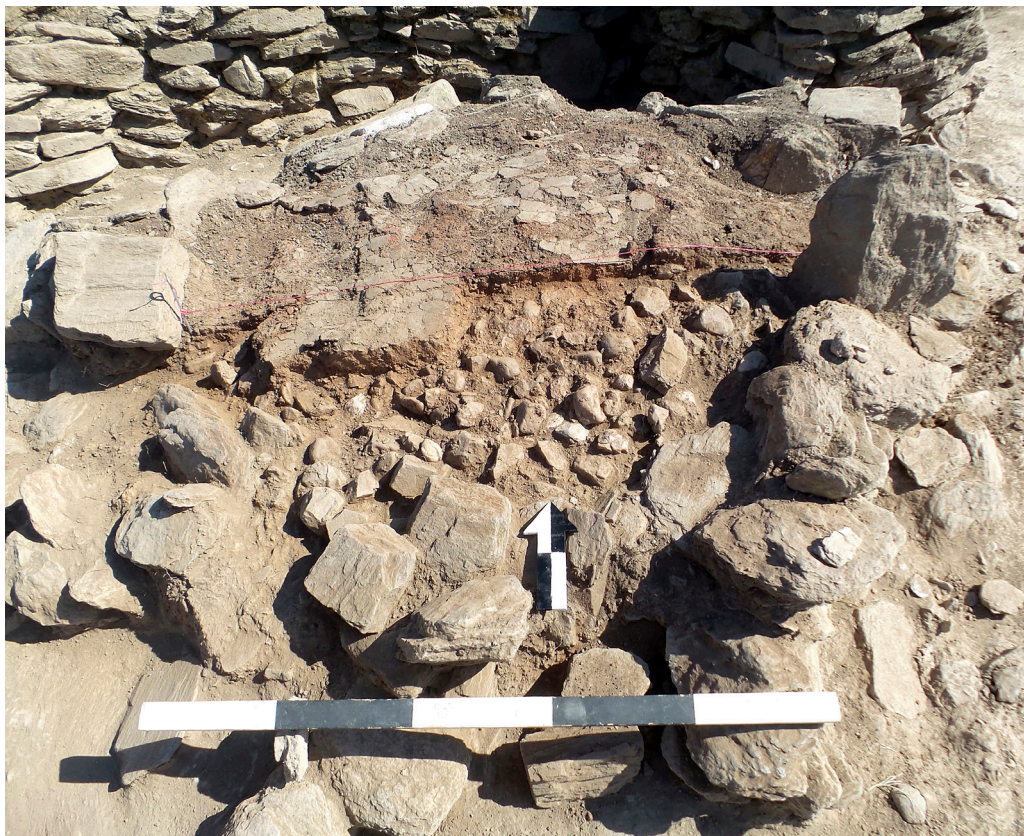
Fig. 8: Well-preserved oven (93.545.171) built near a wall of the inner citadel during excavation. Sectioning reveals its pebble and cobble base layer (© Gygaia Projects).

One of the more substantially preserved earthen features so-far excavated at Kaymakçı, circular oven 93.545.171 (**Fig. 8**), enabled easier identification of components of ovens and hearths throughout the site. As already described, it consisted of a hard, grayish mud cap and substructure of increasing coarseness. The cap preserved a very noticeable 0.56 cm hard lens, with a substructure that could not be easily separated from it. However, as the entire context was non-hardened, we were able to subject the looser matrix located immediately below the cap to particle size analysis (sample 93.545.190.5 from the southern section, 93.545.218.1 from the northern section). As the feature was sectioned during analysis, the results here demonstrate the natural variation within sediments. While a sample taken from a southern section was made of nearly equivalent amounts of sand (50.6 %) and silt/clay (49.4 %), a sample taken from the northern section consisted of slightly less sand (46.6 %) and more clay (53.4 %).

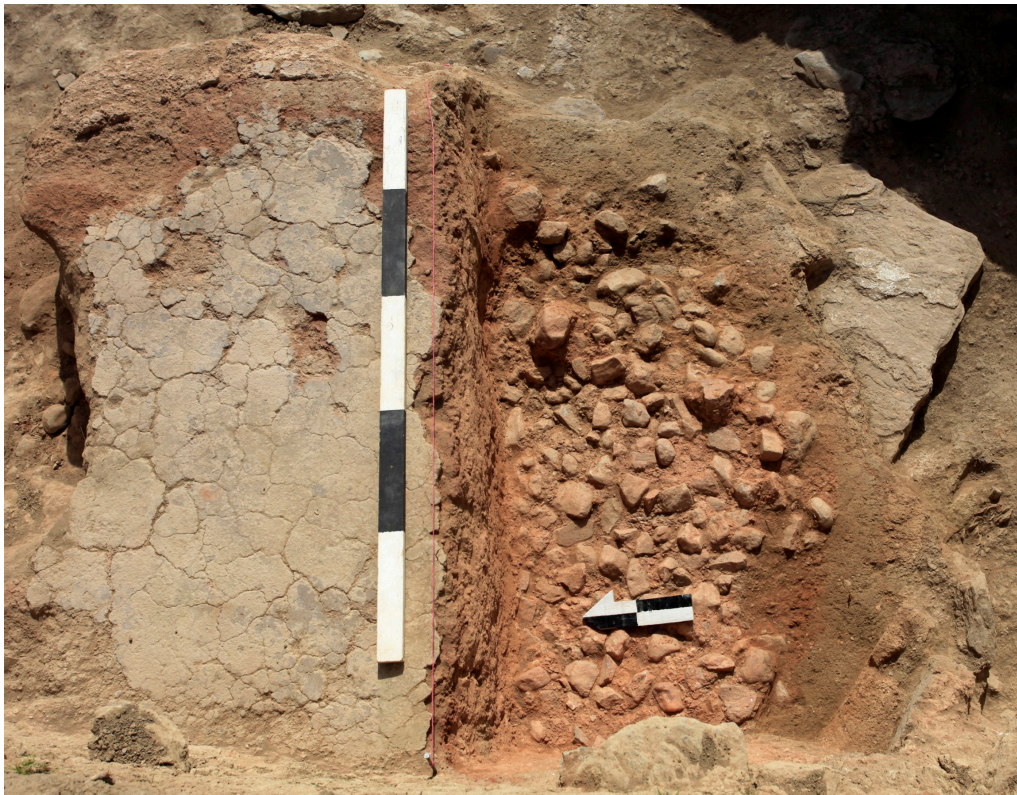
Fig. 9: Large platform/oven (99.526.79) during excavation. Sectioning reveals its cobble base layer as well as a mudbrick rim that delineates its southwestern edge (bottom right corner of image) (© Gygaia Projects).

Feature 99.526.79 in area 99.526 on the southern terrace presents an example of a working platform, or perhaps a different type of hearth or oven, supported by a layer of cobbles and enclosed by a mudbrick rim (**Fig. 9**; ROOSEVELT *et al.* 2018, 191). It consists of a series of alternating hard packed, clay-rich surfaces with earthen substructure: the earlier surface 276 (light reddish brown, 5YR 5/4) was supported by two fills, 286 and 295 (reddish brown, 5YR 5/4), superimposed by a later surface 264 (light brownish grey, 10 YR 6/2), and fill 267 (reddish brown, 2.5YR 4/4). Its surfaces are relatively heterogeneous as they were built at different times. The topmost hardened surface had a very hard, ca. 0.8 cm thick lens, with a slightly softer and wider ca. 1.4 cm thick lens immediately below it, similar to the uppermost layers of the installation in 93.545.

The feature is surrounded by three vertically positioned mudbricks creating a rim that delineates the feature on its south side. These concentrically arranged rim mudbricks differ in color, and their temper consists mostly of stone aggregate – micas and limestone – as well as calcium carbonate, with little visible chaff/straw, thus distinguishing them from structural mudbricks used for architectural purposes. These types of rim mudbricks are described fully in the following section.

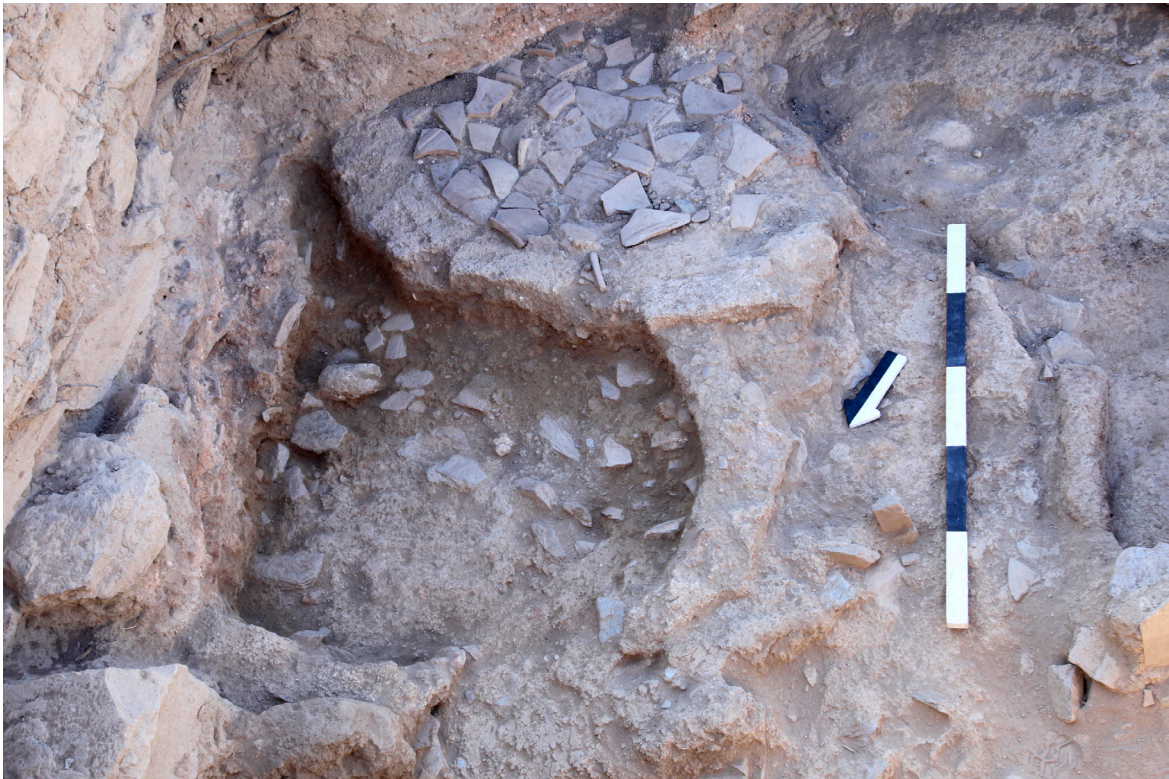
Fig. 10: Sherd hearth (99.526.385) and hearth (99.526.386) during excavation. A mudbrick rim lines the northern edge of the feature (© Gygaia Projects).

Mudbricks used in installations were found almost exclusively in area 99.526 on the southern terrace. Features 99.526.385 and 99.526.386, identified as hearths, ovens, or some other type of cooking platforms, showcase the use of these types of mudbricks (99.526.393.2, 426.1, 428.1) (**Fig. 10**). Both features were of oval shape and delineated on all sides by mudbricks that, together, created an elevated rim surrounding the functional surface. Each rim was constructed of three individual rectangular mudbricks, each stood on their short ends. Each mudbrick bore different visual characteristics and varied compositionally in terms of sand, clay, and silt ratios. Here, individual bricks ranged from brown (7.5YR 5/2) to light brownish gray (10YR 6/2).

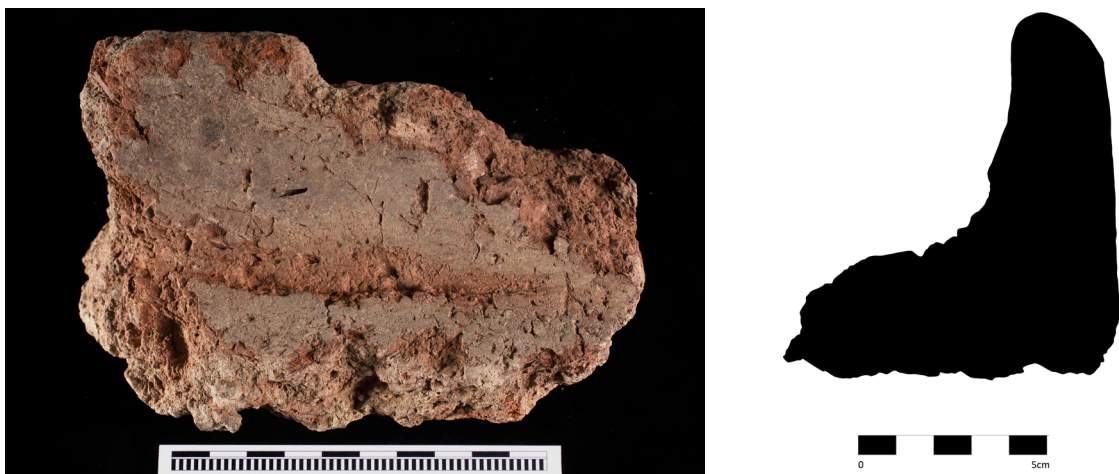
Fig. 11: Example of an installation - tray with straight raised edges and slip (99.526.350.5). Photograph and section (N. Gail and P. Demján; © Gygaia Projects).

An illustrative example of a tray with a raised rim is fragment 99.526.350.5 (Figs. 11). The tray is only 3.1 cm thick and its straight rim with rounded top rises to a height of 9.65 cm. Its interior and exterior surfaces are smoothed. Its bottom surface is rough, slightly irregular, and seems to have taken the shape of the surface it was placed on when wet. Although the fragment is accreted on its interior and exterior surfaces (including the bottom), it is clear that all surfaces were smoothed and evenly treated with a slip, unlike other recovered examples.

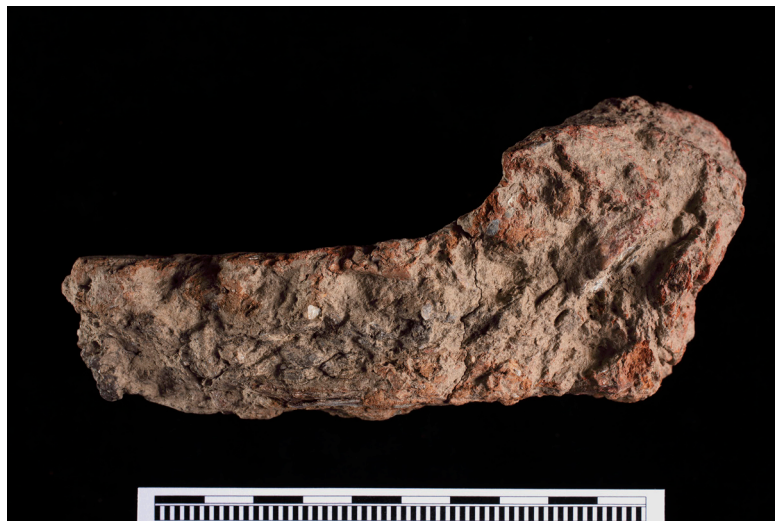
Fig. 12: Example of a roughly smoothed installation - tray (97.541. 68. 17) (N. Gail; © Gygaia Projects).

Most other trays have similarly flat bottoms and straight raised edges but are only roughly smoothed and bear no other treatment. An example of this more typical type is fragment 97.541.68.17 (**Fig. 12**), the maximum preserved bottom thickness of which is 3.2 cm, while the raised edge rises to a height of 6.4 cm. The fabric of this tray includes micaceous and quartz particles, calcium carbonate, and only a small amount of chaff and straw.

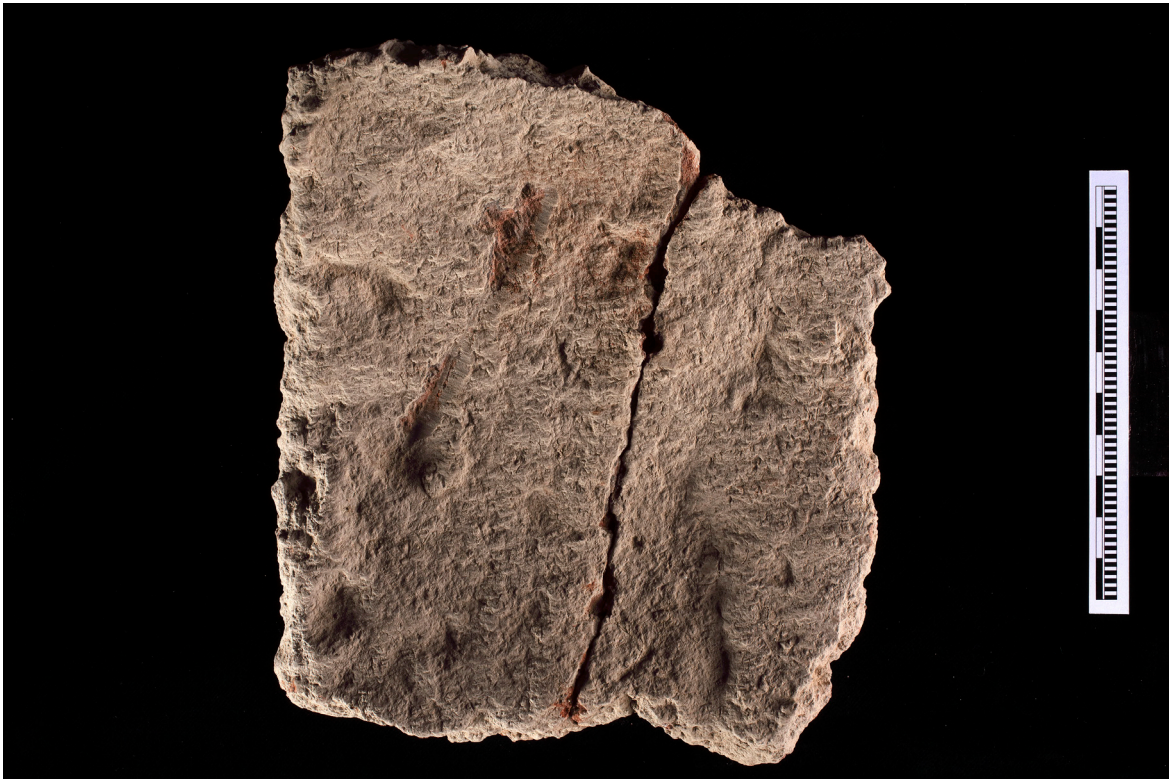
Fig. 14: Example of a portable tray (93.545.265.12) (N. Gail; © Gygaia Projects).

Flat and relatively thin fragments of hardened portable earthen materials were found primarily in the inner citadel excavations. In total, 11 fragments are characterized primarily by their flatness and thinness: their top surface is smooth, their bottom either smooth or rough, and curved raised edges terminate in rounded rims. Their form and sturdy lightness suggest their function as utilitarian and portable trays. They were likely fashioned and fired at low temperature in the same place, even though most have smooth bottoms, suggesting they were handled during shaping. Representative samples are noticeably lighter than non-portable ‘installation-tray’ fragments. Their coarse fabric has well sorted inclusions, the most common of which are micas and calcium carbonate. Their color ranges from reddish brown (2.5YR 5/4) to pinkish grey (7.5YR 6/2). Their thickness ranges from 1.9–4.9 cm, with an average around 3.2–3.6 cm. Their overall size and shape cannot be determined with certainty owing to their fragmentary state of preservation, but they were likely either rectangular or semi-rounded in plan: most examples have curved rather than straight edges in plan with straight raised edges. (**Fig. 14**).

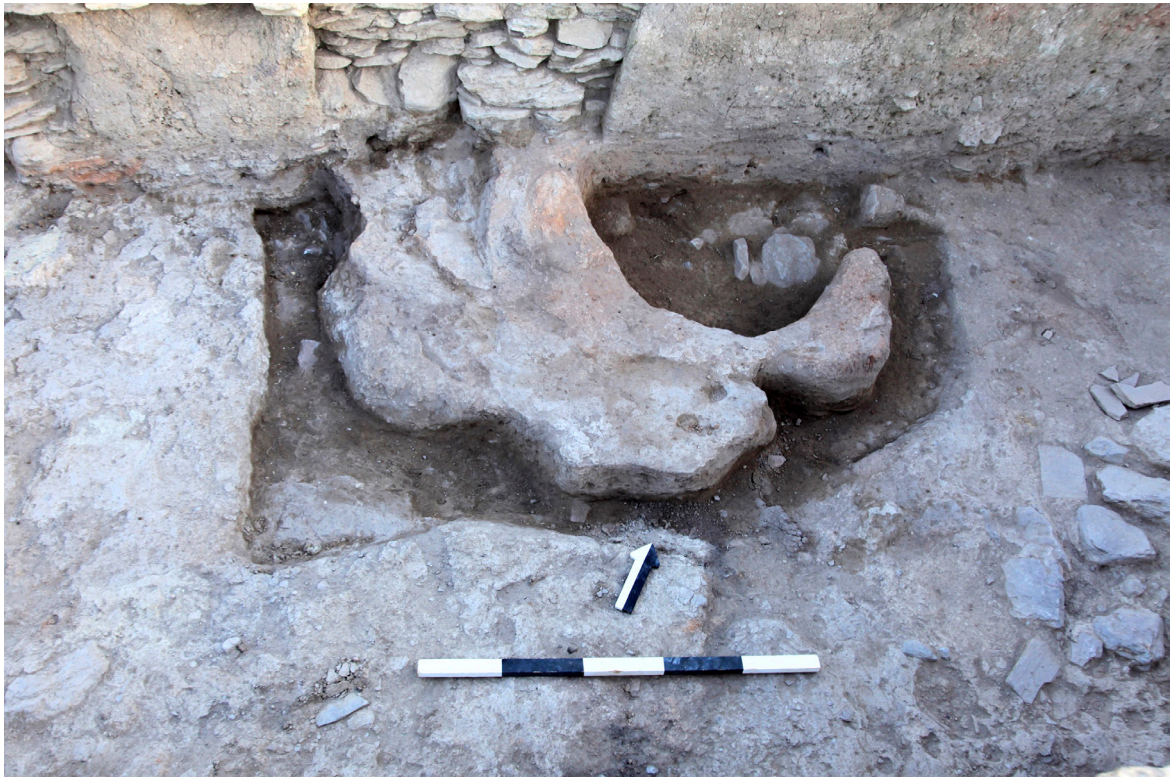
Fig. 15: Poorly preserved circular hearth (99.526.315) with a series of mudbricks around it creating a rim (© Gygaia Projects).

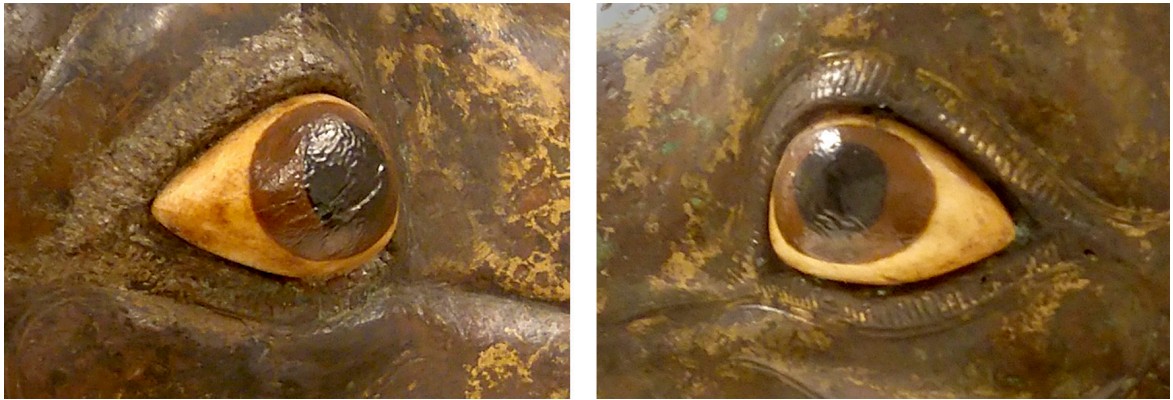
Pl. 2/1: Detail of the ivory and painted eyes that decorate the protome, restored by J. Ternbach (photos by G. Zuferrri, with permission of the SLAM).

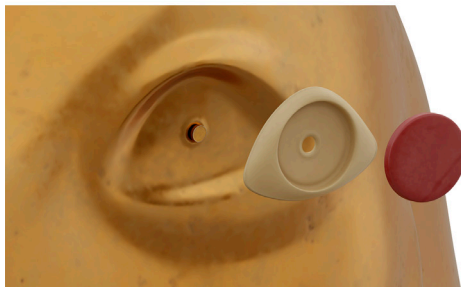
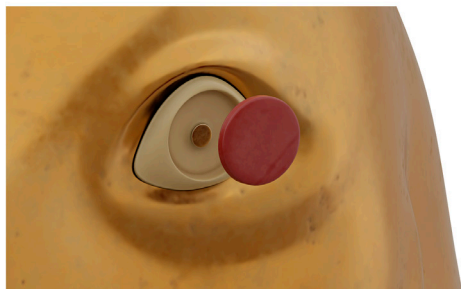
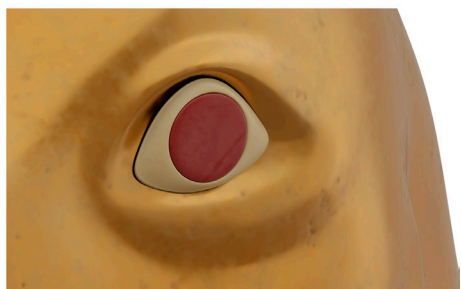
Pl. 2/2: 3D reconstruction of the assembly sequence of the eyes that decorated the protome. This sequence is also applicable to the Cheekpiece appliqués with the only difference being the position of the central nails: present in the structure of the protome and applied from the outside for the Cheekpieces (3D drawing M. Sánchez).

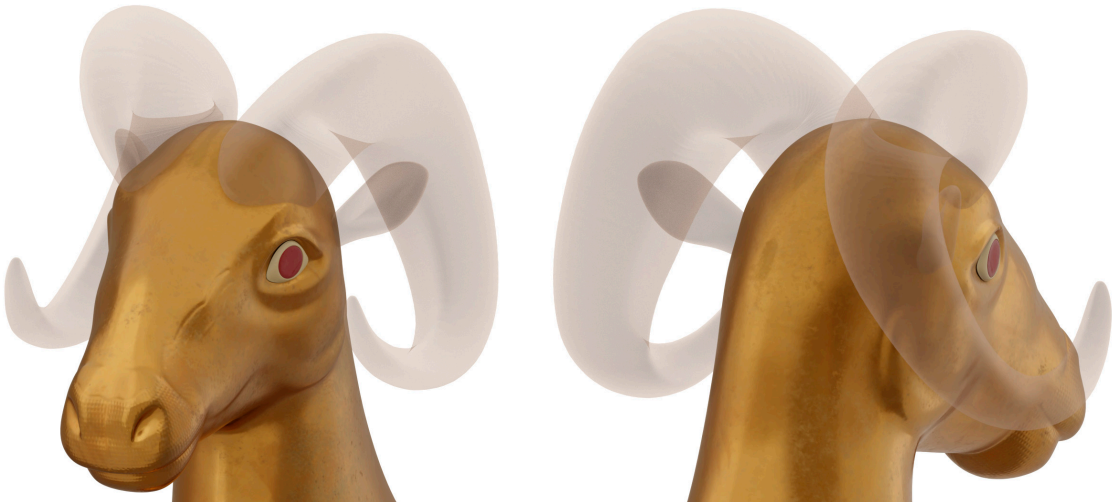
Pl. 2/4: 3D reconstruction of the protome with a realistic system of horns and ears. Nothing of the original system is preserved. Only the two fragments commented on in Fig. 17 could be related, without certainty (3D drawing M. Sánchez).

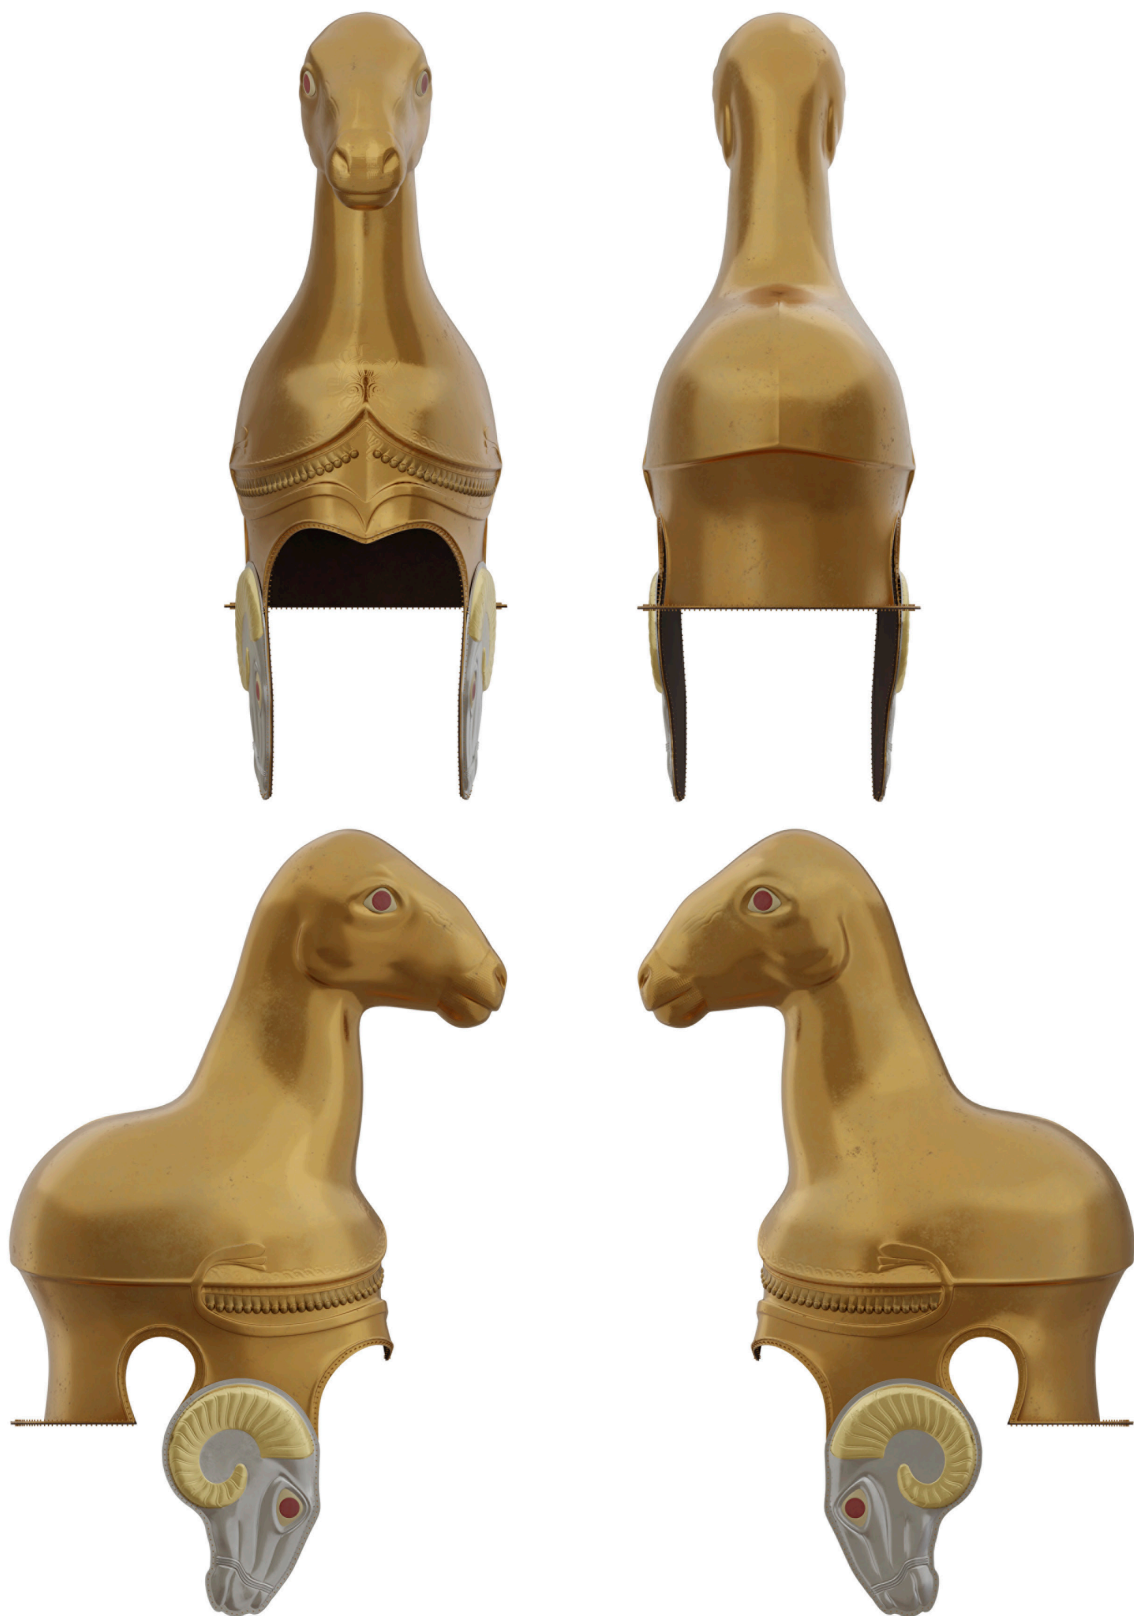
Pl. 2/6: 3D reconstruction of the original appearance of the helmet (3D drawings M. Sánchez).

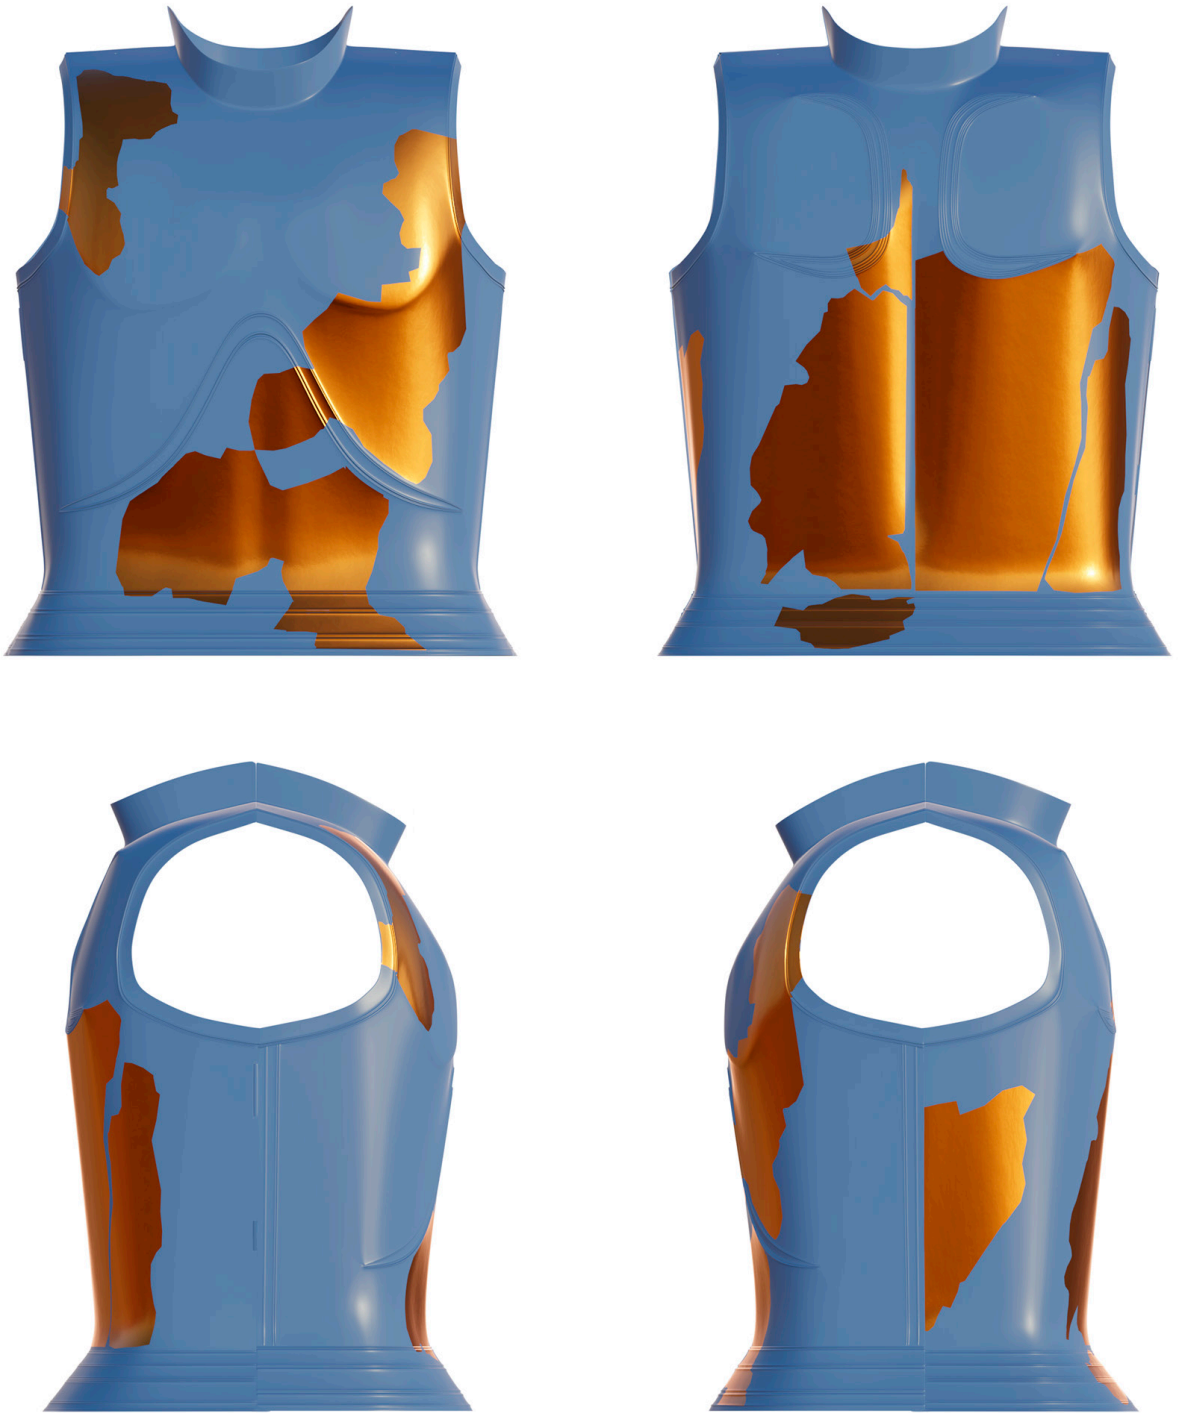
Pl. 2/7: 3D reconstruction of the bell cuirass (3D drawings J. Quesada).

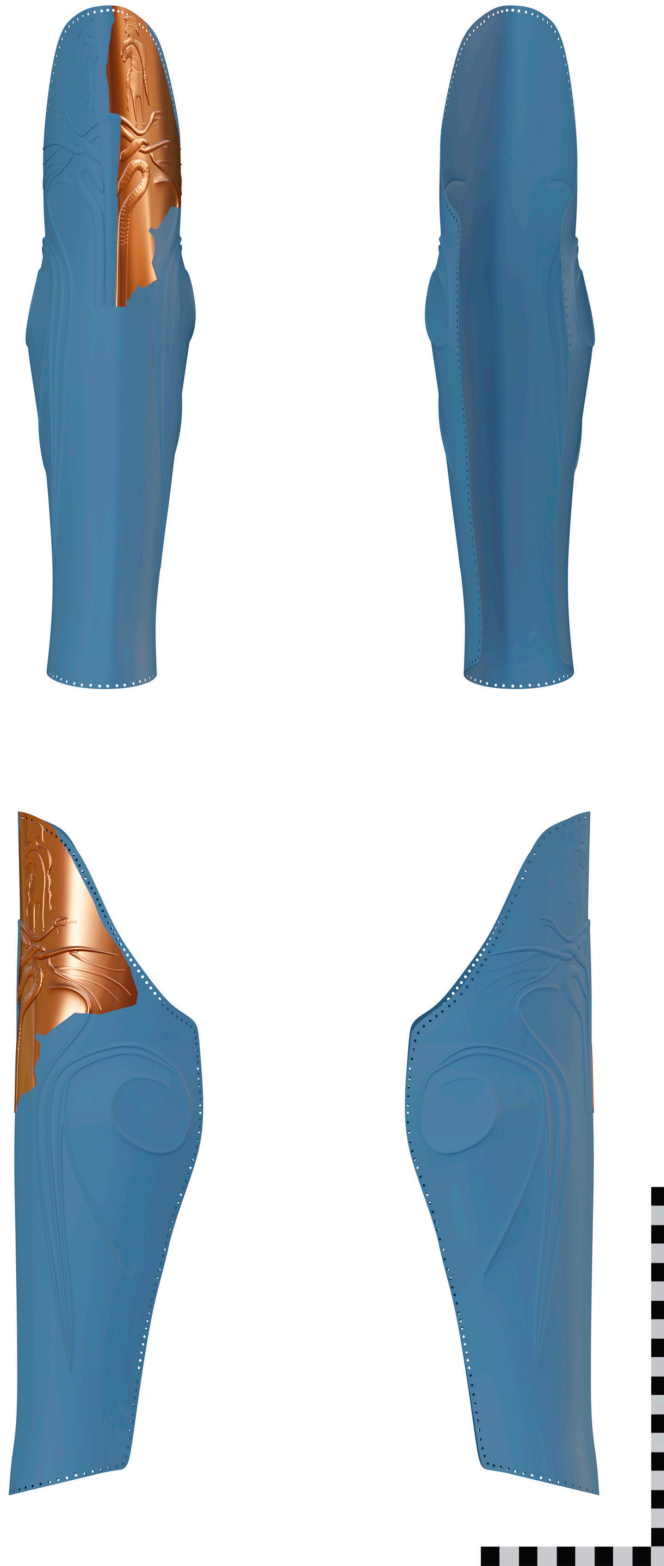
Pl. 2/8: 3D reconstruction of the decorated greave fragment following the morphology of the so-called Club Variant (3D drawings J. Quesada).
