Manandhar, V., Shrestha, H., Marasini, N. P., Prajapati, R., Guragain, R., Chaulagain, R., Sextos, A., Alexander, N. A., De Luca, F., & Giordano, N. (2020). *EXPERIMENTAL INVESTIGATION OF LOW COST STEEL WIRE MESH RETROFIT FOR STONE MASONRY IN MUD MORTAR*. Paper presented at 17th World Conference on Earthquake Engineering, Sendai, Japan.

EXPERIMENTAL INVESTIGATION OF LOW COST STEEL WIRE MESH RETROFIT FOR STONE MASONRY IN MUD MORTAR

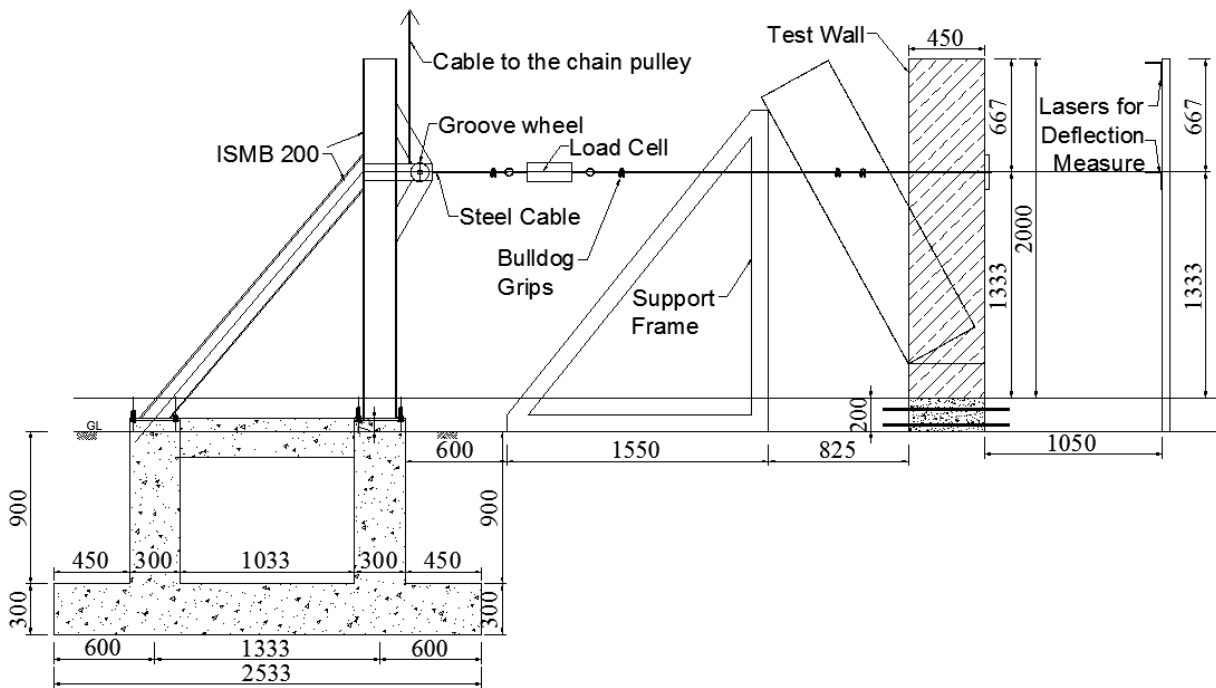
Figure 6 Setup for Pulldown test

Learning from the Pilot test, it was decided to devise a mechanism that can apply a continuous monotonic deflection to the test model. A pulldown setup was designed and constructed at the NSET premises using a chain pulley for the application of load. For load measurement, a much accurate digital load cell was used and lasers were used for deflection measurement.
