Beaty, P., Temple, B., Marshall, M.B. et al. (1 more author) (2016) Experimental modelling of lipping in insulated rail joints and investigation of rail head material improvements. *Proceedings of the Institution of Mechanical Engineers, Part F: Journal of Rail and Rapid Transit* , 230 (4). pp. 1375-1387. ISSN 0954-4097

Experimental modelling of lipping in insulated rail joints and investigation of rail head material improvements

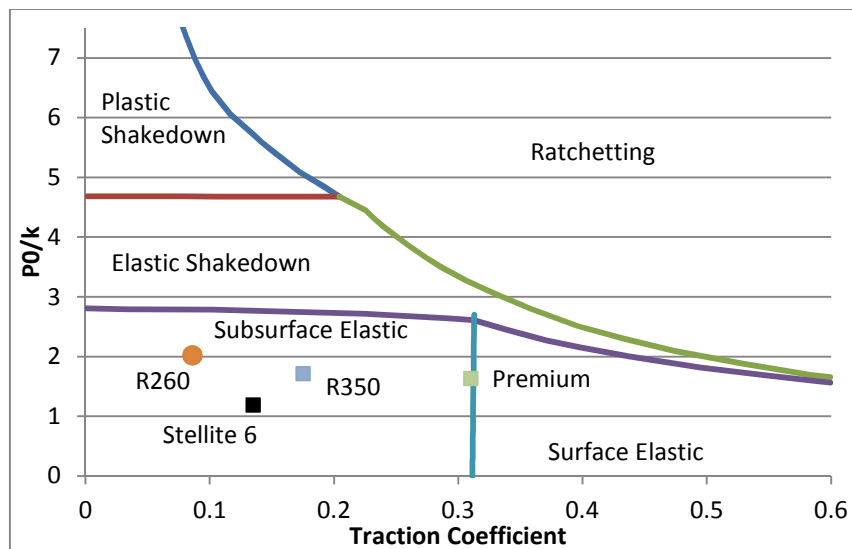
Figure 8: Shakedown plot with different rail materials

The lack of ratchetting that is seen in these discs can be explained by analysis of a shakedown plot, shown in Figure 8. This is a plot of the coefficient of traction against the load factor. The R260 grade discs falls into the lower left side of the graph which represents a subsurface elastic condition and therefore ratchetting is unlikely to occur in these discs with test parameters that have been applied. It should be noted that the reason for the spread in values for coefficient of traction could be the test length. As will be discussed later, the tests that ran for longer had a higher value than those run for 2000 cycles.

maximum shear stress slightly. The level of the coefficient of friction required to bring the peak shear stress to the surface is 0.3 as seen in the plot in Figure 8, the R260 disc contact had a coefficient of friction of 0.08, and therefore the peak shear stress would still be below the surface. The peak shear stress at a depth of 0.25mm, or slightly less than this when taking friction into account (which equation 1 does not account for), corresponds well with the deformation seen in Figure 6.

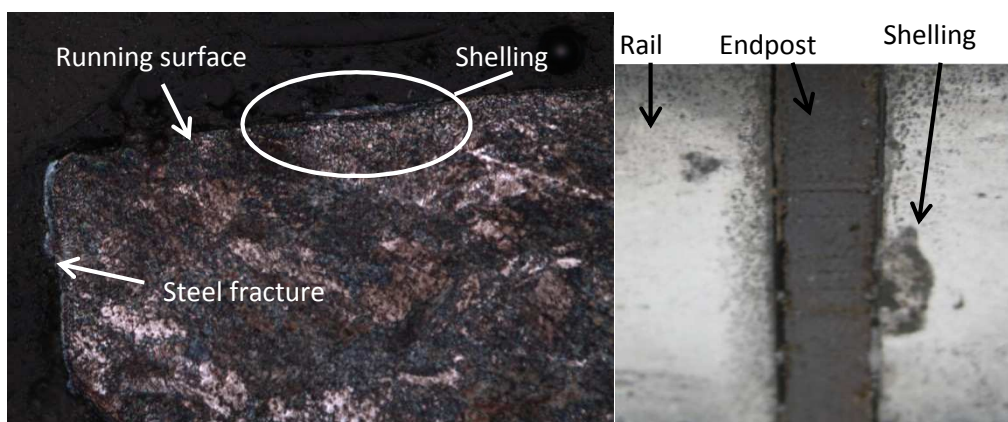
Figure 10: Comparison of shelling in a) the twin disc test and b) in the field [4]

A comparison of the testing in the twin disc machine and studies of in-situ joint studies can be made by comparing the two images in Figure 10. In addition to the fracture of the steel due to high contact pressures discussed above, damage is apparent on the running surface of the disc. This can be compared to shelling that has been noticed to occur around the endpost of IBJs in the field. Similar shelling or cracking can be seen on the surface images of the disc in Figure 5.

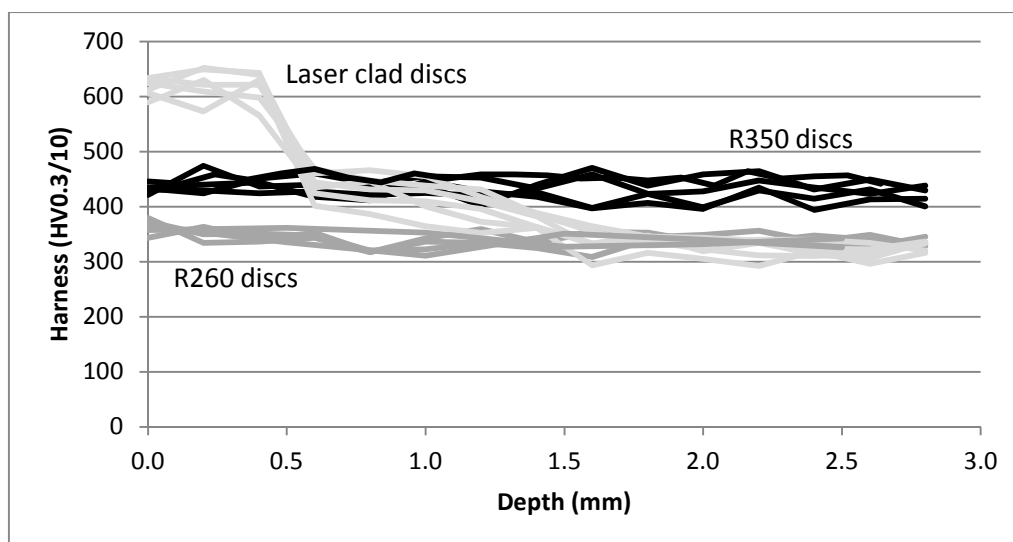
Figure 19: Hardness of grade R260, R350 and laser clad twin disc samples

The reduction in lipping of the laser clad sample compared to the R260 sample can clearly be seen in Figure 18. The improved lipping performance is for the same reasons that the R350 grade discs show better qualities, the laser clad layer is harder and tougher and so resists the high contact pressures better. The increase in hardness between the different materials can be seen in Figure 19. From this graph it can be seen that the laser clad layer has a higher hardness than the R350 and R260 discs and the layer is around 0.5mm in thickness. Underneath the laser clad layer the hardness of these discs is increased over the bulk material from a depth of 0.5 to 1.5mm. This is the heat affected zone where the properties of the R260 material have been changed by the laser cladding process and are roughly the same hardness value as the R350 discs. Beyond this heat affected zone the hardness is similar to that of the R260 grade disc. For the full-scale, the clad layer thickness would be chosen to avoid the peak shear stress being near the interface or in the HAZ much as it has been for the twin disc tests.

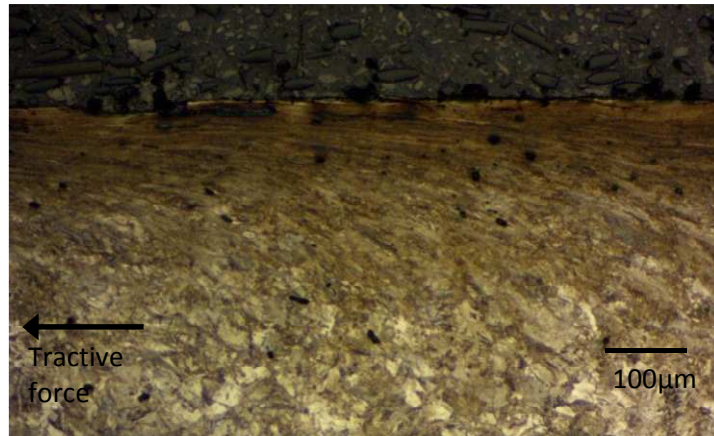
Figure 22: Image of the running surface of the premium rail disc in cross section displaying ratchetting behaviour

In Figure 21 the laser cladding layer can clearly be seen in image (b). The steel in these images has been etched to display the grain boundaries and the Stellite 6 layer is visible because of this process. A closer image of the surface of the premium rail disc in cross section can be seen in Figure 22. This image shows the ratchetting behaviour of the disc to a depth of around 0.3mm. The total depth of deformation of the steel in Figure 21 (b) is around 0.7mm, this would suggest that bulk deformation is still occurring, as was displayed in the previous results. However, the bulk deformation is heavily influenced by the tractive force as there is a much greater lip formed in this direction than is formed against the direction of the tractive force.

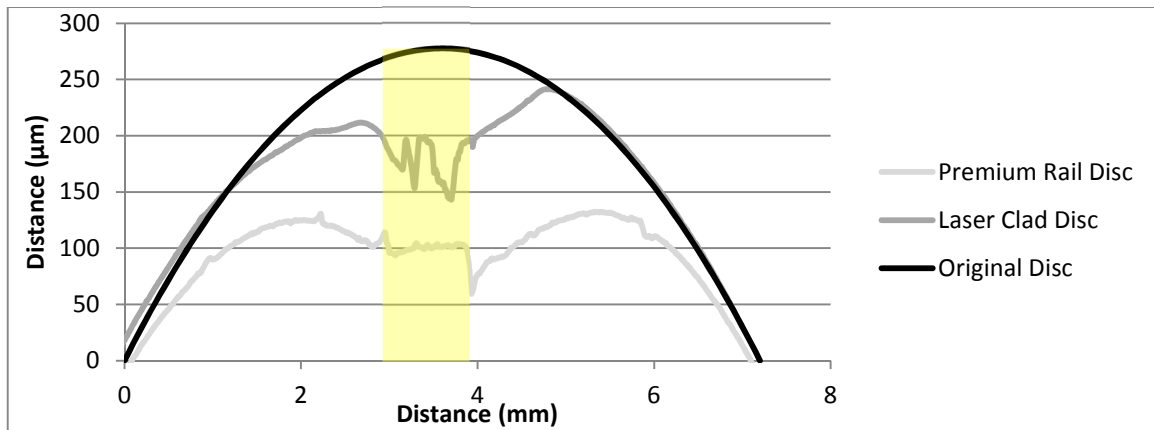
Figure 24: Graph showing the different profiles of the tested rail discs in comparison with a new disc, the shaded area denotes the location of the endpost

Profile measurements were also taken of the discs used in this test which can be seen in Figure 24. The results are similar to that shown in Figure 17, the laser clad rail disc which shows an increased performance in lipping also displays less vertical deformation at the running surface than the premium rail disc.
