Three-dimensional Modelling of the Interaction Between Buildings and Tunnelling Operations

Keywords: Tunnels, Masonry Structures, Finite Elements, Settlements

3. Ramsgate Harbour Approach Tunnel Case History

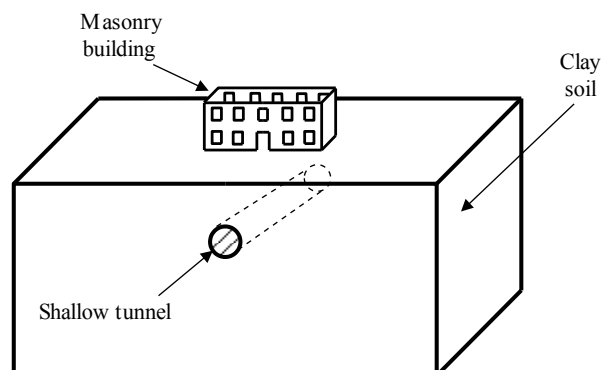
Figure 1: Idealisation of tunnelling under a building in three dimensions

The principle of the model adopted is illustrated in Figure 1. The building, the ground and the tunnelling processes are combined in a single three-dimensional numerical model. The analyses are carried out using the finite element program OXFEM, developed at Oxford University. Details of the relevant finite element formulations are given by Burd *et al* (1994), Augarde *et al* (1995), Augarde (1997), Liu (1997) and Augarde *et al* (1998).

The facades of the structure are modelled by plane stress elements. The roof, floors and internal partitions are not included, although internal load-bearing structural walls are included when necessary. The facades are connected together and to the ground using tie elements (Liu, 1997; Houlsby *et al*, 2000). Foundation details may be modelled if necessary, but are often neglected if the building is on strip footings.

Ten-noded tetrahedral solid elements model the ground, with a free mesh that enables the density to be increased near the tunnel and building. The ground contains a zone of elements defining the tunnel, and these are removed during the analysis to simulate excavation. This may be carried out incrementally to model the response as tunnel construction progresses: this cannot be done in two-dimensional analysis. The tunnel may be unlined, or lined with shell elements, which enable the ground loss due to tunnelling to be controlled and modelled.

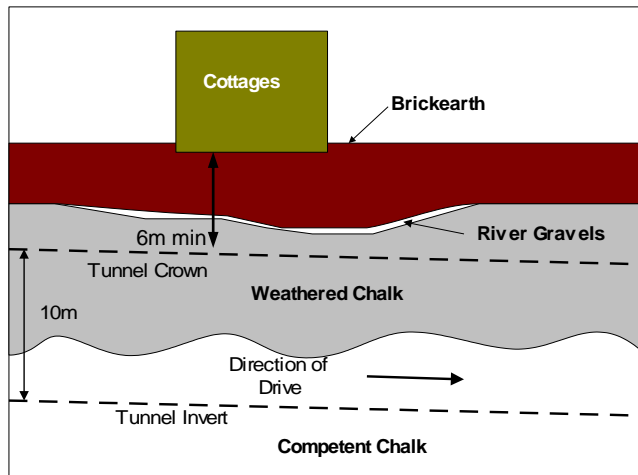
Figure 2: Section through cottages on axis of tunnel

however, the Chalk is weathered to grade Dm in places and the thickness of the overlying surface layers become significant (Fig. 2). The tunnel invert remains within chalk that is structured and relatively unweathered, but still rather weak. The upper part of the bore is in weathered to highly weathered chalk. Overlying this is a layer of 2m - 3m of red brickearth, a firm to stiff silty clay. At the location of the cottages, a buried valley crosses the alignment, decreasing the chalk cover over the crown, and increasing the penetration of weathering.

observed settlements in Figure 10. Agreement is good, particularly at the rear. The model over-predicts the settlements at the front, which were less than at the rear probably because of the less depth of brickearth at the front (Fig. 2).

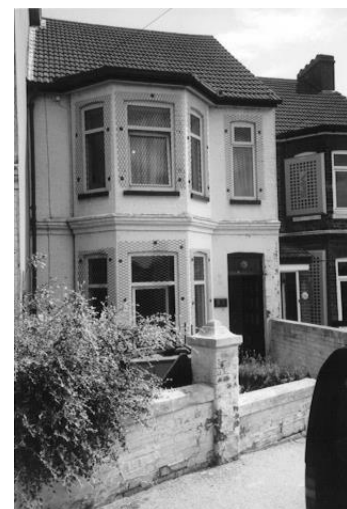
Figure 3: Typical cottage

The cottages consist of a terrace of eight similar properties, dating from the early 1900's (Fig. 3). The tunnel passes under the cottages with about 6m cover, on a skew, with the angle between the tunnel axis and front of the cottages being 40° (Fig. 4). The houses are of two storeys, 6m high and without basements. They are of load-bearing brick, on shallow strip foundations, with wooden suspended floors and ceilings. The most important load-bearing walls for each cottage are the party walls each side and the front

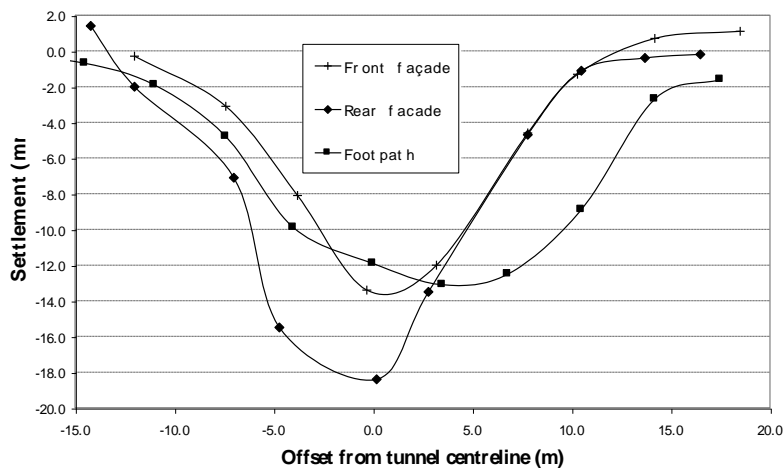
Figure 5: Observed settlement profiles

from the cottages and a section on the footpath in front of them. The settlements finally stabilised after two weeks, although the majority of settlement occurred in the first four days after the tunnel face passed. The maximum settlements observed were 13.4mm at the front, 18.4mm at the rear and 12.8mm on the footpath (Fig. 5).

The final settlement troughs approximated reasonably well to Gaussian shapes, with a trough width parameter (i) estimated as 4.5m at the front, and a calculated volume loss of 0.15% - 0.20%.

When the building was included in the model, the surface settlements were as shown in Figure 9. They did not differ significantly from the greenfield case, indicating that in the model the building responded flexibly, as observed in the field (Fig. 5). Profiles of the façade settlements predicted by the model are compared with the

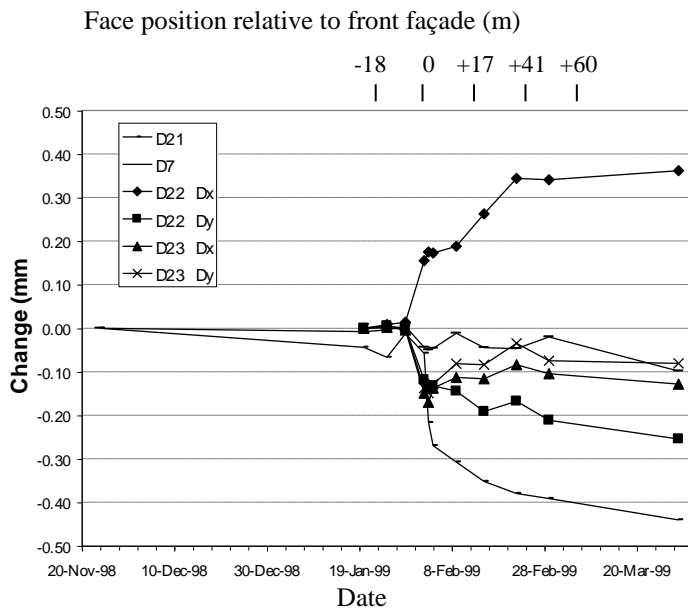
Figure 6: Movement of pre-existing cracks

The Demec studs on the front of the cottages within the settlement trough recorded some slight movements (Fig. 6). Some cracks were observed to open, some to close, and some did not move significantly. The magnitudes of the typical movements, at 0.4mm – 0.5mm, represent a damage category of Very Slight in the Burland *et al* (1977) classification. The readings at the rear were similar. The damaged cottage at the southern end was outside the observed settlement trough, and although movements of cracks of up to 2mm were observed over the duration of the project, they were not strongly correlated in time with the passage of the tunnel heading.

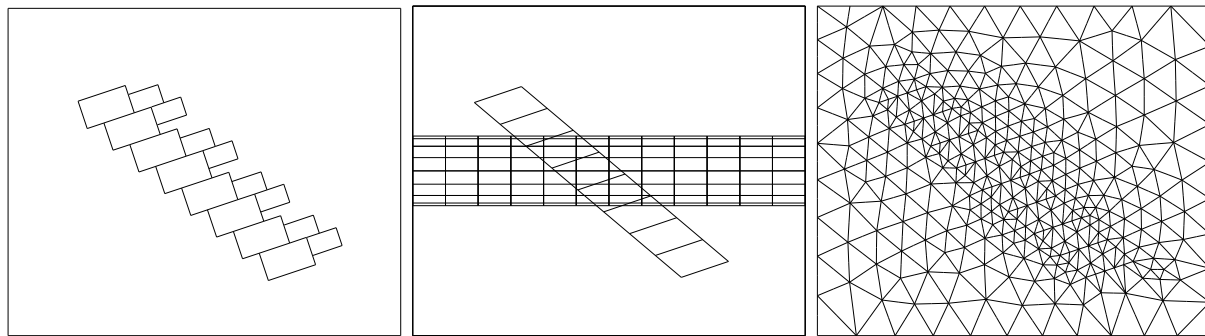
Figure 7: Development stages for the finite element model

The development of the geometry of the facades of the terrace was simplified as shown in Figures 7(a) and (b), with the front and rear facades modelled as straight and the party walls between cottages included in the model. The tunnel passes beneath the terrace as shown in Figure 7(b). The finite element mesh for the ground is shown in Figure 7(c) and Figure 8.

(a) Outline plan of cottages (b) Tunnel and simplified building outline (c) Mesh on ground surface

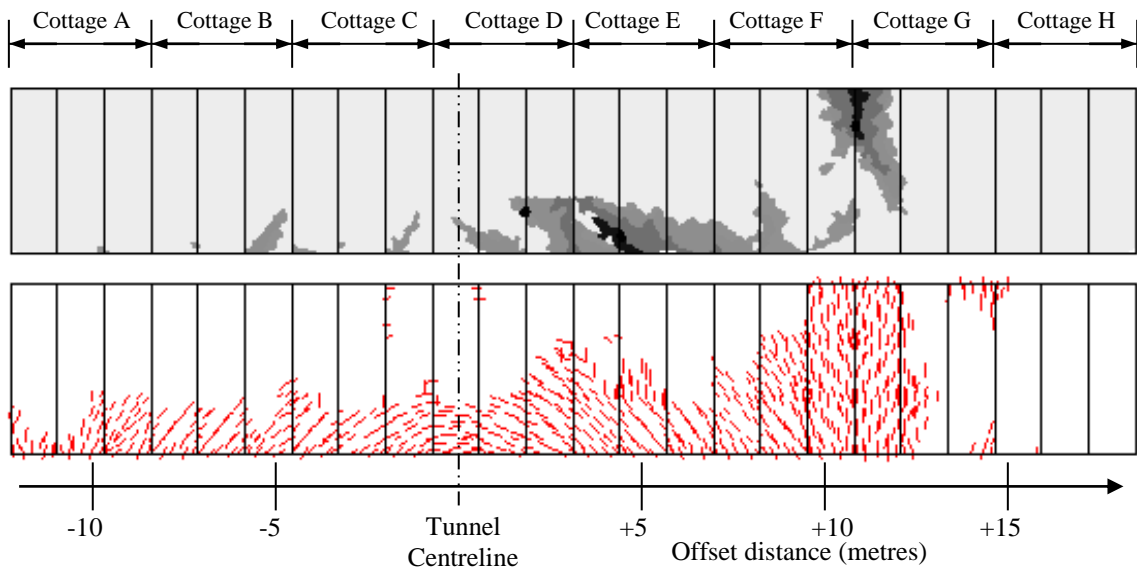
Figure 11: Front façade damage category (key on Figure 13) and crack pattern, viewed from front of cottages

The effects of the tunnelling settlements upon the model of the building are shown in Figures 11 to 13 for the front façade, rear façade and a party wall above the tunnel respectively. The party walls suffered progressively less damage with distance from the tunnel axis. For each façade, the crack strain is contoured according to the categories in Table 1. In addition the crack

pattern is illustrated by a method in which a single line is drawn at each stress point for which the crack strain exceeds $500\mu\epsilon$. The direction of the line indicates the expected crack direction and its thickness the severity of cracking.

It may be seen that the façades are mainly undamaged, but where damage occurs it is mainly of Very Slight category, with isolated areas of greater damage. The average damage category for the façades is Very Slight.
