# Effect of transversal steel connectors on the behaviour of rubble stone-masonry walls: two case studies in Italy

**ABSTRACT:** Multi-leaf masonry walls are very common in historical constructions and have been primarily designed to resist vertical static loads. Recent earthquakes have shown their high vulnerability against dynamic horizontal and static compression loads which can easily produce the detachment of the different leaves and determine important damage and catastrophic consequences. An increasing interest in the conservation of historic masonry constructions has produced a need for new consolidation and retrofitting methods. With the aim of increasing the mechanical characteristics, the overall structural behaviour and ultimately the safety of multi-leaf masonry wall panels against out-of-plane collapse mechanisms, several reinforced techniques have been investigated. In this paper, a new strengthening system which consists in the application of a pre-loaded steel bar enclosed into a fabric protective bag-case, is investigated. The steel-bar connector is inserted into a pre-drilled hole made in the masonry in order to bond the masonry leaves and to prevent the detachm

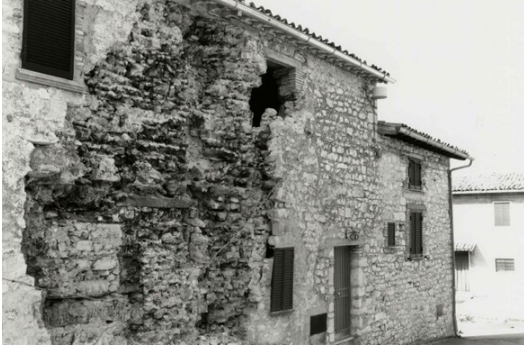
Figure 1. Example of separation between two leaves of masonry due to seismic action.

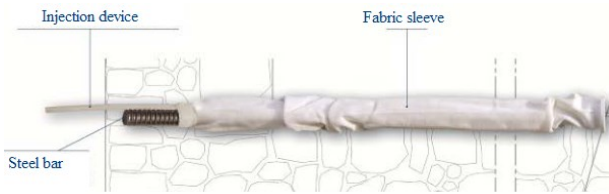
Figure 3. Anchor with fabric bag-case.

The strengthening system (Fig. 3) consists in a steel bar inserted in a mesh fabric sleeve (bag-case). This is injected at high-pressure (3-5 atm, depending on the quality of the masonry material) using a high-strength cement-based grout. The fabric sleeve avoids unexpected and often damaging scattering and wastefulness of the grout between the masonry leaves and increases the level of connection of the injected material to the masonry surface throughout its entire length.

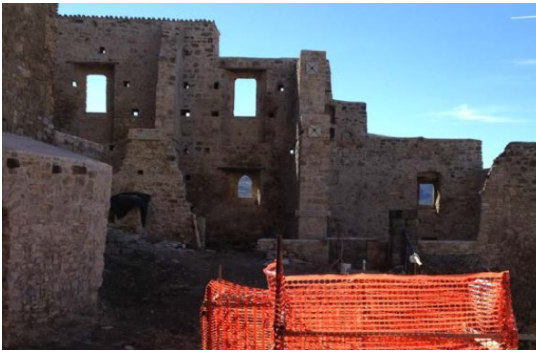
Figure 11. Main entrance of the castle where the connectors have been applied.

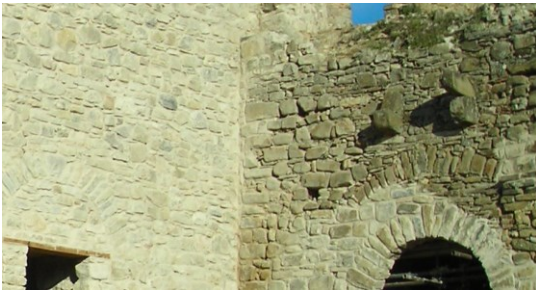
Figure 12. Masonry arrangement of the Laurenzana castle.

The existing walls are made of barely cut stone-masonry bonded with a weak (pulverulent) lime-based mortar, often damaged from excessive water action. The walls are made of 3 adjacent masonry leaves (triple-leaf walls) with a total thickness varying between 100 and 169 cm. The strengthening intervention has interested these massive walls, which are located near the main entrance of the castle (Fig. 11). The masonry arrangement is shown in Figure 12. Stones with larger dimension of approx. 35 cm were used together with smaller pinning stones, needed to increase the stability of larger stones. The three masonry leaves are weakly connected to each other. In order to increase the transversal connection of the different layers the technique described in the previous paragraphs has been choice by the authors. Twenty eight connectors GBOS 20-60 P characterized by steel bar with nominal diameter of 20 mm have been placed in a hole with diameter of 60 mm while the both sides of the hole were characterized by a diameter of 90 mm (Fig. 13a) to allow the pre-stress of the bar.

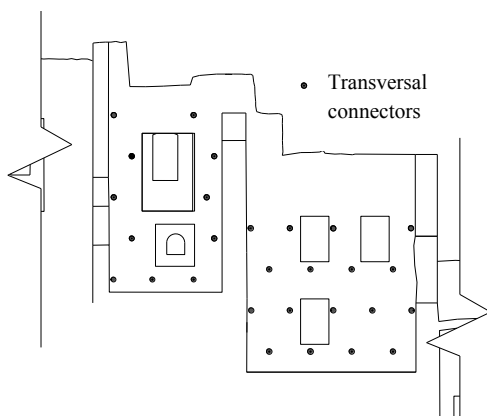
Figure 14. Arrangement of the position of the connectors.

The length of the bars varied between 960 and 1650 mm and the mutual distance in the horizontal and vertical direction between the connectors was around 1500 mm and they have been placed in according with the geometry in Figure 14. The holes have been drilled with drilling machines with diamond bits that work only with rotation movement in

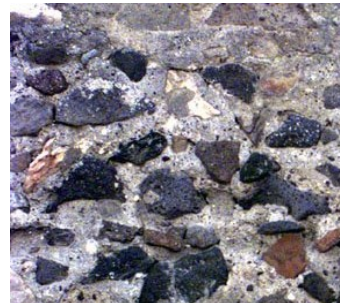
Figure 16. Tuff masonry arrangement of the goat house of the Royal Palace of Capodimonte.

The goat house is a two storey building made of tuffstone masonry walls and vaults (Fig. 16). Tuff was the typical stone of the area coming from local quarries. Double-leaf wall panels were used when a thicknesses between 46 and 55 cm was required. For larger thicknesses (between 57 and 103 cm) completely disconnected triple-leaf masonry have been

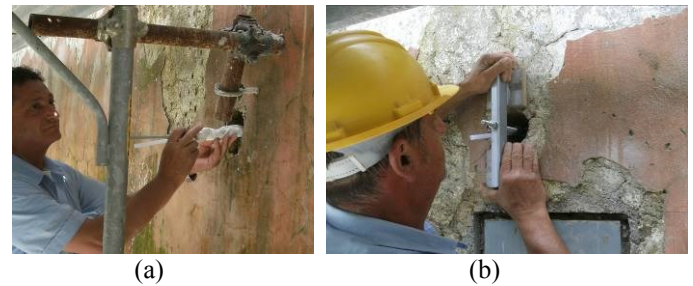
Figure 20. (a) Insertion of the steel bar; (b) pre-load application.

The steel bars, supplied with the special fabric bag-case, are then installed inside the holes (Fig. 20a). A tensile pre-load of 7.84 kN was also applied using a standard torque wrench. It was possible to keep the steel bars under loading using a reaction steel element (Fig. 20b). Finally the cement-based grout has been injected inside the fabric bag-case at pressure of 2.5 bar (Fig. 21a). The grout was cured for 28 days (Fig. 21b). At the end of this period, the reac-

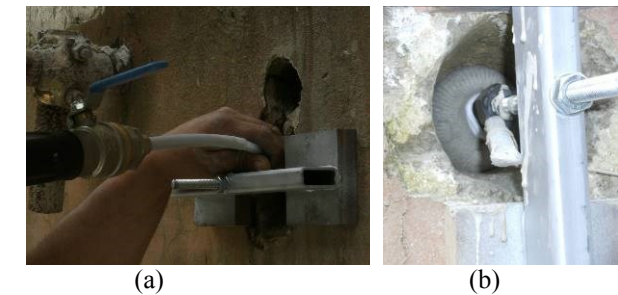
Figure 21. (a) Grouting operation; (b) the reinforcement during curing time.
