Tomczyk, Aleksandra M., White, Piran C L orcid.org/0000-0002-7496-5775 and Ewertowski, Marek W. (2016) Effects of extreme natural events on the provision of ecosystem services in a mountain environment : The importance of trail design in delivering system resilience and ecosystem service co-benefits. *Journal of Environmental Management*. pp. 156-167. ISSN 0301-4797

Effects of extreme natural events on the provision of ecosystem services in a mountain environment: the importance of trail design in delivering system resilience and ecosystem service co-benefits

Aleksandra M. Tomczyk^{a,b,*}, Piran C.L. White^a, Marek W. Ewertowski^{b,c}

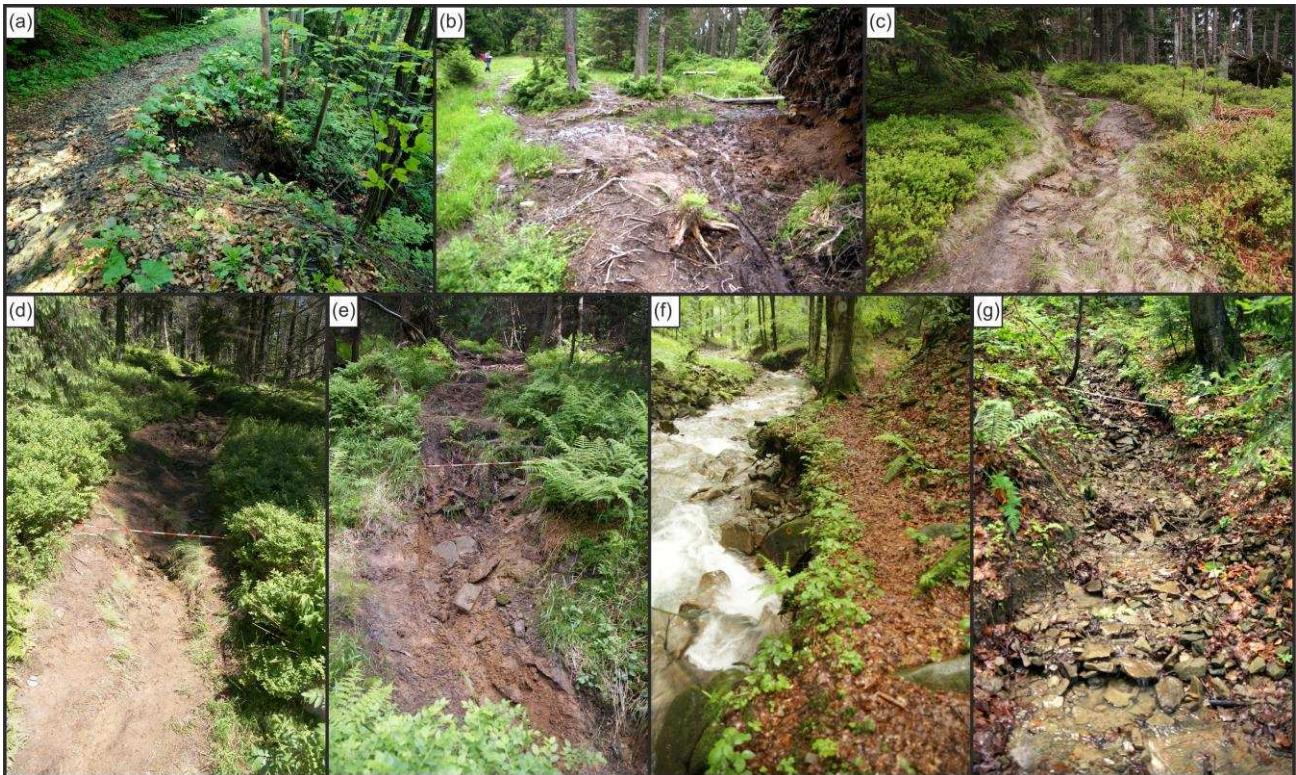
Figure 2. Examples of impacts in Gorce National Park related to the extreme rainfall event in May 2010: (a) damage to trail tread due to small landslide; (b) creation of muddy sections; (c), (d), (e) development of erosional rills destroying trail tread; (f) undercutting of trail treads by a stream; (g) increase in delivery of sediments due to soil erosion.

The intense rainfall in May 2010 caused a variety of damage within the Park area. The most important effects were the following (Fig. 2): (1) development of erosional rills on trail treads; (2) damage or destruction of bridges, culverts and water bars; (3) creation of extensive muddy sections; and (4) overall increase in soil erosion. These degradation problems created difficult and unsafe travel conditions. Visitors, trying to avoid these difficulties, started to trample trailside vegetation, leading to the additional widening of the trail tread. Moreover, in several places, alternative (informal) sections of trails were developed by users. Among other consequences of the intense rainfall were a rise in delivery of sediments into streams and retention ponds following soil erosion, and an increase in flood risk, which affected not only the Park area, but also areas downstream.
