FITZNER, B., HEINRICHS, K. & LA BOUCHARDIERE, D. (2002): Damage index for stone monuments.- in: Galan, E. & Zezza, F. (ed.): Protection and Conservation of the Cultural Heritage of the Mediterranean Cities, Proceedings of the 5th International Symposium on the Conservation of Monuments in the Mediterranean Basin, Sevilla, Spain, 5-8 April 2000: 315-326, Swets & Zeitlinger, Lisse, The Netherlands.

## Damage index for stone monuments

**ABSTRACT:** Precise diagnosis is required for characterisation, interpretation, rating and prediction of the weathering damages at stone monuments and is vital for remedy of stone damages and sustainable monument preservation. Quantitative rating of damages represents an important scientific contribution to reliable damage diagnosis at stone monuments. Damage indices are introduced as new tool for scientific quantification and rating of stone damages. Application of damage indices improves stone damage diagnosis and is very suitable for evaluation and certification of preservation measures and for long-term survey and maintenance of stone monuments. Importance and use of damage indices are presented for monuments in Germany, Malta, Jordan, Egypt and

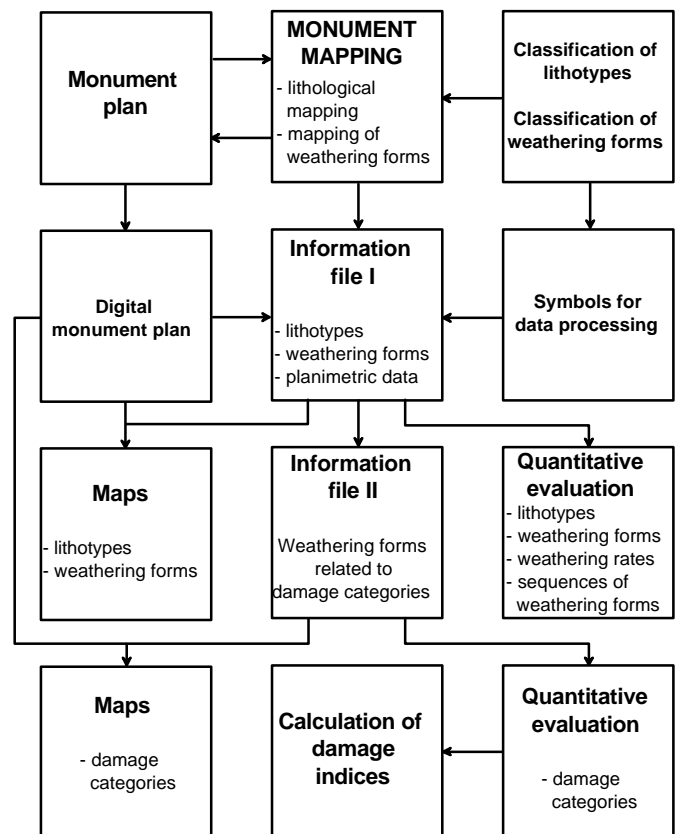
Figure 2. Monument mapping. Data processing and evaluation.

Damage indices are introduced now for conclusive quantification and rating of stone damages. Determination of damage indices is based on quantitative evaluation of damage categories. Damage indices complete a consistent and convincing approach to characterisation, evaluation, quantification and rating of stone damages. The application of the modular components “weathering forms”, “damage categories” and “damage indices” allows detailed damage diagnosis of entire stone monuments or single structures (Fig. 1). The individual steps of monument mapping procedure, data processing and evaluation are presented in Figure 2.

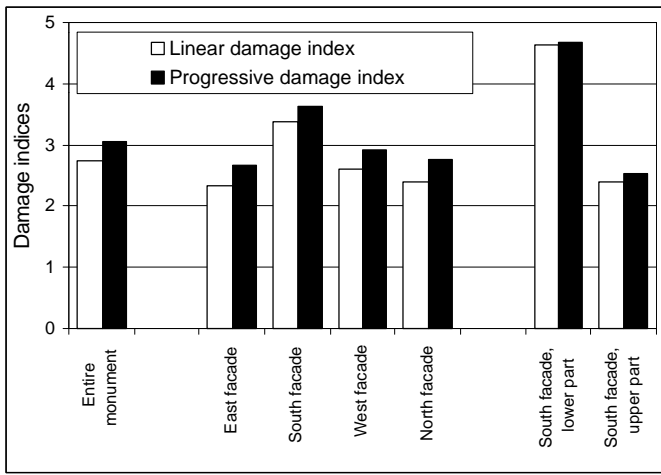
Figure 9. Damage indices. Church of Sta. Marija Ta' Cwerra.

Damage indices have been determined via weathering forms and damage categories for the entire monument and for the four facades of the free-standing monument. Vertical zonation of damages at the facades has been characterised by means of damage indices (Figs 8, 9). For the entire monument high damage indices have been stated. The linear damage index  $DI_{lin} = 2.73$  and the progressive damage index  $DI_{prog} = 3.07$  indicate the need of intervention. Considering the age of the monument, the damage indices show a high susceptibility of the Globigerina limestone to salt weathering.

Comparing the damage indices of the four facades, the south facade shows the most severe state of damage ( $DI_{lin} = 3.38$ ,  $DI_{prog} = 3.64$ ). This is due to extreme microclimatic variations at this facade causing intense salt weathering processes. At all four facades two zones of damages can be distinguished: an upper zone with mainly slight damages and a lower zone with mainly severe or even very severe damages (Fig. 8). The lower zone corresponds to parts of the church affected by salt-loaded rising damp. Salt load in these lower part is remarkably higher than in the upper part. The damage indices for these two zones – presented as example for the south facade (Fig. 9) - reflect the different state of damage as consequence of different salt load (south facade - lower part:  $DI_{lin} = 4.64$ ,  $DI_{prog} = 4.69$ ; upper part:  $DI_{lin} = 2.40$ ,  $DI_{prog} = 2.54$ ). Prospective interventions have to be addressed to the lower parts of the church.

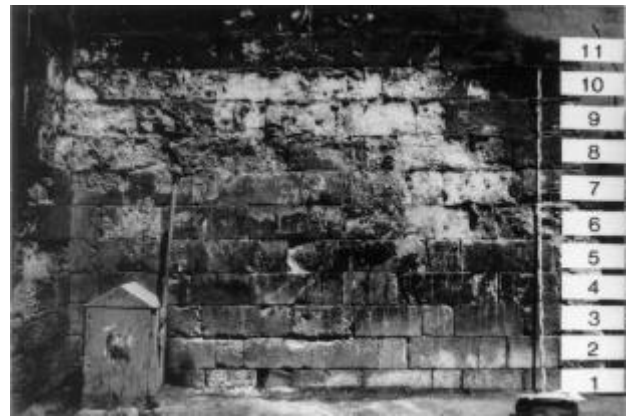
Figure 10. El-Merdani Mosque – Cairo/Egypt. Lower part of the SE-facade with numbering of rows of dimension stones.

El-Merdani Mosque is located in the historic center of Cairo. The Islamic Cairo has been declared by UNESCO as “World cultural heritage”. The mosque was built in the 14<sup>th</sup> century as one of the finest examples of Islamic architecture in Cairo. Porous limestones from the Mokattam mountains east of Cairo were used for construction. The mosque was restored a century ago, but it needs again intervention. Especially damages in the lower parts of the monument are striking (Figs 10, 11).

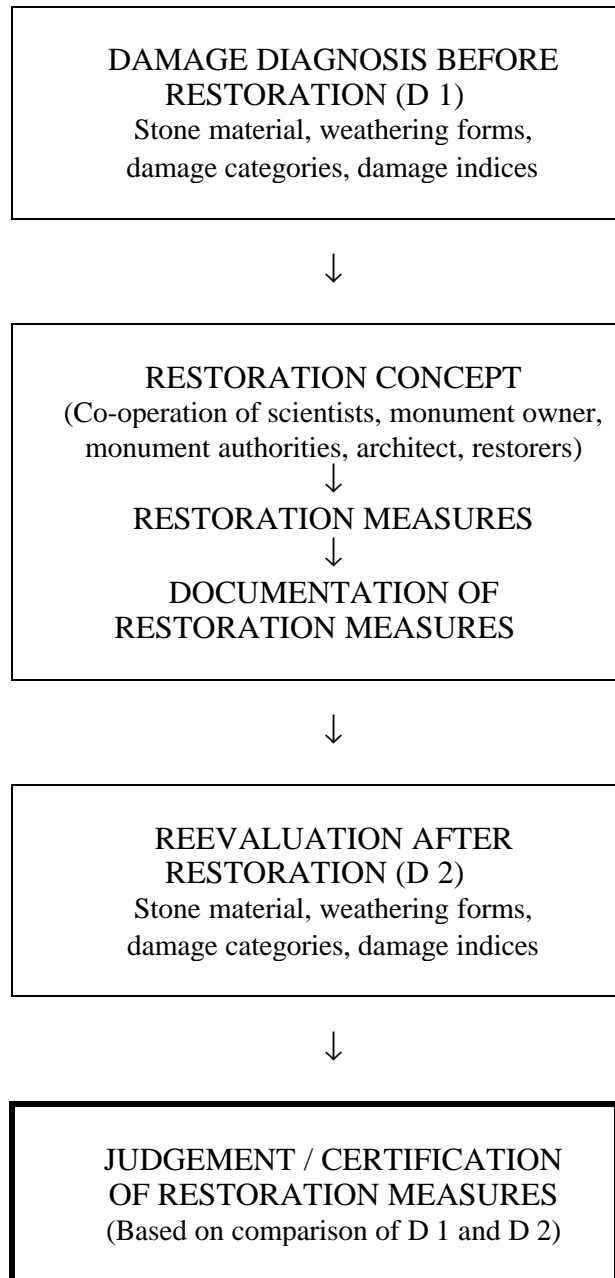
Figure 16. Damage diagnosis for monument restoration.

Extensive studies have been carried out at the monument in order of damage diagnosis and appropriate restoration. The interdisciplinary cooperation of scientists, curator, representatives of monument authorities, architect, engineers and restorers has comprised precise damage diagnosis, development of a restoration concept based on the damage diagnosis, execution and documentation of restoration measures, reevaluation after restoration and judgement of restoration measures (Fig. 16). Results of the reevaluation after restoration are necessary for future restoration activities and maintenance of the monument. With this step the approach to effective and economic monument preservation is completed.

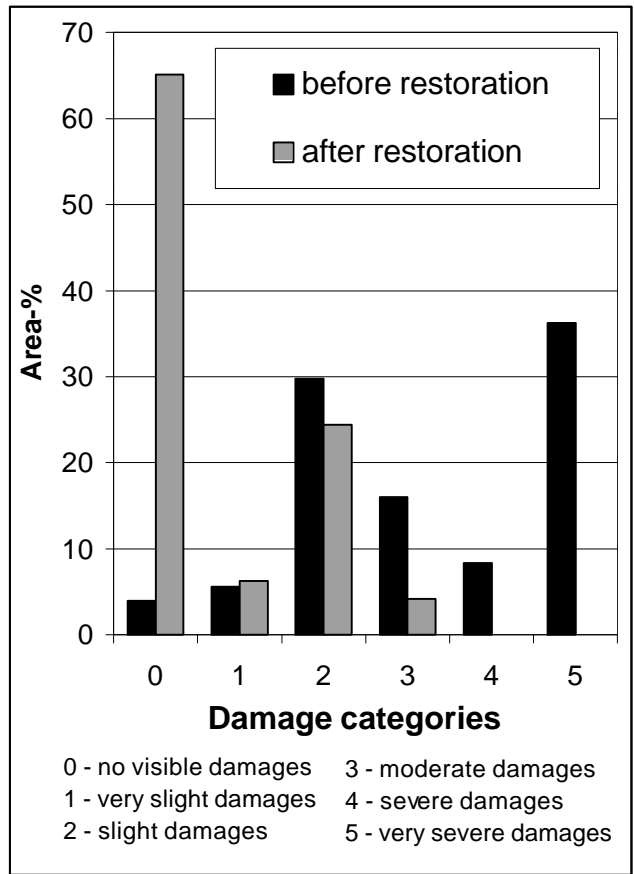
Figure 19. Damage categories before and after restoration. Part of Minster St. Quirin.

In order to judge resp. certificate restoration measures, the state of damage before and after restoration has been compared. In a first step of evaluation, damage categories before and after restoration have been considered. In the Figures 17 and 18 maps of damage categories before and after restoration are presented for a part at the south facade of the tower. The quantitative evaluation of damage categories for this investigation area is shown in Figure 19. The very severe and the severe damages (damage categories 4, 5) and most of the moderate damages (damage category 3) have been remedied or reduced in the course of restoration. After restoration about two third of the stone surface is without visible damages. Damage indices have been calculated from proportion of damages categories before and after restoration for conclusive judgement/certification of the restoration measures.

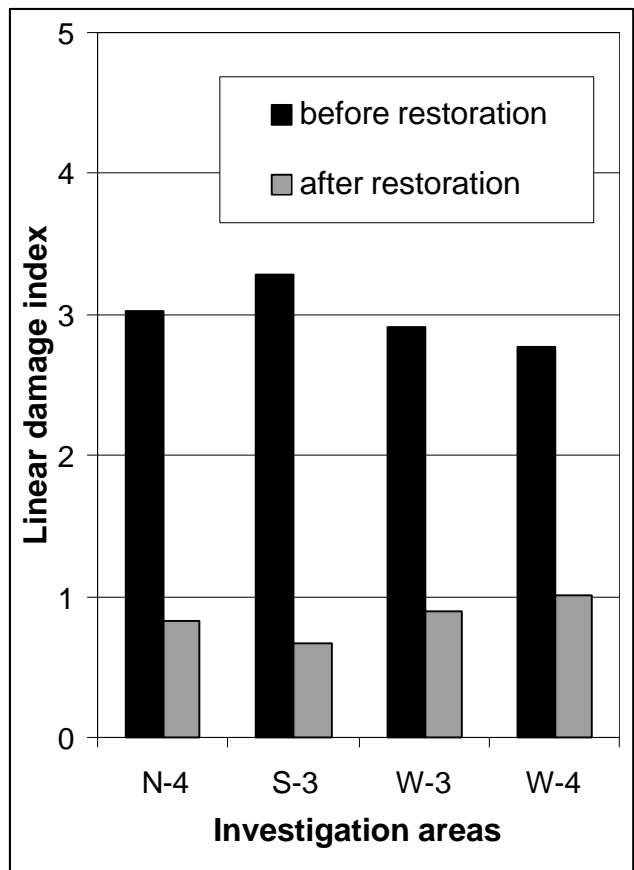
Figure 20. Linear damage index before and after restoration. Minster St. Quirin. Parts of the tower.

In Figure 20 damage indices before and after restoration are compared. The linear damage index is taken as example. Compared to damage indices before restoration, a reduction of damage indices up to 80 % can be stated after restoration. Restoration never will achieve an absolutely damage-free situation. The comparison of damage indices before and after restoration proves great success of the executed restoration measures. In a further step of evaluation by means of damage indices it is possible to judge success of restoration measures individually for each stone type. This is of special importance for all monuments constructed from stone types with different degradation behaviour.
