THE AEGEAN EARTHQUAKE and TSUNAMI OF 30 OCTOBER 2020

A FIELD REPORT BY EEFIT

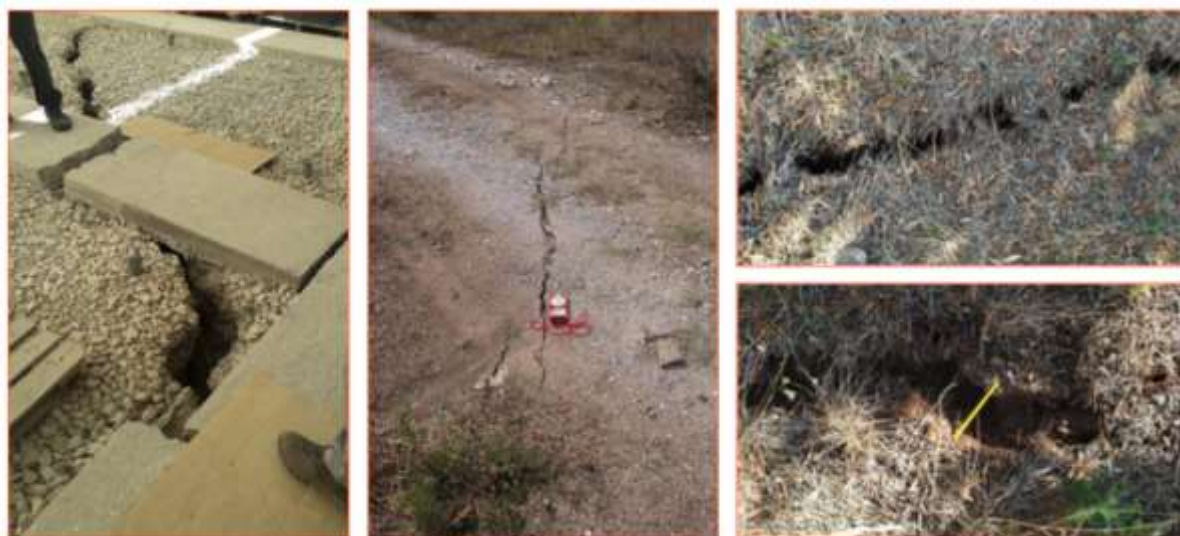
Due to the high magnitude and shallow nature of the 30th October 2020 earthquake, the island of Samos and area SW of Izmir displayed the full effects of the high ground motions produced. One of the first observations was coseismic surface rupturing which was documented across the Island of Samos and along the Eastern coast of Chios island, Greece. Our EFFIT field team located some metre-scale ruptures in northern Samos (Latitude: 37.803591° / Longitude: 26.724584°) as well as some structural ground cracking with offsets of < 30cm. The ruptures are continuous for up to ~10 m and strike ~60° NE as expected, as this is parallel with the main strain direction and active faulting in the area, especially the >10 km long Karlovasi fault (Pavlidis et al., 2009). Lekkas et al. (2020) also report many metre-scale surface ruptures with centimetre-scale offsets in the nearby Agios Nikolaos, Agios Elias and Kontakaeika villages in NW Samos. The ruptures in the area of Agios Nikolaos strike 40-70° NE, consistent with our findings. The ruptures were semi-continuous for lengths < 1 km and caused vertical and horizontal offsets between 5 – 8 cm (see **Figure 11**).

Figure 11: Photographs from Lekkas et al. (2020) illustrating surface rupturing in the Agios Nikolaos area in NW Samos.

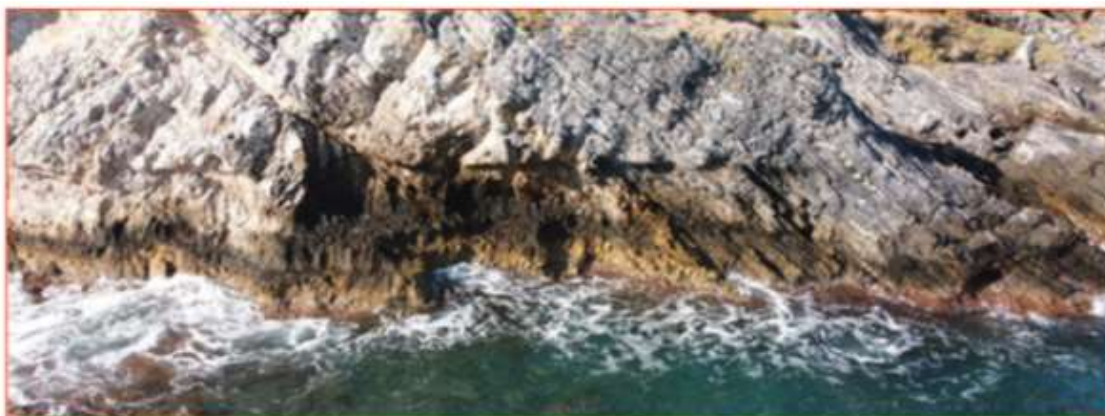
Figure 12: Photograph from Lekkas et al. (2020) illustrating 22 cm of coastal uplift in Punta, Samos, measured relative to values from Stiros et al. (2000).

Lekkas et al. (2020) also documented the permanent coseismic uplift attributed to the 30th October 2020 earthquake (see **Figure 12**), which was easy to see along the rocky shoreline and port/harbour walls due to the old waterline left behind. This observation is not unique to the region as many studies have documented tectonic uplift and subsidence across the Gulf of Corinth (Jackson et al., 1982; McNeill and Collier, 2004), Ionian Islands (Pirazzoli et al., 1994), Euboea (Stiros et al., 1992), Rhodes (Pirazzoli et al., 1989), Crete (Tiberti et al., 2014) and the Cyclades (Evelpidou et al., 2014).

In the region local to the 30th October 2020 earthquake, Stiros et al. (2000) and Evelpidou et al. (2019) have previously documented the change in shorelines along the coast of Samos, which offered a good measurable indicator for the uplift attributed to the recent M_w 6.9 earthquake. Lekkas et al. (2020) noted between 8 and 35cm of uplift at various locations along the coast, many of which were comparable with the Stiros et al. (2000) measurements.

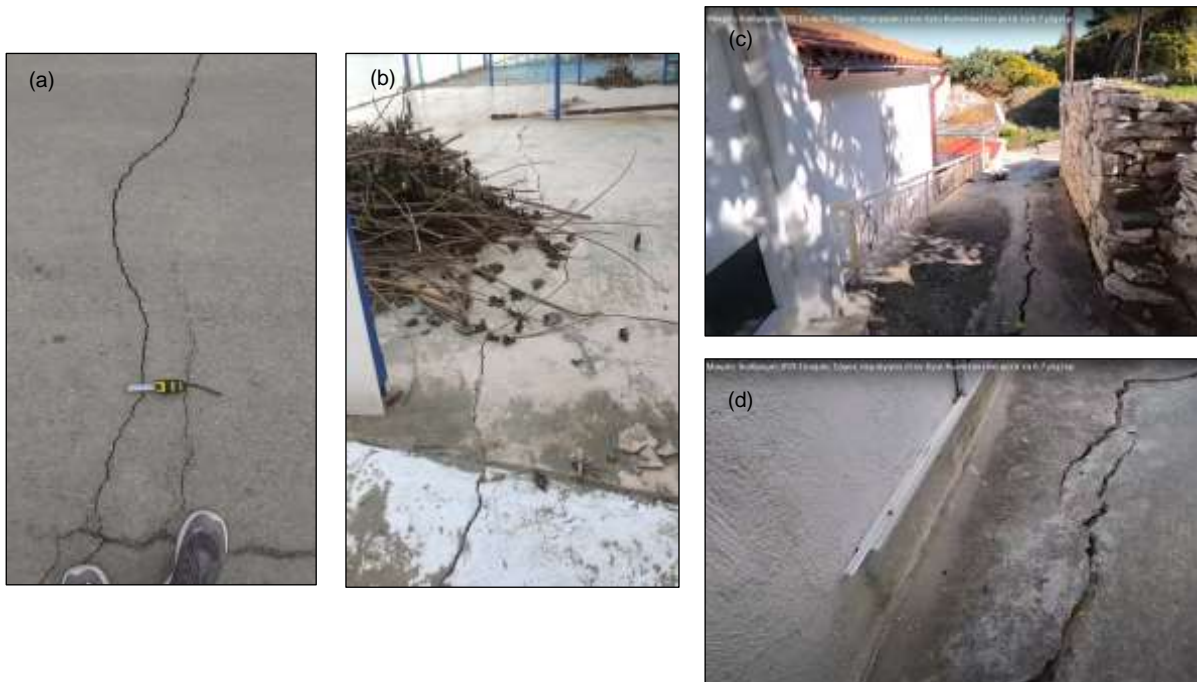
Figure 34: The observed ground cracks in a) Karlovasi, b) Kokkari and c) and d) at the village of Agios Konstantinos (source: <https://www.youtube.com/watch?v=E5lv20MwagI&t=1s>)

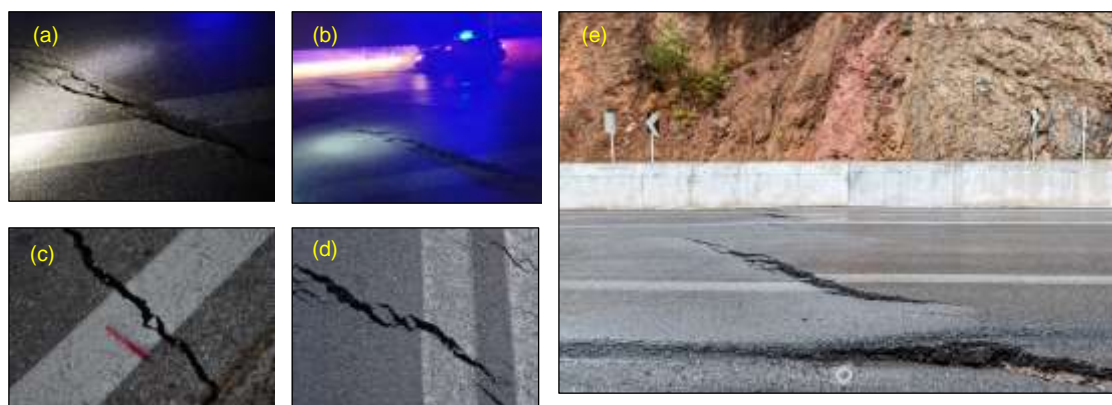
Figure 35: Road cracks observed in the area of (a) Vathy-Karlovasi road (Vadaloukas et al., 2020), (b, c) Agios Nikolaos (Lekkas et al. 2020), and (d) the main road Vathy-Karlovasi close to Karlovasi (photo taken by Manolis Thralvalos)

Moreover, some cracks were observed along the Vathy-Karlovasi road (**Figure 35a&b**), and roads network in the area of Agios Nikolaos (**Figure 35c&d**). Some additional effects were observed on the Vathy-Karlovasi road close to Karlovasi (**Figure 35e**). This area is located to the northeast, and composed of schists of the Ampelos nappe (Papadimitriou et al. 2020). The E–W-striking and N-dipping ruptures were reported in this location (Mavroulis et al 2021), which cut through the roads shown.

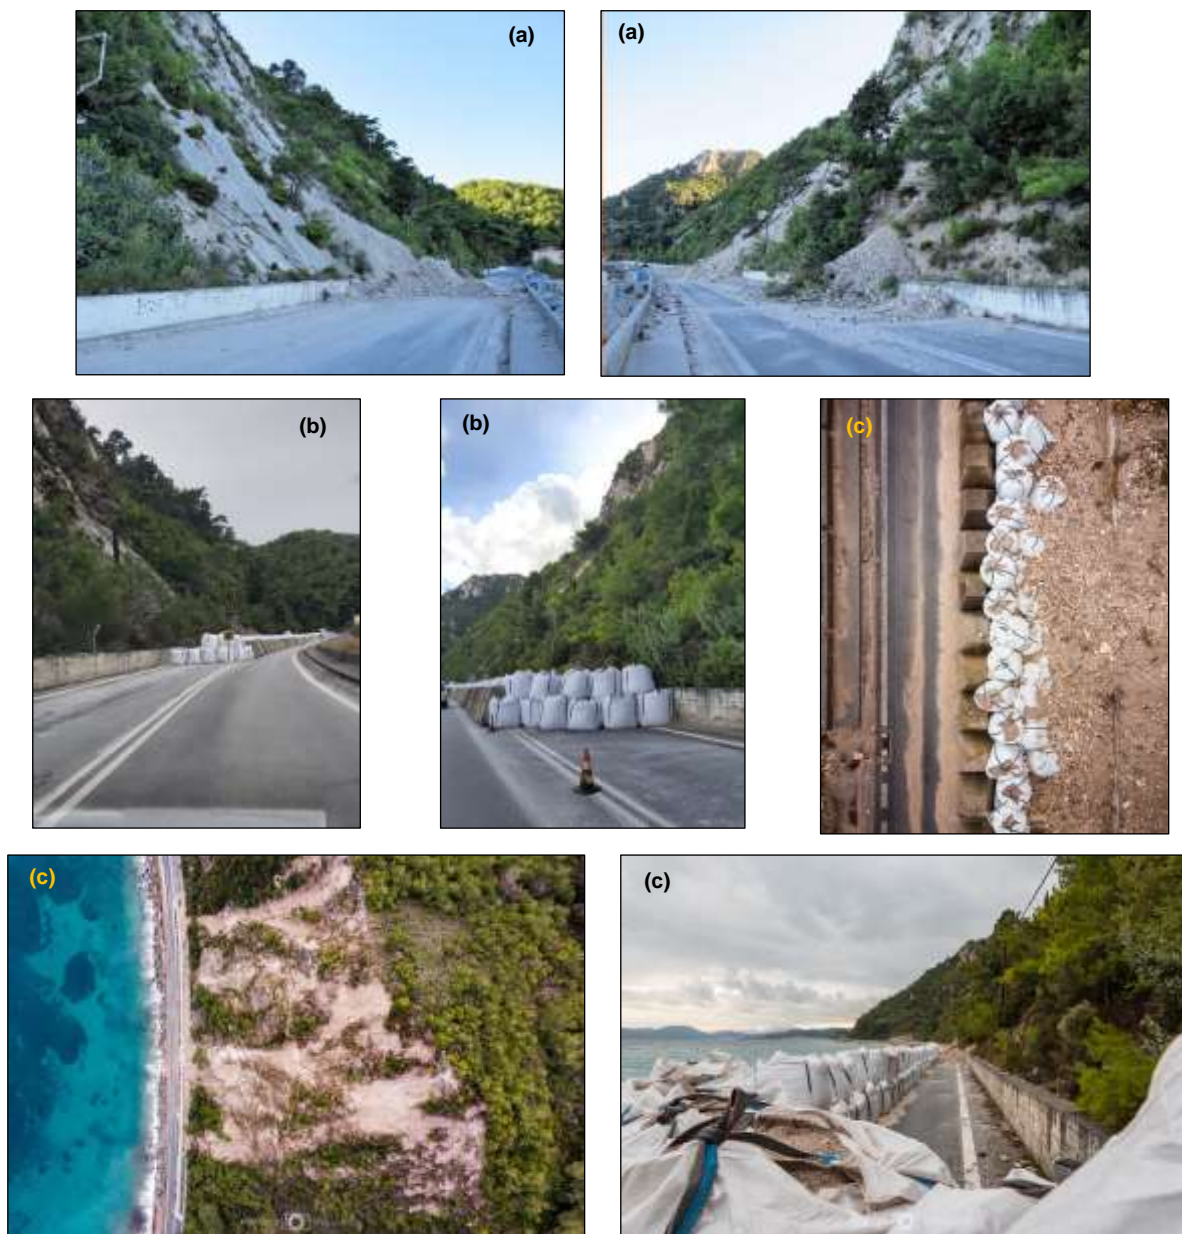
Figure 36: Landslides were generated along coastal slopes in Avlakia area a) immediately after the earthquake (31.10.2020) (Lekkas et al. 2020), b) large concrete block in order to protect the road from further slope failures (15.11.2020) and c) slope failures 45 days after earthquake (16.12.2020) (photos taken by Manolis Thravalos) (37°47'48.0"N, 26°51'27.7"E).

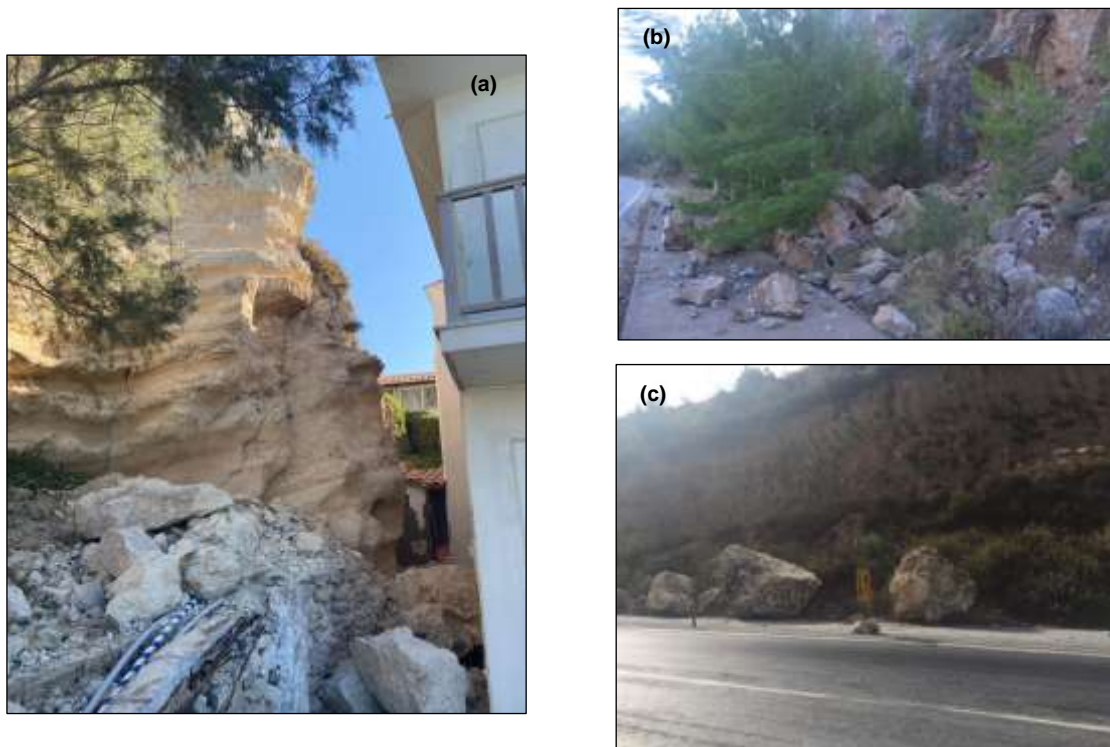
Figure 37: Rock falls (along with a large crack on the rock slope with future failure potential) were observed in a) in the Kokkari region (Samos Island, HAEE, 2020), b) near Tsambou beach (Samos Island, HAEE 2020), and c) Kuşadası (Turkey, 37.897341, 27.368394) (METU/EERC 2020)

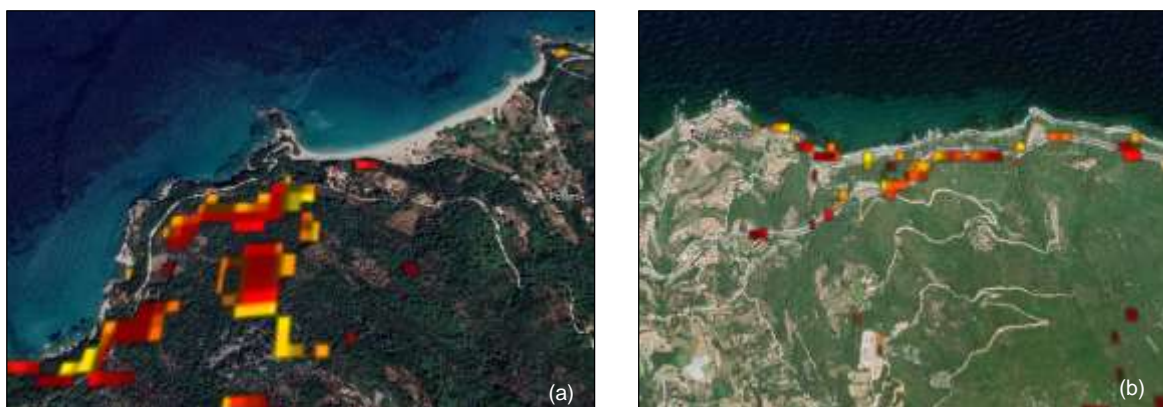
Figure 38: Damage Proxy Map (DPM) of Potami close to Karlovasi and Kontakeika (from the Advanced Rapid Imaging and Analysis (ARIA) Centre for Natural Hazards, <https://aria-share.jpl.nasa.gov/20201030-Samos-Izmir-EQ/DPM/>). The colour grading from yellow to red indicates increasingly higher ground deformation.

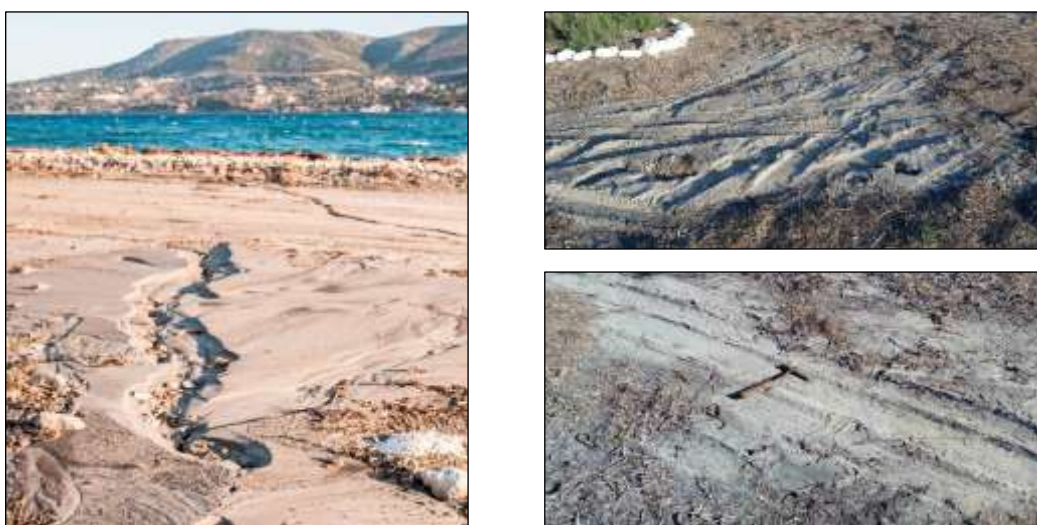
Figure 40: Soil liquefaction in the form of sand boils in Malagari (source: photo on the left after Lekkas et al. 2020) and photos on the courtesy of Dr. A. Ganas)

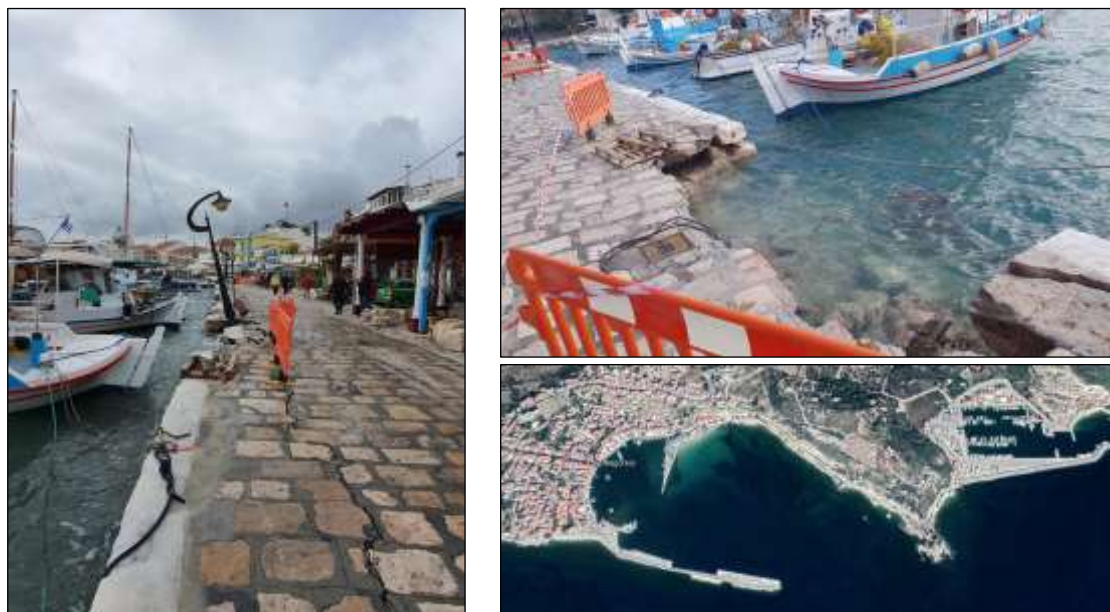
Figure 41: Damage was observed on Pythagoreio port

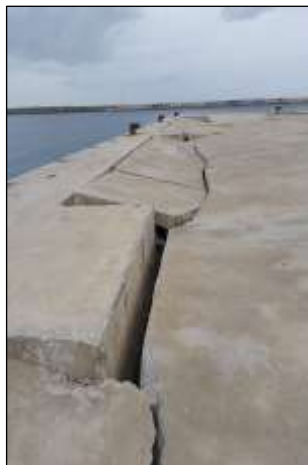
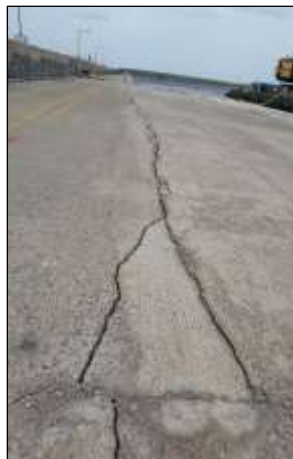
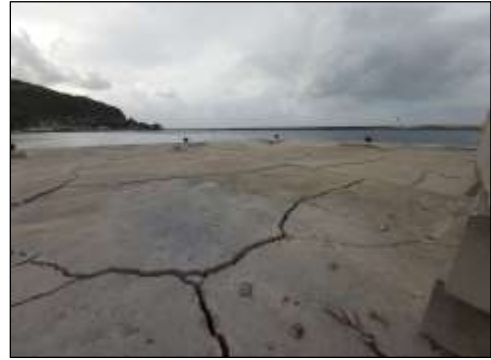
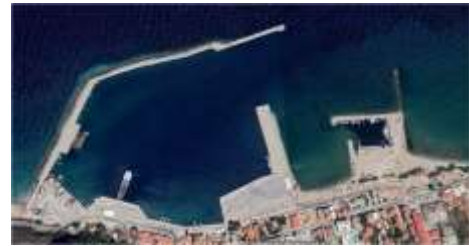
Figure 42: Significant damage was observed on Karlovasi ports of Samos.

The Karlovasi and Vathy ports are situated in north Samos, and Kokkari (smaller port) is located between these two ports. In ports of Karlovasi and Vathy, there are two facilities: the eastern port and the western port. The western port of Vathy is known as the “Malagari” port and the eastern port of Karlovasi is a new port. More details on these ports can be found in Cetin et al. (2020). **Figure 42-44** show the extensive cracks and deformation that observed in these ports.

The level of failures observed at the block-type gravity quay wall structures in these areas might be due to a combination of the dynamic consolidation of the back-fill soil material, cracks on the surface, the near-surface liquefaction and displacements, and horizontal spread of the soil to the sea.

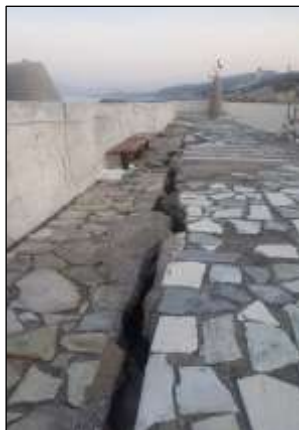
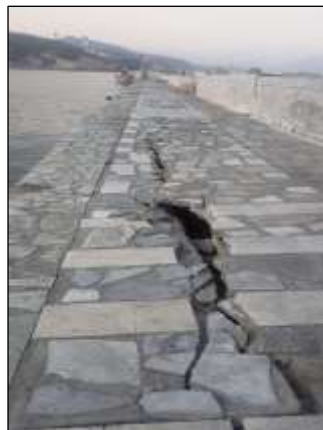
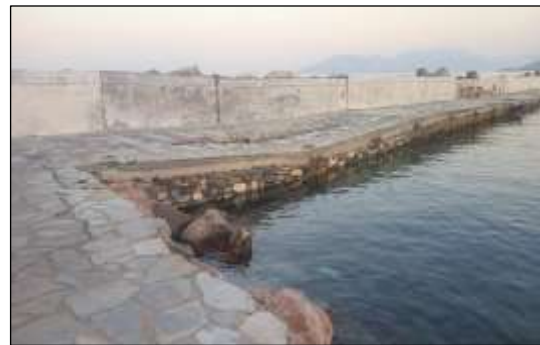
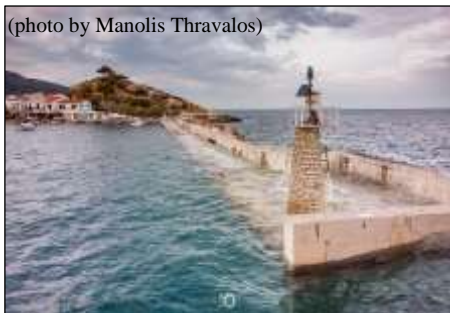
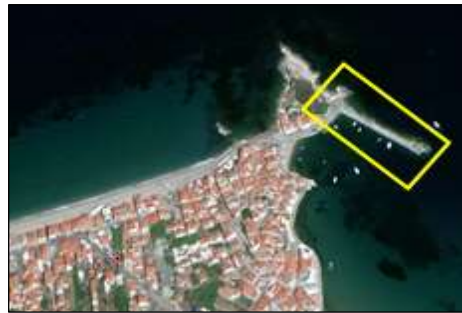
Figure 43: Significant damage was observed on Kokkari ports of Samos

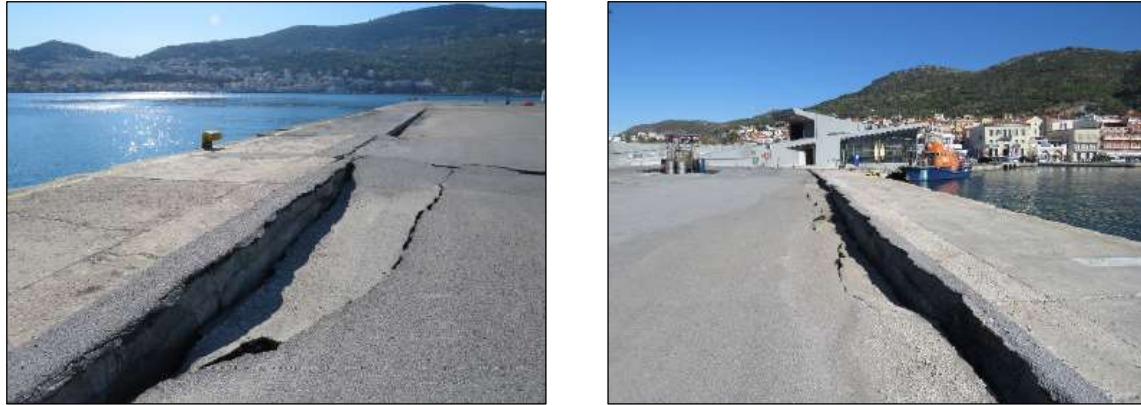
Figure 44: Significant damage was observed on Vathy ports of Samos (Lekkas et al., 2020)

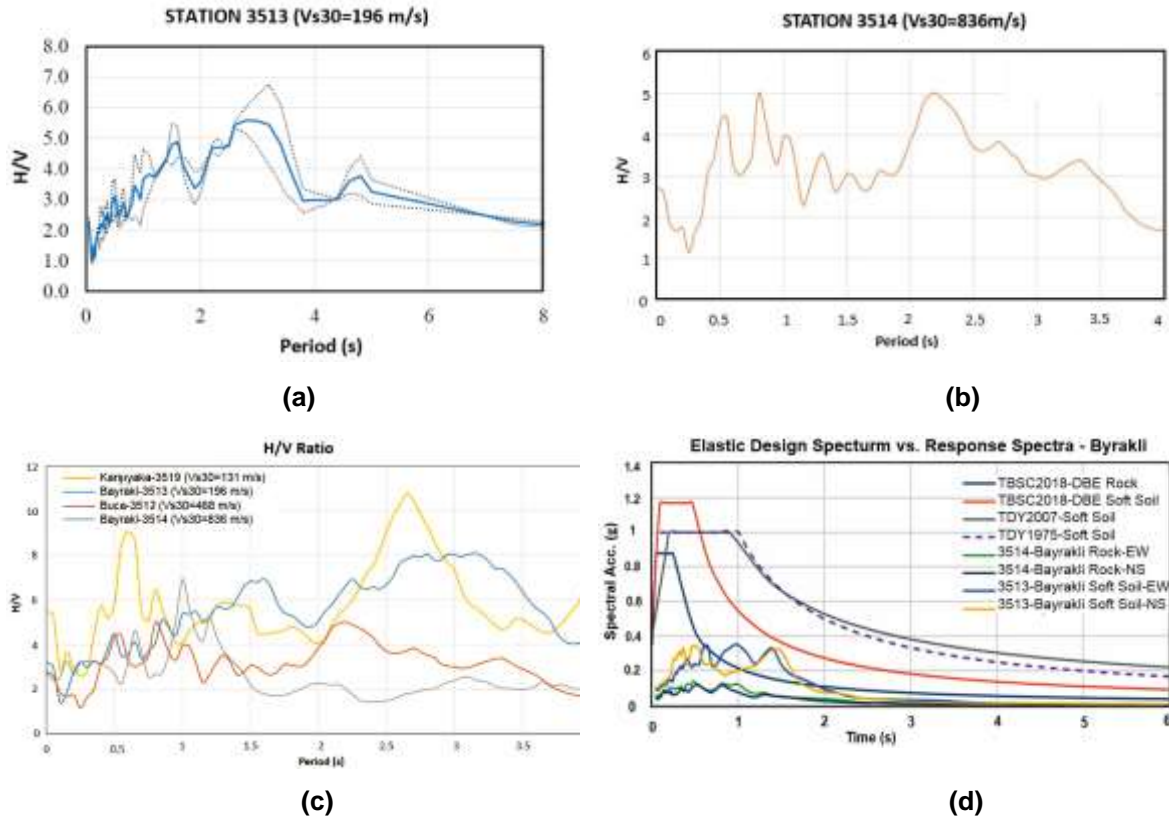
Figure 49: (a) and (b) The amplification spectra for stations 3513 and 3514 (ITU Report, 2020) and (c) the ratios of the horizontal and vertical of the acceleration spectra (H / V) graph for Buca, Bayraklı and Karşıyaka stations and d) comparison of the acceleration response spectra of the recorded ground motion at the two stations against the DBE level spectra of current and earlier versions of Turkish Seismic Codes at these locations (adapted from Erdik et al. 2020)

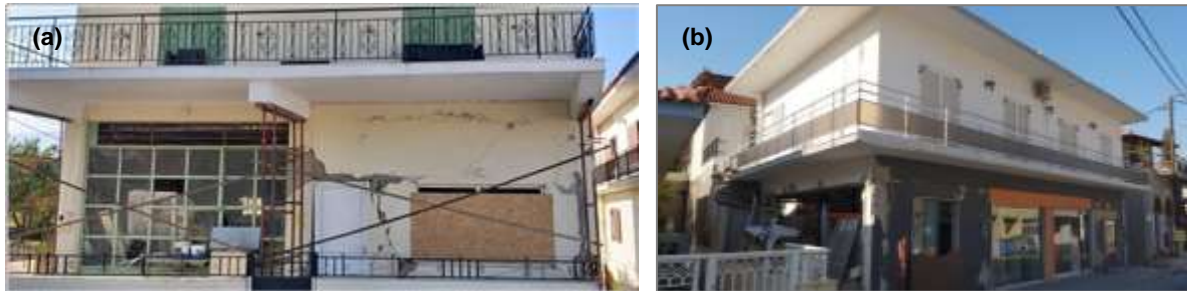
Figure 60: Damage to infill walls in two RC buildings in Samos: (a) in plane and (b) out of plane failure

The most common damage mechanism observed was the failure of infill walls, both in plane (**Figure 60a**) and out-of-plane (**Figure 60b**). In particular, significant separations from the frame as well as corner failures and diagonal shear cracks were observed. In some cases, localised or extended infill collapses were also recorded.

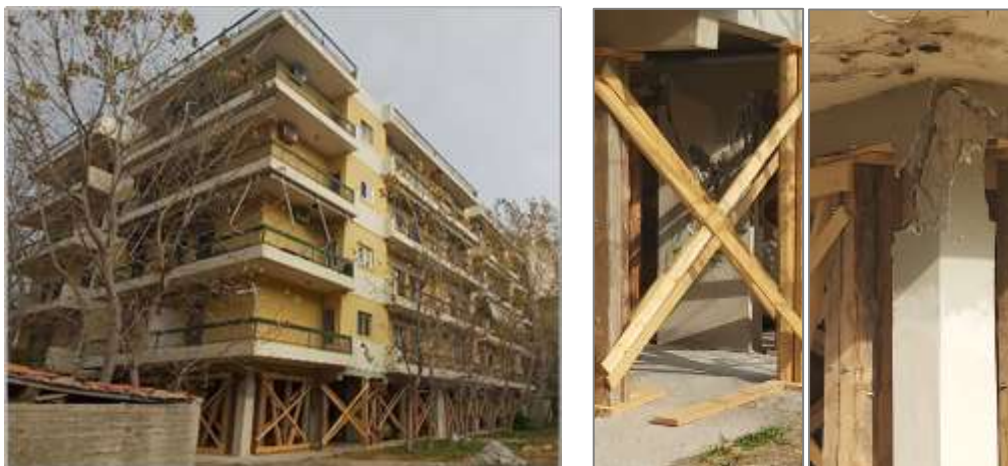
Figure 61: Five-storey building with soft first storey (pilotis) failure at the ground level in Karlovasi (Samos)

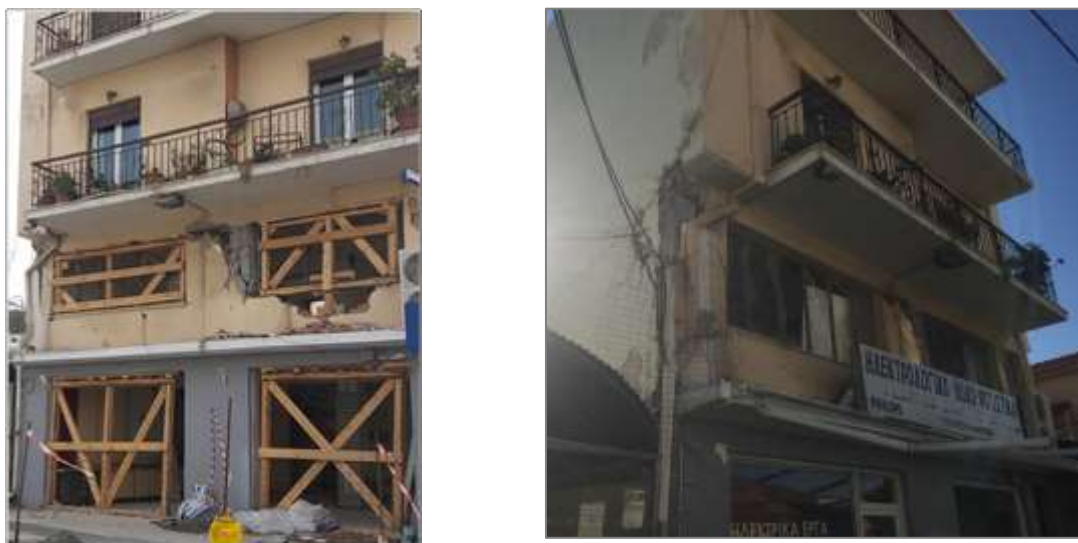
Figure 62: Four-storey building with short column failure in Samos

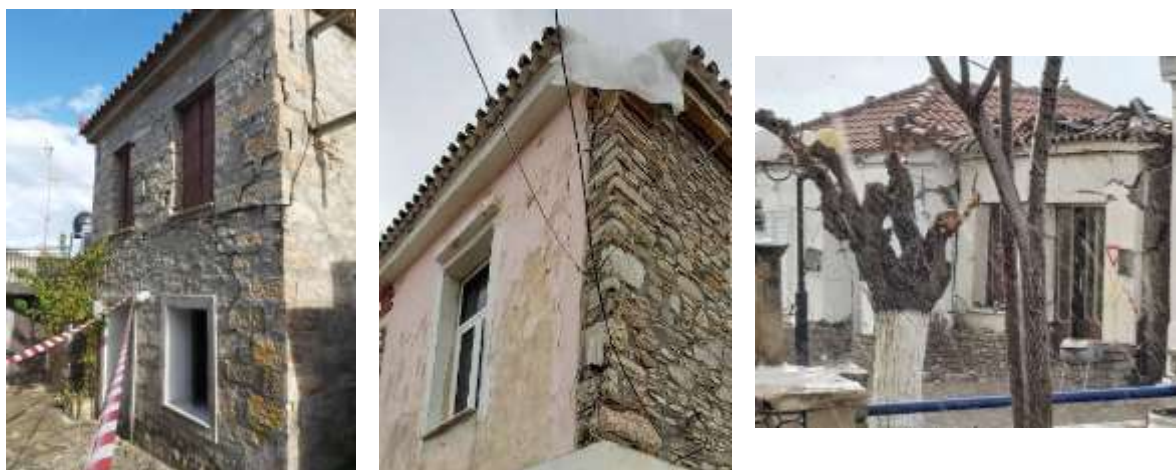
Figure 63: Corner failure in masonry buildings in Samos.

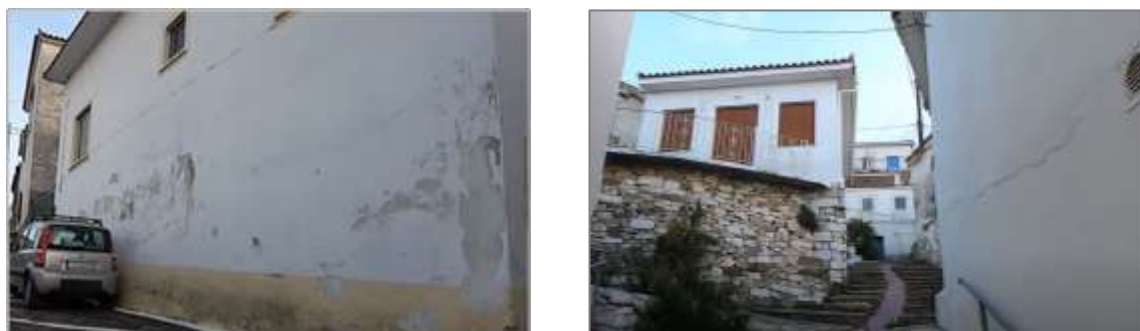
Figure 64: Damage in masonry buildings in Samos with horizontal cracks at floor level due to sliding (Photo credits to "Mikres diadromes" youtube channel)

The load bearing masonry buildings, typically but not exclusively built using local stone, was one of the structural typologies most affected by this event. The field damage assessment showed that only 32% of the surveyed buildings suffered slight or no damage. Common failure modes include, corner failures were registered at the intersection of the two orthogonal walls (**Figure 63**). Depending on the extent of the dislocation, this damage mechanism led to diverse damage grades and usability levels. This failure mode is often combined with vertical cracks along the two orthogonal walls which tend to get separated with cracks of different width (**Figure 63**). Horizontal cracks at the floor level were observed in a few cases, due to sliding between the timber floor and the bearing masonry wall underneath (**Figure 64**). Different extents of roof damage were also observed in many masonry structures (**Figure 65**).

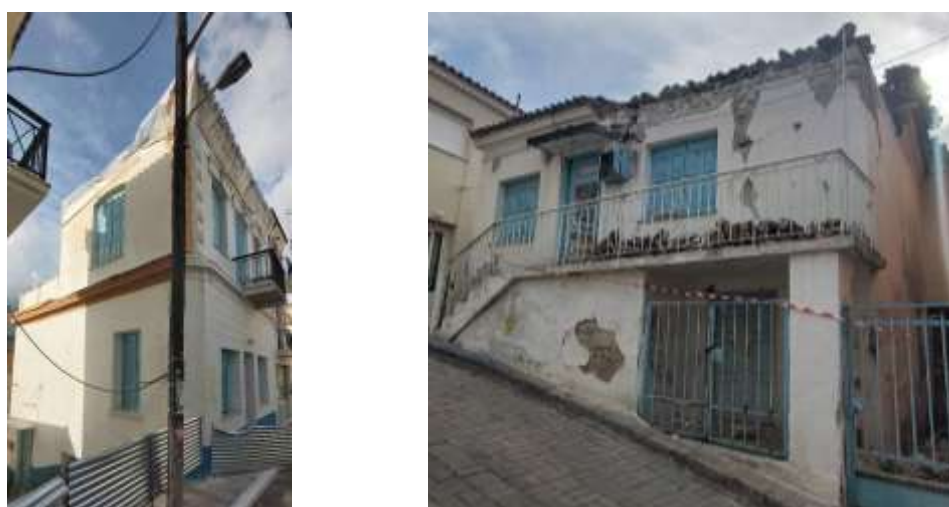
Figure 65: Roof damage to masonry buildings in Samos.

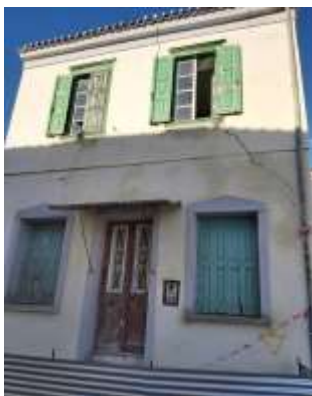
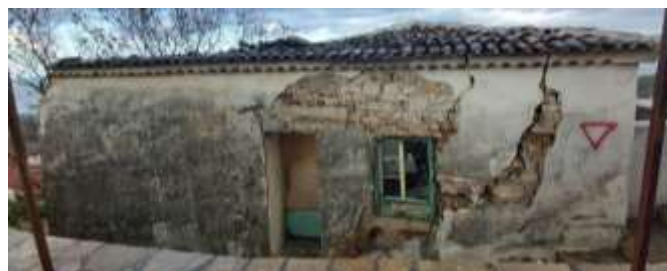
Figure 66: Diagonal shear cracks to the walls with different widths.

Moreover, diagonal cracks along the walls (**Figure 66**), spandrels and piers (**Figure 67**) were another common damage pattern in masonry structures due to shear failure of the horizontal and vertical segments of the envelope. The crack width/extension varied, leading to diverse complex failure mechanisms, including out-of plane failure and partial collapse. In case of multi-leaf envelopes, the separation of the two wall wythes due to bad quality mortar was observed to lead to dislocation of the external wythe, and even to out-of-plane collapse (**Figure 67b**). Both partial and total collapse was mostly encountered in case of abandoned buildings with significant material deterioration and resulting overall structural delapidation prior to the earthquake (**Figure 68**).

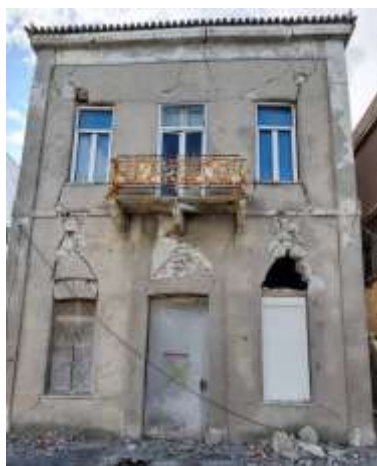
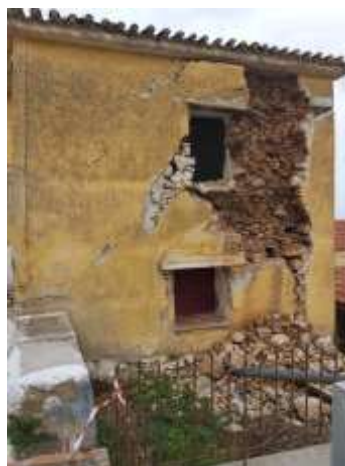
Figure 67: (a) In plane cracks to spandrels and piers, (b) out of plane wall failure

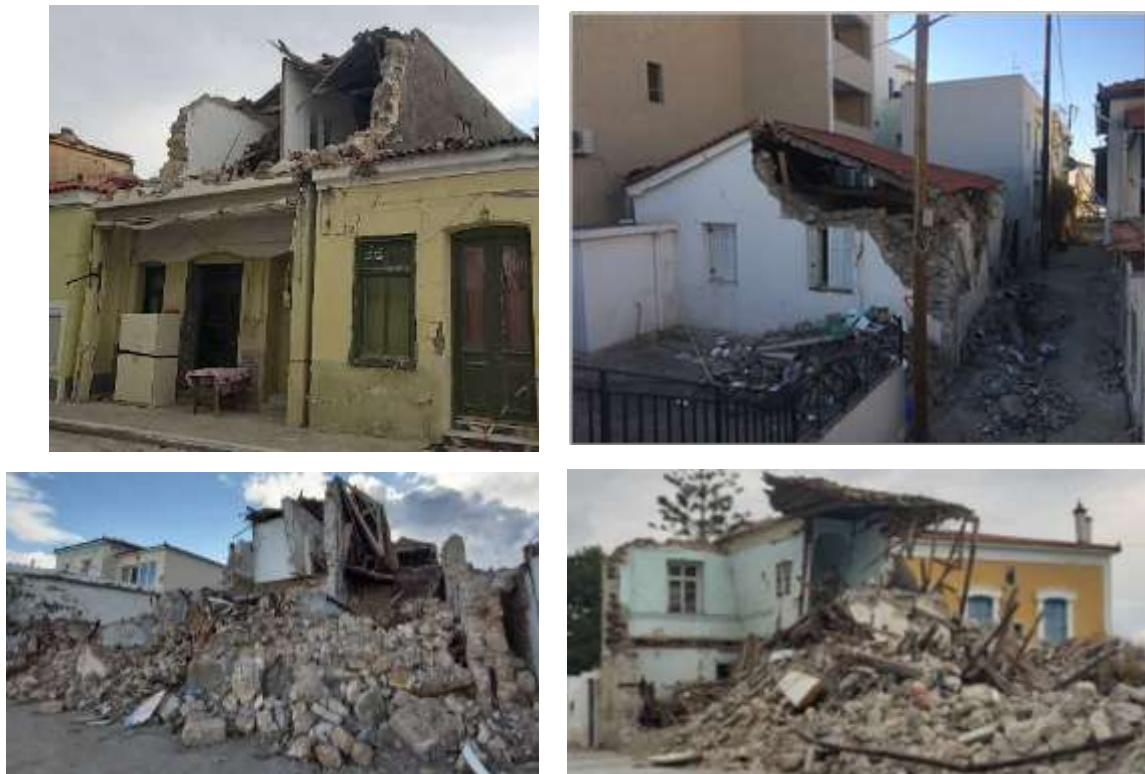
Figure 68: Partially and totally collapsed buildings in rural localities and Samos town.

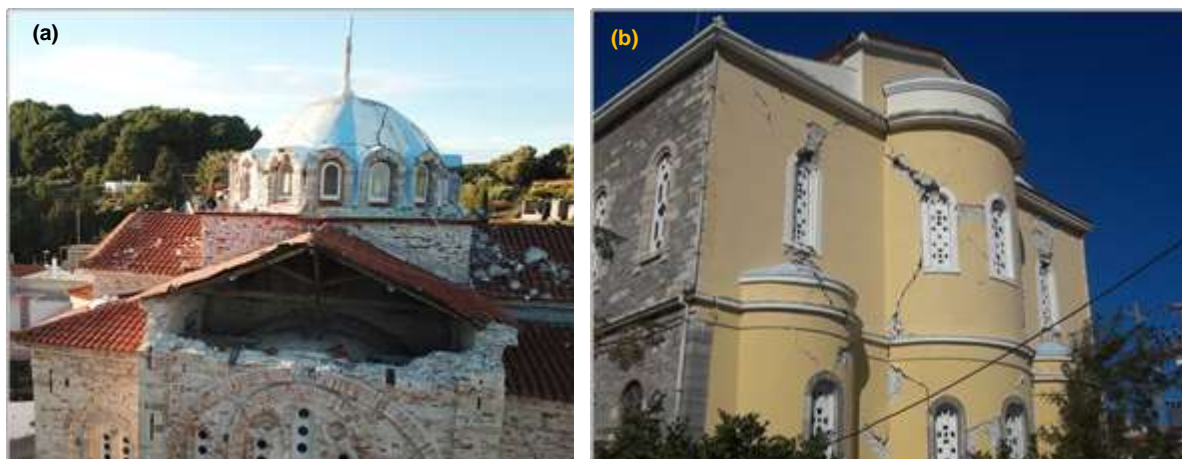
Figure 69: (a) Panaghia Vrontiani, Konteika and (b) Agios Nikolaos, Kokkari (Photo credit: D.Malliaros, E.Giovani, A. Tatouris)

Heavy damage was observed to dome, roof and facades of several large churches (**Figure 69**). Few cases were damaged beyond repair (almost collapsed). The most notable heavy damage was observed to the roof and one façade of The Church of the Assumption of the Virgin Mary in Karlovasi (**Figure 70**). Small churches had a better performance (**Figure 71**) under the seismic actions.

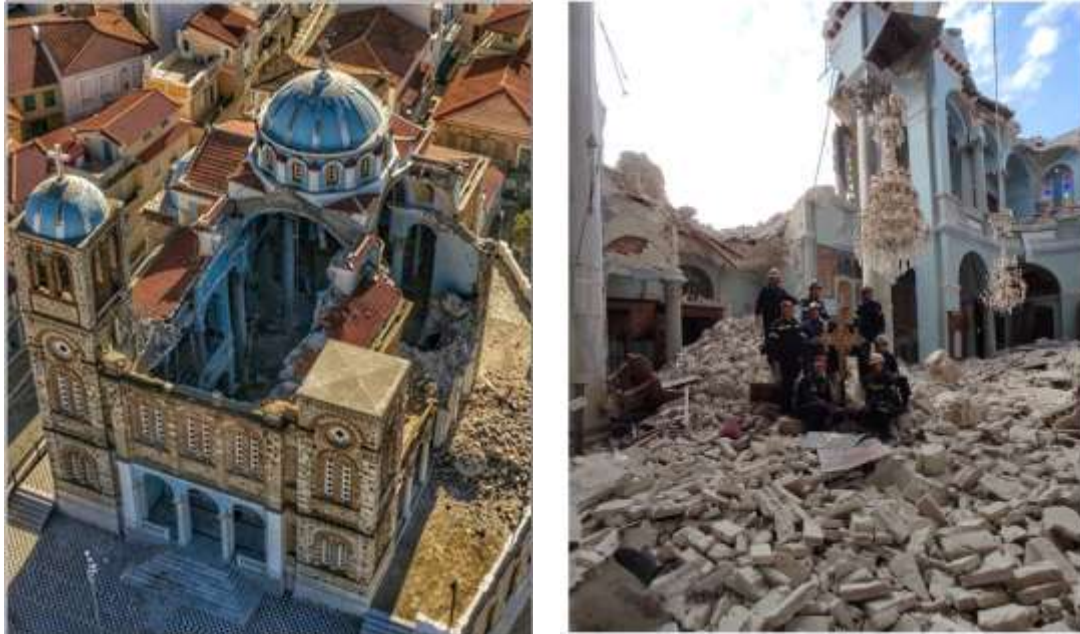
Figure 70: Koimisi Theotokou, Karlovasi (Samosvoice 2020)

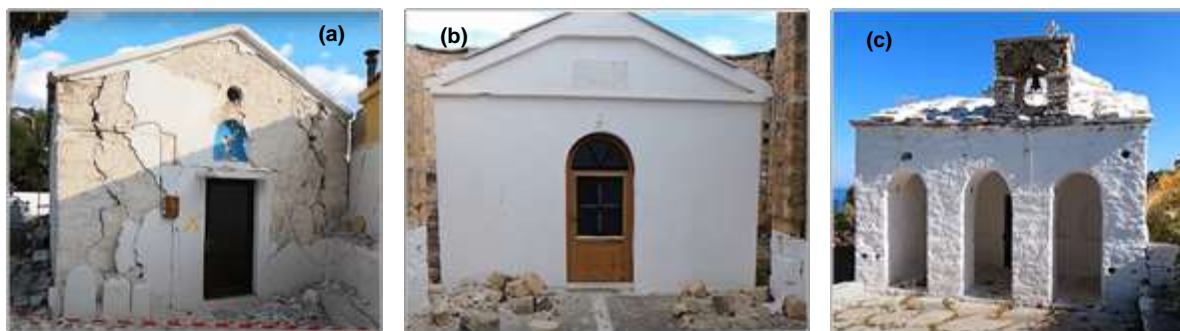
Figure 71: (a) Agia Sofia, Chora; (b) Agios Georgios, Pyrgos; (c) Agios Konstantinos, Agios Konstantinos

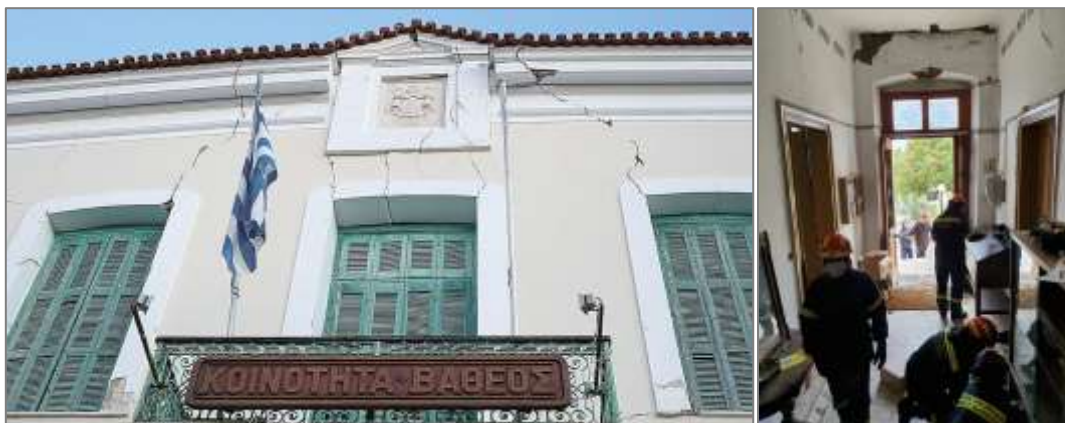
Figure 73: Severely damaged historical building of the town hall of Vathy (photo credit: Facebook page - Kathimerini)

Other historical structures suffered damage, including the Pythagoreio Castle ruins, town halls and the Old Tanneries in Karlovasi (Figure 72-73). The earthquake had also effects on museum contents. For example, at the Archaeological Museum at Pythagoreio, significant damage was observed to the pottery exhibition (Figure 74a) and at the Archaeological Museum of Vathy, a crack appeared at the gigantic foot of the man sculpture (“Kouros”) (Figure 74b). Moreover, several exhibits of choroplasty and ceramics broke when falling from the showcases in the Archaeological Museum of Chios.

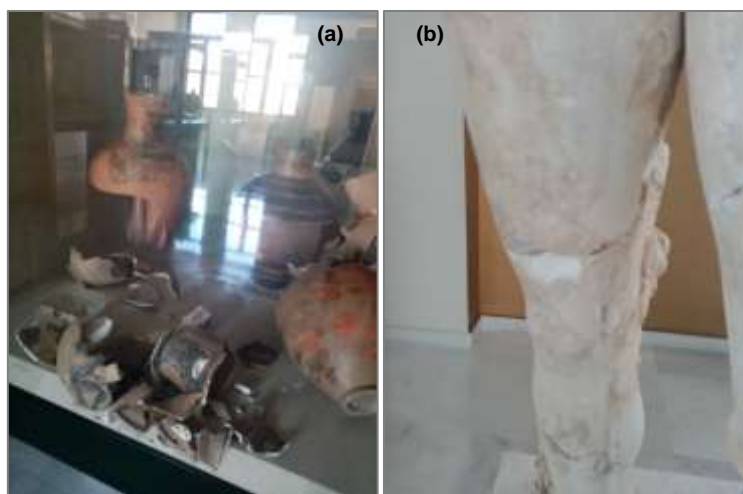
Figure 74: (a) Damage to pottery exhibition at Archaeological Museum of Pythagoreio and (b) crack at the male sculpture at the Archaeological Museum of Vathy (Skai 2020)

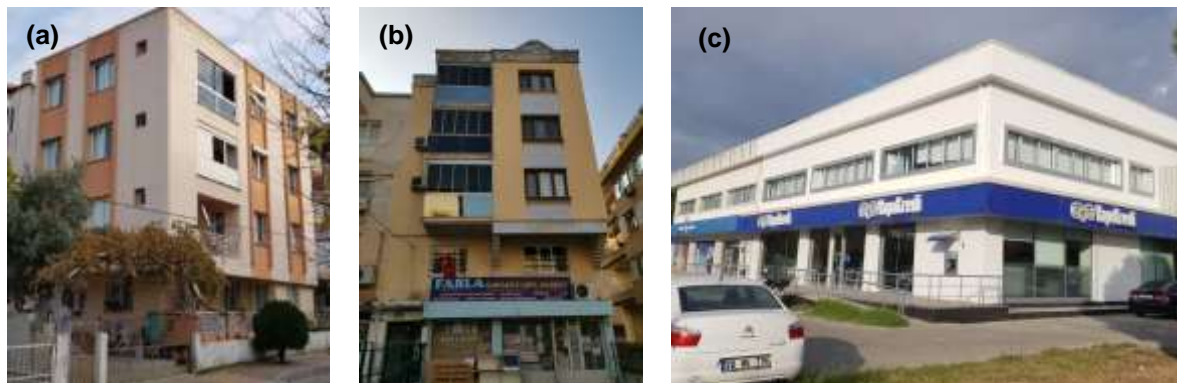
Figure 80: Good response of (a) – (b) RC frames with infill masonry walls and (c) RC precast industrial building

Figure 80 shows some examples of good response by RC structures with residential/commercial and industrial use. The reported structures have the typical features of the buildings in this region: medium rise buildings with irregularities in elevation (mainly due to the opening layout at the ground floor). In several buildings the use of parts of the buildings changed during its lifetime; for example, most of the visited/assessed structures had balconies that were closed with infill walls to become proper internal floors (**Figure 80b**). This feature affected the regularity of the building in elevation at different storeys as well as the actions distributions and/or intensity.

A very good response was also observed in industrial structures (**Figure 80c**), typically consisting of RC precast buildings (one or two-storey). The field crew visited some of the factories in the Izmir Atatürk Organized Industrial Zone (IAOIZ) in Çiğli at north-east of the city. The assessed behaviour can be justified by two main reasons: (1) the industrial structures in this area are quite modern and they were built with the most current design codes; (2) these structures are very flexible and the recorded spectral accelerations did not achieve large values at high periods (larger than 2.0 seconds).

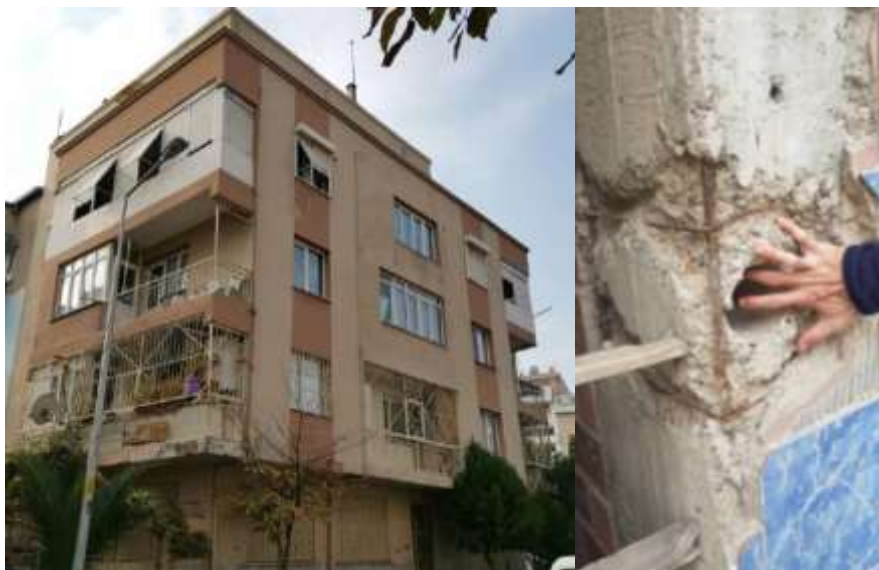
Figure 81: Degradation in structural material and poor detailing in an RC element

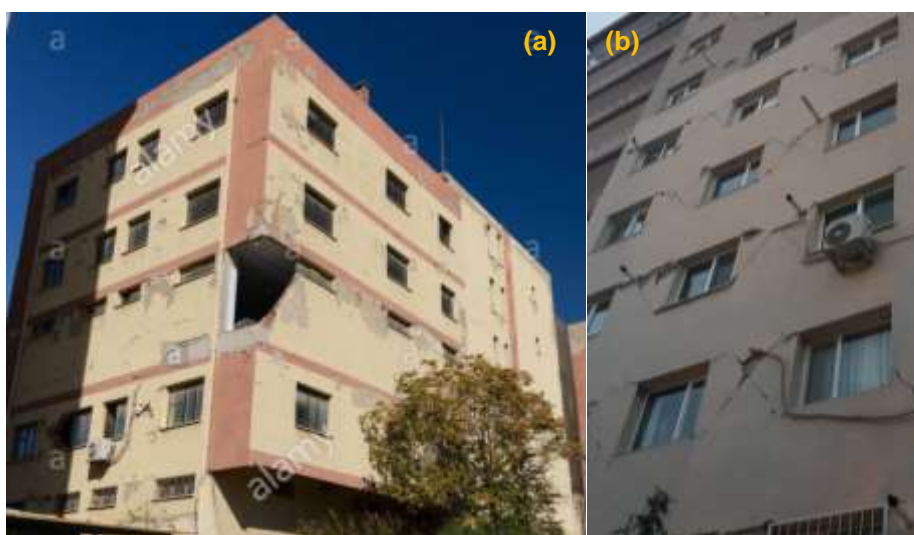
Figure 82: Infill walls damage in RC frames: (a) out of plane (Arda Savaşcıoğulları / Alamy Stock Photo) and (b) in-plane failure

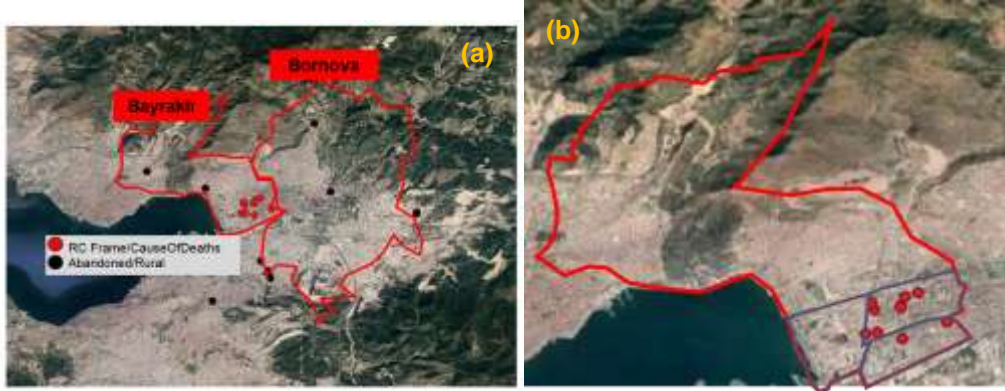
Figure 83: Map of collapsed buildings in Bayraklı and Bornova (21) and (b) location of the RC frame buildings in Bayraklı

Based on the TMoEU database (<https://hasartespit.csb.gov.tr/#/>), 17 buildings collapsed after the earthquake in two Izmir's districts: Bayraklı and Bornova (**Figure 83a**). Among those cases, 9 were RC frame structures in three neighbourhoods in Bayraklı (**Figure 83b**) where most of the casualties and losses were recorded. This section aims to present the most peculiar cases to stress their similarities as well as to contribute to the discussion about the possible causes. The first common features are:

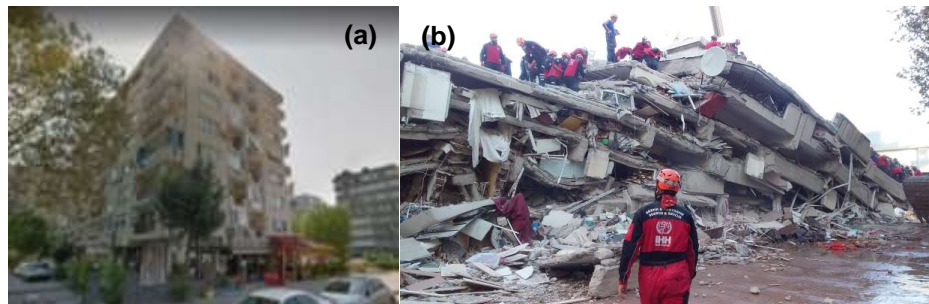
Figure 84: Doğanlar apartment: (a) before (Google Maps) and (b) after the earthquake (photo courtesy of Mauricio Morales-Beltran)

Figure 84 shows the case of the Doğanlar apartment: an RC 8-storey frame built in 1990 and designed according to the 1975 earthquake regulations. This building collapsed, killing 14 people (12 people escaped death, including a mother and her four kids who were saved from the debris after 23 hours following the event; see “Son dakika: Tek kelimeyle rezalet! İzmir'deki deprem bölgesine gelen 9 kişi yakalandı”, 2020 and “23 saat sonra gelen mucize kurtuluş: İzmir'deki depremde yıkılan Doğanlar Apartmanı enkazından anne ve 3 çocuğu çıkarıldı”, 2020). The collapse can be explained based on the combined impact of the amplification of the seismic action due to the soil properties in the area as well as pre-existing damage due to past earthquakes (1992 İzmir Earthquake with Mw=6.1 and in 2005 with Mw=5.9). Other buildings around Doğanlar apartment demonstrated a much different response during this event despite their similar age, structural system and number of storeys.

The reports prepared by the Bayraklı Municipality Earthquake Study Center indicated problems with all these three apartment buildings (“CHP’nin İzmir raporu: Fay kanunu teklifi bir an önce kanunlaştırılmalı”, 2020): in 2018 for Doğanlar apartment door jams and floor level irregularities on the ground floor attributed to liquefaction and earthquakes, as well as visible deformations on the balconies were noted, and a thorough soil survey and performance analysis was recommended. In a 2012 report, the issues flagged for the Rıza Bey Apartments on the other hand included inadequate rebar detailing, soft ground floor due to commercial use, heavy overhangs, cosmetic repair of the cracks induced by the 2005 earthquake, humidity induced material degradation, low concrete class and flat bar reinforcements, recommending similarly a thorough soil survey and performance analysis. However, in both cases, despite the municipality reports deeming the buildings unsafe, it was claimed that the ministry was never informed about this (Gurcaner and Torlak, 2020).

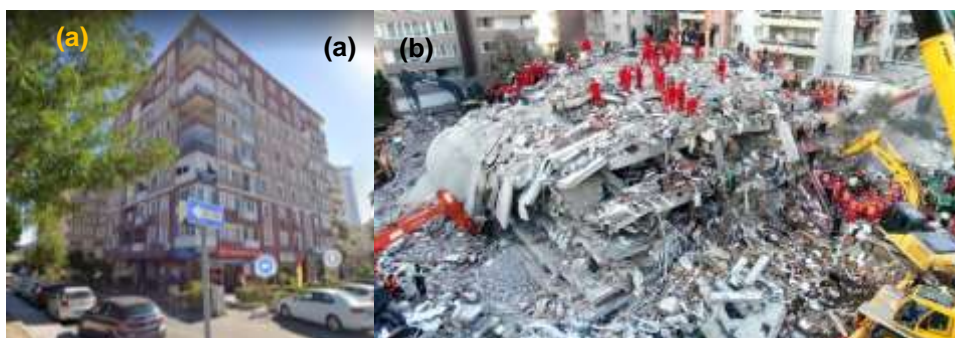
Figure 85: Riza Bey Apartments: (a) before (Google Maps) and (b) after the earthquake (<https://www.haberler.com/riza-bey-apartmani-nerede-riza-bey-apartmani-13705665-haberi/>)

Very similar conclusions can be drawn in the case of both the Rıza Bey Apartments (**Figure 85**) and the Karagül Apartments (**Figure 86**), which are both 8/9 storey RC frame structures built in the 90s based on the 1975 regulations. While a 70 and 3-year old was saved from under the debris after 33 and 91 hours, respectively (“Ayda Gezgin 91. saatte kurtarıldı”, 2020), 34 people died in the Rıza Bey Apartments, including the latter’s mother; whereas all residents were able to be evacuated from the Karagül Apartments on time.
