THE AEGEAN EARTHQUAKE and TSUNAMI OF 30 OCTOBER 2020

A FIELD REPORT BY EEFIT

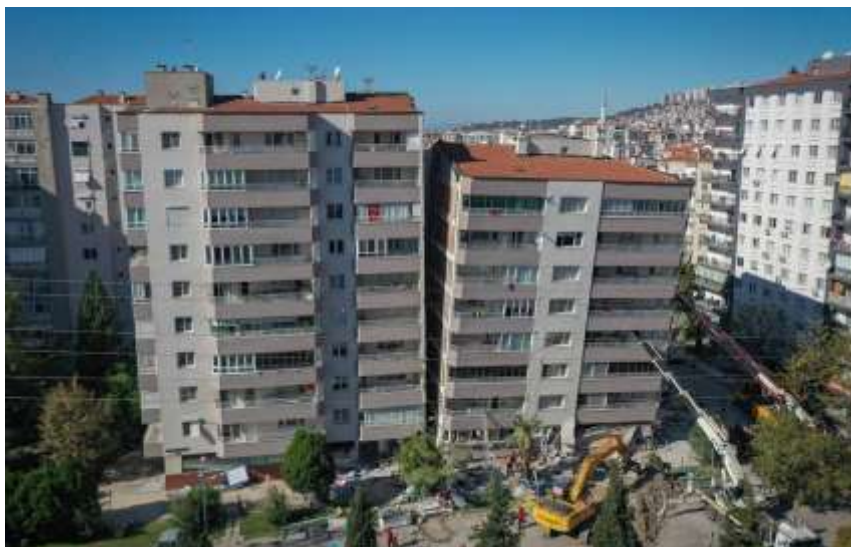
Figure 87: Yılmaz Erbek Apartments (<https://www.tr724.com/savcilik-raporu-bimin-oldugu-apartmanda-kolonlar-kesildi/>)

The collapse of the other two RC buildings can also teach another important lesson on seismic vulnerability in existing structures. The Yılmaz Erbek Apartments (**Figure 87**) consisted of two twin structures built in 1992 with 11-storey RC frames. Both structures were damaged, but only one of them collapsed with a local mechanism (soft storey) involving the first two floors, killing 9 people out of 22 who were in the building at the time of the event (Yılmaz Erbek Apartmanı'nda acı bilanço!, 2020). It was claimed that the supermarket under the building cut the columns to make space, although this has not been verified. A similar example was the collapse of three out of the four buildings in the Barış Sitesi complex (**Figure 88**), built in 1999 and sadly allocated for the survivors of the Gölcük earthquake in 1999, relocated in Izmir. The 7-storey RC frame collapsed with soft storey mechanisms (involving different number of storeys at different levels), killing seven of the eleven people who are known to be in the building when the earthquake hit (Barış Sitesi'nde arama-kurtarma durduruldu! Enkazda 2 kişi var!, 2020). The different behaviours of the structures with the same design in the same location can be attributed to the fact that different contractors were involved during the construction as well as to the post-construction modifications during the last 20 years (change of actions, openings layout and ground floor use).

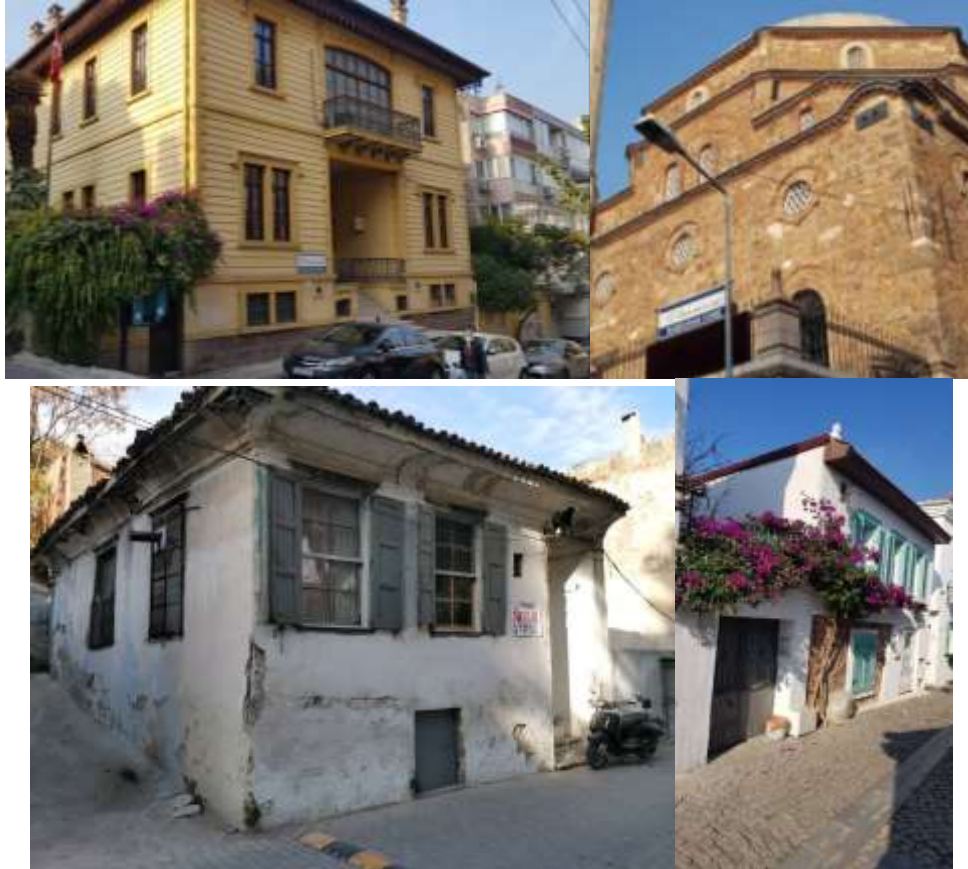
Figure 89: Good response of masonry buildings: (top row) monumental examples in central Izmir; (bottom row) vernacular typologies in Seferihisar

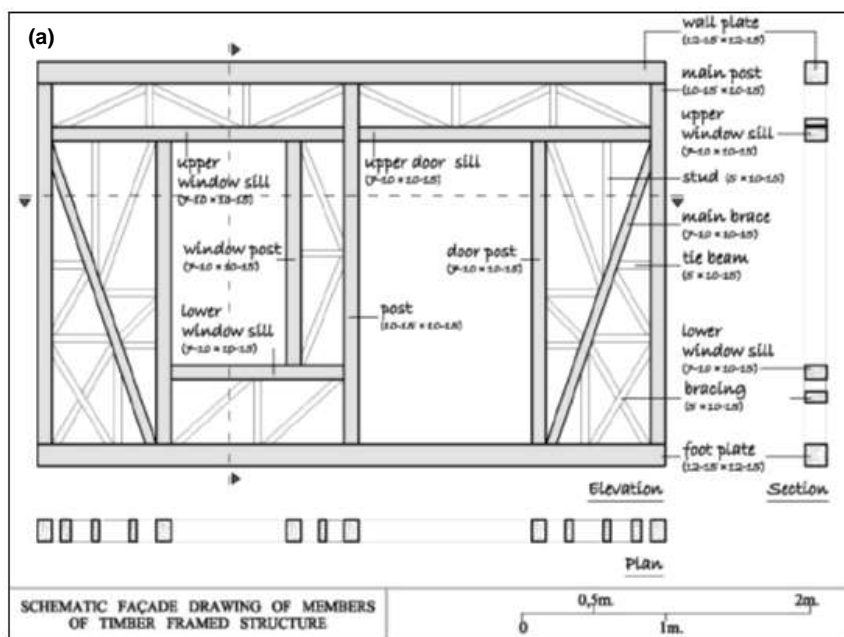
Figure 92: (a) Schematic representation of a timber frame (after Diri, 2010) and (b) two buildings with stone infill (the building in the middle) and *bagdadi* cladding (the building on the right) (from "Mikres diadromes" youtube channel)

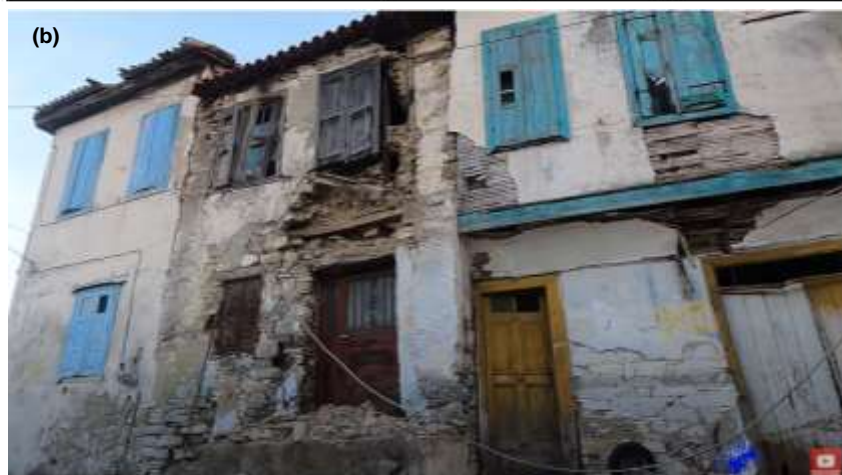
Past reconnaissance studies concluded that these typologies were overall rather resistant to seismic events (Ambraseys and Jackson, 1981). This inherent seismic resilient behaviour of *himiş* structures has also been confirmed through experimental (Aktas et al, 2014) and analytical (Aktas and Turer, 2016) work, and has been explained by the following main factors: (1) High ductility and energy dissipation levels owed to (mostly) nailed connections, (2) High lateral load bearing capacity due to diagonal braces within the frames (**Figure 92a**). (3) Lightweight: This is especially the case with the cladded more than infilled typologies (**Figure 92b**). One of the most common cladding types is known as *bağdadi*, where 2-4 cm wide laths are nailed onto the frame with around 1 cm gap in between, resulting to a system which is very lightweight and with an efficient diaphragm action.

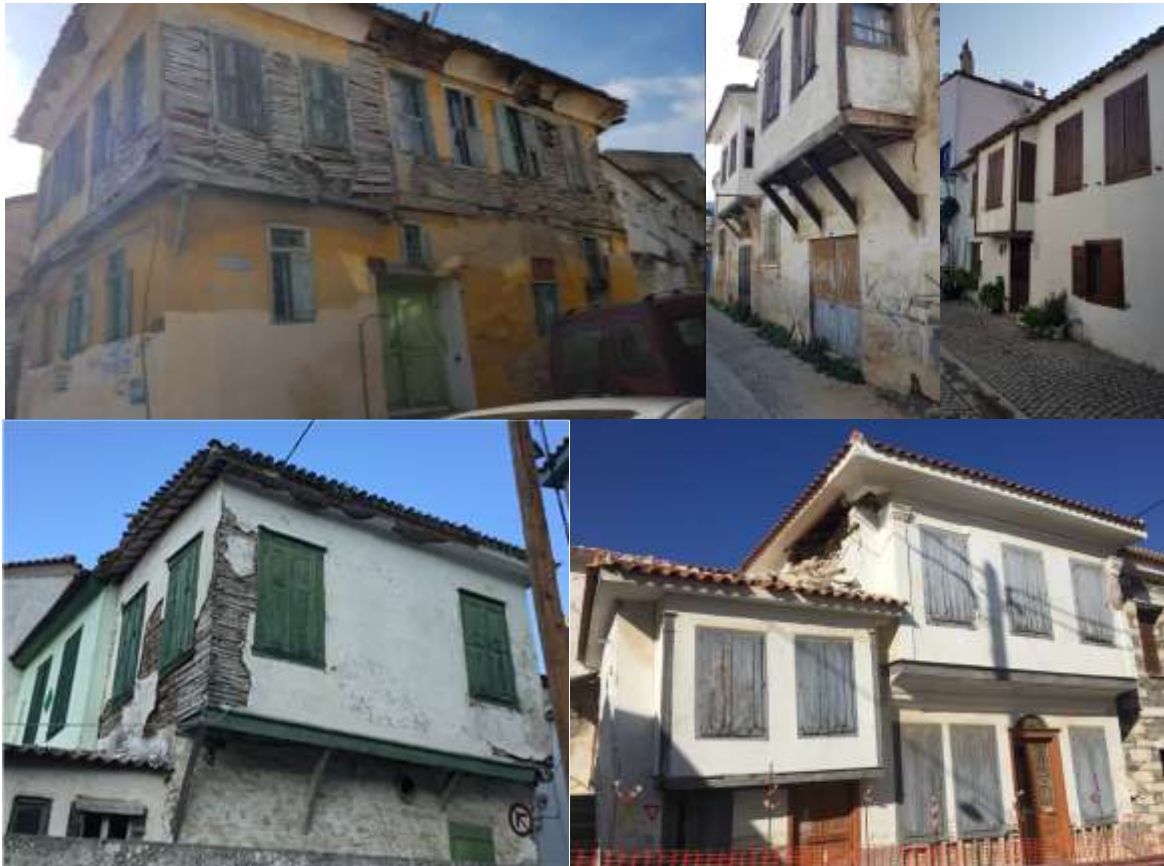
The examples observed on site for both Samos and Turkey seem to be dominated by examples with *bagdadi* cladding (**Figure 93**). In case of Turkey, no or little damage is observed to this typology, while in Samos there are a few heavy damage cases, where the observed failure mechanisms are in broad agreement with those reported in previous post-earthquake studies, including out-of-plane failure of masonry infill (**Figure 94a**) and out-of-plane failure of upper floor masonry service walls (**Figure 94b**). There are also cases where the damage is limited to loss of plaster, which is particularly common in already dilapidated facades (**Figure 94c**). Other failure modes common to this typology include global failure due to collapse of the masonry ground floor and loss of the box action in the upper floors due to poor/deteriorated connections failing under elevated drift.

The discrepancy between the seismic performances of Turkey and Samos vernacular masonry/timber hybrid structures can be explained by the level of maintenance and occupancy status: the Samos examples seem to be relatively more poorly maintained and in certain cases abandoned.

Figure 93: Some examples of *hımsı* structures in the affected areas (top row) in Turkey and (bottom row) in Samos

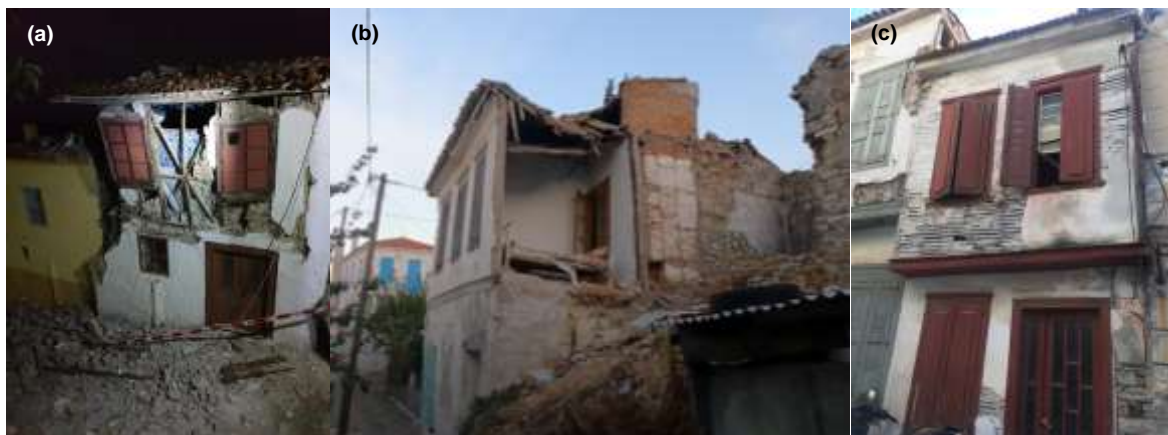
Figure 94: Examples to damage in *hımsı* structures

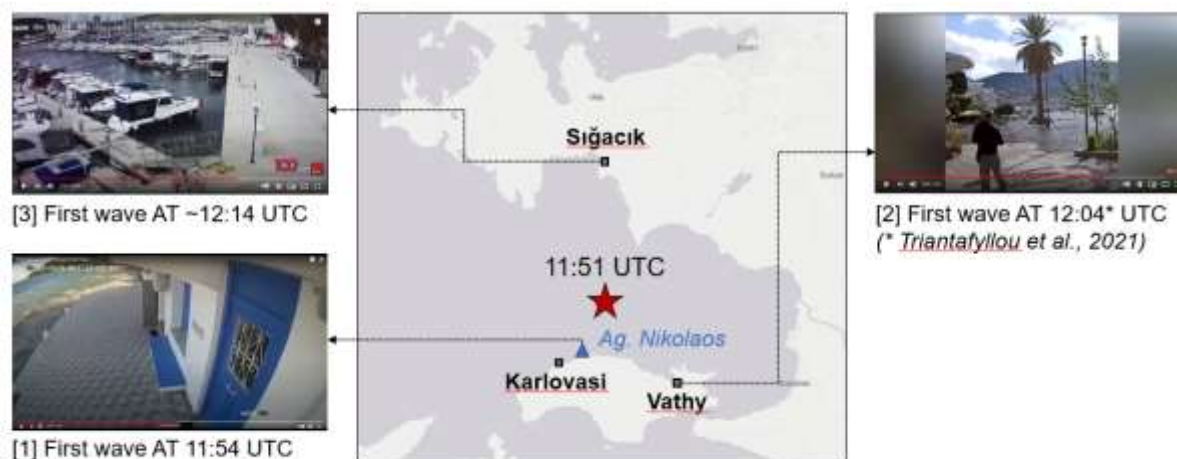
As described in Chapter 2, the 30 October 2020 event (11:51:27 UTC) was a submarine normal fault earthquake under the shallow waters between the Greek island of Samos and the coast of the Aegean region of Turkey. The downward slip of the seafloor on one side of the fault and the upward movement on the other side triggered the setup of a tsunami wave. The wave travelled quickly towards the shoreline. It took just a few minutes for the tsunami wave to reach the coast of Samos Island near Karlovasi, and less than half an hour to inundate the towns of Vathy (Greece) and Sığacık (Turkey). **Figure 97** shows the arrival times based on video recordings published online and a recent study (Triantafyllou et al., 2021).

Figure 97: Tsunami arrival times on Samos island and Turkey. Note: AT = Arrival Time. YouTube Video frames: [1] https://youtu.be/_el3NfEJJKQ; [2] <https://youtu.be/9wcz1p9cKt4>; and [3] <https://youtu.be/bxar6B2ysFA>;

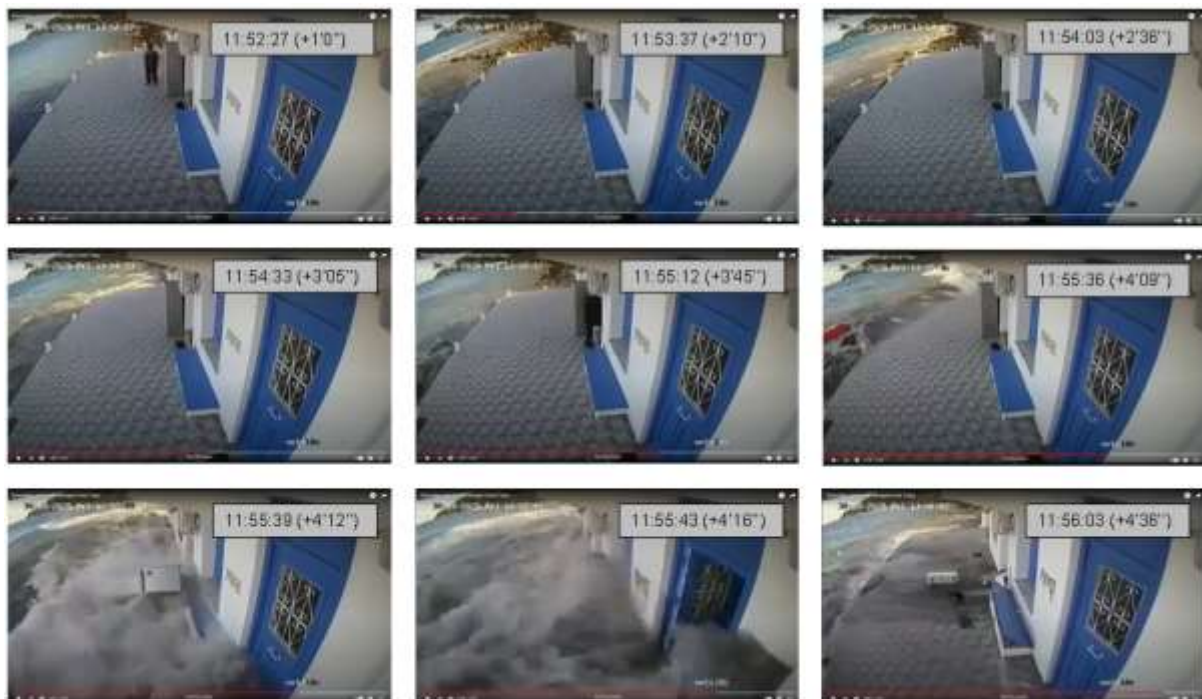
A CCTV installed at a house along the Ayios Nikolaos beach (coordinates: 37.8126747, 26.7422152), provided an extremely valuable recording of the onshore tsunami inundation. This location is at approximately 5 km distance from Karlovasi and very close to the earthquake epicentre (**Figure 97**). **Figure 98** illustrates the video frames of the tsunami inundation. It can be seen that only two minutes after the earthquake (11:53:37 UTC) the sea rapidly receded. Then, the water level increased to reach the house apron (11:54:33 UTC). These observations indicate that the tsunami was trough-led in this location (**Figure 95b**). In the next minute, the sea receded again, but this was followed by a much larger

wave that moved obliquely to the coast, eventually inundating the house (11:55:39 UTC) (**Figure 98**). There are two mechanisms suggested in Triantafyllou et al. (2021) to explain the nature and magnitude of this second wave, i.e. either a submarine landslide off this site or a near-field edge wave (waves trapped by refraction that propagate parallel to the shoreline; see Geist, 2012) phase. Eyewitnesses reported the arrival of a third small wave at around 12:15 UTC, which was not captured by the camera due to a power outage (Triantafyllou et al., 2021). The EEFIT Greek field crew visited the house and its surroundings on 8 December 2020 (**Figure 99**). The apron level was found 1.20 m above the sea level (asl). The water on the walls might have reached a depth in excess of 1.50 m above the apron, i.e. 2.80 m asl. Triantafyllou et al. (2021) estimated the splash might have inundated the house wall up to 2m. It is noted that, following the earthquake, the ground on Samos island experienced a coseismic uplift of around 20 cm (see Chapter 2). In the aftermath of the event, it is reported that the house owner observed a drop in the sea level of the same magnitude (Triantafyllou et al., 2021). The uplift certainly led to a reduction in the inundation measures recorded along the coast of Samos island.

Figure 98: Tsunami inundation in Ayios Nikolaos beach (coordinates: 37.8126747, 26.7422152; Samos Island, Greece).
YouTube Video frames: https://youtu.be/_eI3NfEJkQ.

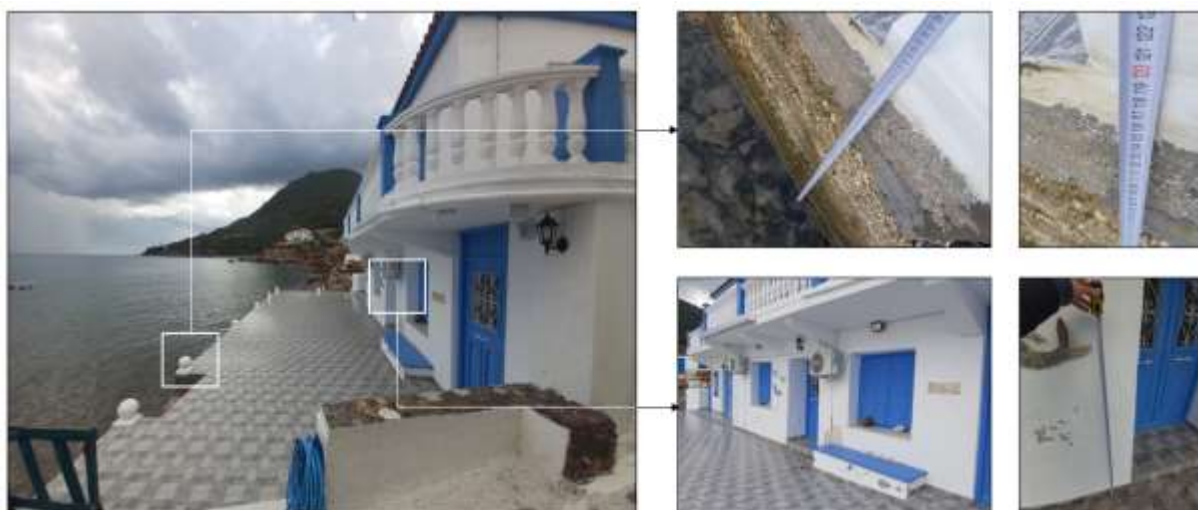
Figure 99: House at Ayios Nikolaos beach: measurements by EEFIT Greek field crew.

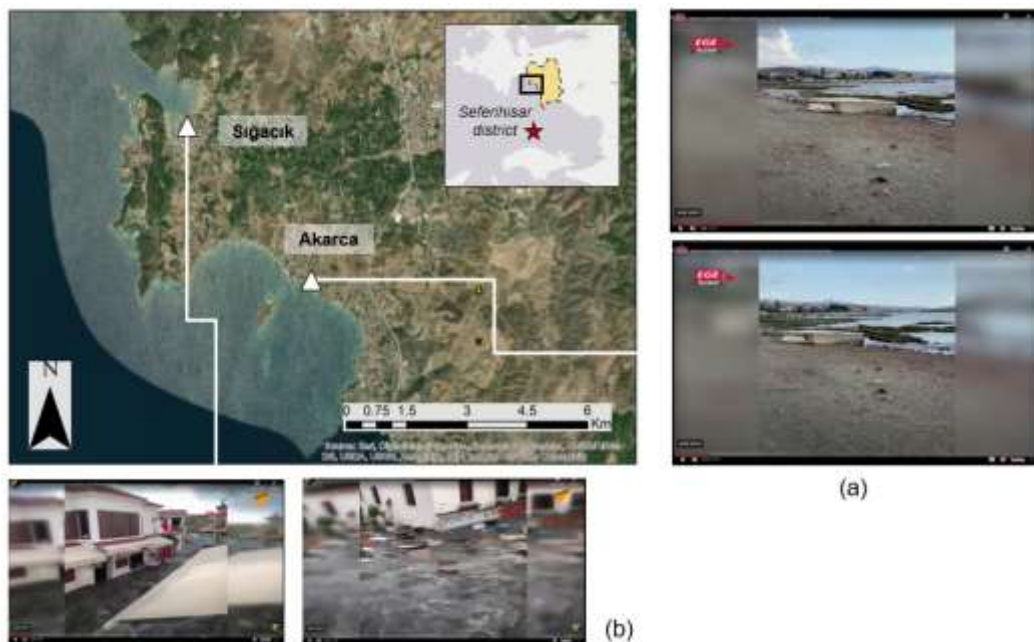
Figure 102: Tsunami inundation video frames recorded in Seferihisar district: (a) Akarca (source: <https://youtu.be/Fl-QDMXALTA>) and (b) Siğacık (source: <https://youtu.be/XJzIRNYvoiU>).

Akarca is the second and last location in Seferihisar district (see **Figure 102**) that was visited by the EEFIT crew for tsunami damage assessment. In this coastal town, the building portfolio is different from Sığacık town and is made mainly of reinforced concrete structures. As reported in Cetin et al. (2021), tsunami impacted more significantly the southern coast. It appears that the configuration of the bay (see **Figure 102**) had a sheltering effect for the northern part of Akarca. Boats and cars were damaged, as well as fishery port piers, while very limited non-structural damage was recorded in the aftermath of the event (Cetin et al., 2021). At the time of the visit, there was still some evidence of the tsunami inundation,

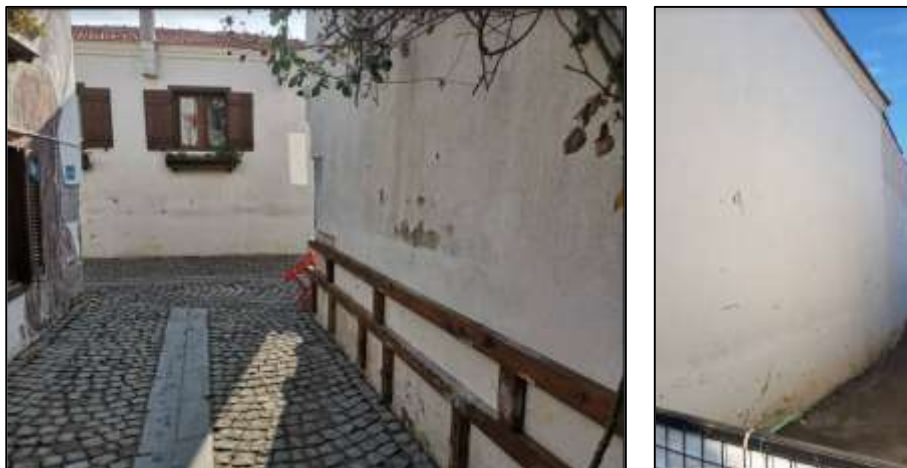
In Siğacık, the field visit mainly focused on the historical centre that was affected by the sustained tsunami flow. Damage to shops, properties, cars and boats was substantial (Cetin et al., 2021). **Figure 104** illustrates the location and damage grade of the buildings surveyed by the EEFIT Turkish crew team. One month after the event, the town was in good conditions. All debris was cleared and no visible structural and non-structural damage was observed for most of the historical masonry buildings (DG0). On a few buildings, water marks could still be observed, indicating some minor damage to external walls (DG1) – see **Figure 105**. Despite being relatively close to the epicentre, buildings did not suffer any significant damage due to the earthquake. The survey did not cover Teos Marina, a large private marina, where extensive damage was reported to numerous boats and yachts. Chapter 6 will present data about the economic impact of tsunami damage occurred in ports and marinas in Turkey.

Figure 105: Buildings surveyed in Sığacık (coordinates: 38.1944937, 26.7854733).

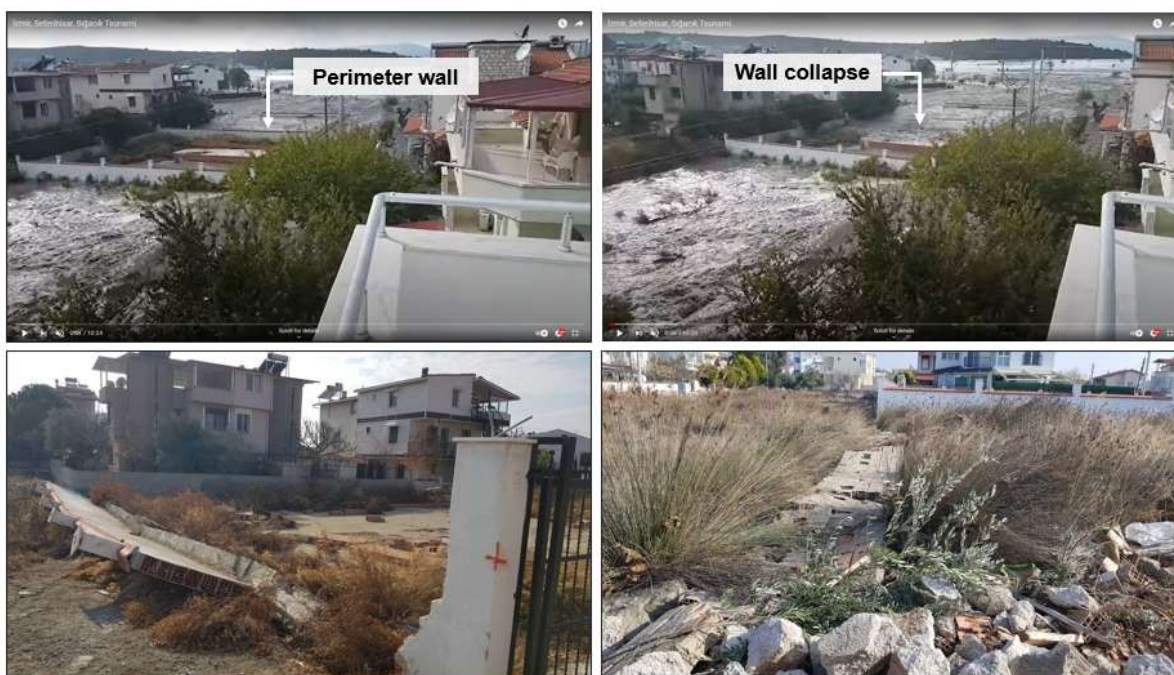
Figure 106: Perimeter wall overturning due to tsunami hydrodynamic effects in Sığacık (coordinates: 38.1982930, 26.7902697). Video frames (on top) from YouTube video: <https://youtu.be/n93puRYKhs0>

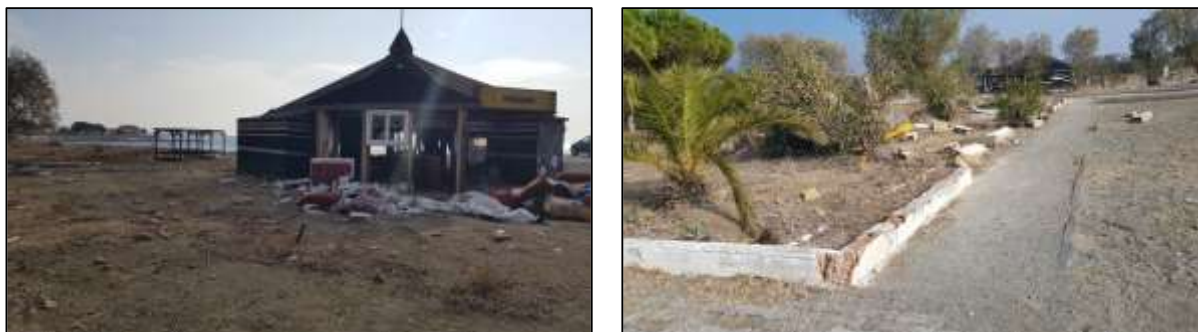
with some rubble and debris still to clear. No structural damage was observed on the most exposed buildings along the beach that were surveyed (**Figure 107**).

Figure 107: Tsunami effects in Akarca (coordinates: 38.166245, 26.810087).

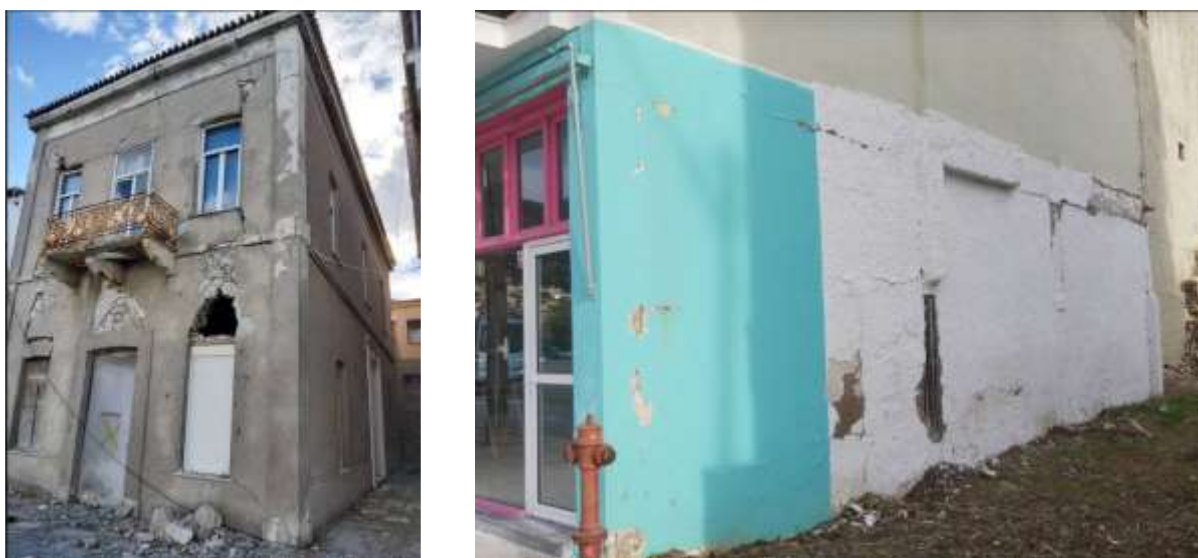
Figure 108: Buildings affected by earthquake and tsunami: Karlovasi (coordinates: 37.800145, 26.704959) and Vathy (coordinates: 37.751835, 26.976584).

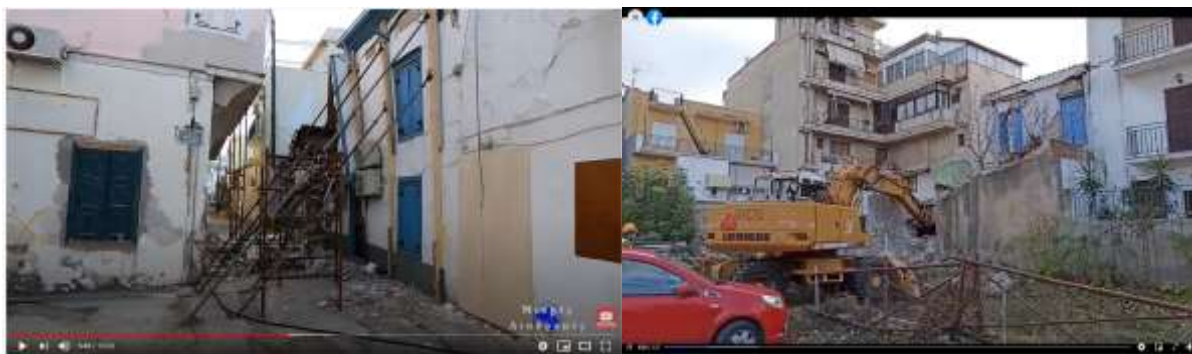
Figure 122: Shoring of near collapse buildings (“Mikres diadromes” you tube channel) and demolition of dangerous buildings (“Agakliazo ti Samo” facebook page)

Following the death of two adolescents, killed by a collapse wall while walking past an abandoned building, the government launched an initiative to address the issue of dilapidated buildings posing hazardous conditions. A new legal framework to encourage the rehabilitation or demolition of buildings was announced, which includes the registration and marking of dilapidated buildings throughout the country. Municipalities will undertake the demolition of dilapidated buildings with financing secured by the state. Incentives and subsidies have been announced to encourage the maintenance and rehabilitations of derelict buildings. The demolition of the most dangerous buildings started one month after the earthquake with the building that killed the two adolescents (**Figure 122**).

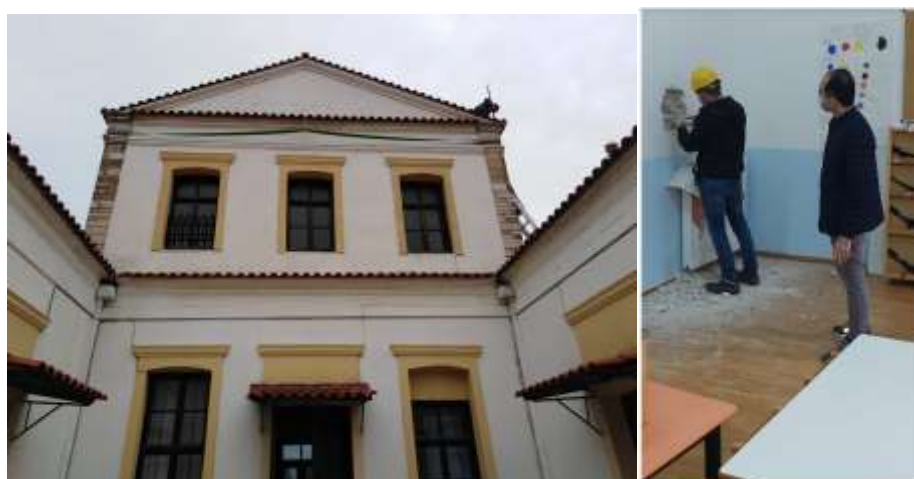
Figure 123: Primary school of Mitilinioi, confinement of the walls with external straps (left); repair works at Agios Konstantinos Primary School, so that their function can be resumed (Municipality of Eastern Samos Facebook page, 16.01.20)

In Samos and Icaria, schools remained closed from Oct 31, 2020. The country entered lockdown due to the COVID pandemic on Nov 7. Primary schools opened again Jan 11, 2021 while schools of higher grades have remained closed up to the time of writing. According to the municipality of Samos, the primary school of Vathy and the Nursery of Palaiokastros are being relocated. The Pagonda and Mitilinioi (**Figure 123**) primary schools will be reopened after rehabilitation works are completed. The Chora primary school and Nursery will both temporarily continue to operate in containers. Agios Konstantinos primary school and the 3rd Primary school will open normally. Repair and retrofitting works have been undertaken at some other schools to render them safe to use.

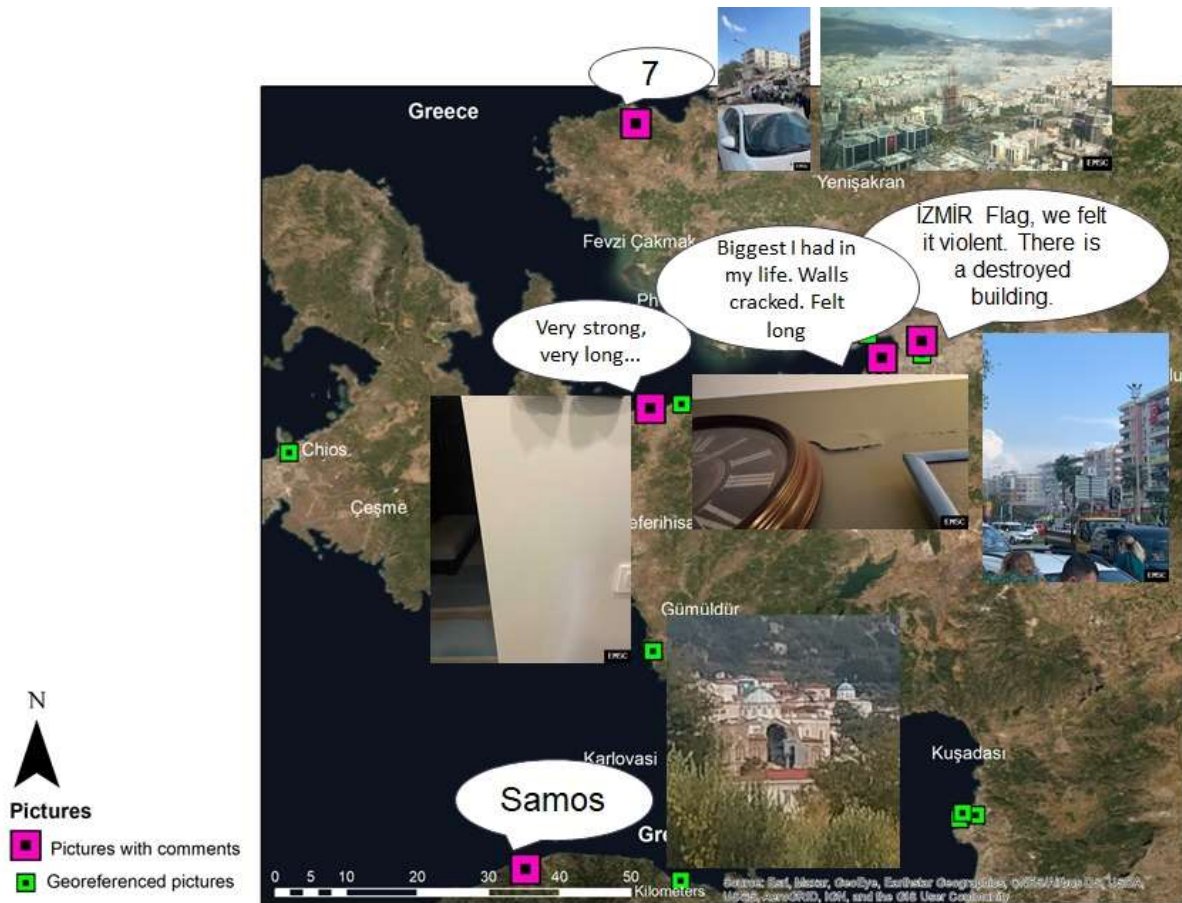
Figure 143: Georeferenced Pictures with comments taken by LastQuake app users (Source: Authors)

From 2518 comments written by LastQuake app users, only 88 (3%) included georeferenced pictures. From those comments with pictures, we extracted 61 (69%), because some of the pictures were repeated, others were pictures of TV screens, and at least 4 did not include proper coordinates. The location of the georeferenced pictures and those with comments in the case study area are depicted in **Figure 143** and pictures without comments in **Figure 144**. However, approximately only 10% were useful for building damage assessment.

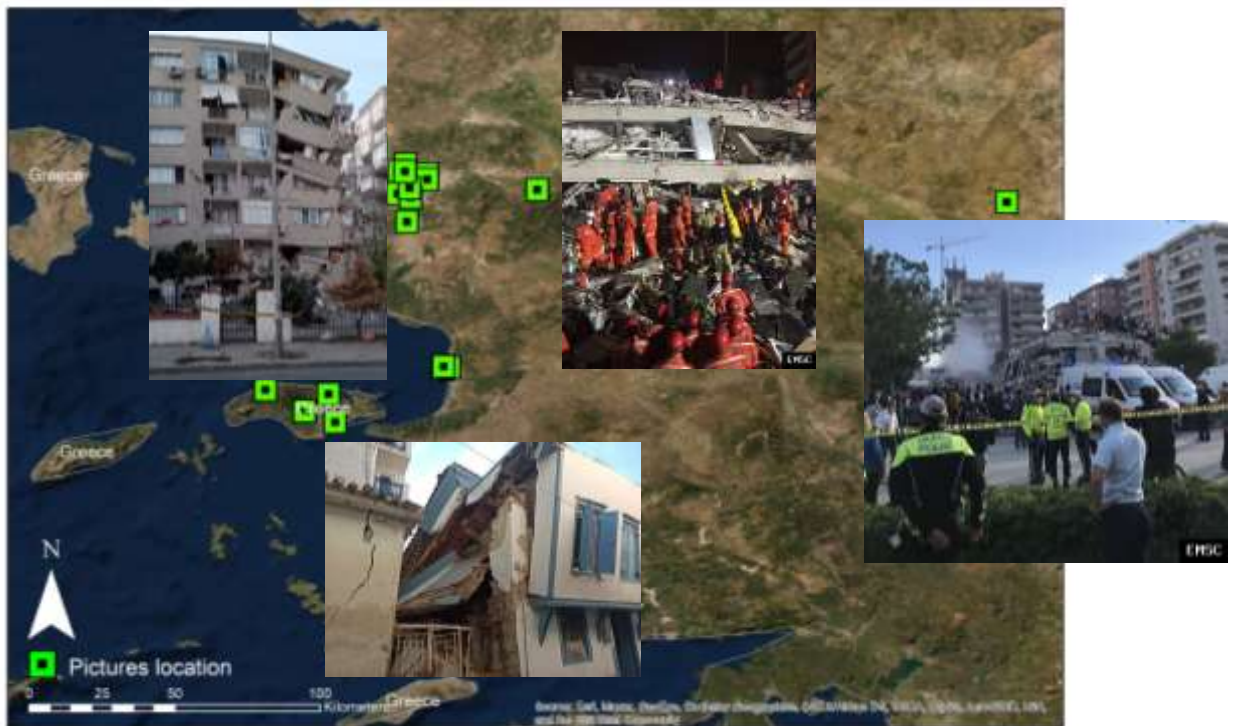
Figure 144: Georeferenced Pictures without comments taken by LastQuake app users.

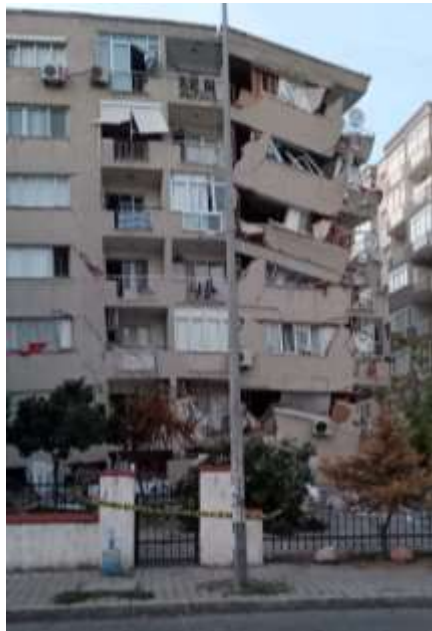
- Longitude: 27.1352
- Latitude: 38.3103
- Intensity: Not reported
- Distance to the epicentre: 51.5 Km

Figure 145: Data for earthquake reconnaissance mission planning in Izmir, Turkey. Source: EMSC

These georeferenced pictures show the location and the degree of damage of buildings. This data can contribute to the planning and the deployment of the earthquake reconnaissance mission, especially in site planning and route selection. Examples of data and images obtained from LastQuake are depicted in **Figure 145** and **146**.

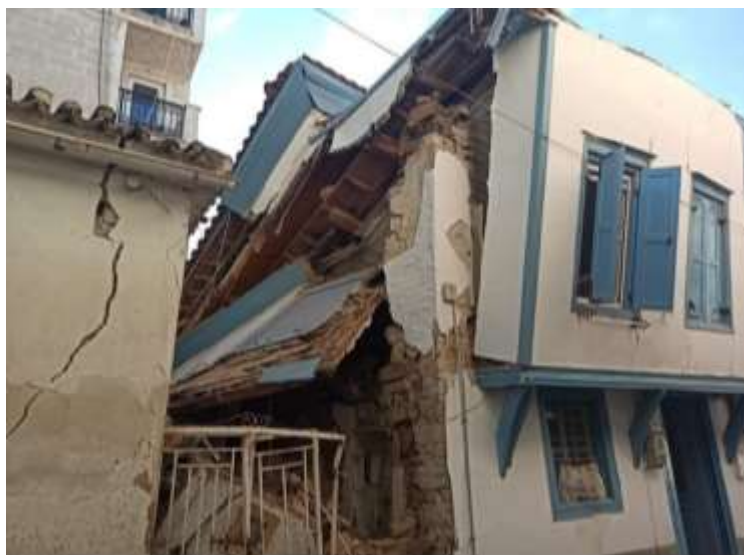
- Longitude: 26.9139
- Latitude: 37.6909
- Intensity: Not reported
- Distance to the epicentre: 25.2 Km

Figure 146: Data for earthquake reconnaissance mission planning in Samos, Greece. Source: EMSC
