Effect of corrosion on the mechanical properties of the corroded reinforcement and the residual structural performance of the corroded beams

Wenjun Zhu

THÈSE

DOCTORAT DE L'UNIVERSITÉ DE TOULOUSE

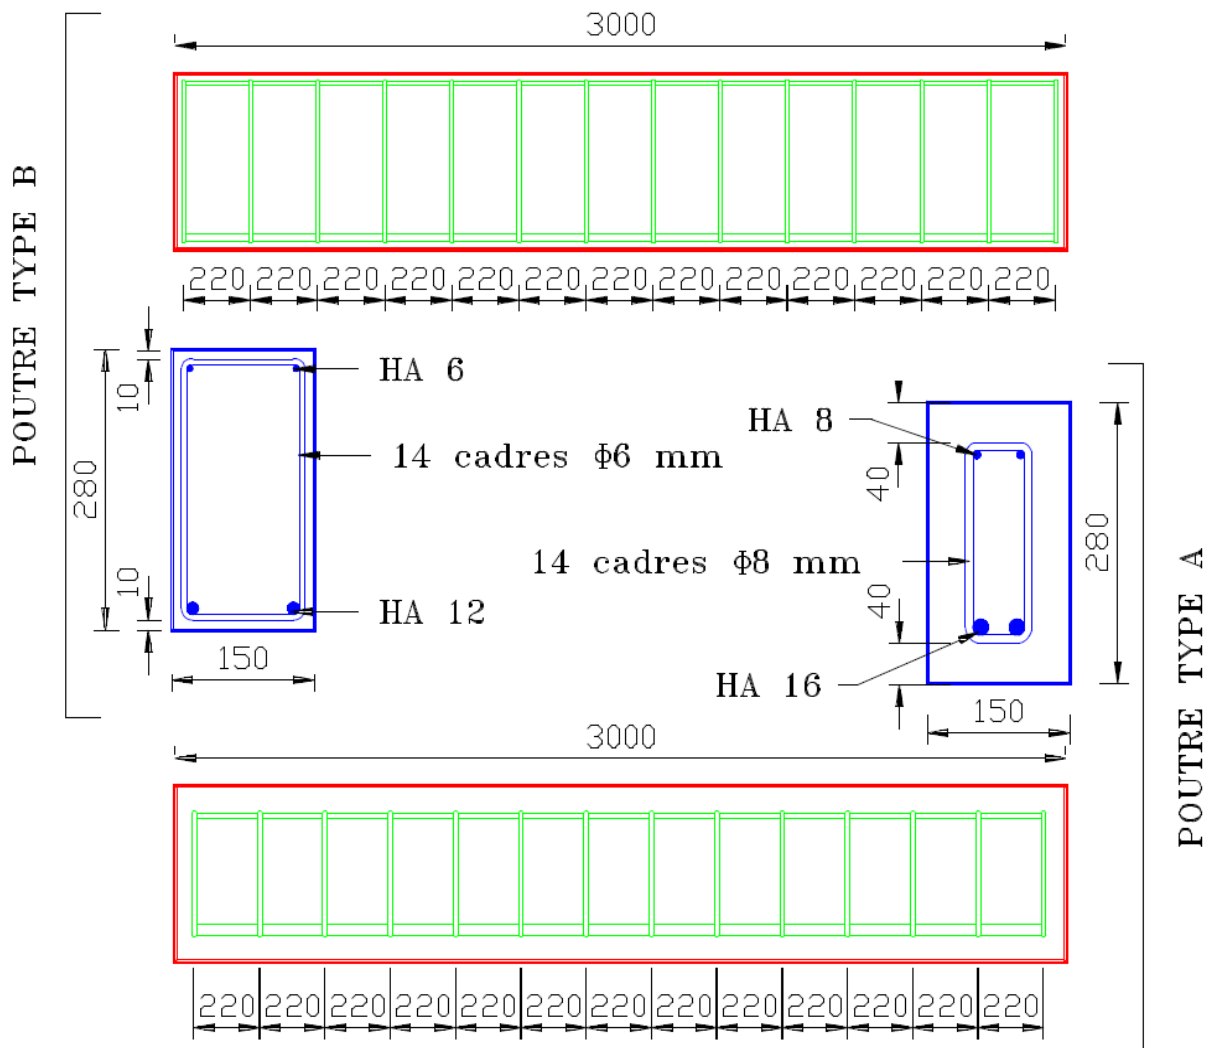
Figure 2: plan de ferrailage des deux types de pout

La phase de propagation de la corrosion avait débuté presque en même temps pour les poutres de type B à faible enrobage (1 cm) que pour les poutres A à fort enrobage (4cm) avec dans ce dernier cas des fissures de corrosion démarrant à l'intersection entre fissures de flexion et armatures tendues (figure 2). Cependant la corrosion des poutres B a démarré à la fois au niveau des armatures tendues et des armatures comprimées alors que dans le cas des poutres A les armatures tendues ont été d'abord corrodées bien avant que la corrosion démarre également sur les armatures comprimées.

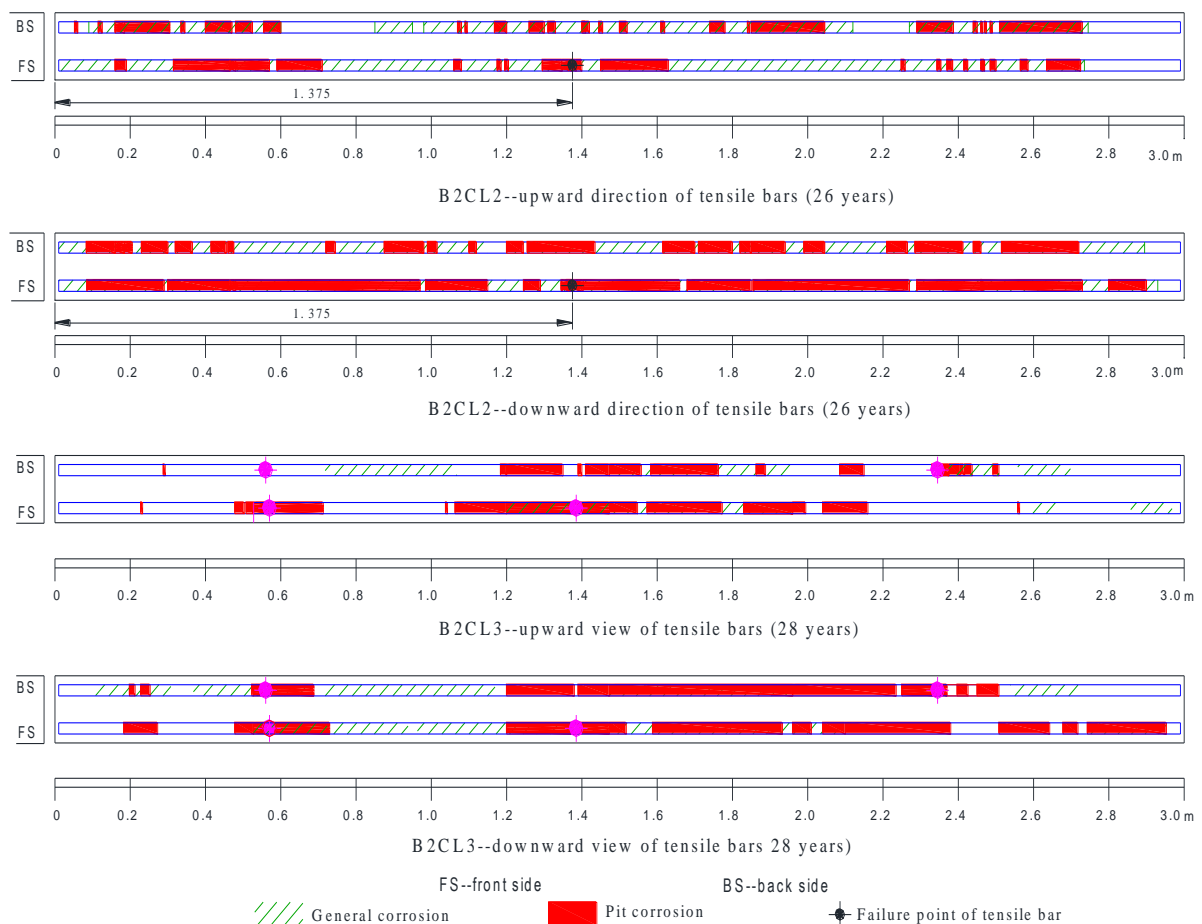
Figure 6: corrosion sur les barres longitudinales tendues

Les cartes de corrosion ont également été élaborés (figure 6), qui montrent l'étendue de la corrosion sur les barres longitudinales tendues FS (barre antérieure) et BS (barre postérieure). Les cartes sont tracées dans deux directions: l'orientation vers le bas pour le côté de l'acier directement exposé aux fissures et à solution saline et la direction vers le haut dans laquelle la face d'acier a une couverture de béton beaucoup plus épaisse. Il est constaté que l'attaque de corrosion n'est pas uniforme. Beaucoup de piqûres de corrosion ont été observés de façon hétérogène sur les barres et la perte maximale de section des armatures tendues atteint 43% au niveau des piqûres de corrosion les plus importantes. Les armatures « comprimées » présentent également une corrosion très développée et non uniforme avec des pertes locales de sections dépassant largement 50% de la section initiale.

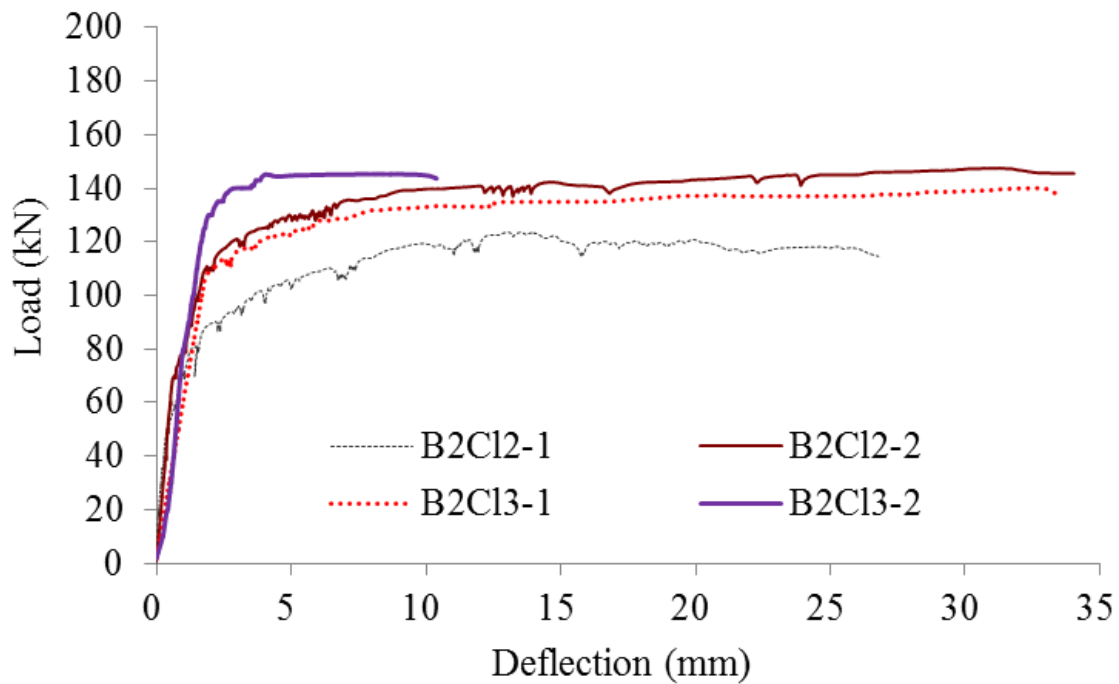
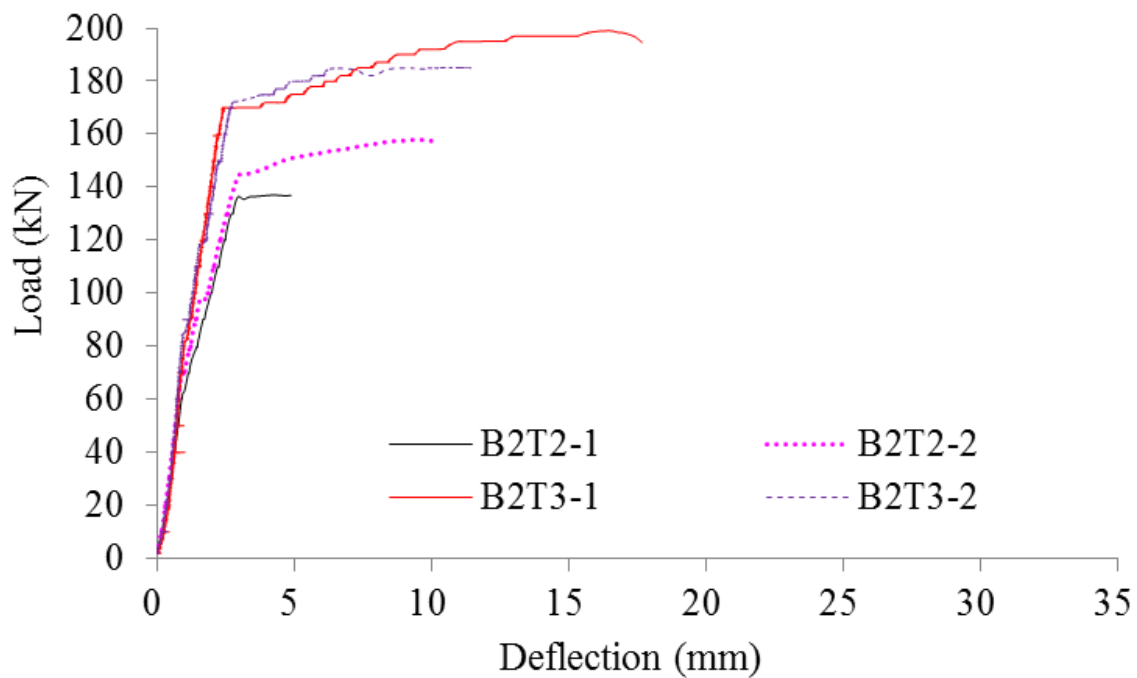
Une autre surprise des études sur poutres courtes critiques vis-à-vis de l'effort tranchant est le fait que les poutres corrodées présentent une meilleure ductilité (un plus grand allongement à rupture) que les poutres témoins, ce qui est totalement opposé aux résultats de l'étude du comportement mécanique des poutres « longues » en flexion. Ce paradoxe apparent s'explique par un changement de mode de rupture induit par la corrosion. En effet, les poutres courtes témoins périssent comme prévu sous l'effet de l'effort tranchant : fissures inclinées à 45° près des appuis ; ce qui est un mode de rupture fragile. En revanche, la perte de section d'acier induite par la corrosion conduit à une plastification précoce en zone centrale et à un palier plastique typique du comportement en flexion. En dépit d'une fragilité accrue des aciers tendus corrodés, le mode de rupture en flexion reste moins fragile que celui en cisaillement d'effort tranchant (figure 10).

(a) réponse force-flèche des poutres corrodées

(b) réponse force-flèche des poutres témoins

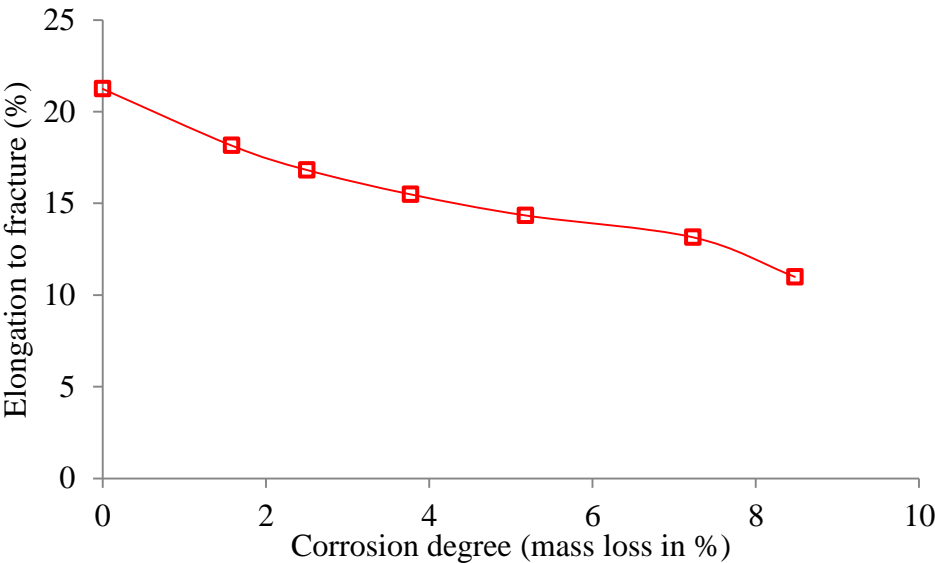
Apostolopoulos et al. [3, 19, 20] carried out the experimental tests on the corroded reinforcement on the steel bars S400 and BSt 500s as referred in above sections. The results of the elongation to fracture (ultimate strain) and the corrosion degree of the reinforcement were shown in Figure 2-13 and Figure 2-14 respectively. According to the two figures, the elongation to fracture of the corroded reinforcement got reduced significantly with the increase of the corrosion degree. Moreover, the elongation decreased more significantly for the steel bar BSt 500s than S400 when the reinforcement were in the same corrosion degree, which showed that the ductility was reduced more seriously in this condition.

Figure 2-13 Effect of natural corrosion on elongation (steel bar S400)[3, 19, 20]

Figure 2-14 Effect of natural corrosion on elongation (steel bar BSt 500s)[3, 19, 20]

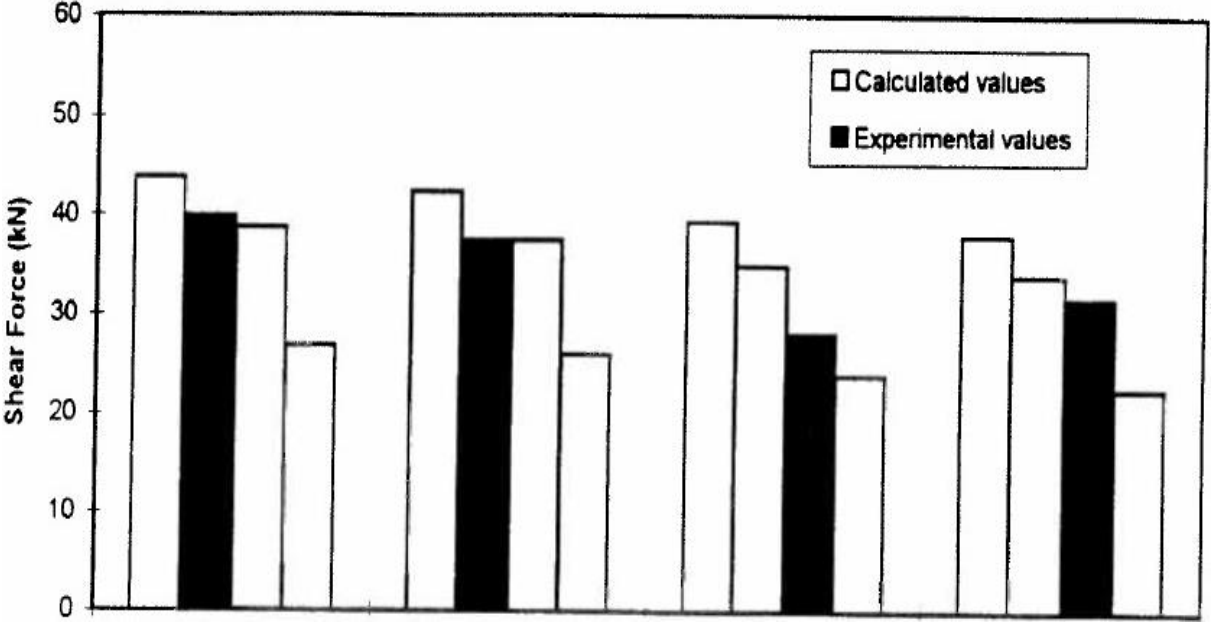
Figure 2-21 Shear capacity of the corrosion beams (with different cross-sections)[25]

The comparison of the experimental results and the theoretical results in three methods are shown in Figure 2-21. The results showed that the corrosion did reduce the shear capacity as experimental results were smaller than that of the calculated results based on nominal cross-section. However, the theoretical results due to the parent concrete in the third method were relatively conservative.
