# Influence of casting defects on the fatigue behaviour of an A357-T6 aerospace alloy

THÈSE

**l'Institut National des Sciences Appliquées de Lyon**

**Itziar SERRANO MUNOZ**

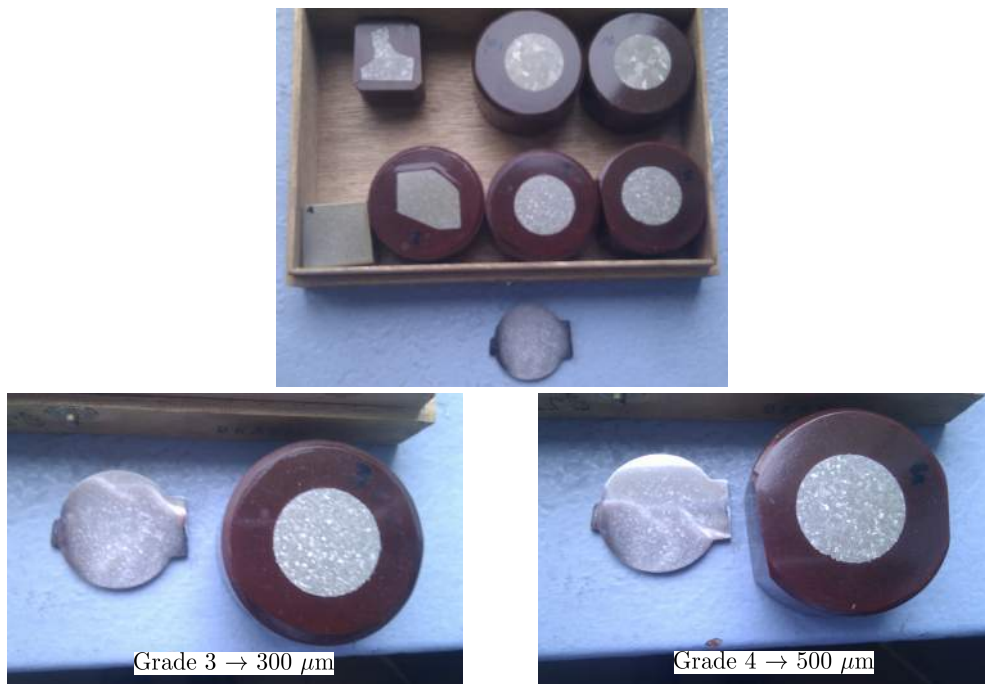
**Fig. 1.18:** Grain microstructure was revealed by using a chemical etchant on a mirror polished sample. Comparison between this sample and CTIF rating charts enables determination of the average grain size.

In this study the average grain size was measured using two different methods. The first one consists in etching for a few seconds a mirror polished sample with ferric chloride ( $\text{FeCl}_3$ ). The sample is then visually characterized by comparing the etched surface (Fig. 1.18) to CTIF rating charts for grain sizes. This method was used by technicians at CTIF and gives a grain size in the range of [300-500]  $\mu\text{m}$ .

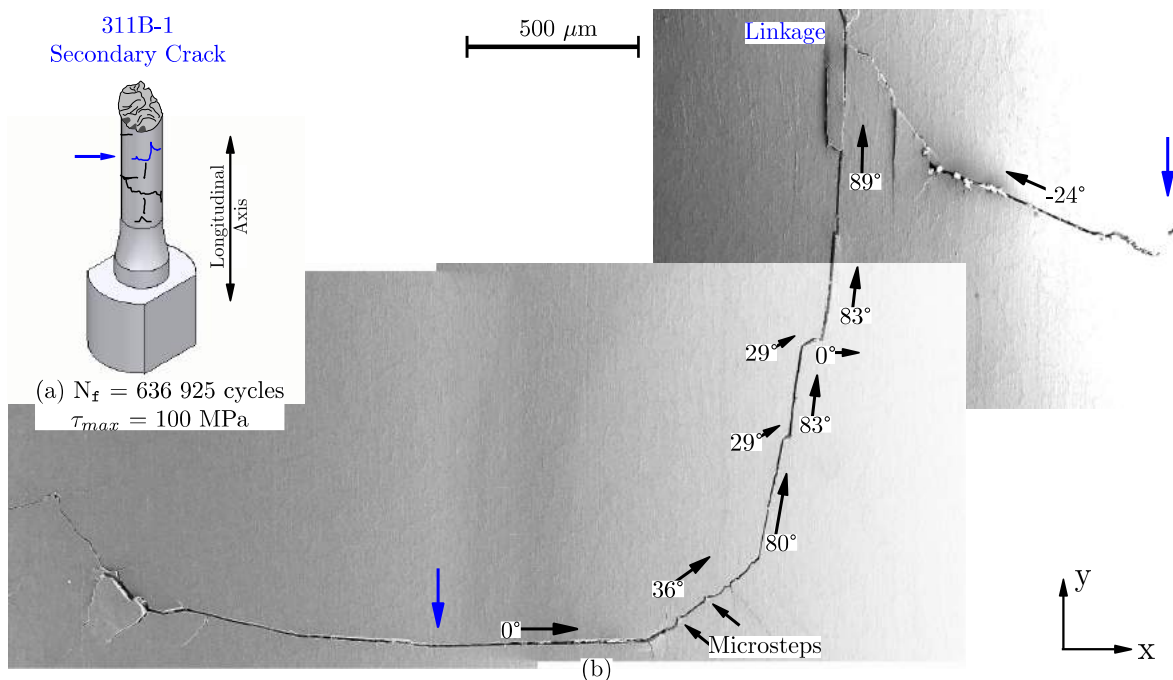
**Fig. 2.46:** (a) Schematic illustration of one half of the fractured gage showing the location of 311B-1 secondary crack. (b) SEM image of this crack where the two blue arrows indicate the presumed locations of the nucleation sites.

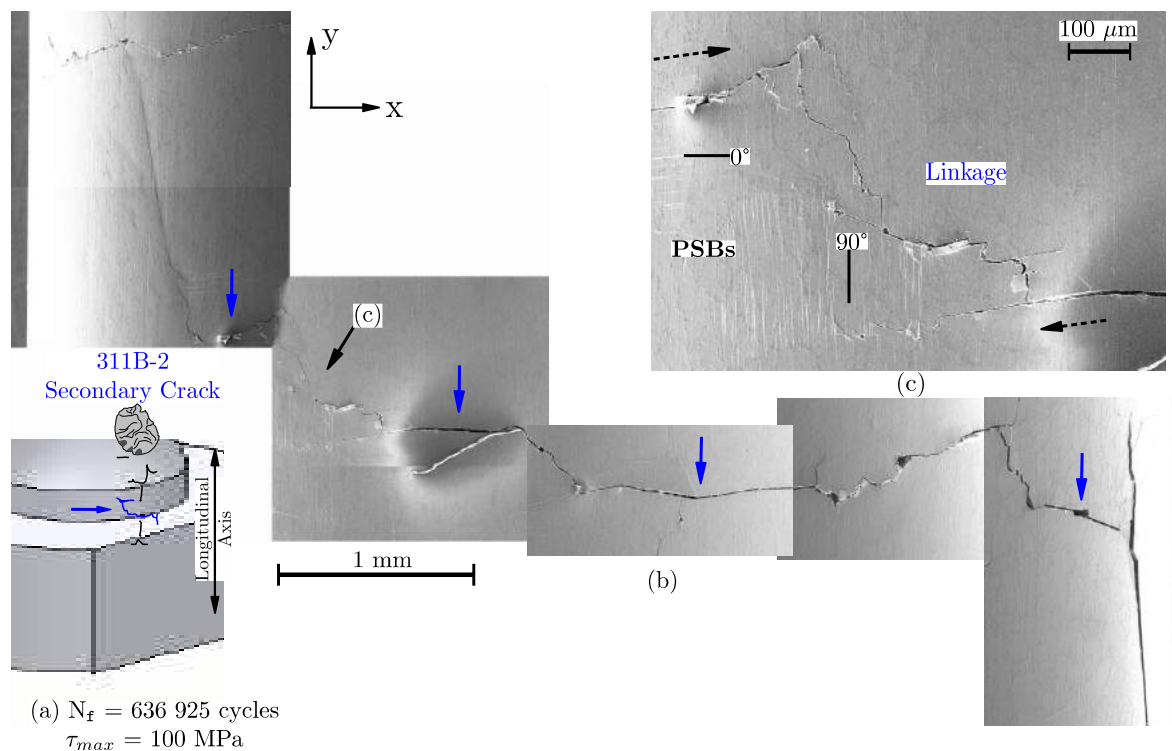
**Fig. 2.47:** (a) Schematic illustration of one half of the fractured gage showing the location of 311B-2 secondary crack. (b) SEM image of this extensive crack which is presumed to be the result of several linkages. (c) Higher magnification of a linking point where some PSBs at  $0^\circ$  and  $90^\circ$  can be observed.

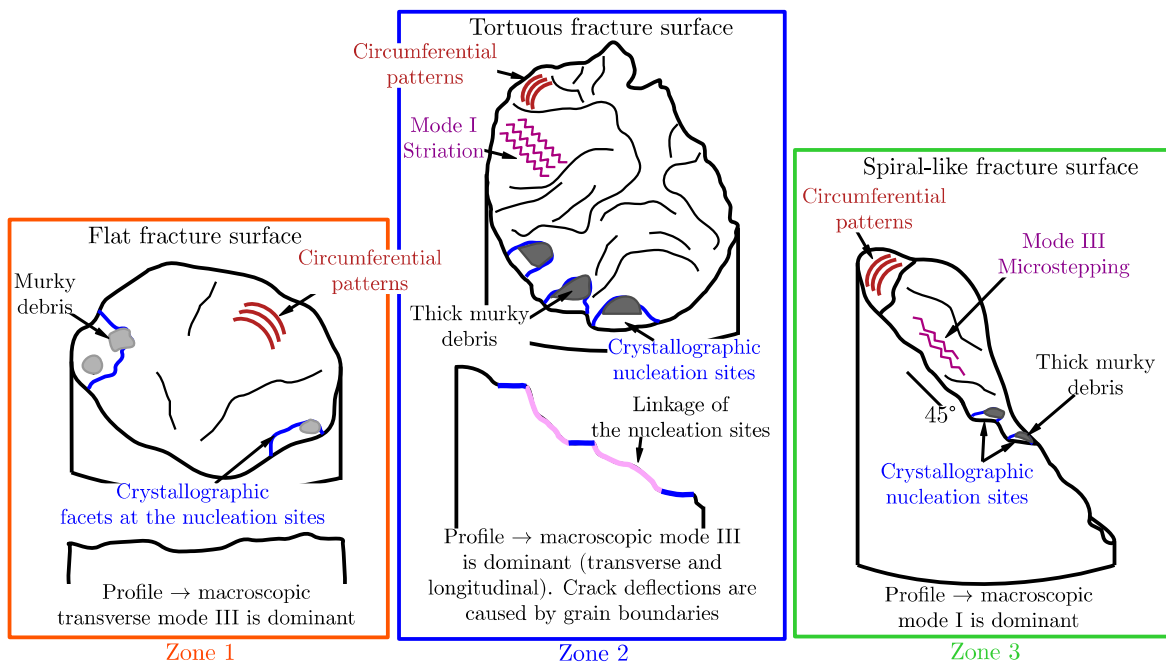
**Fig. 2.61:** Schematic illustration of the most remarkable features that have been observed in Zone 1, Zone 2 and Zone 3

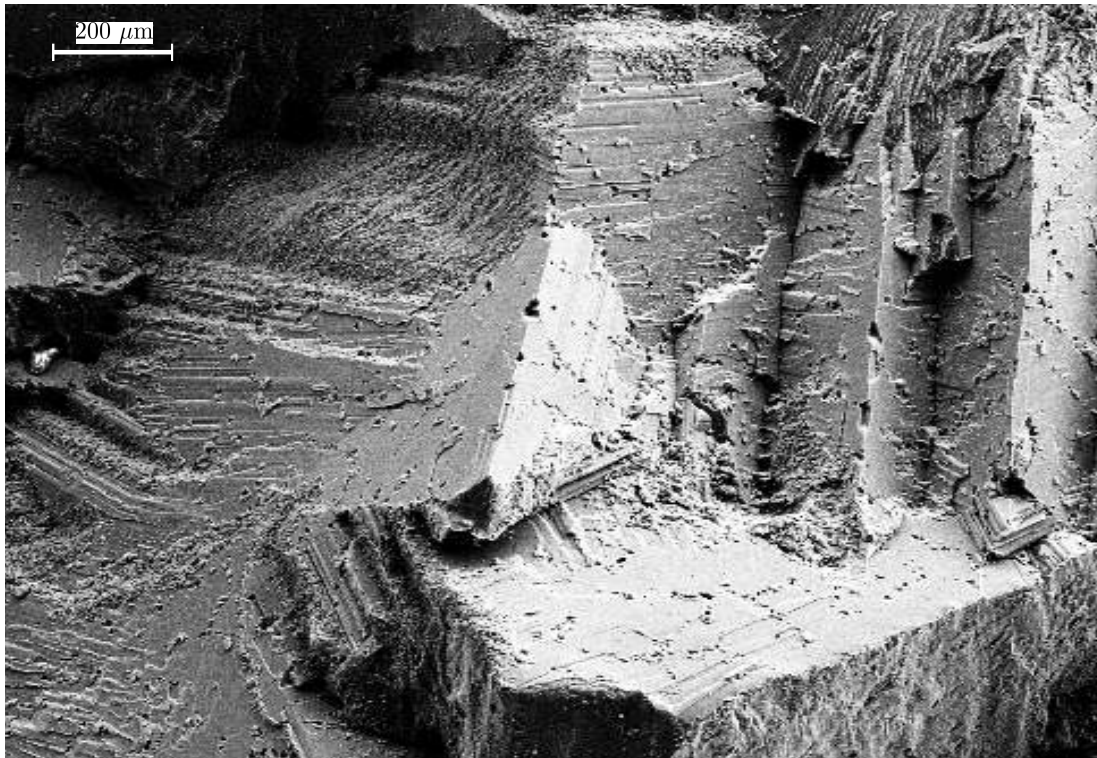
**Fig. 3.10:** Higher magnification on the Region II of CTIF-131.104 fracture surface where a zigzag topography can be observed due to large crystallographic facets.

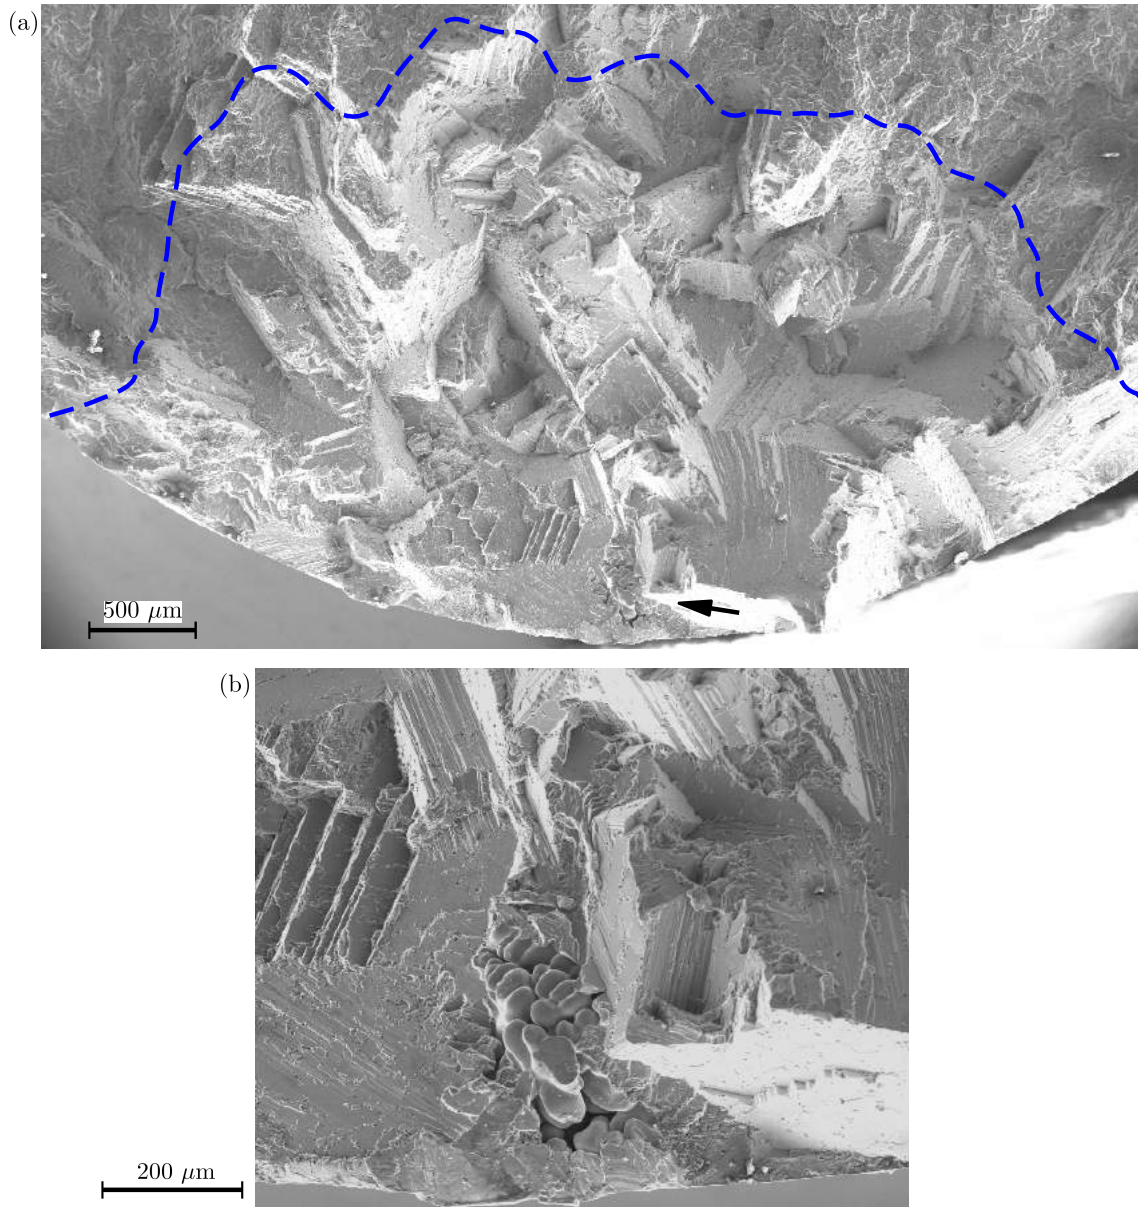
**Fig. 3.16:** (a) SEM observations on the fracture surface of ENSMA-SNV-03 specimen (vacuum,  $N_f = 3\,356\,341$  cycles,  $\sigma_{max} = 133$  MPa, Artificial Defect  $\sqrt{A} = 278$   $\mu\text{m}$ ). Only Region II propagation is observed. (b) Higher magnification on the first propagation stages from a surface microshrinkage, close to the region indicated by the black arrow.

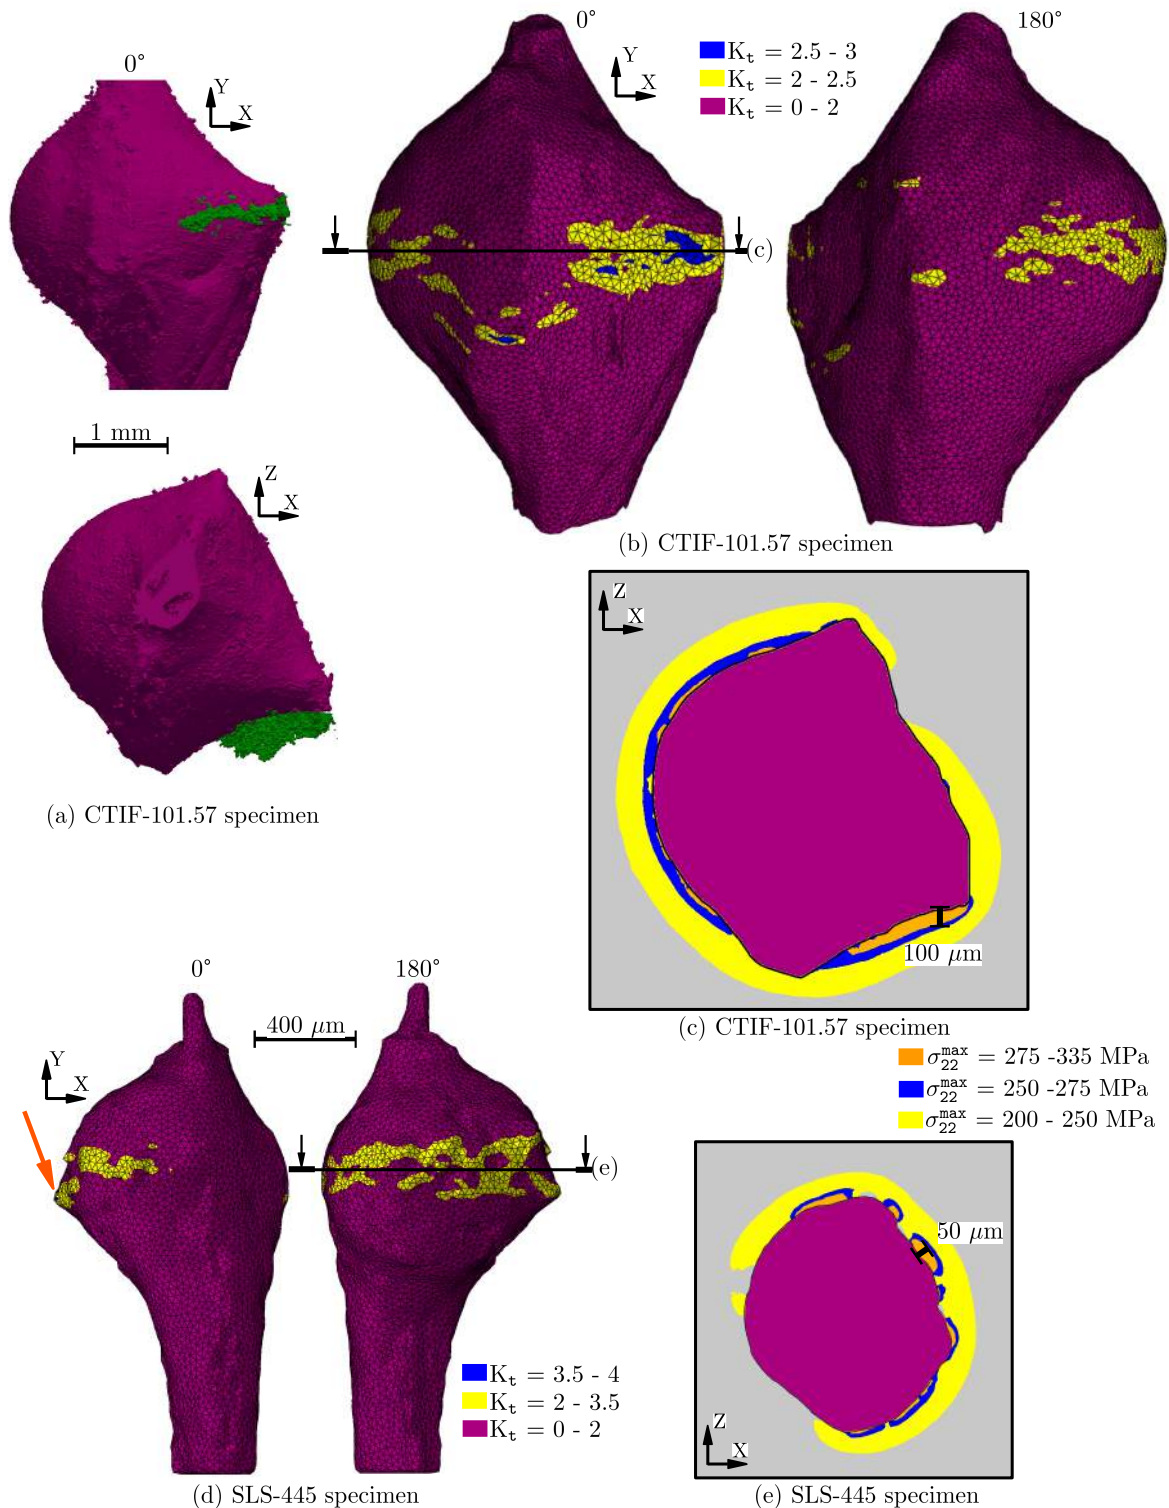
**Fig. 3.27:** (a) 3D renderings of the artificial defect of CTIF-101-57 specimen showing the internal crack (in green) formed at its equator after 938 500 cycles ( $\sqrt{A} = 2064 \mu\text{m}$ ,  $\sigma_{\max} = 140$  MPa). (b)  $K_t$  evaluation over the artificial defect profile of CTIF-101-57 specimen. (c) Slice performed along the “equator” of the artificial defect (CTIF-101-57 specimen) on a plane perpendicular to the loading direction showing elasto-plastic results. (d)  $K_t$  evaluation over the artificial defect profile of SLS-445 specimen ( $\sqrt{A} = 875 \mu\text{m}$ ,  $\sigma_{\max} = 140$  MPa). Orange arrow indicates the location of a small blue ( $K_t = 3.5-4$ ) region. (e) Slice performed along the “equator” of the artificial defect (SLS-445 specimen) on a plane perpendicular to the loading direction showing elasto-plastic results.

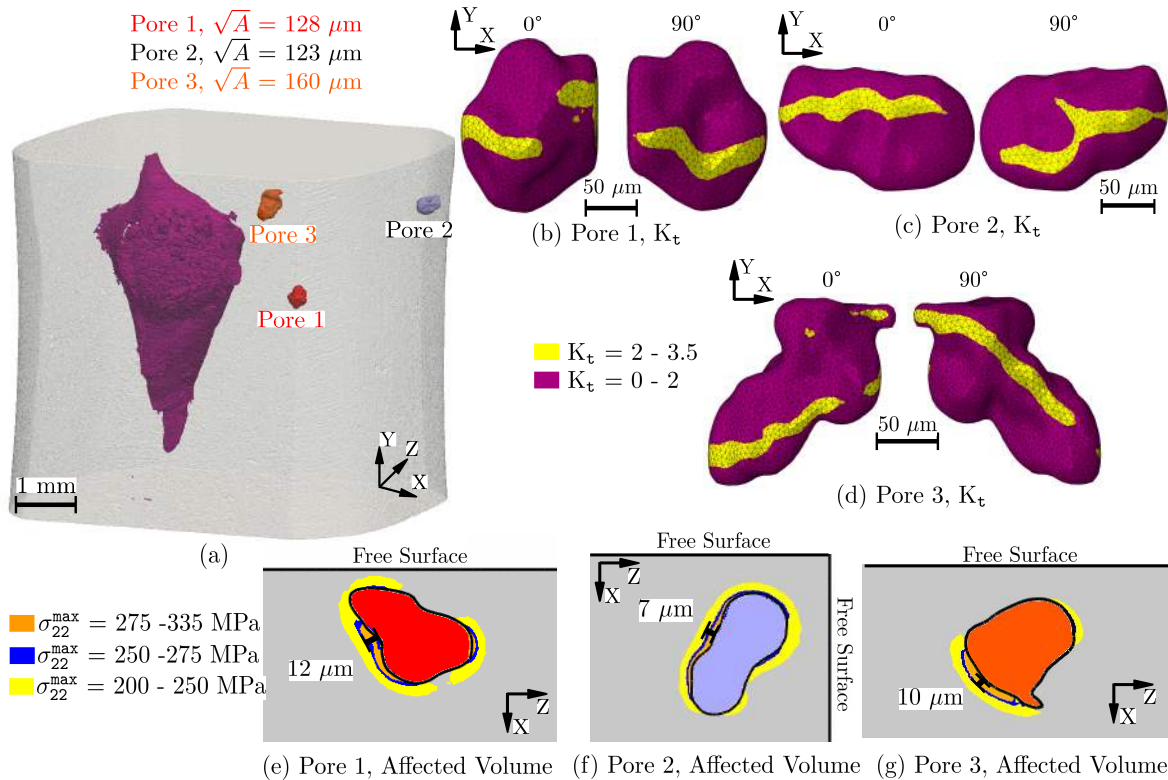
**Fig. 3.29:** (a) 3D rendering of SLS-449 specimen showing the artificial defect and three surface pores which did not nucleate any crack. The fatigue testing parameters are  $N_f = 140\,000$  cycles,  $\sigma_{\text{max}} = 140 \text{ MPa}$ , Artificial Defect  $\sqrt{A} = 830 \mu\text{m}$ . (b)  $K_t$  evaluation for Pore 1 (no crack nucleation after 140 000 cycles). (c)  $K_t$  evaluation for Pore 2 (no crack nucleation after 140 000 cycles). (d)  $K_t$  evaluation for Pore 3 (no crack nucleation after 140 000 cycles). (e) Slice performed along the middle plane perpendicular to the loading direction for Pore 1 and showing elasto-plastic results. (f) Same as before but for Pore 2 and (g) Pore 3.

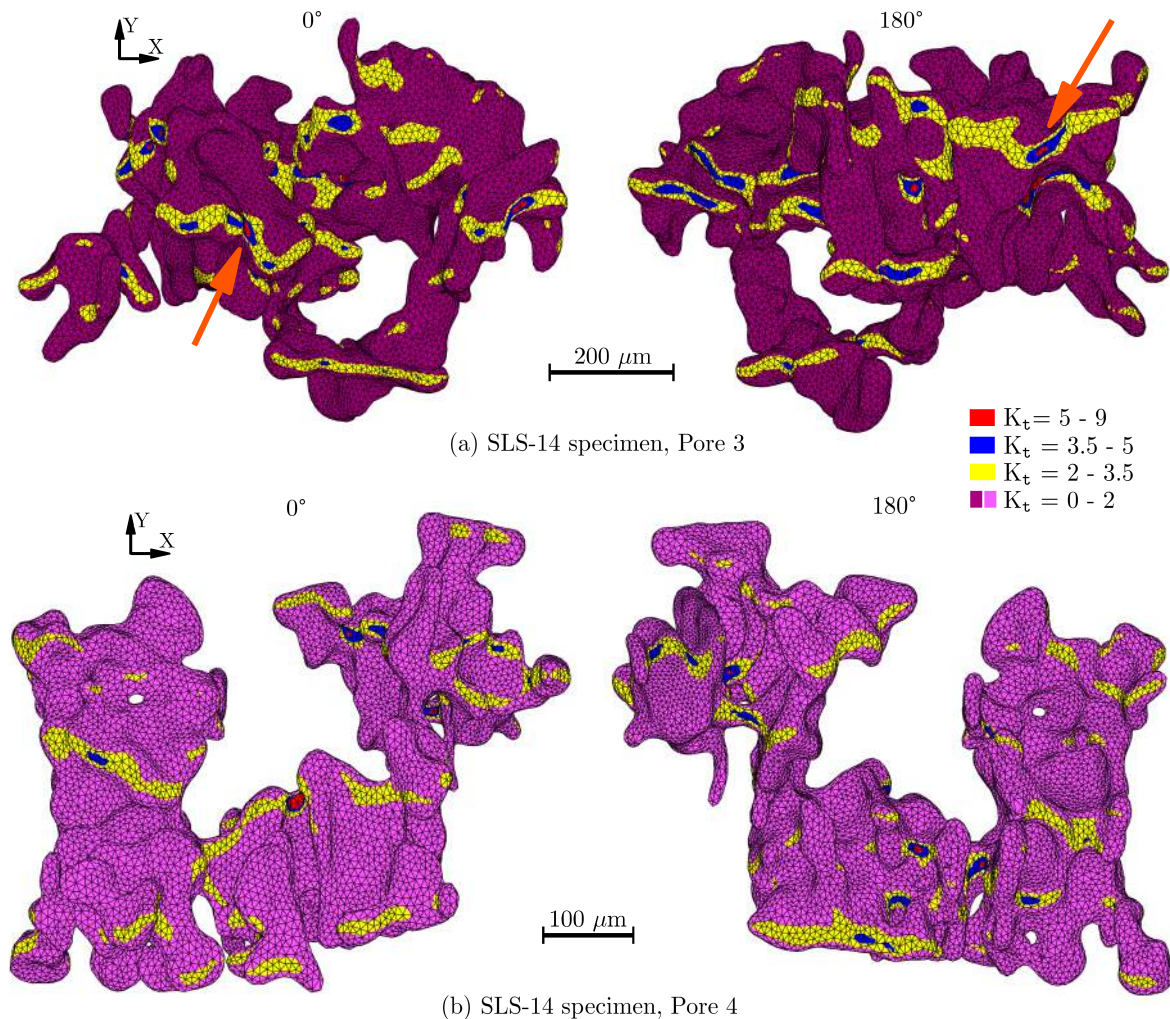
**Fig. 3.31:** (a) 3D renderings at  $0^\circ$  and  $180^\circ$  of the  $K_t$  evaluation on Pore 3 (SLS-14 specimen). (b) The same as before but for Pore 4 (SLS-14 specimen). Orange arrows indicate some of the largest red-blue zones ( $K_t = 9-5$ ) that are formed over the pore convoluted morphology.

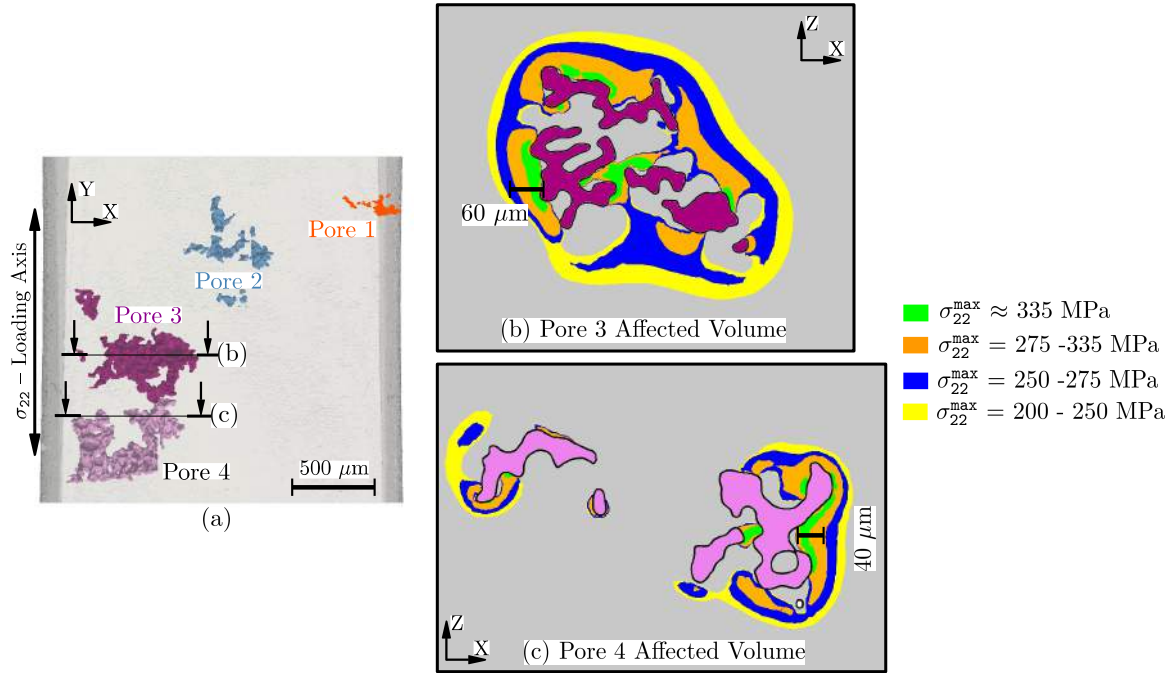
**Fig. 3.33:** (a) 3D rendering of the pore distribution within the gage of SLS-14 specimen where the approximate locations of images (b) and (c) are indicated. The fatigue testing parameters are  $N_f = 73\ 000$  cycles,  $\sigma_{\max} = 230$  MPa (b) Slice performed along a random plane perpendicular to the loading direction for Pore 3 showing the elasto-plastic results. (c) The same as before but for Pore 4.

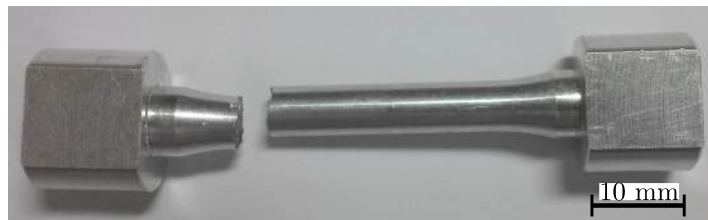
**Fig. B.1:** Image showing an example of a post-mortem as-machined specimen which failed at one of the junctions.

First torsion tests were performed using as-machined specimens that systematically failed at junctions. Fig. B.1 shows an example of a post-mortem as-machined specimen. In order to establish the possible causes responsible for this localised fatigue failure, it was decided to carry out a finite element study in conjunction with a profilometry analysis.

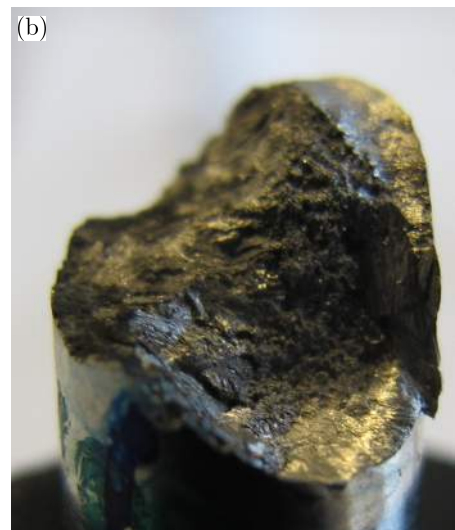
**Fig. C.4:** (a) SEM observation at low magnification on the fracture surface of 323A specimen. The fatigue testing parameters are:  $N_f = 2\,425\,685$  cycles,  $\tau_{\max} = 85$  MPa. (b) 3D optical observation on the fracture surface of 323A specimen.
