E-20137

PROGRESS REPORT

LARGE-SCALE TESTS OF A LOW-RISE UNREINFORCED MASONRY BUILDING SYSTEM

March 1, 2002

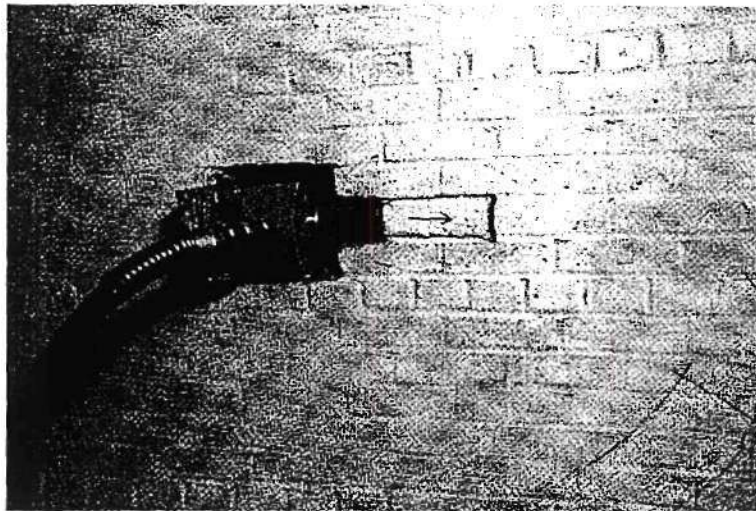
Figure 2.3 Test set up for Shove test (adapt from Costley 1996)

The in-place shear test, or shove test, has been recommended by FEMA 273 (ATC 1997) and is widely used for measuring masonry shear strength in existing masonry buildings. It usually requires the removal of a single brick and a head joint one brick away on the same course. A jack is placed in the cavity and used to laterally push the brick between the cavity and the missing head joint until slip occurs (Fig. 2.3). A total of 19 in-place shear tests conducted in the URM walls of a building being demolished were reported in ABK (1984). The test results showed rather large scatter,

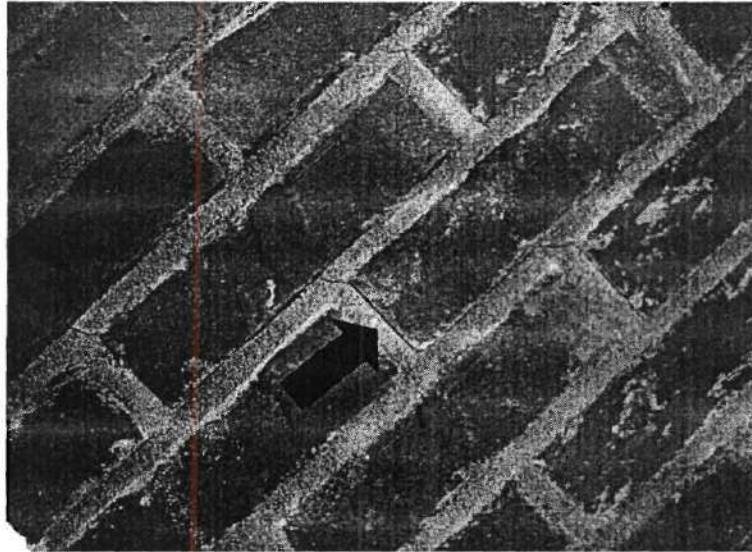
Figure 2.4 Interface cracks between units and mortar (taken in ST11 material test)

As evidenced in the material tests carried out for this research and discussed in Section 3.3, for strong unit-weak mortar type masonry, the shear crack occurs neither in the unit nor in the mortar, but at the interface between units and mortar (Fig. 2.4). The shear strength of this type of masonry depends primarily on the type of mortar, roughness of the surface of the units, water absorption capacity of units, and water volume in units and mortar. All the tests showed that, for a limited range of normal stresses (0 to 50 psi), the linear Mohr-Coulomb envelope is a good model for the shear strength, which expresses the shear strength of a bed joint under normal stress as:

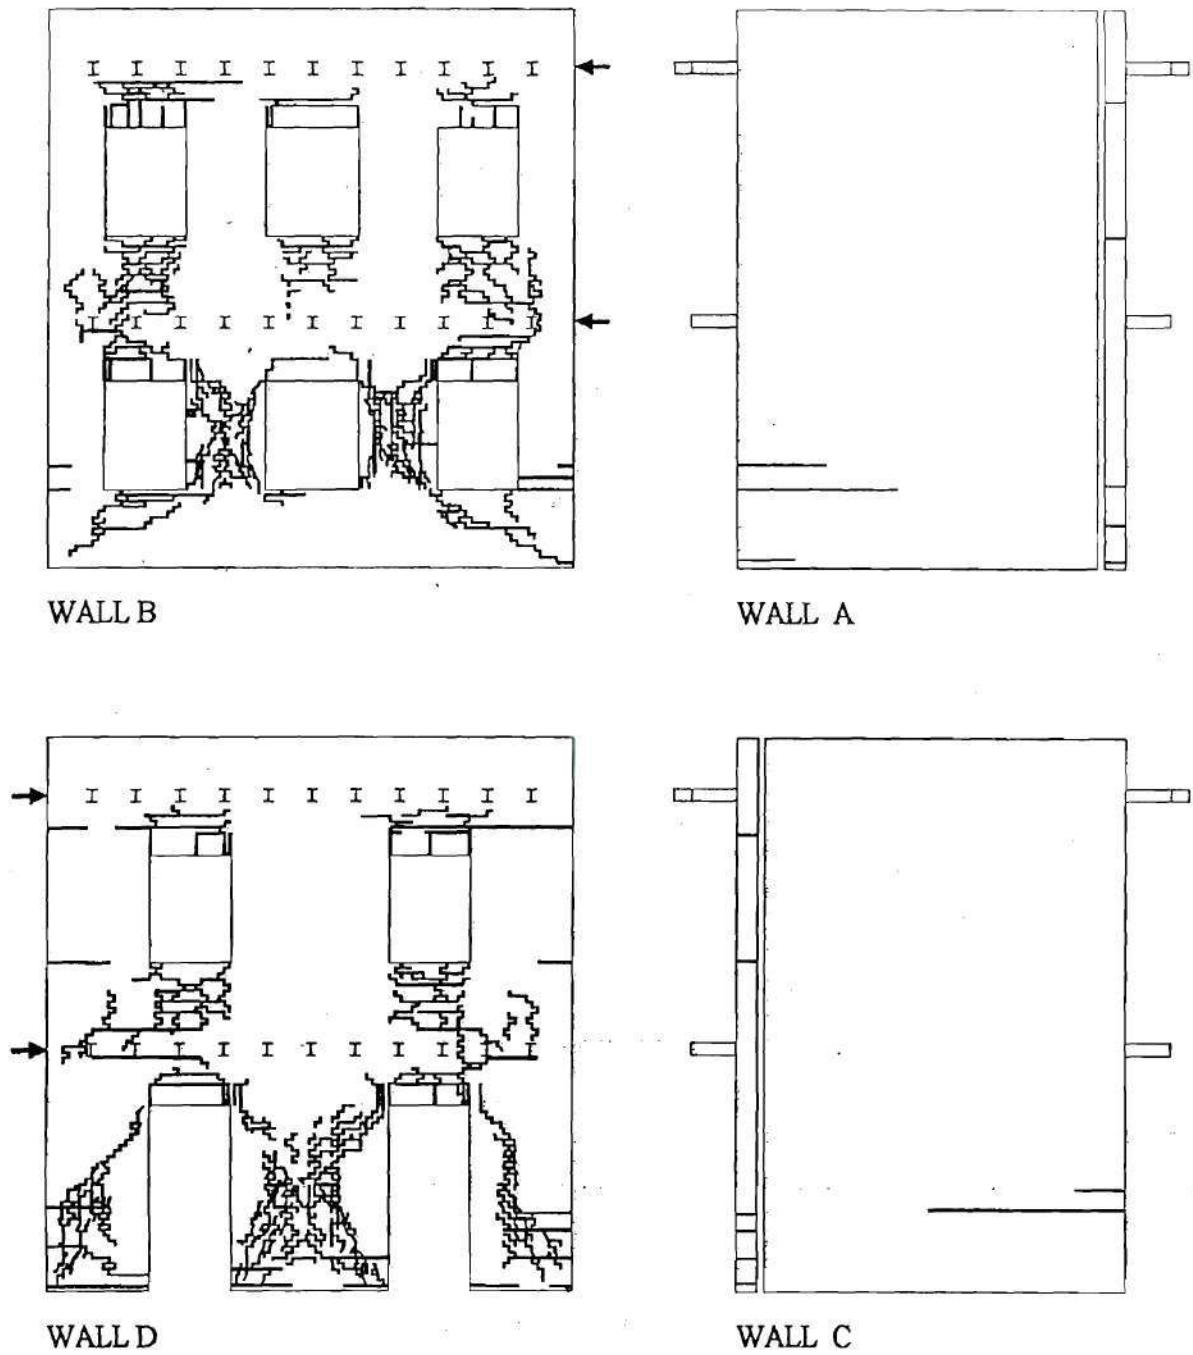
Figure 2.21 Final crack pattern in static tested specimen (from Magenes et al 1995)

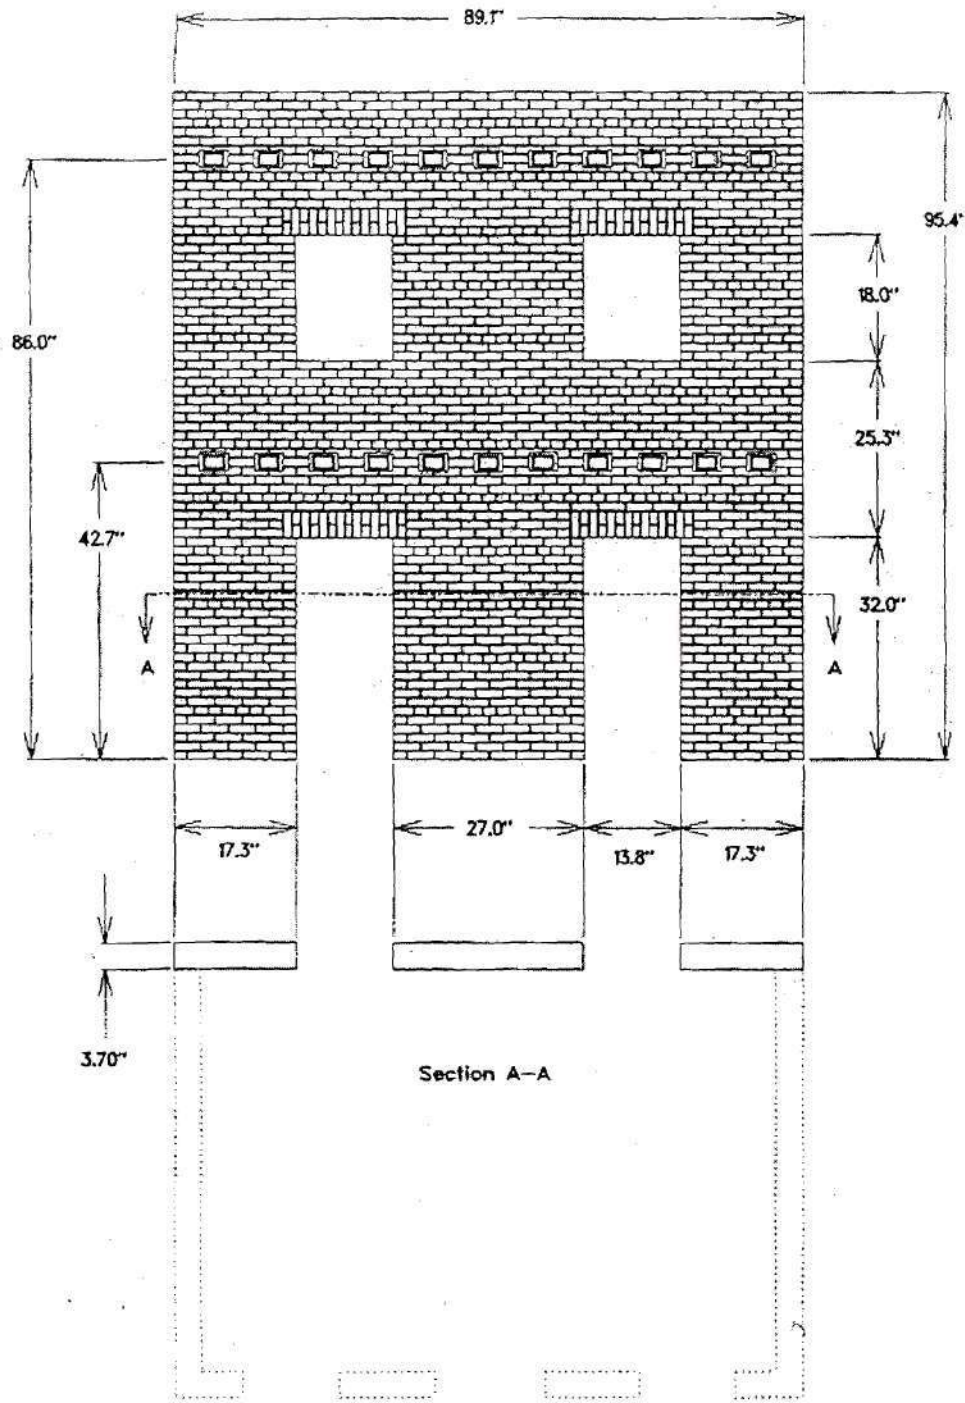
Fig. 2.17. The test specimens Door wall in Costley's test (taken from Costley 1996)

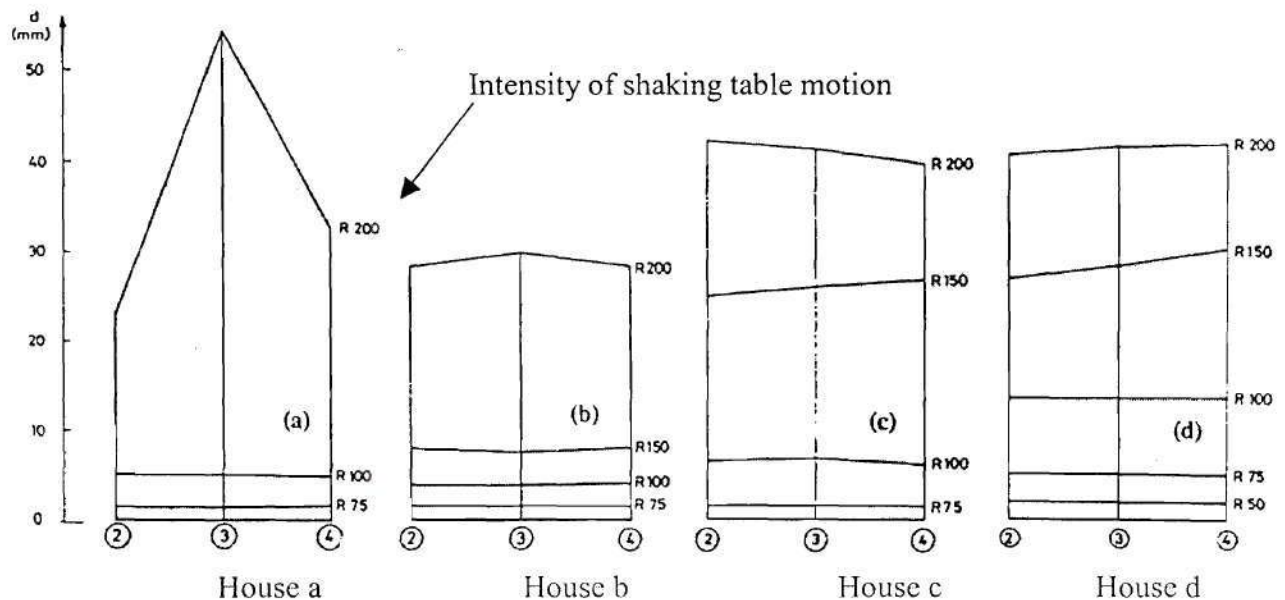
Figure 2.16. Distribution of displacements along the top floor
 (Locations: 2, 4 the in-plane walls, 3 center of the out-of-plane wall)
 (Tomazevic (1993))

The lateral deformation shapes were also obtained in this experiment. Fig. 2.16. shows the distribution of the displacements along the roof. The displacements of the in-plane walls and the out-of-plane walls were almost the same in the elastic range for the different diaphragms, possibly due to the large thickness of the masonry walls. However, with increasing ground motion, the differences between the lateral displacements of the in-plane walls and that of the out-of-plane wall increased. As observed in the experiment, there was out-of-plane failure in Model A, but not in Model B, C, and D.

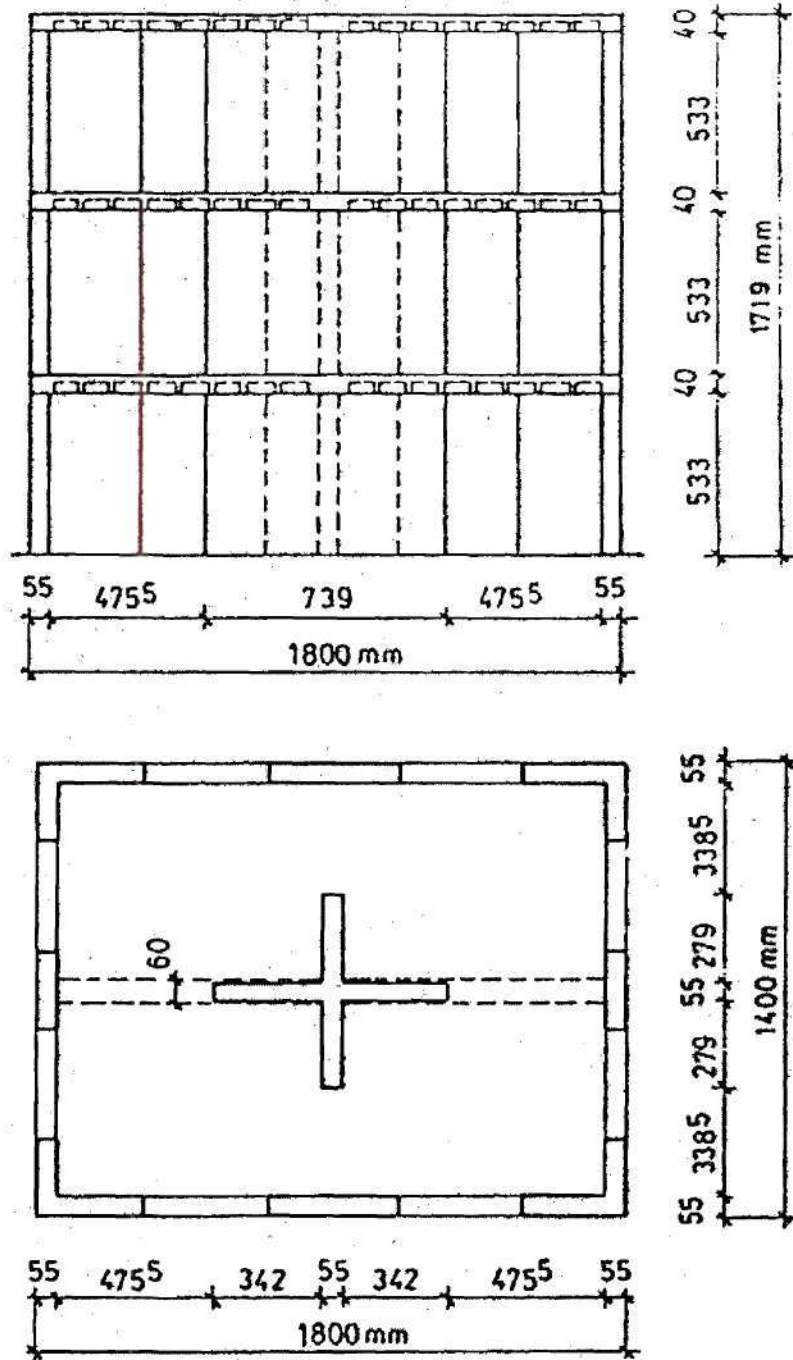
Fig. 2. 14. Specimen Model 2 in Tomazevic (1990)'s test
(taken from Tomazevic 1990)

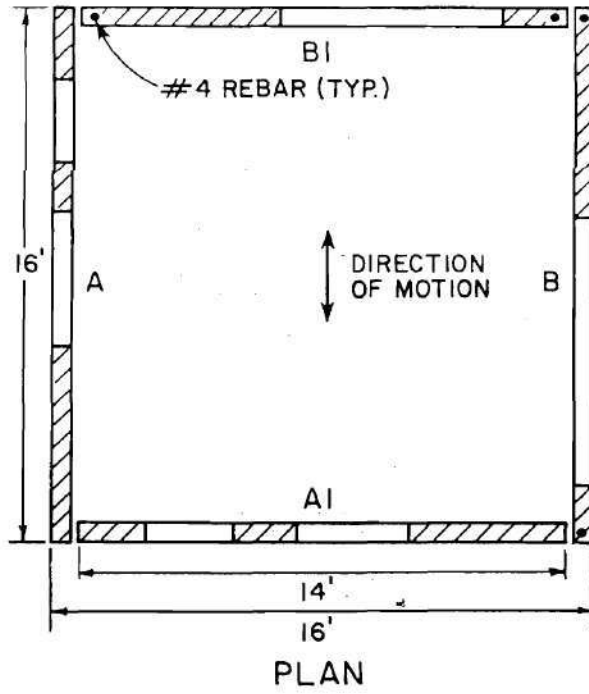
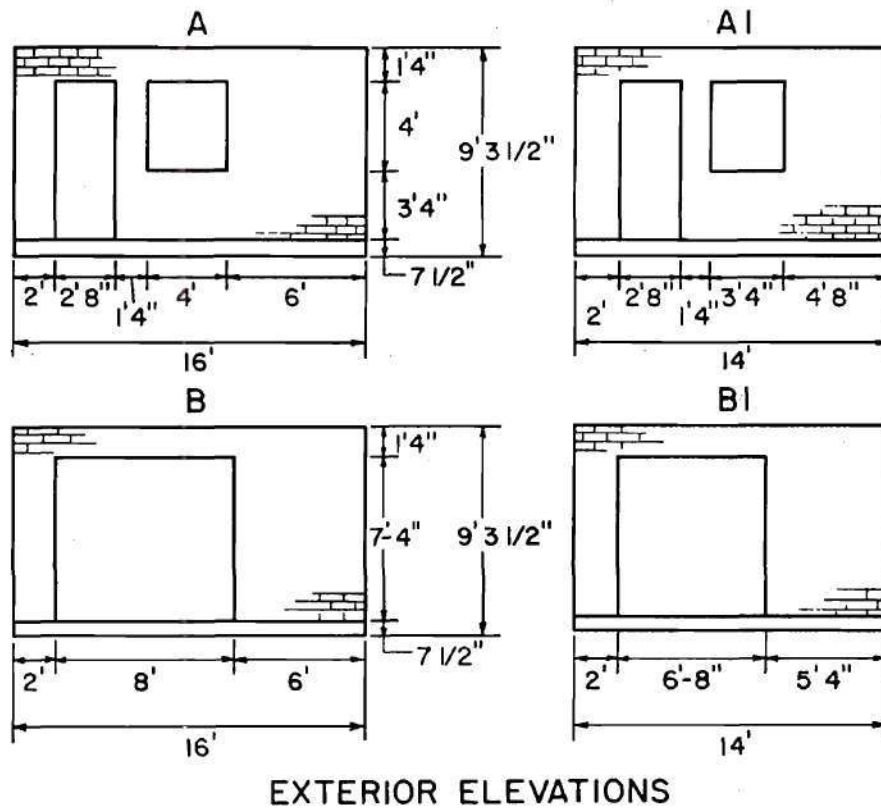
Figure 2.13 Specimen House 2 in Clough's test (taken from Clough et al 1979)

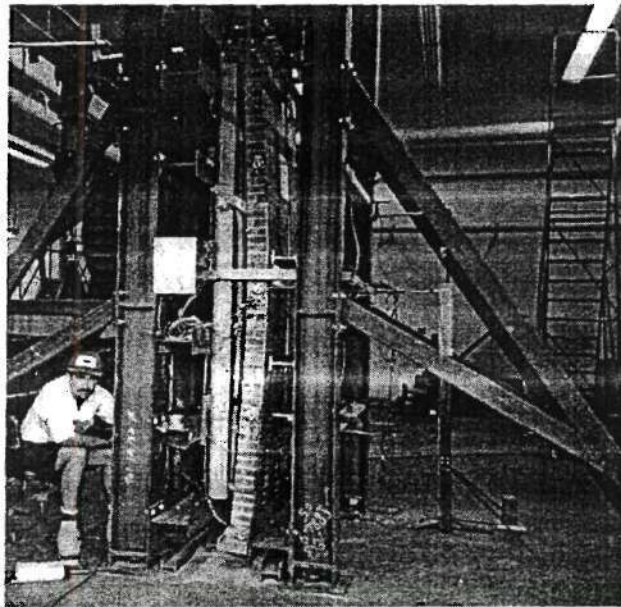
**Figure 2.10. Airbag used in the out-of-plane test of URM wall
(taken from Velazquez-Dimas 2000)**

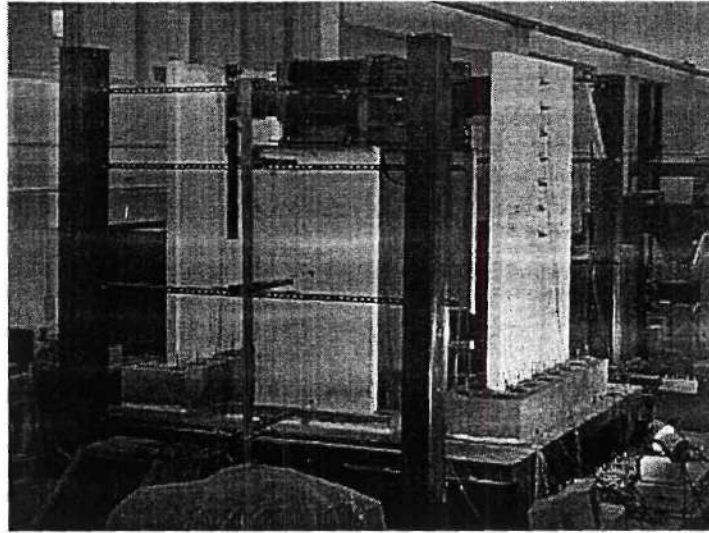
Figure 2.9 Dynamical test set up used in MAEC project ST10

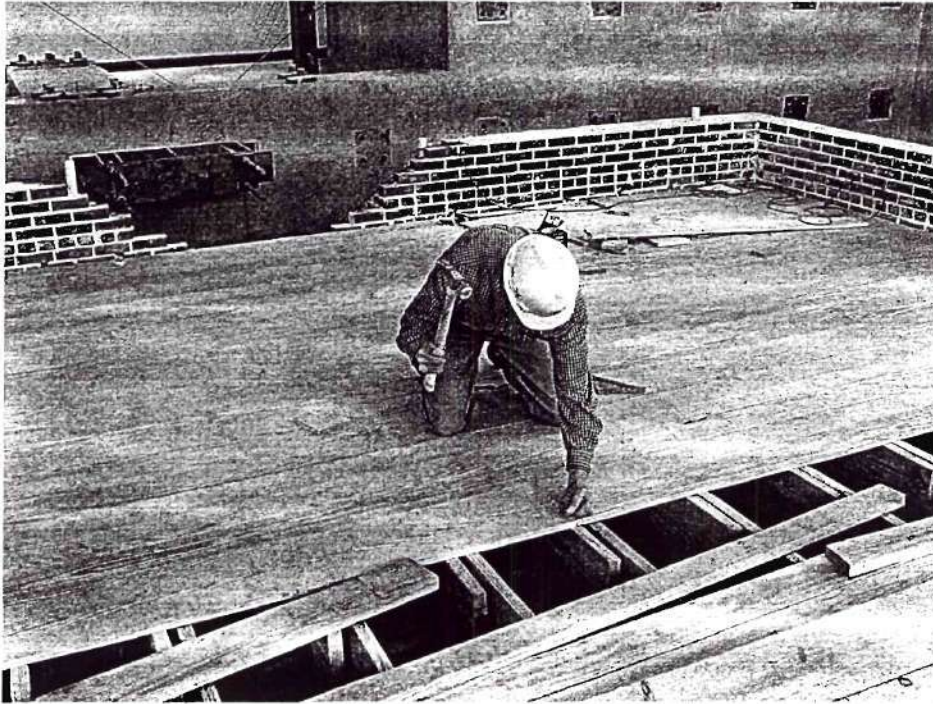
Figure 3.24. Construction of the floor and roof diaphragms.

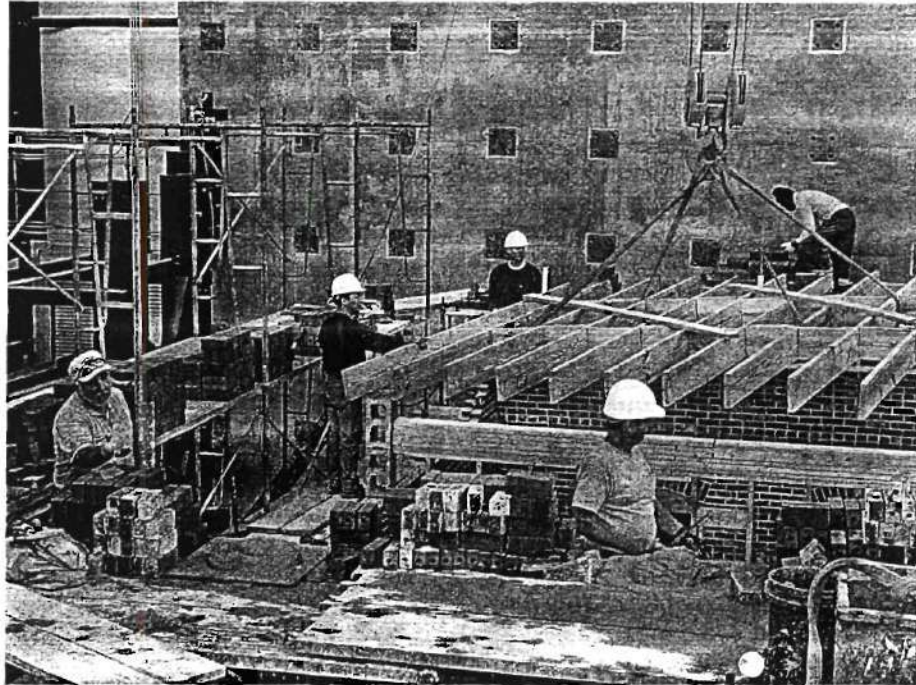
Figure 3.22. Assembly of the floor systems

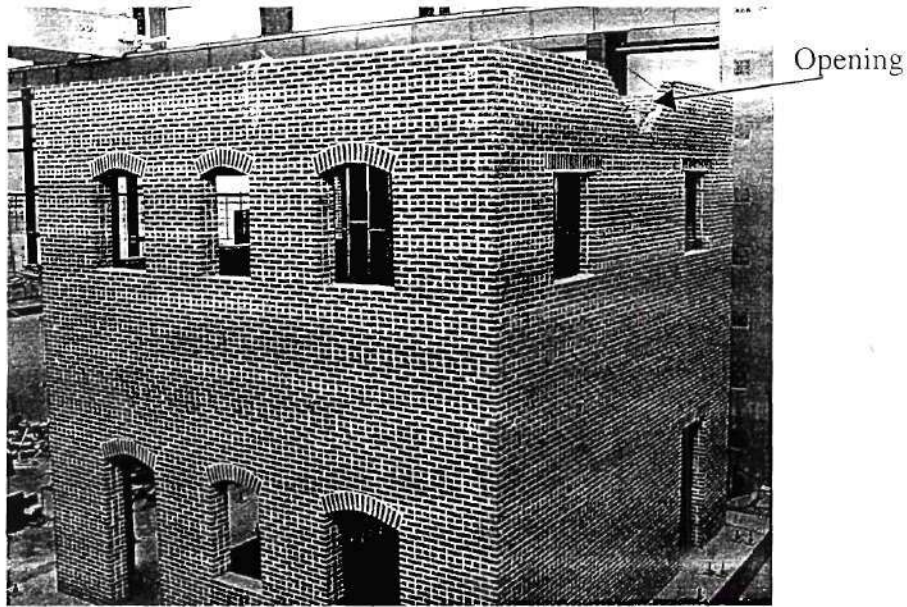
Fig. 3.21 Opening left at the top of Wall 1

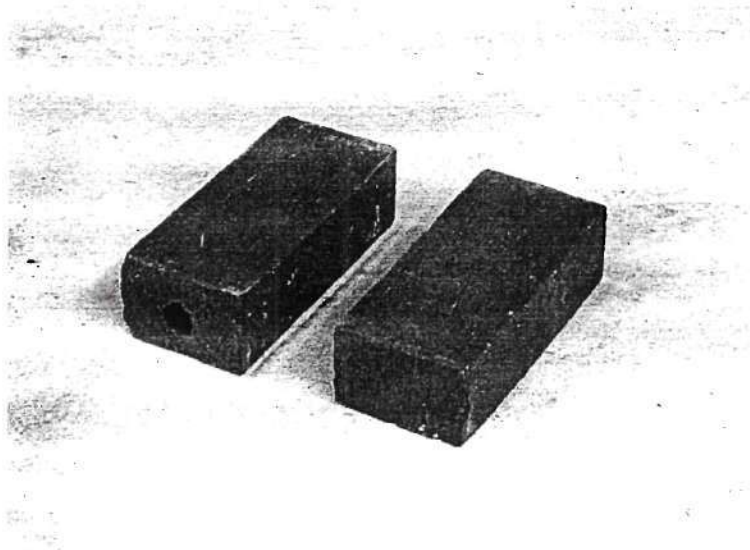
Figure 3.17. Two different bricks

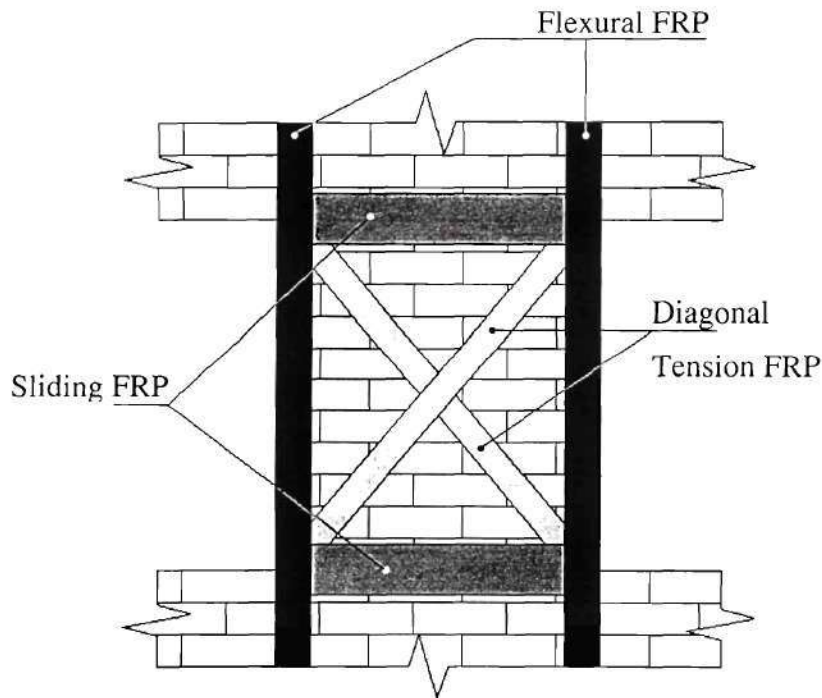
Figure 3.13 Common configuration of FRP retrofit

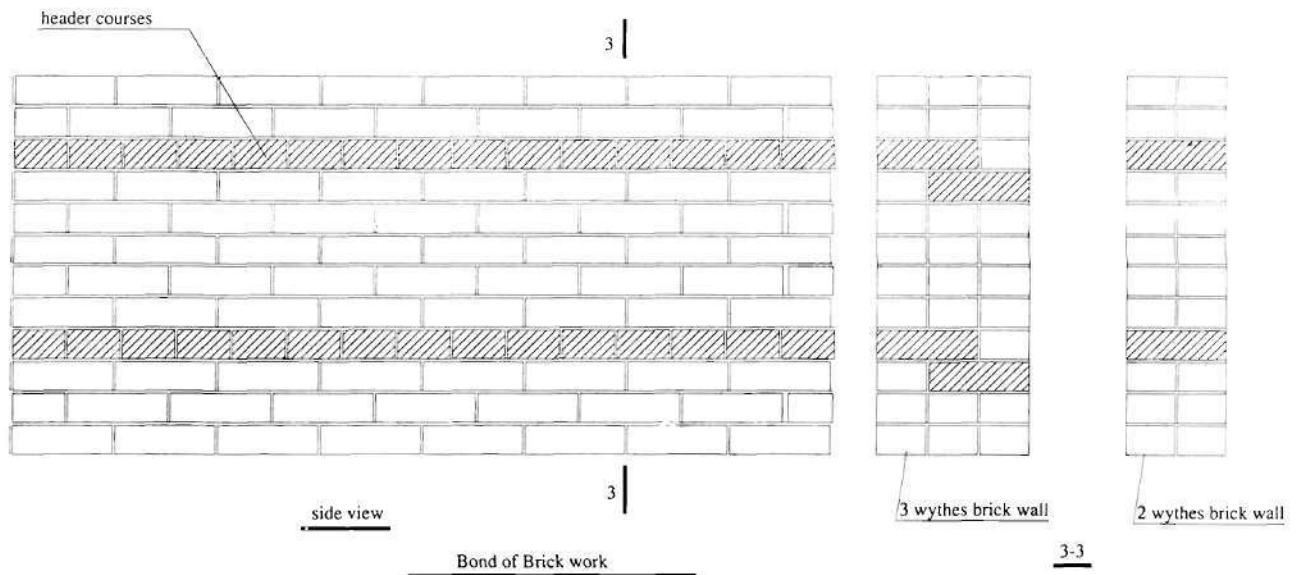
Figure 3.9. Detail of American bond

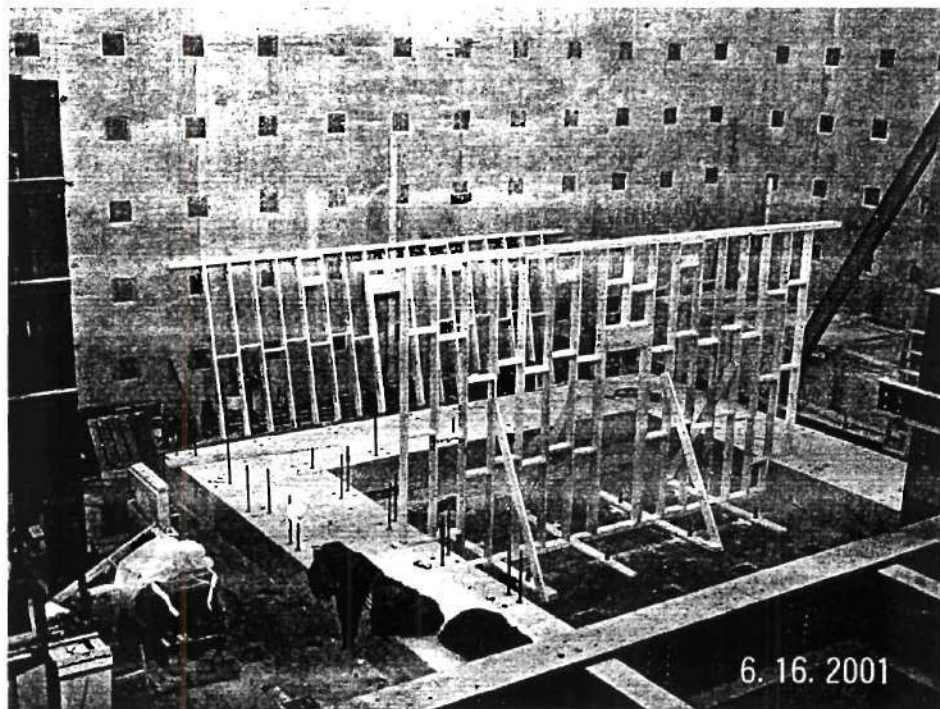
Figure 3.4. Photo of the stud wall together with the foundation

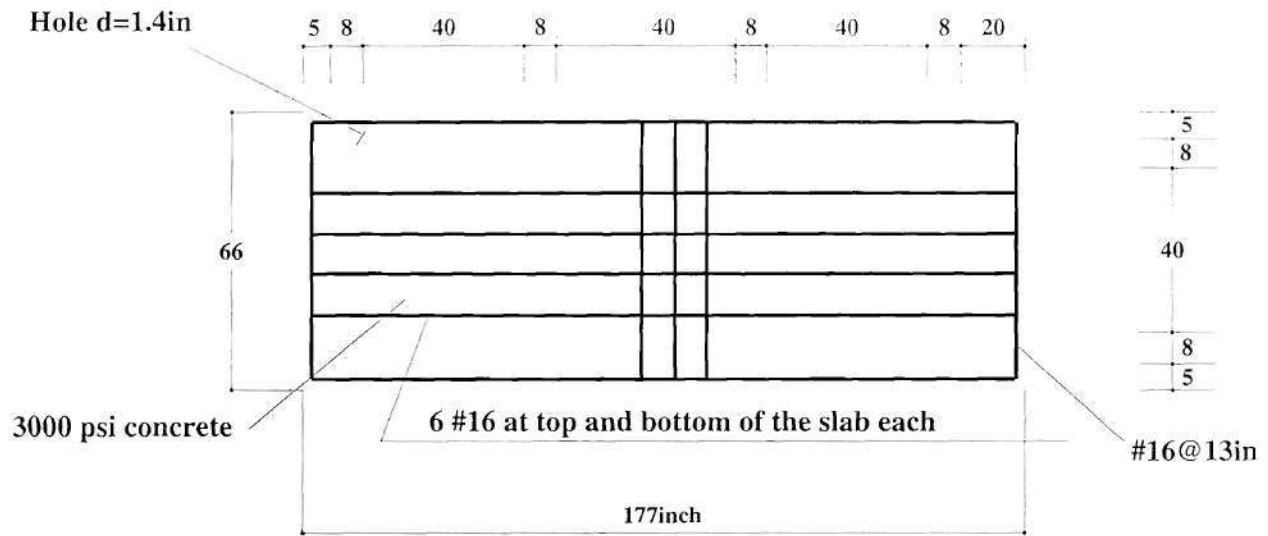
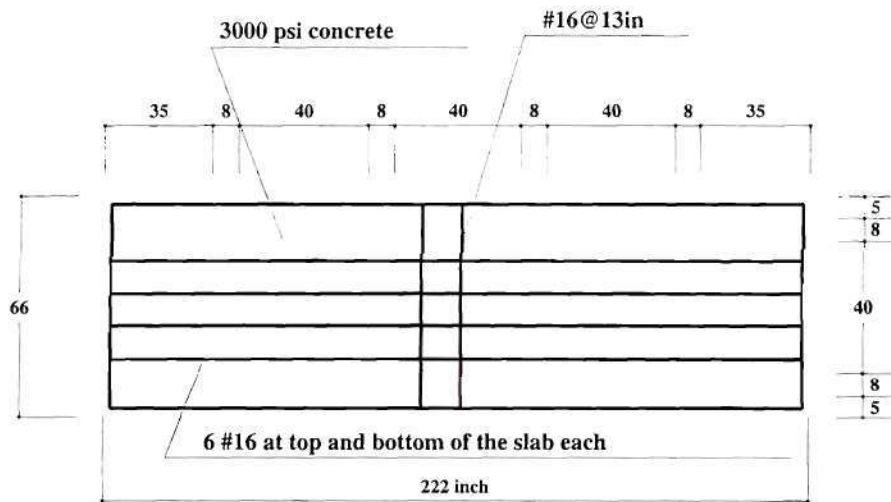
Figure. 3.3. Reinforcement detail of the foundation slabs (dimensions are in in.).

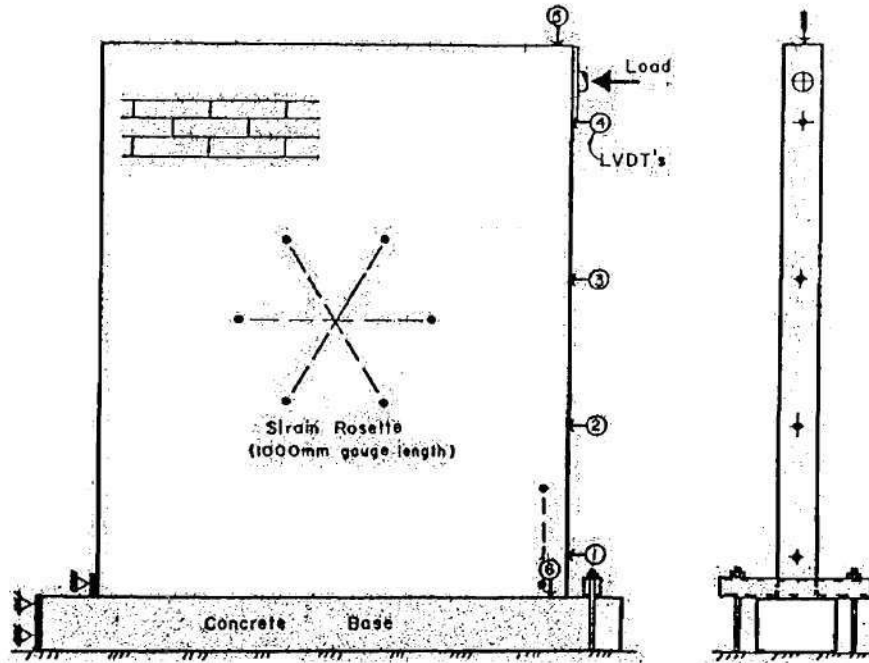
Figure 2.42. In-plane test setup and instrumentation layout (taken from Page and Huizer, 1998)

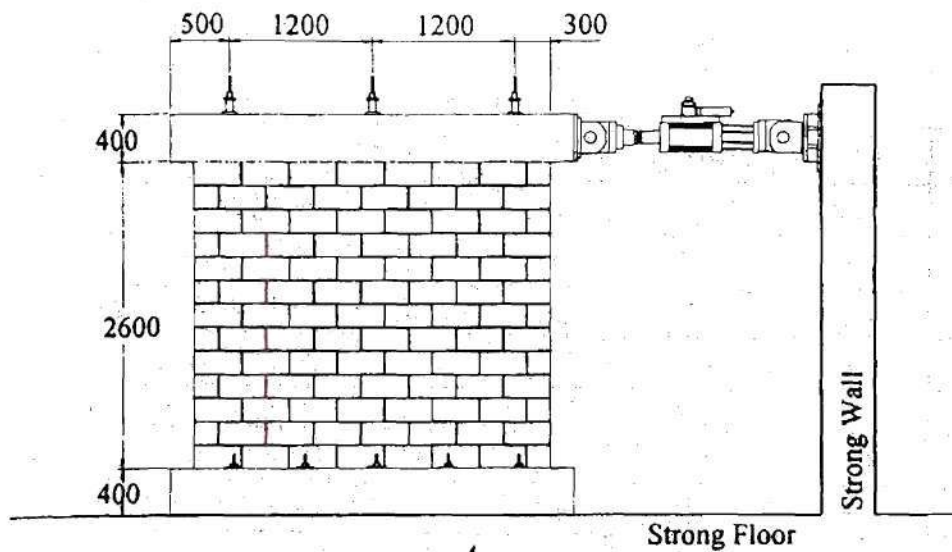
Figure 2.40. Schematic of in-plane post-tensioned URM pier test setup (taken from Laursen and Ingham, 2001a)

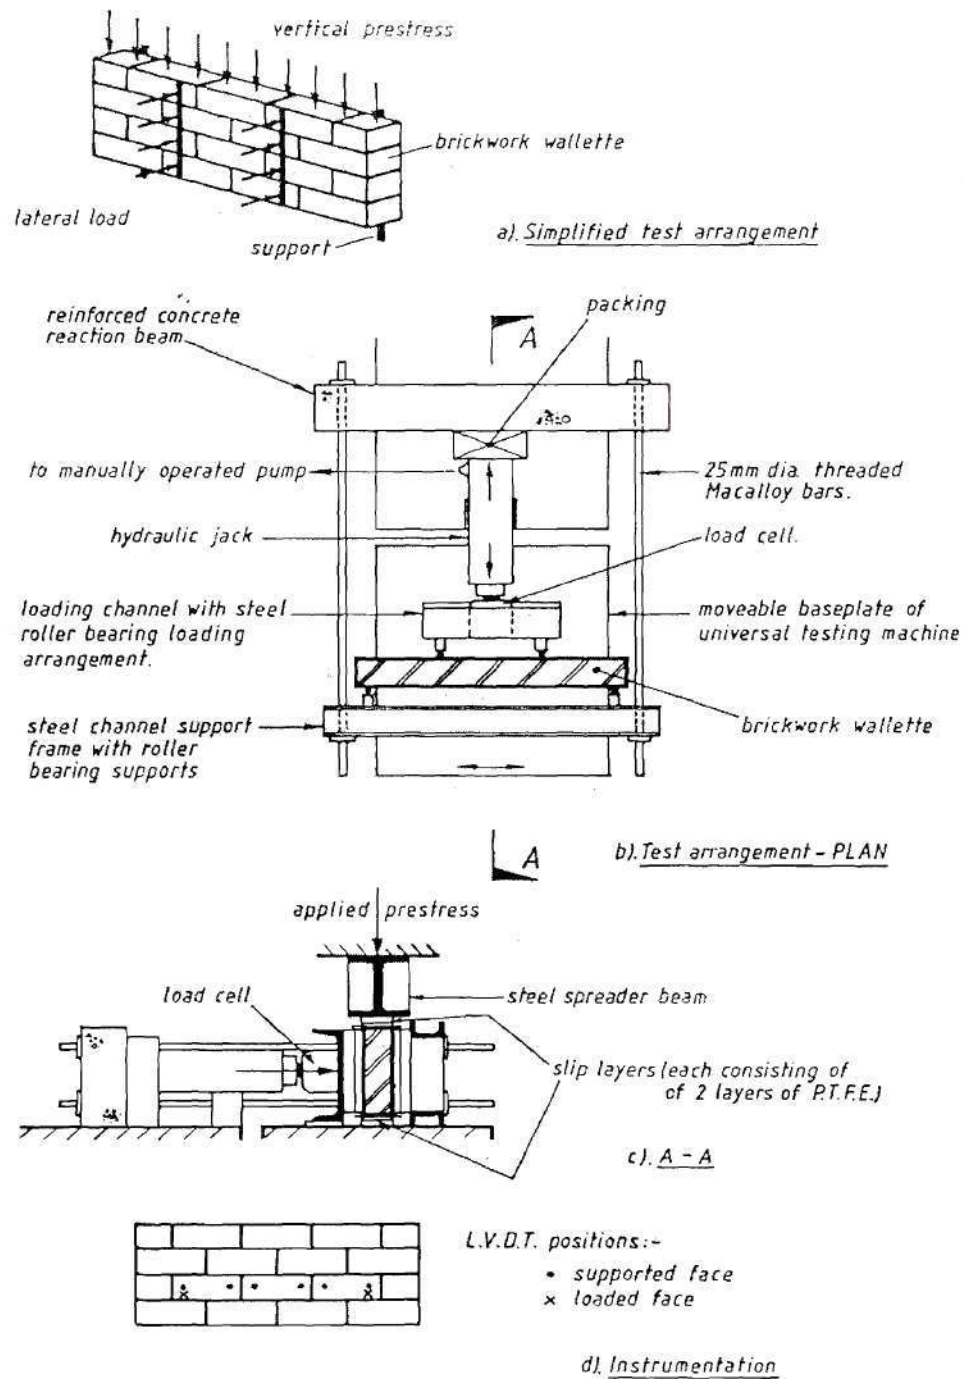
Figure 2.39. Schematic of Test setup (taken from Garrity and Phipps, 1987)

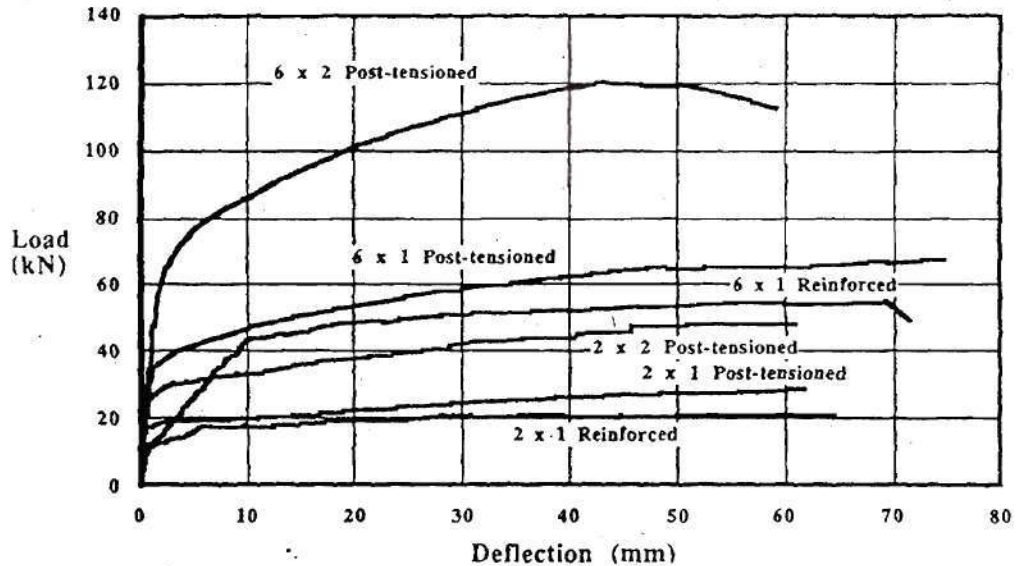
Figure 2.38. Load-deflection curves up to ultimate (taken from Al-Manaseer and Neis, 1987)

load at mid-height. Fig. 2.38 shows the load-deflection curves for each of the walls tested.

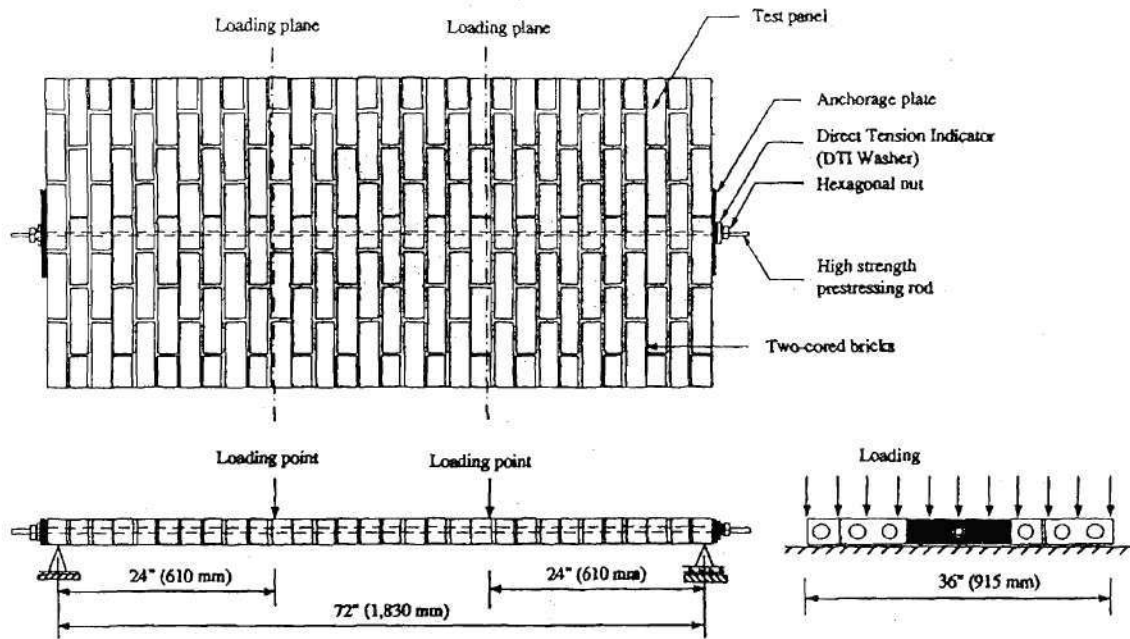
Figure 2.36. Schematic of test setup and specimen. (taken from Devalapura et al., 1996)

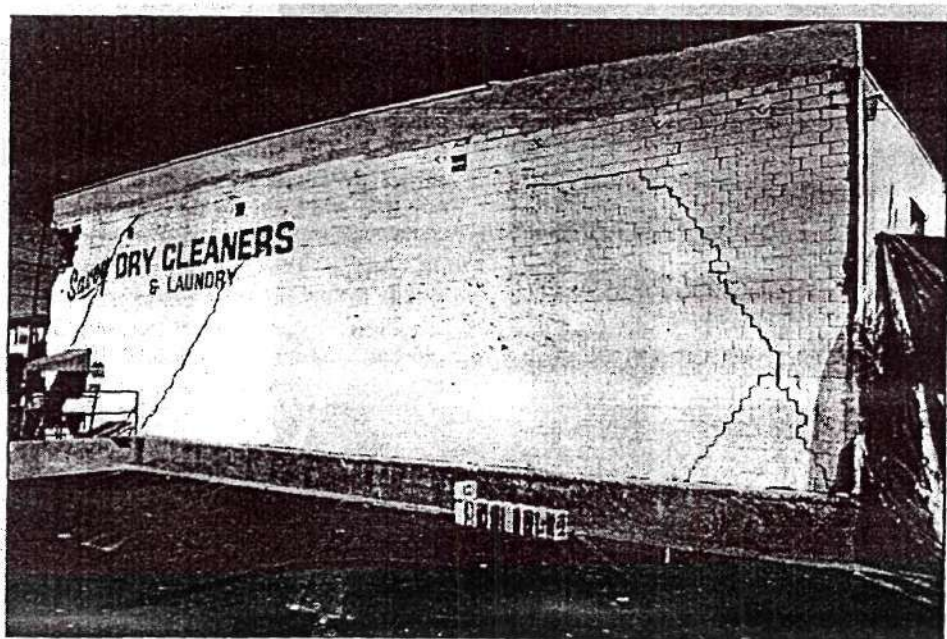
Figure 2.35. Damage sustained prior to retrofit with FRP overlays (taken from

Ehsani and Saasatmanesh (1996) and Ehsani (1995) reported the first application of FRP to a masonry structure for retrofit. The structure chosen for retrofit was one-story tall and constructed of concrete block masonry. The structure has been damaged during the Northridge Earthquake in 1994. A few years before the earthquake the structure had been retrofit with a steel frame in the center of the structure and with ties that connected the roof diaphragm with the walls. This retrofit was effective in preventing collapse although severe damage still occurred in part because the shear strength of the masonry was over estimated by a factor of two (Fig. 2.35).

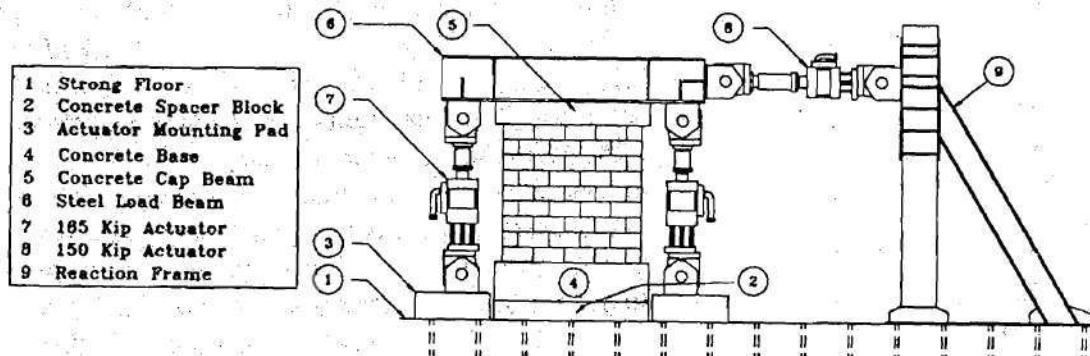
Figure 2.34. Schematic of in-plane test setup (taken from Laursen et al., 1995)

The effectiveness of a unidirectional carbon FRP (CFRP) overlay system on increasing the in-plane behavior of reinforced concrete masonry walls was investigated by Laursen et al. (1995). The two test specimens measured 6ft tall by 6ft wide, and contained 0.14% horizontal reinforcement and 0.54% vertical reinforcement. The specimens were tested in-plane with a vertical stress of 270psi and boundary conditions equivalent to a cantilever (see Fig. 2.34).

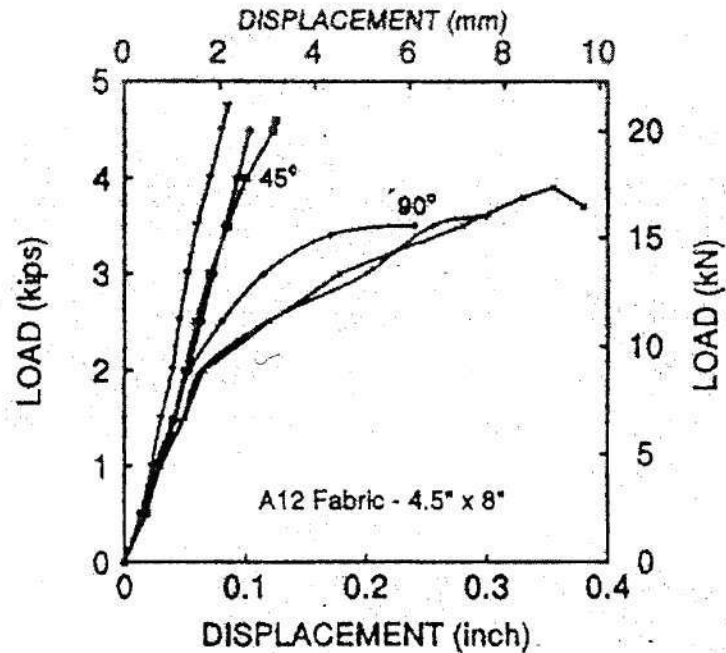
Figure 2.33. Force-displacement response of brick assemblages retrofitted with 0-90 and +/-45 FRP overlays (taken from Ehsani et al, 1997)

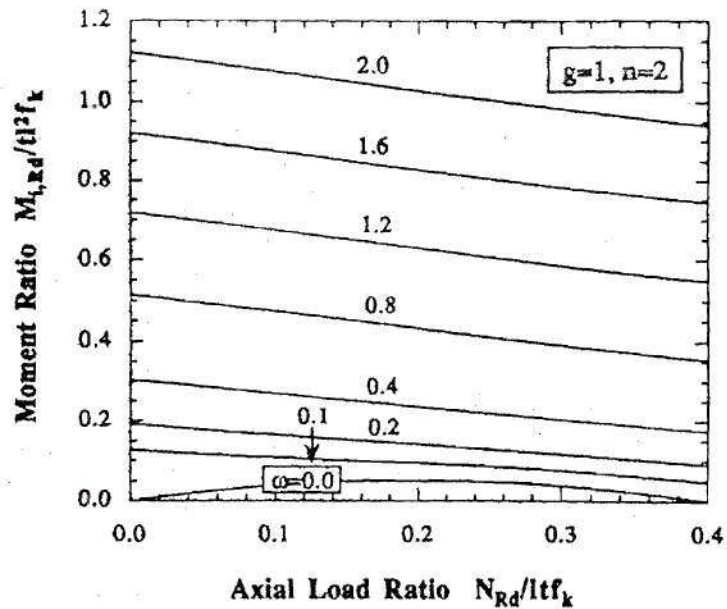
Figure 2.30. In-plane moment capacity versus axial load for various normalized FRP area fractions. (taken from Triantafillou, 1998)

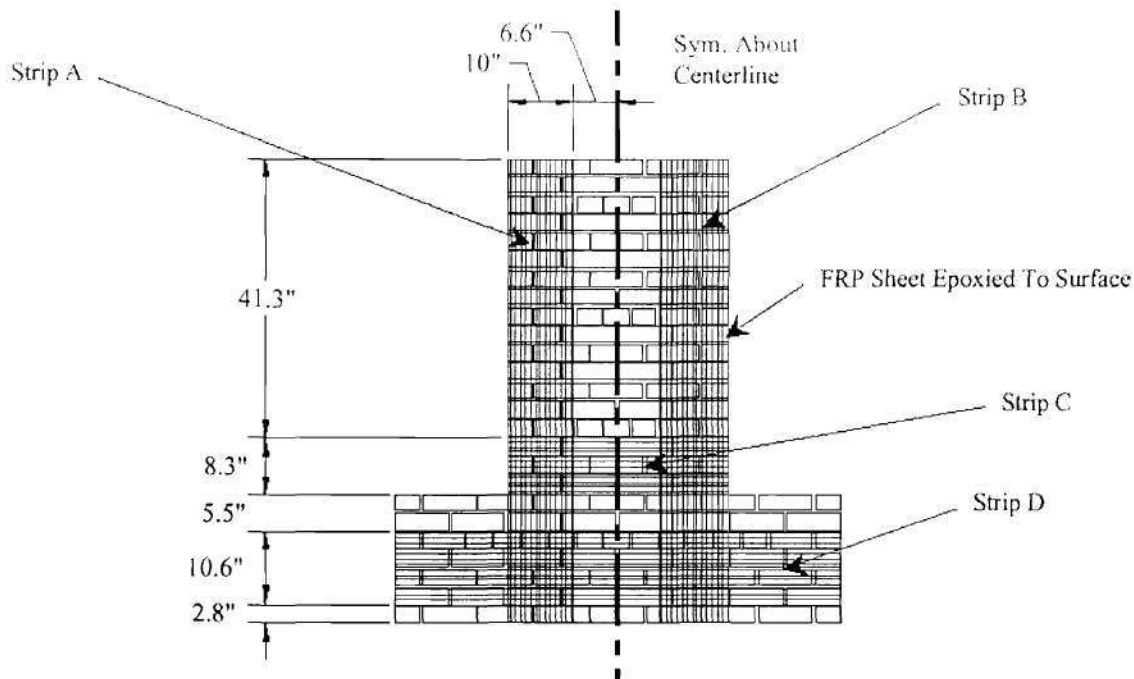
Figure 2.28. Schematic of in-plane test specimen showing the location of FRP reinforcement.(taken from Franklin et al, 2001)

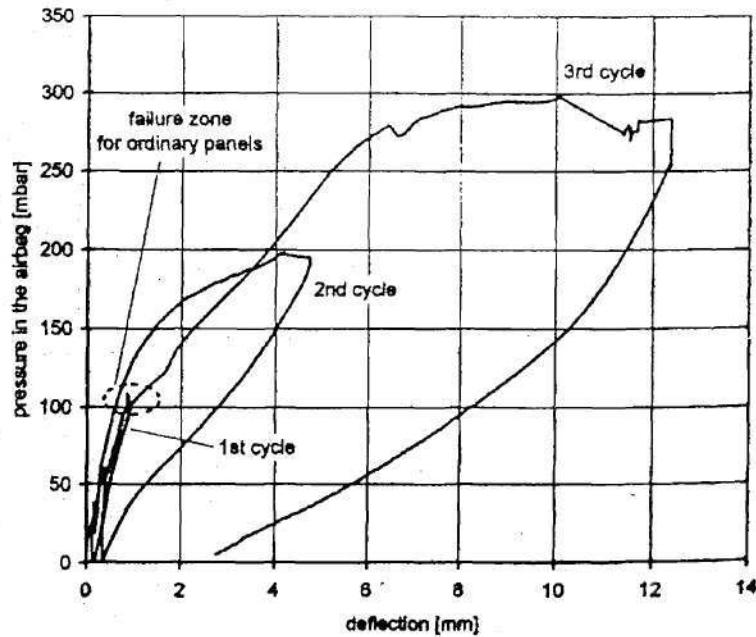
Figure 2.27. Force-displacement response (taken from Kolsch, 1998)

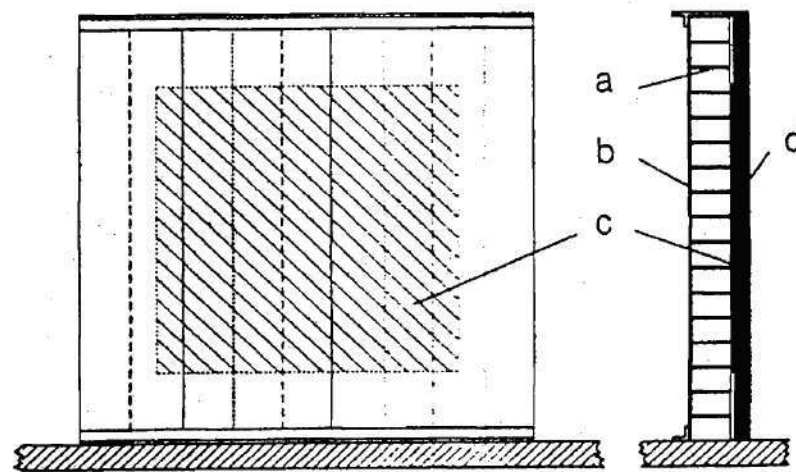
Figure 2.26. Schematic of test setup (taken from Kolsch, 1998); (a) masonry wall; (b) overlay; (c) pressurized airbag; (d) reaction wall

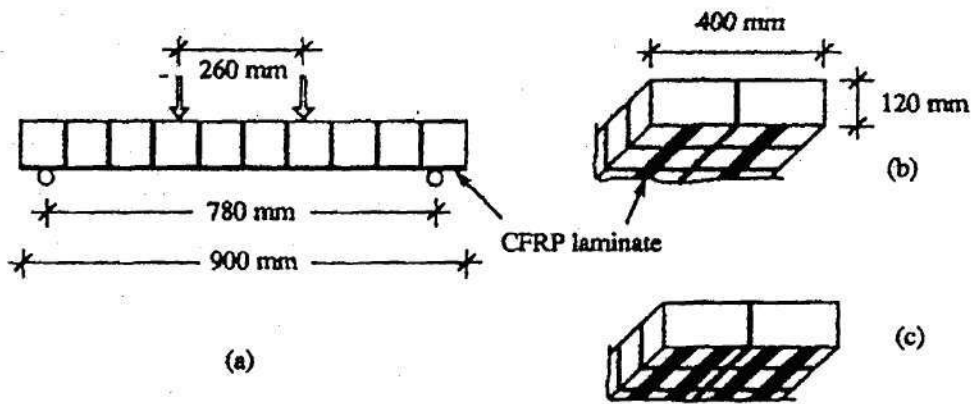
Figure 2.25. Schematic of test setup (taken from Triantafillou, 1998)

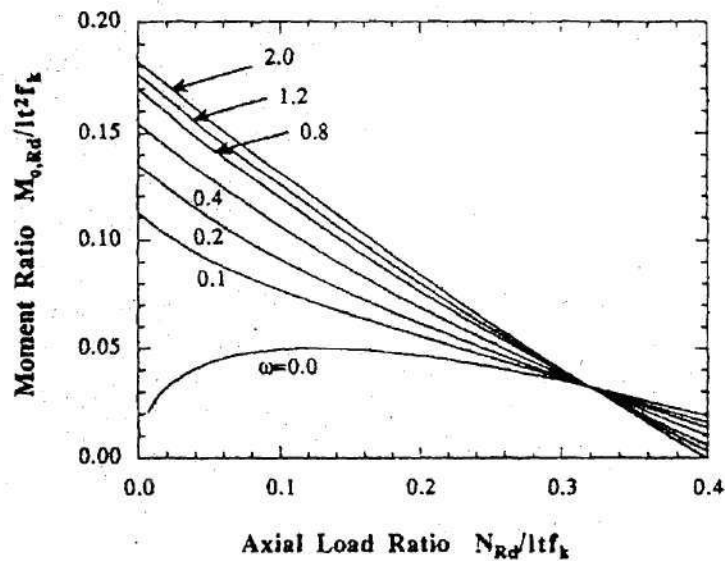
Figure 2.24. Moment Capacity versus Axial load for various normalized FRP area fractions (taken from Triantafillou, 1998).

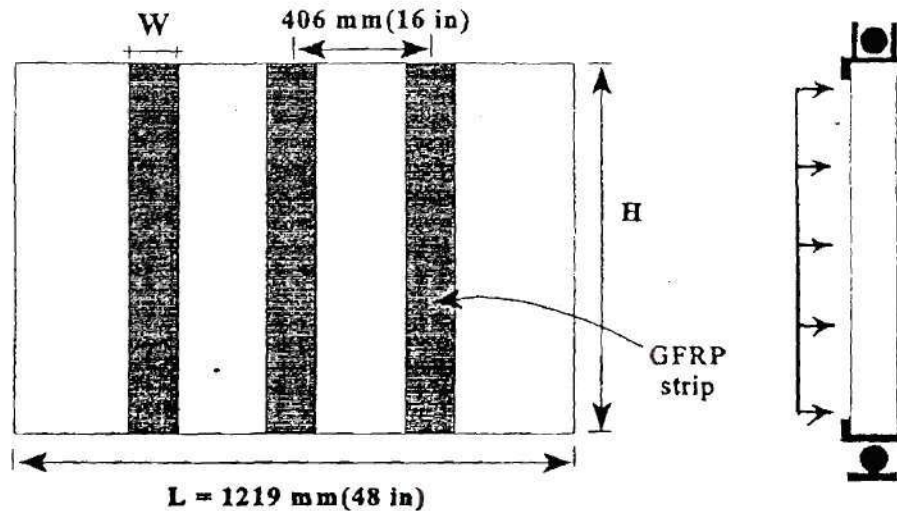
Figure 2.23. Schematic of test setup (taken from Dimas et al., 2000a)
