E-20137

PROGRESS REPORT

LARGE-SCALE TESTS OF A LOW-RISE UNREINFORCED MASONRY BUILDING SYSTEM

March 1, 2002

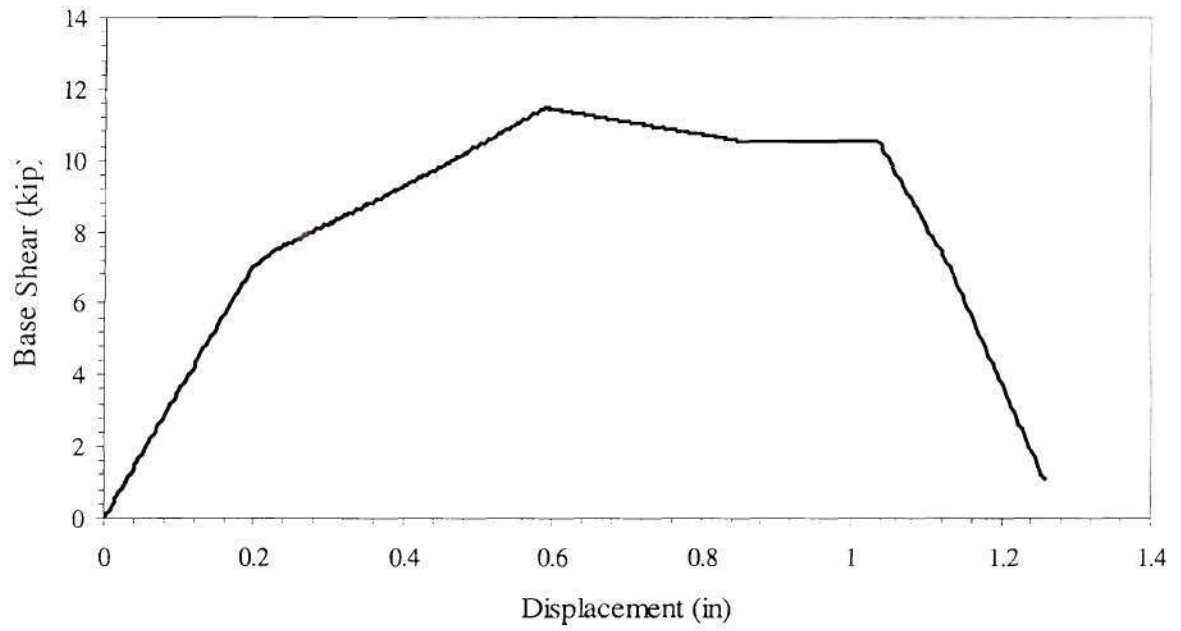
Figure 4.27. Force-displacement curve obtained from pushover analysis of Wall 2.

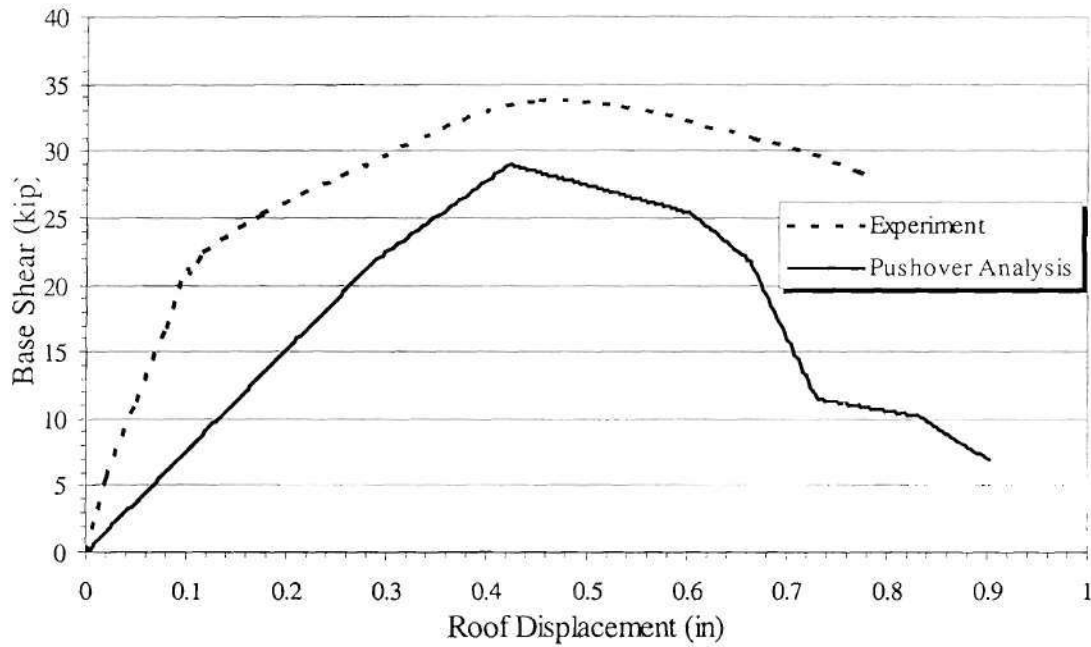
Figure 4.23. Comparison of pushover analysis with Wall D (Magenes et al , 1995)

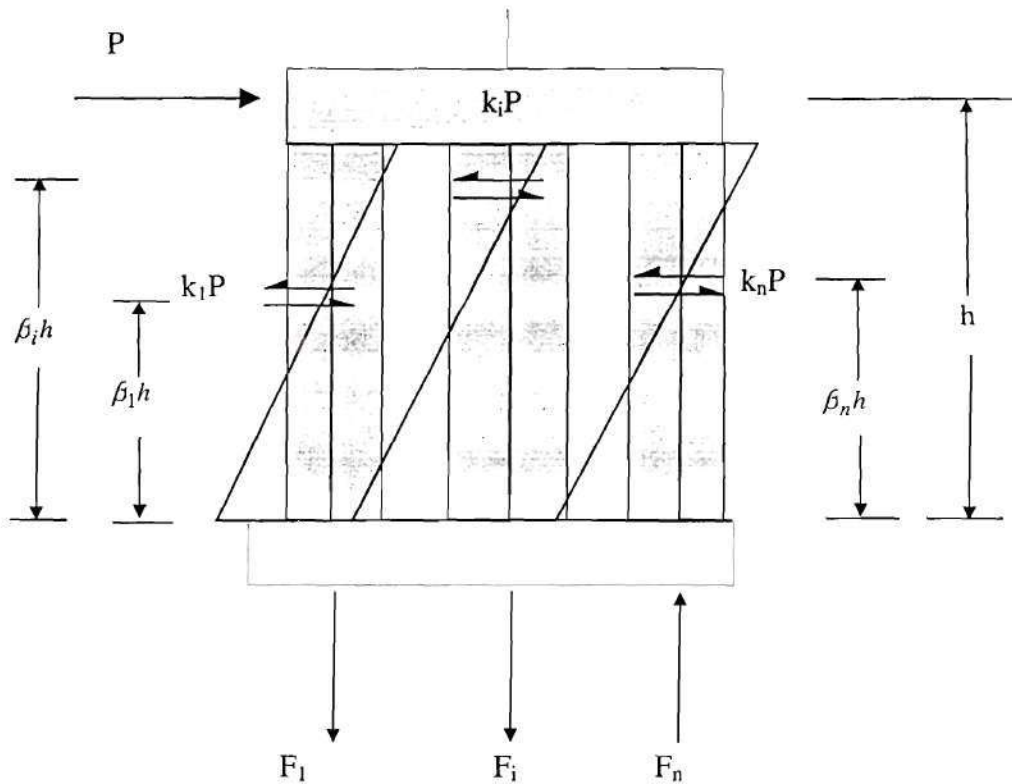
Figure 4.17. Idealized perforated wall

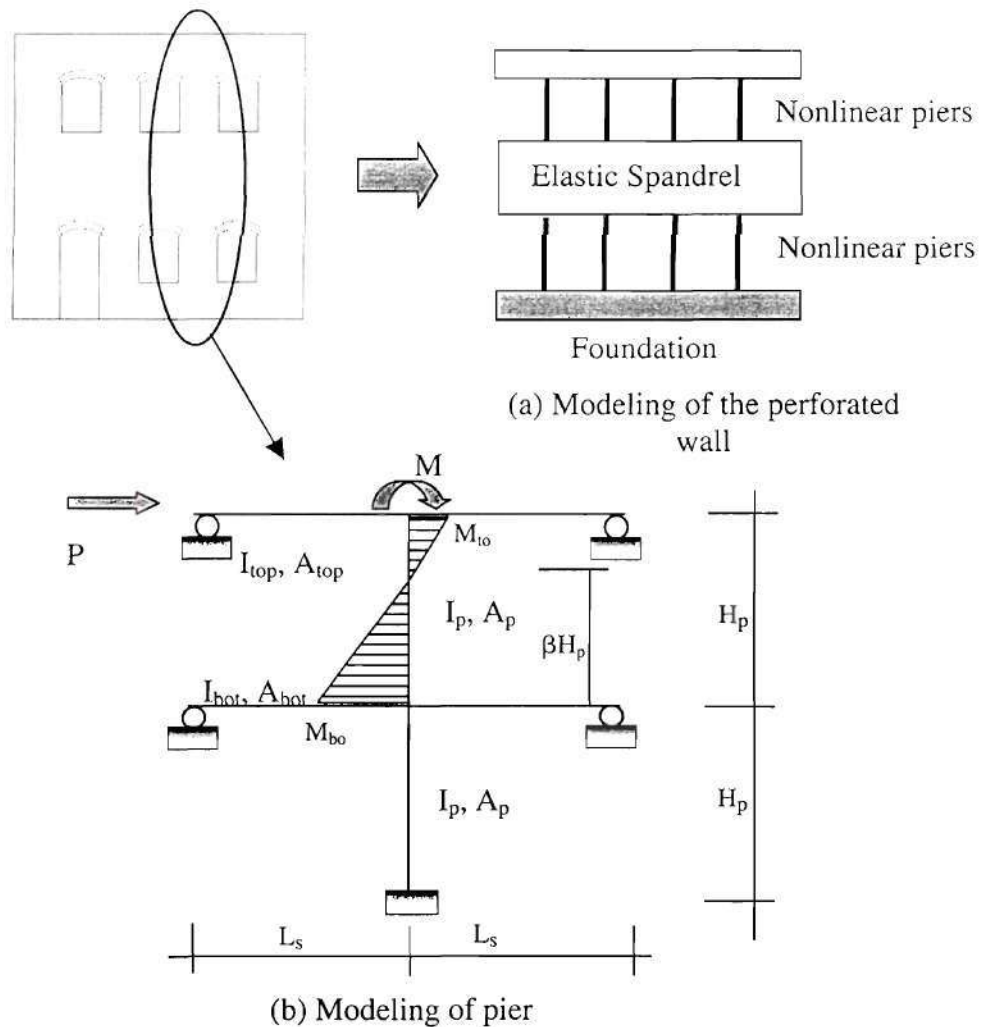
Figure 4.16. Concepts of elastic spandrel-nonlinear pier model

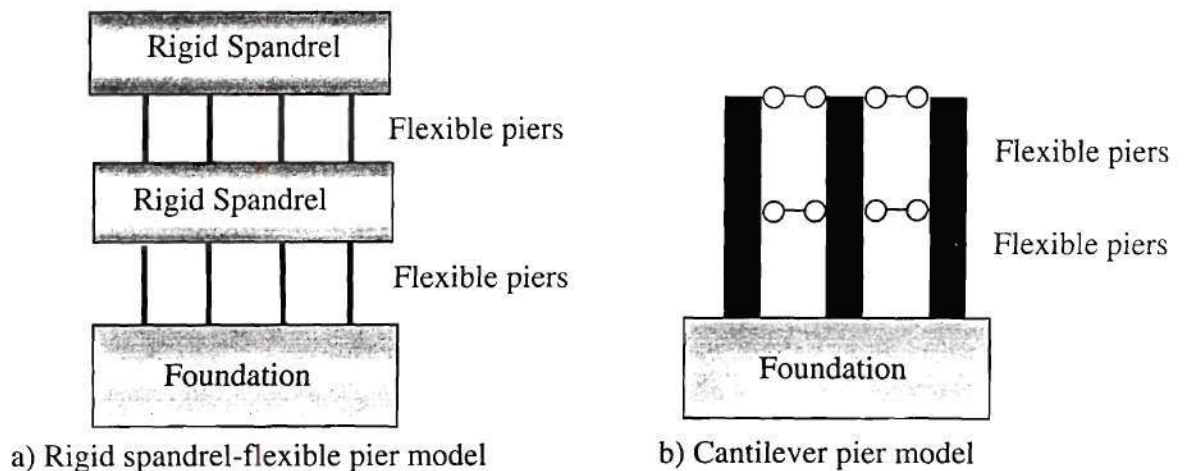
Figure 4.15. Idealized perforated wall models

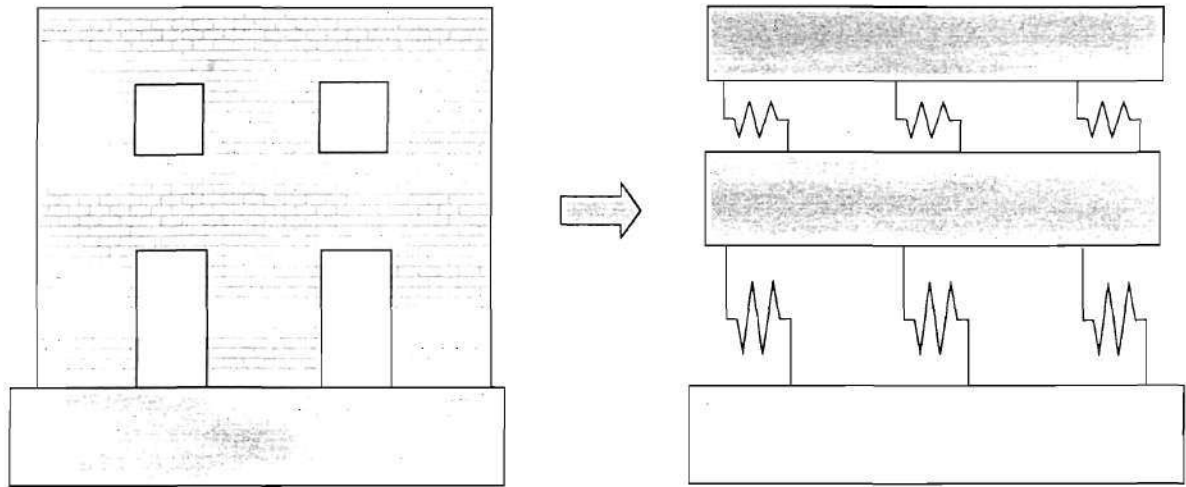
Figure 4.13. URM perforated wall and pushover model.

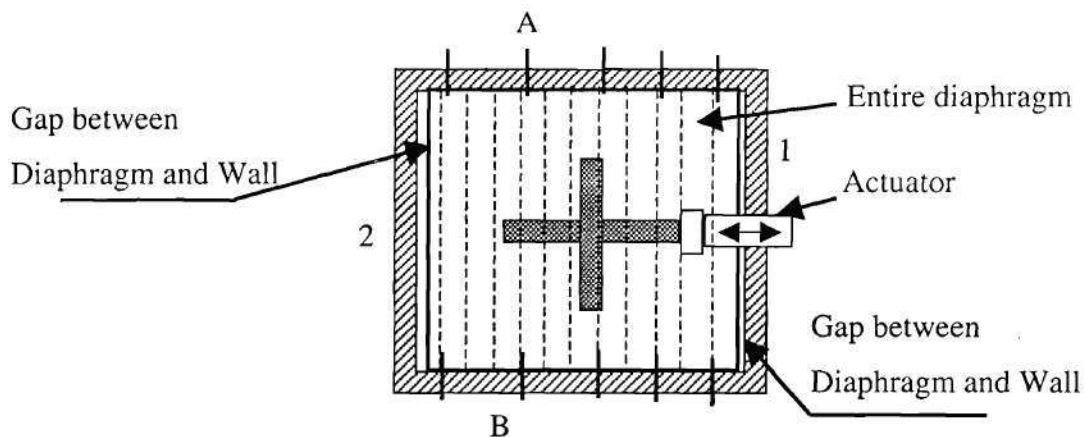
Figure 3.29. Testing of the entire diaphragm perpendicular to the joists

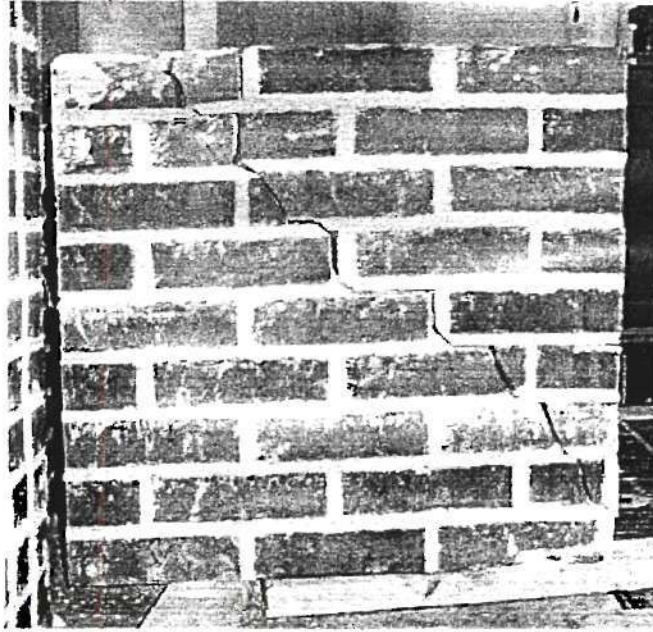
Figure 3.25. Photograph of shear failure through brick.

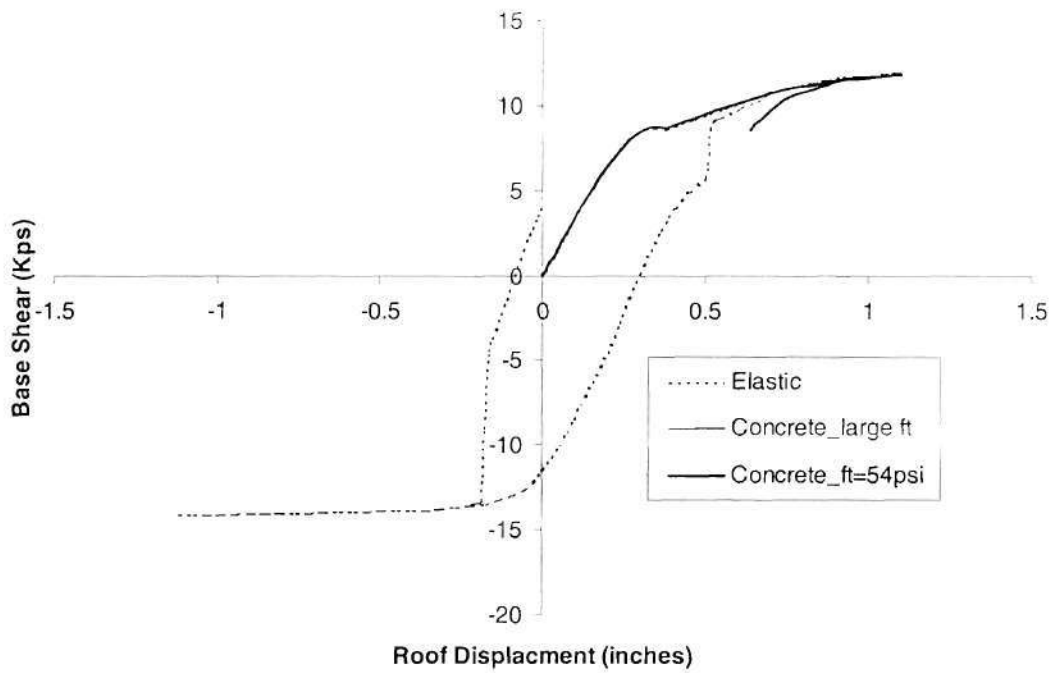
Figure 4.50. Force–displacement response of Wall 2 with different masonry properties (beginning with push to the right)

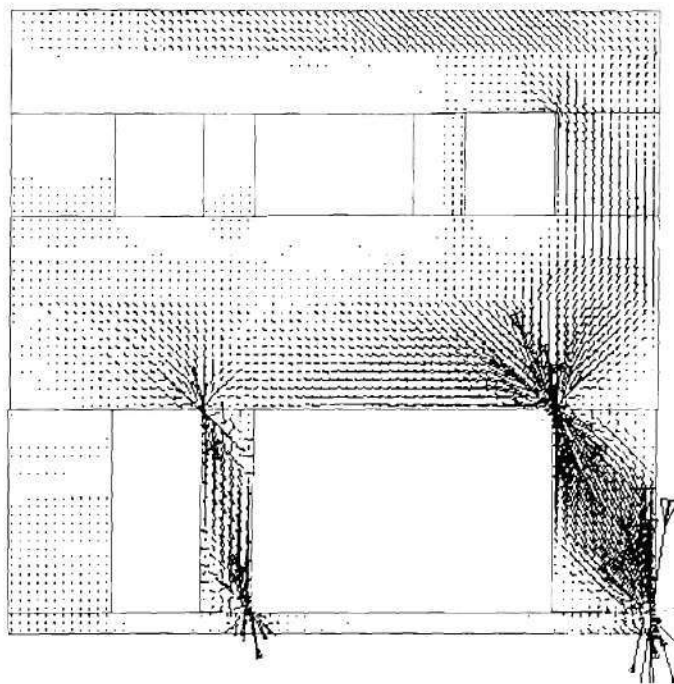
Figure 4.47. Stress contour of Wall 2 (loaded to the right)

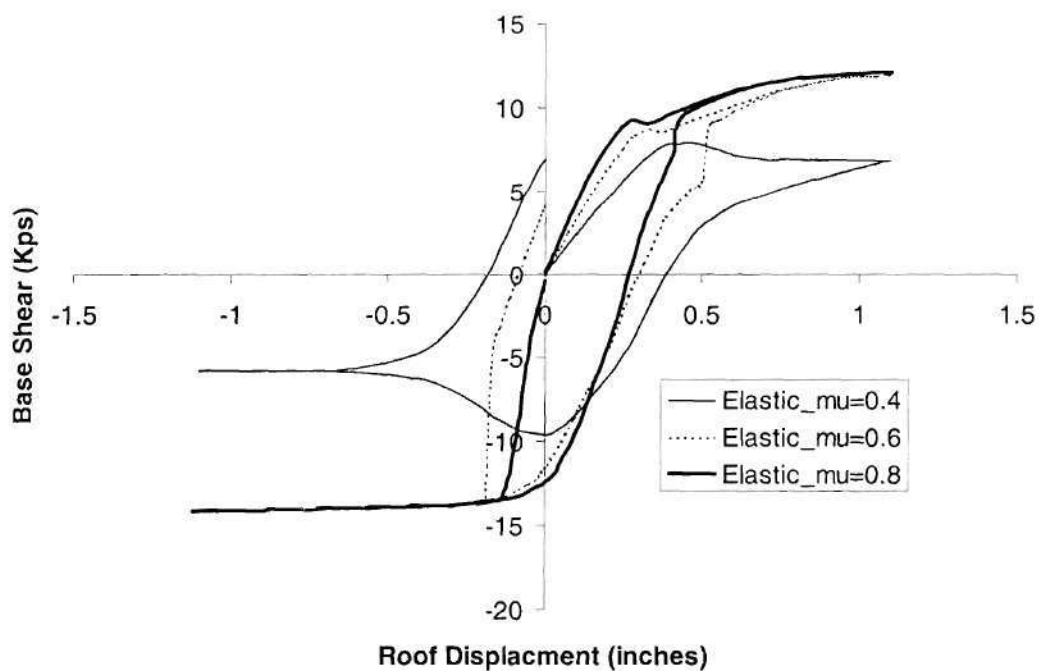
Figure 4.45. Force–displacement response of Wall 2 with different friction coefficients

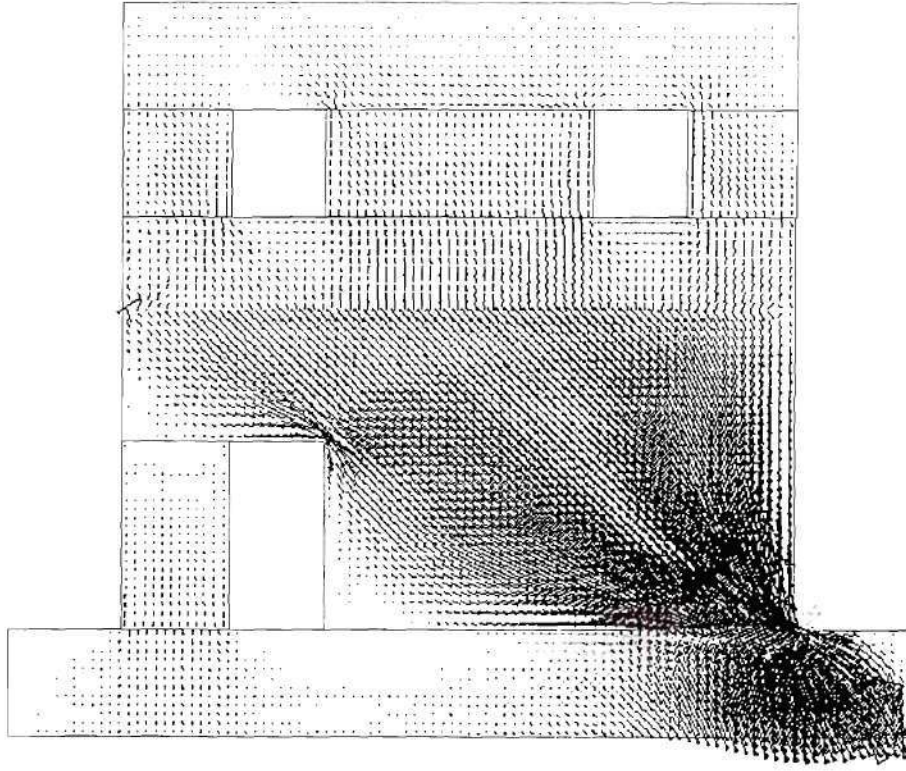
Figure 4.42. Stress contour of Wall 1 (loaded to the right)

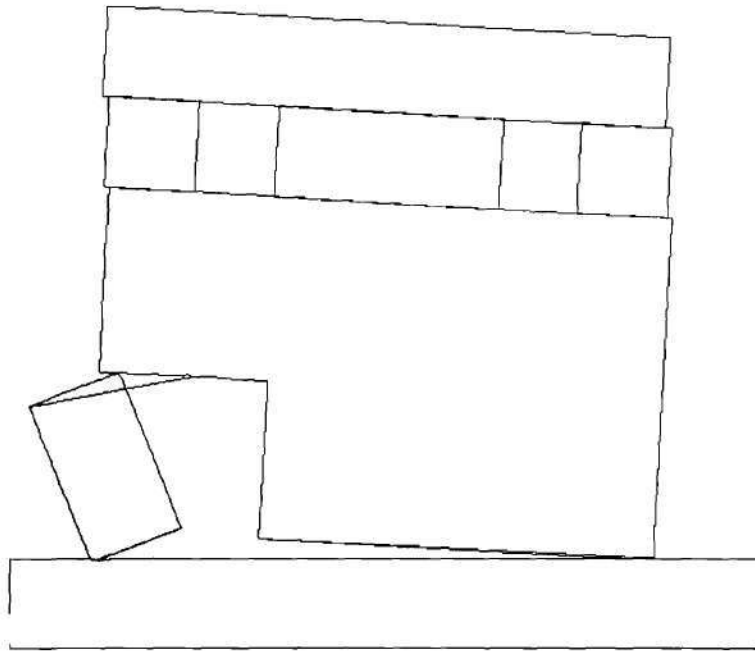
Figure 4.39. Deformed shape of Wall1 (loaded to the left)

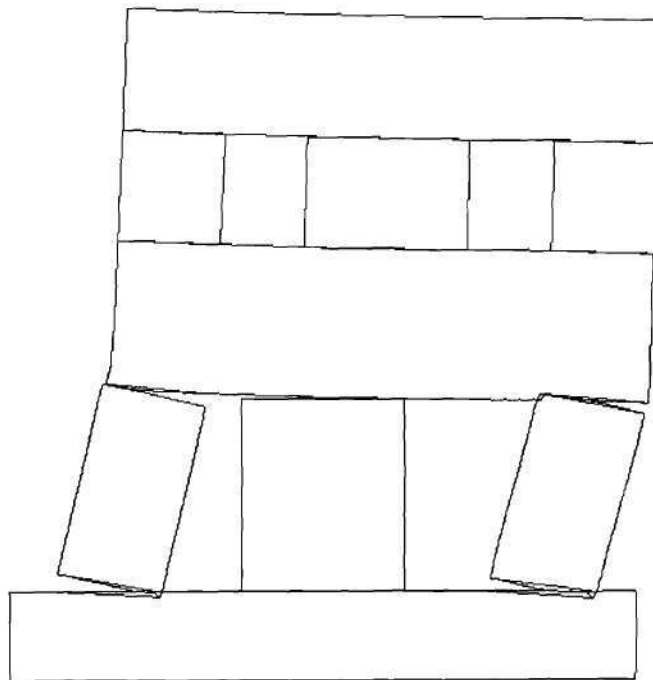
(b) Rocking and sliding of Wall D

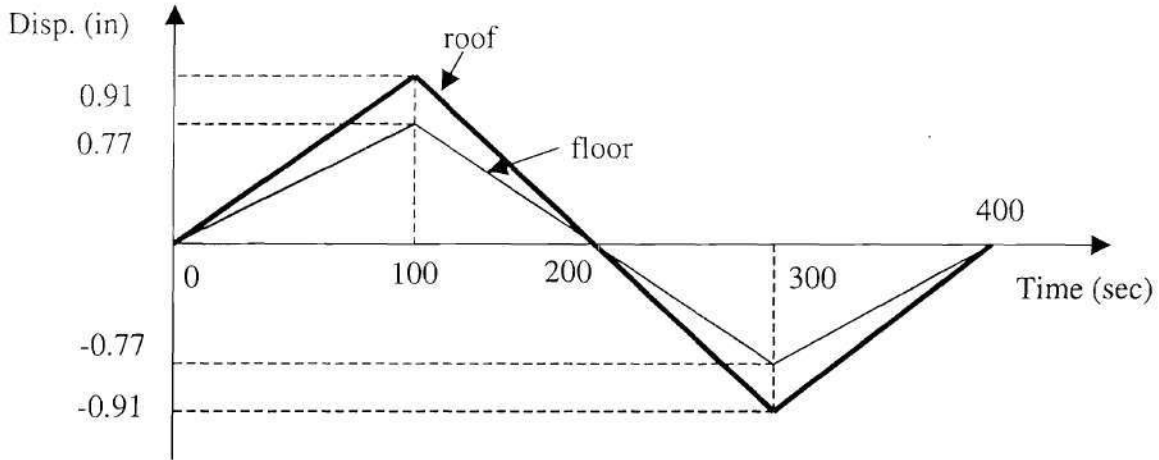
Figure 4.34. Time history for the analysis of the full-scale test in Univ. of Pavia

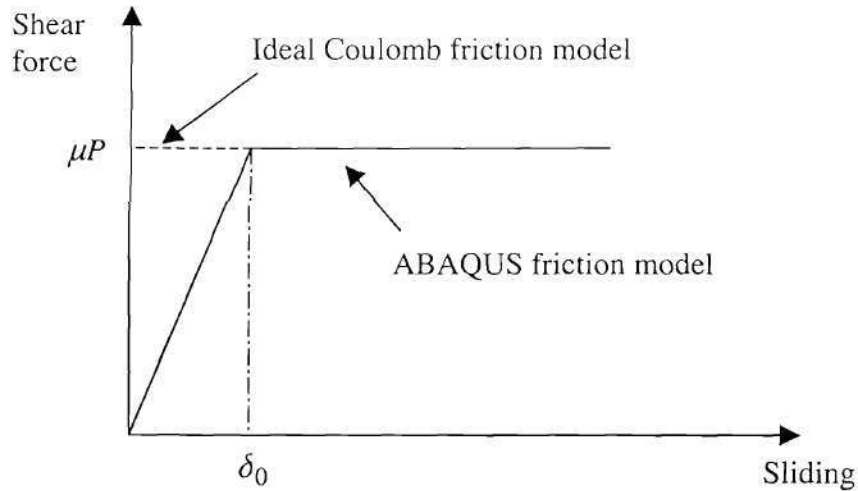
Figure 4.32. Force-Relative displacement relationship for contact elements.

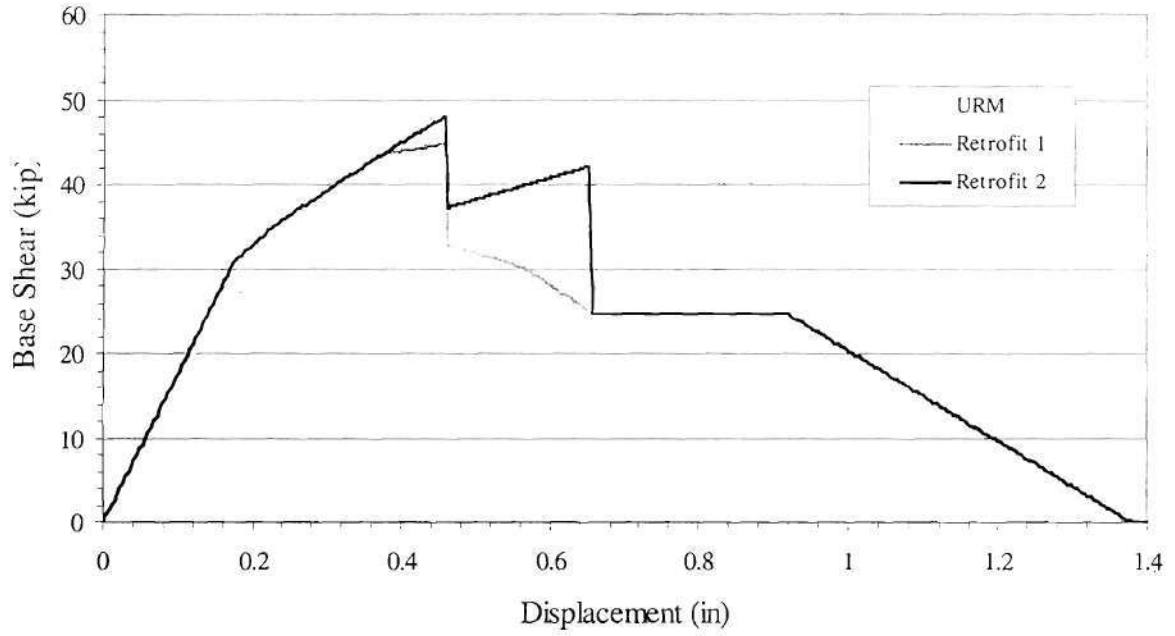
Figure 4.66. Force-displacement curves for Wall 1 in an unreinforced state and after retrofit schemes 1 and 2

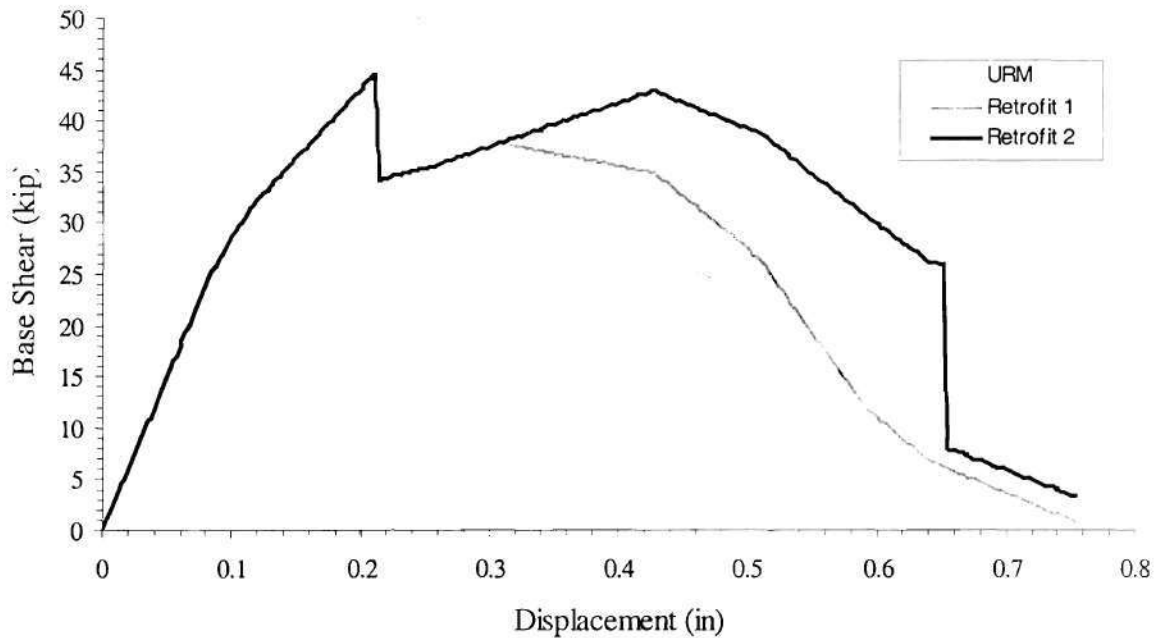
Figure 4.65. Force-displacement curves for Wall AB in an unreinforced state and after retrofit schemes 1 and 2

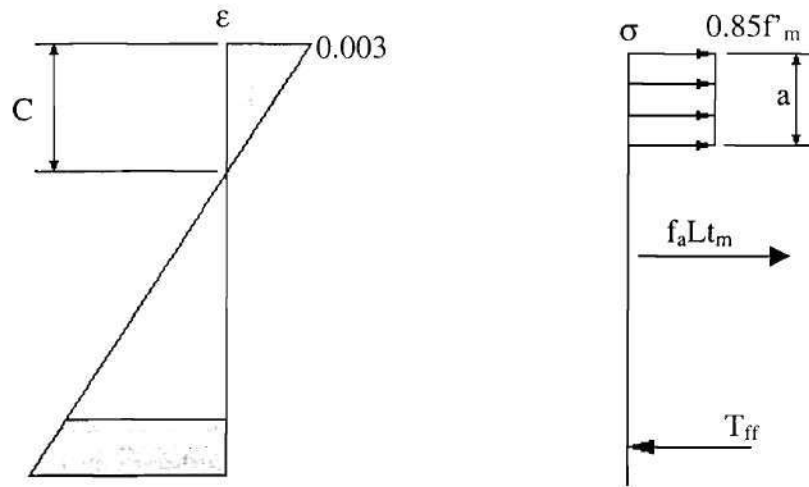
Figure 4.62. Strain and Stress Diagram used to calculate shear capacity associated with the compressive failure of masonry.

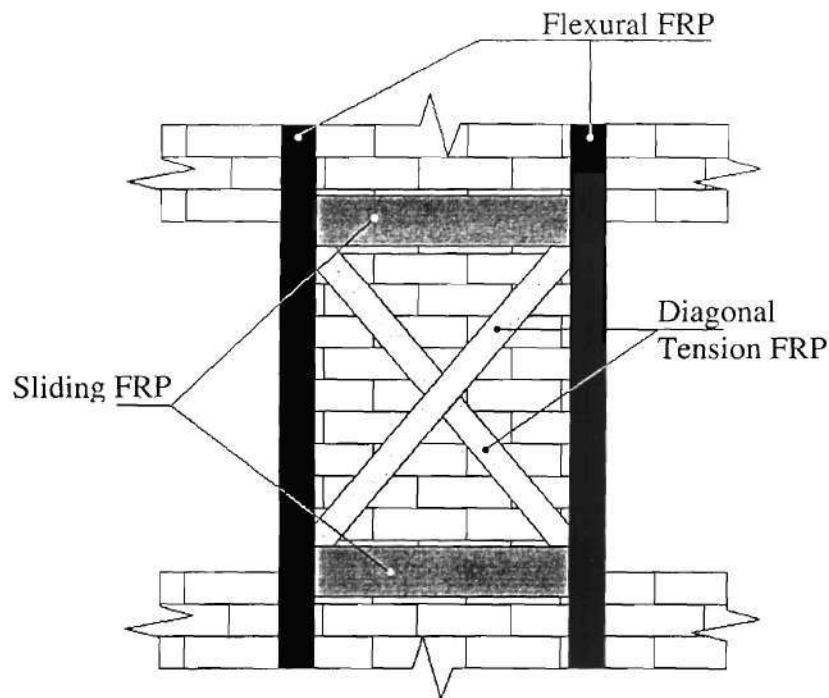
Figure 4.60. URM Retrofit with FRP Strips

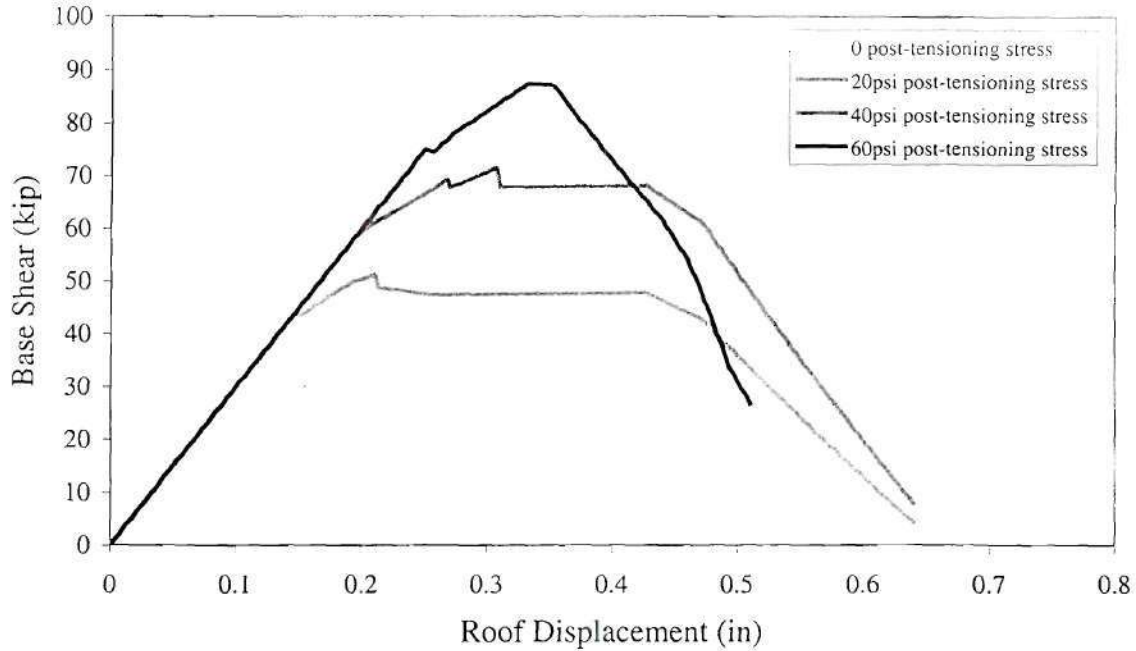
Figure 4.59. Force-displacement curves for Wall AB retrofit with different levels of post-tensioning stress

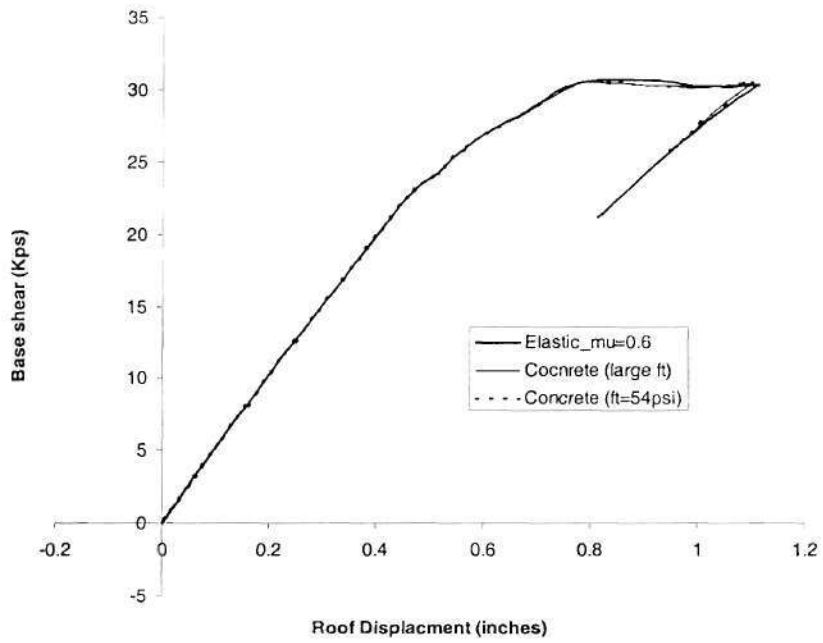
Figure 4.57. Force–displacement response of Wall AB with different masonry properties (beginning with push to the right)

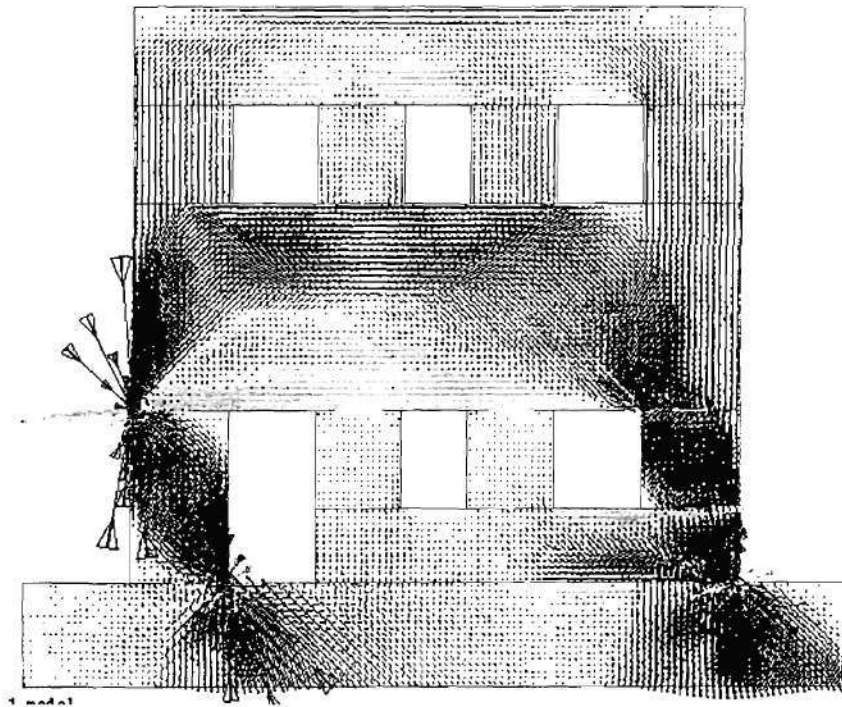
Figure 4.54. Stress contours of Wall AB (loaded to the right)

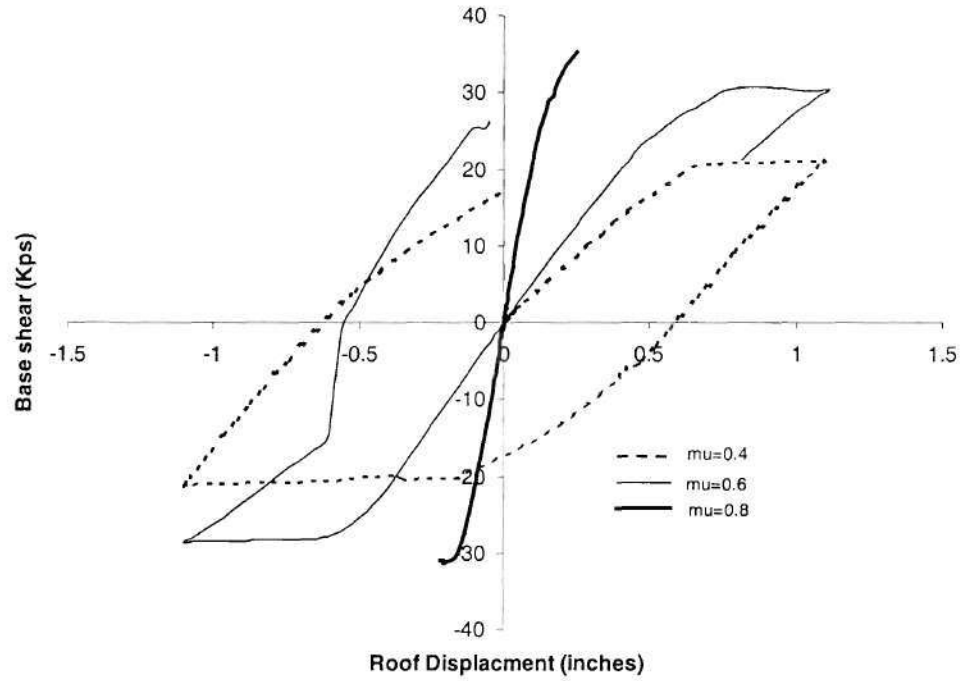
Figure 4.52. Force–displacement response of Wall AB with different friction coefficients
