Hydrologic Restoration of the Biscayne Bay Coastal Wetlands: mosquito and drainage ditch inventory and recommendations

Southeast Environmental Research Center, Florida International University

26 August 2004

Cooperative Agreement H525003D084

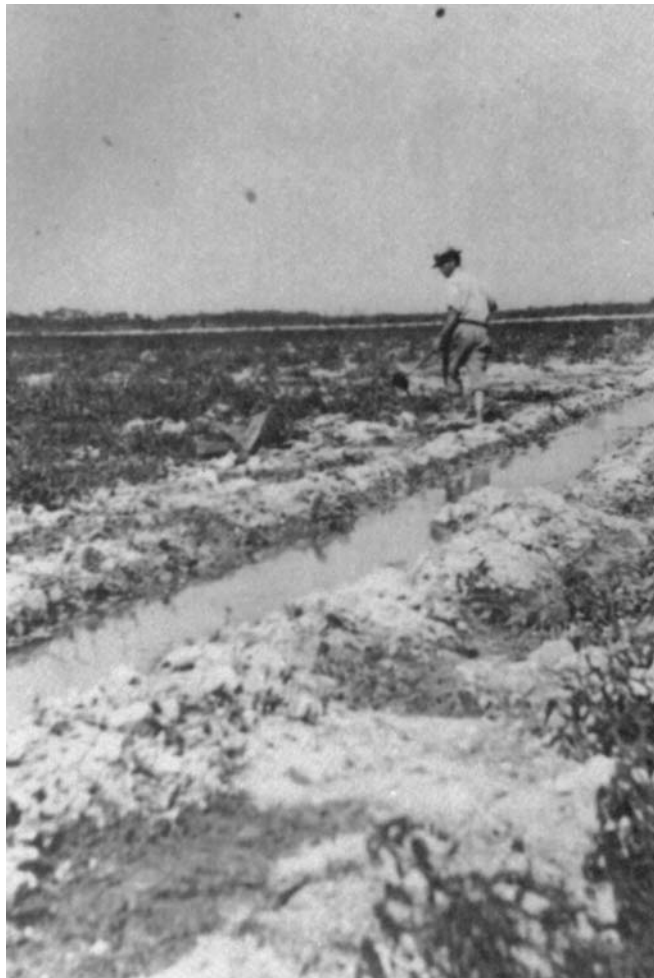
Figure 1: Agricultural drainage ditch in the East Glade agriculture area. Photograph courtesy the Jean Taylor Collection, Historical Museum of Southern Florida.

Based on county records, the construction of mosquito ditches by the county started in the early 1930's with the creation of the Dade County Anti-Mosquito District in 1933. The District was charged with controlling and eliminating the spread of the disease-bearing yellow fever mosquito *Aedes aegypti* and the black salt marsh mosquito *Aedes taeniorhynchus* (Annual Report of the Dade County Anti-Mosquito District 1940). However, by this time, landowners and homesteaders had already begun ditching and draining the BBCW for agriculture and land reclamation. These agricultural ditches generally ran from west to east, and were 1.2 meters wide by 1.2 meters deep (**Figure 1**). In later years, they were used by the Anti-Mosquito District

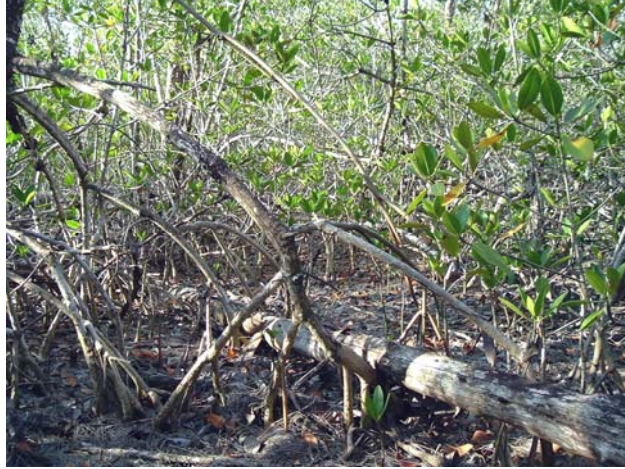
Figure 4a: Mosquito ditch silted-in and hydrologically inert.

A total of 554 mosquito ditches and 102 drainage ditches were found within the study area (**Table 1** & **Figure 2**). Drainage ditches were generally deeper and longer than the mosquito ditches but not necessarily wider (**Table 1**). Drainage ditches on the west side of the L-31E levee (Reach 2) tended to be uniform in depth, partially silted-in, and stagnant. On the other hand, the drainage ditches on the other three Reaches (1, 3, & 4) tend to widen and deepen towards the coast, with few silted-in. For the most part, these drainage ditches emptied directly into Biscayne Bay. However, some ditches were found draining into existing creeks which then emptied into Biscayne Bay. Mosquito ditches, in turn, were found partially or fully connected to the east-west running drainage ditches. In general, mosquito ditches were found in one of the following three conditions: 1) silted-in and hydrologically inert (**Figure 4a**), 2) not fully silted-in but hydrologically inert (**Figure 4b**), or 3) partially silted-in but hydrologically active (**Figure 4c**).

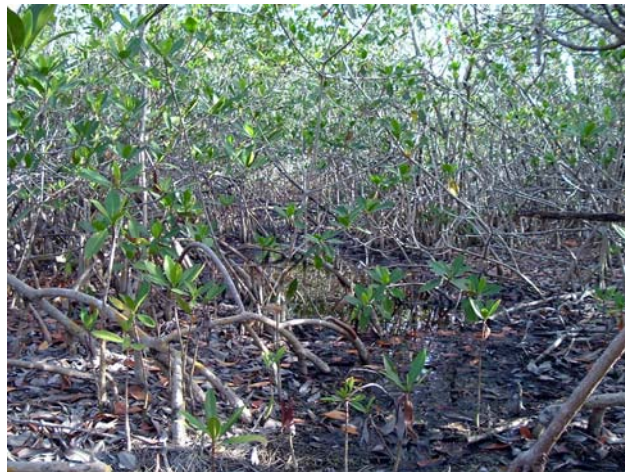
Figure 4b: Mosquito ditch not fully silted-in but hydrologically inert.

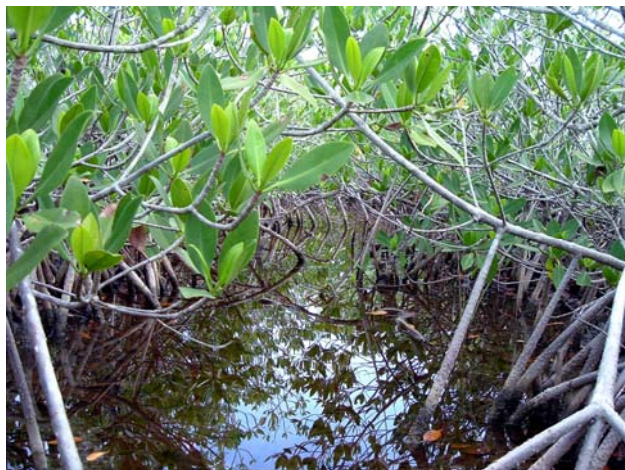
Figure 4c: Mosquito ditch partially silted-in but hydrologically active.

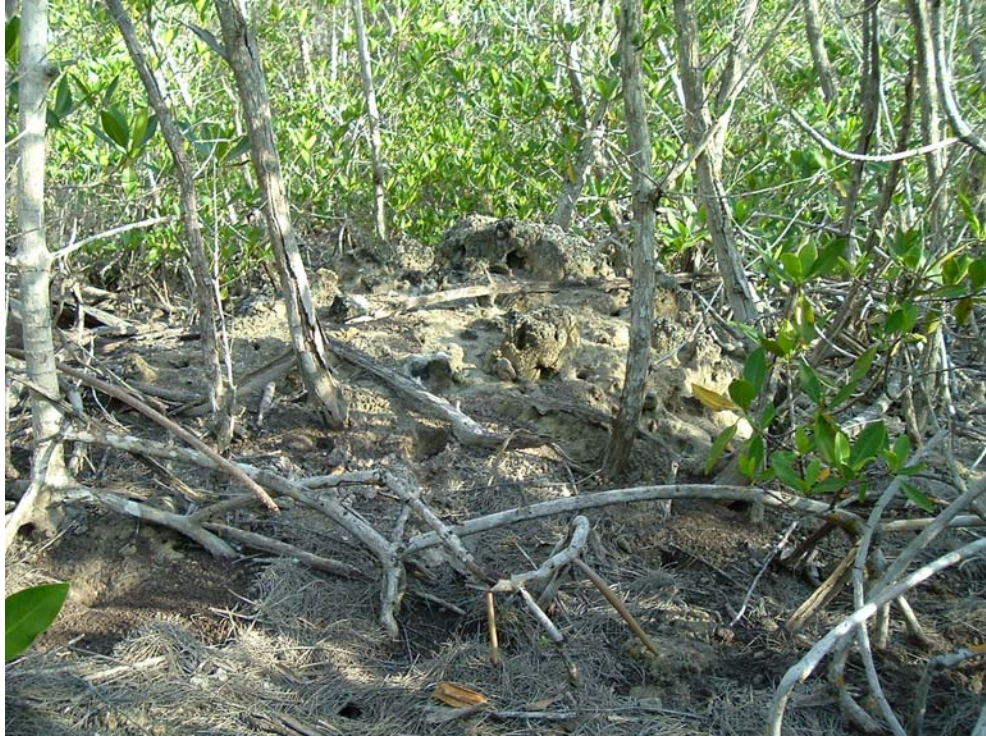
Only in Reaches 1, 2, and 3 were spoil mounds associated with each mosquito ditch. Where spoil mounds existed, they were generally found paralleling the mosquito ditches 5 to 10 meters on either side at four meter intervals. Mounds were generally 5 x 3 x 0.35 meters in size (L x W x H). However, mounds in Reach 2 tended to be twice as long (ca. 11 meters) and slightly higher (0.5 m) than those of Reach 1 and 3. Spoil mounds were also found adjacent to the drainage ditches. However, these mounds tended to be larger (ca. 5 x 15 meters in size in some places) and not as evenly distributed as along the mosquito ditches. In general, mounds consisted of a hardened marl substrate with some or no vegetation (**Figure 5**). However some mounds (Reach 2) were heavily vegetated and covered by a deep litter layer (ca. 30 cm deep) of *C. equisetifolia* detritus.

Figure 5: Typical spoil mound found adjacent to most mosquito ditches within the Biscayne Bay Coastal Wetland complex.

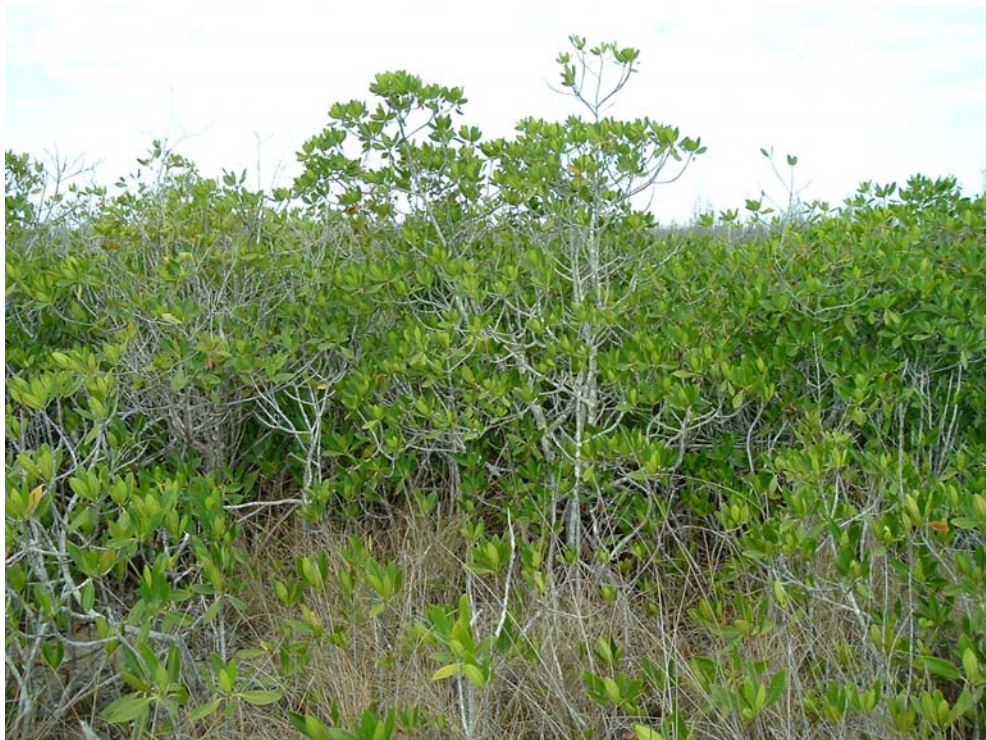
Beside the adjacent spoil mounds, the adjacent ditch banks were generally well vegetated (**Figure 6**). The type, density, and height of the vegetation varied throughout the study area. Mosquito ditch bank vegetation in Reach 1 was exclusively mangrove except for some of the northernmost mosquito ditches near the L-31E Levee where dead and living *C. equisetifolia* trees, some > 12 meters tall were found with *Conocarpus erectus*, *R. mangle*, and *L. racemosa*. In Reach 2, mosquito ditches were flanked on either side by dense *C. equisetifolia* along with *M. cerifera*, *C. erectus*, *R. mangle*, and *L. racemosa*. In Reaches 3 and 4 the vegetation was predominantly a thick mangrove wall < 3 meters tall. Vegetation composition along the drainage ditches resembled that of the mosquito ditches, though vegetation height and density tended to be greater in the former.

Figure 6: Vegetation growth along the bank of a typical mosquito ditch in Reach 1.
