Accelerated Weathering of Overhead Loadbreak Switch Interrupters NEETRAC

Frank C. Lambert
Georgia Tech / NEETRAC

High Voltage Switch Subcommittee

October 15, 2008

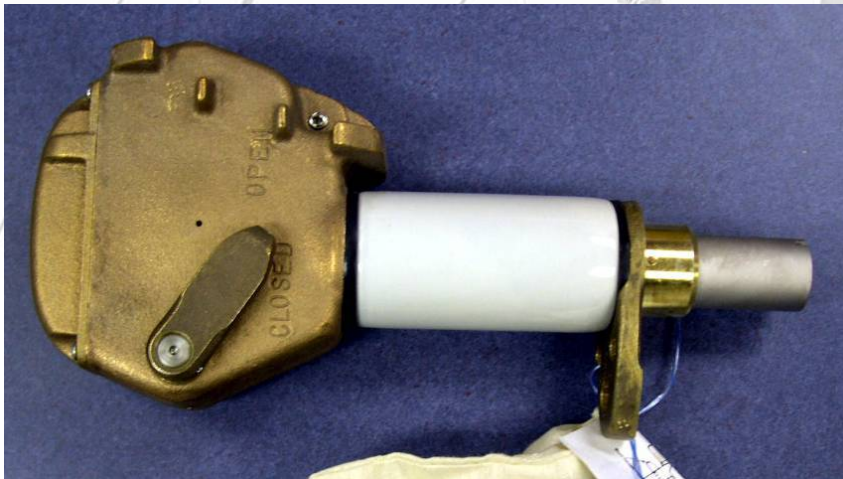
S&C Electric Company
Alduti-Rupter
17 kV, 600 A
137512R7-S102

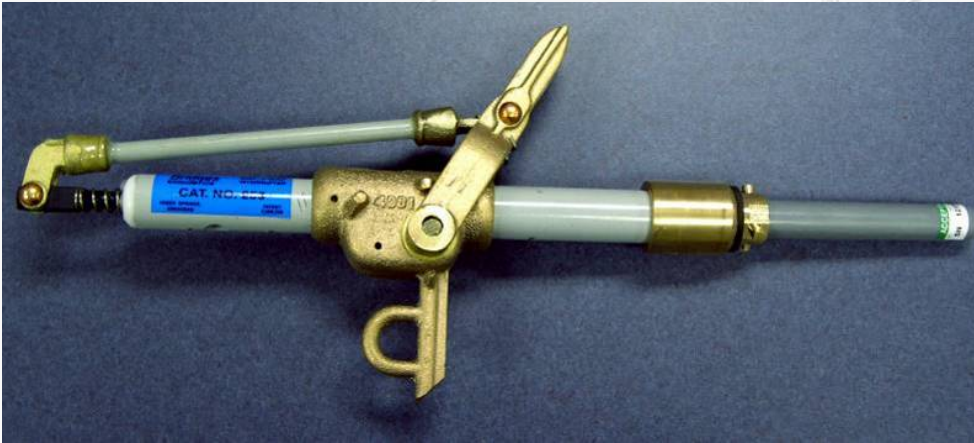
Bridges
Vector
25 kV, 900A
PN963XF-41AS

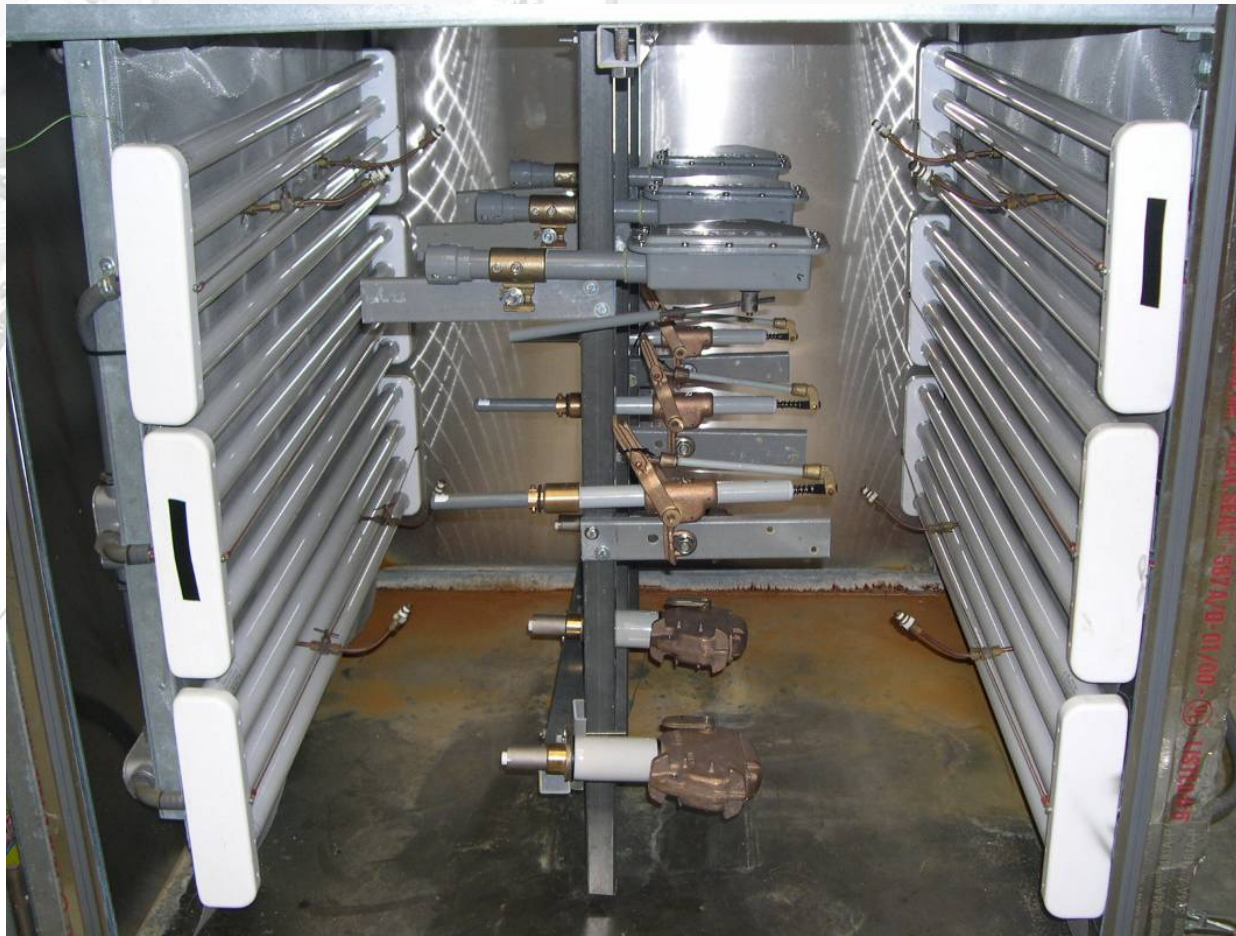
UV / condensation aging according to ASTM D4329-05 and ASTM G154-06 using UVA-340 lamps.

- 2,000 hours total aging was required to produce results similar to those observed on field aged units (includes UV & condensation periods).
- The following aging cycle was used:
 - 8 hours of UV at 60 ± 3 °C
 - 0.25 h water spray (no light), temperature not controlled
 - 3.75 h condensation at 50 ± 3 °C
- Rotation of samples approximately every 333 hours, horizontally across the rack.
- Distilled water was used for the chamber.

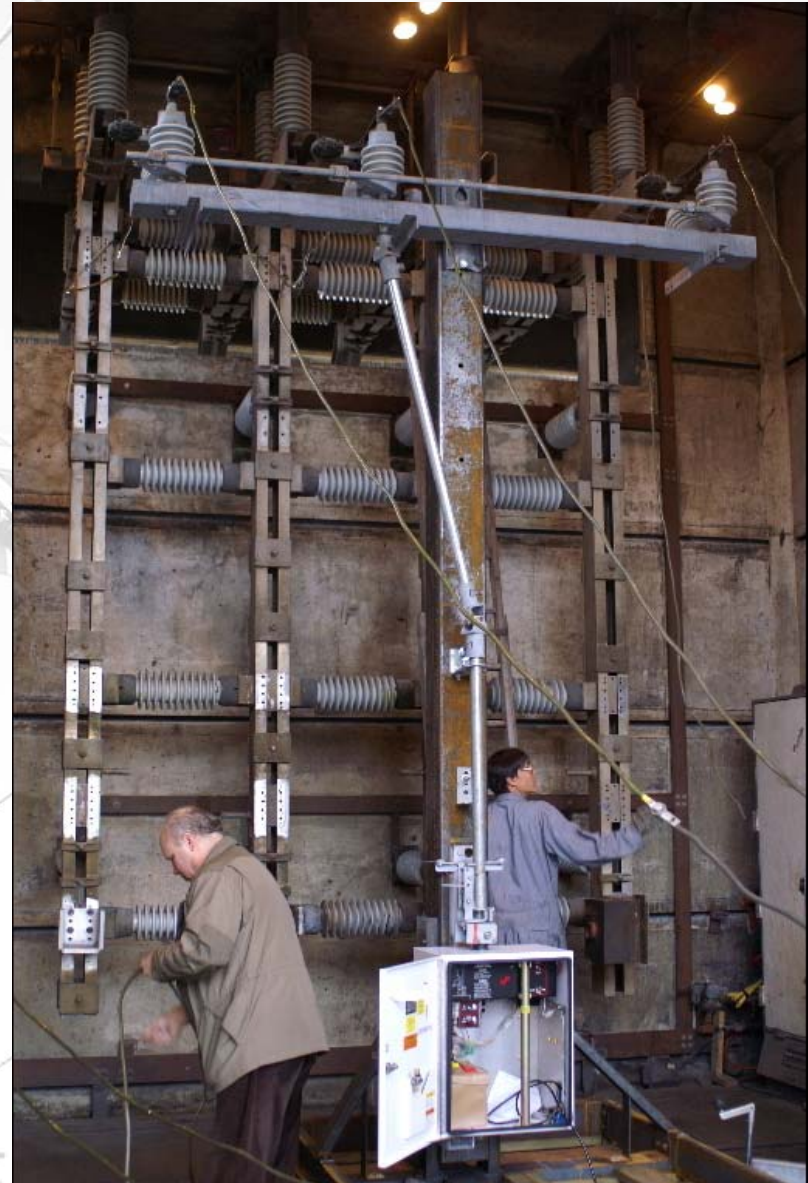
- Performed at Powertech Labs – October 2007
- IEEE Std 1247™ 2005, Clause 8.3.2.1, Load-switching tests
