Façade seismic failure simulation of an old Cathedral in Colima, Mexico by 3D Limit Analysis and Nonlinear Finite Element Method

Preciado, A., Orduña, A, Bartoli, G. and Budelmann, H. (2015). "Façade seismic failure simulation of an old Cathedral in Colima, Mexico by 3D Limit Analysis and Nonlinear Finite Element Method". *Journal of Engineering Failure Analysis*, 49: pp. 20-30.

1 **“Façade Seismic Failure Simulation of an Old Cathedral in Colima, Mexico by 3D**
2 **Limit Analysis and Nonlinear Finite Element Method”**

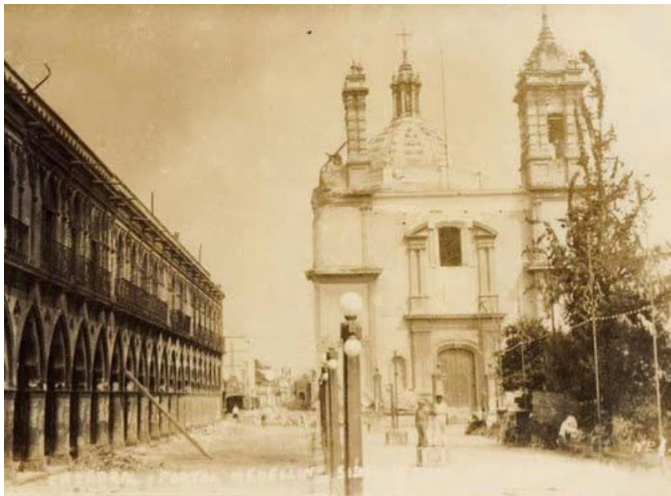
512 Figure 3: Observed damage at the Cathedral of Colima by the 1941 M7.6 EQ; (a) before EQ and

99 The Cathedral of Colima, Mexico (Figs. 1 and 3) was built in 1889 and is recognized by the
100 National Institute of Anthropology and History of Mexico (INAH), and the society, as one of the
101 most important Colonial monuments of all the state of Colima due to its great historical and
102 cultural value. The materials used for its construction were fired clay bricks and carved stone
103 with lime mortar for all the vertical elements such as walls and towers and empty fired clay mugs
104 in a mortar matrix for the vaults. The Cathedral is located at the historical center of Colima City.
105 Historically, the building has been strongly damaged by a large EQ in 1941 of M7.6 (MMI X)
106 that generated the collapse of the East tower and strong damage to other parts of the building as
107 illustrated in Figure 3b. In 2003, Colima City was struck again by a similar damaging M7.5 EQ,
108 but was felt with different intensity at the Cathedral's site (MMI VIII). The rupture mechanism of

172 It is worth noting, in the crack patterns after the 1941 and 2003 EQs of Figures 3 and 4, that the
173 $-X$ direction of the building (main façade to the left, East) was the most vulnerable, presenting
174 strong structural damage with the collapse of the left belfry in the 1941 event. Based on the
175 observed crack pattern, the 3DLA is developed for a seismic action in the $-X$ direction. The crack
176 pattern and our own experience in EQ failure of structures serve as the basis for constructing the
177 rigid blocks model for this specific direction. The interfaces between rigid blocks are modeled as
178 well, based on the direction of the EQ seismic forces, as illustrated in Figure 5. In order to
179 simplify the nonlinear analyses and to avoid non convergence problems related to the size and
180 complexity of the Cathedral only the most damaged part is analyzed. The main façade with both
181 bell-towers is assessed under a seismic action in the $-X$ direction. This specific direction was

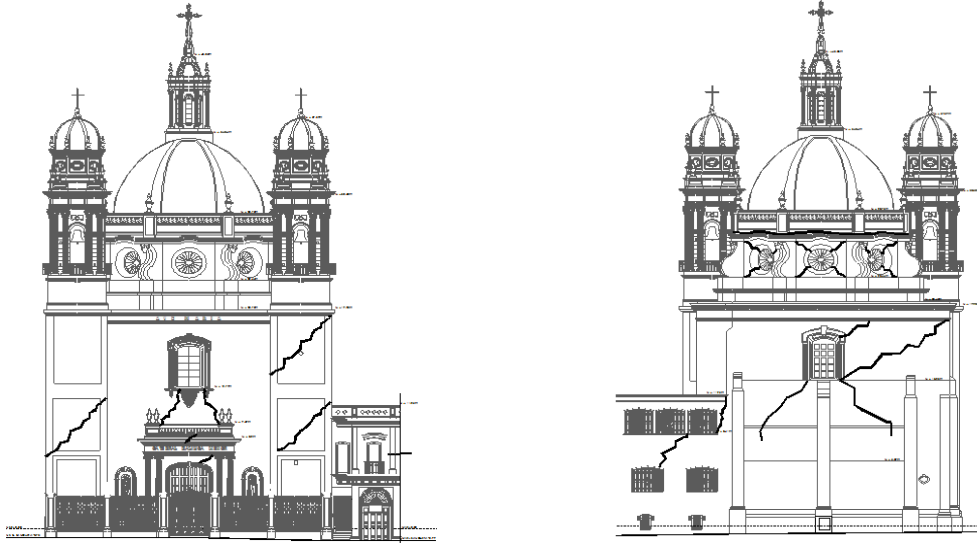
521 Figure 4: Observed failure mechanisms at the Cathedral by the 2003 M7.5 EQ; (a) crack pattern

522 at main and back façades and (b) crack pattern at lateral façades

109 both strong EQs was generated by the convergence of the Cocos and North American plates. The
110 later EQ generated strong damage to the complete building as shown in the crack patterns of
111 Figure 4. The vaulted cover structure and dome were damaged, as well as the façades, especially
112 the frontal one (North) including both bell-towers. The building was subjected to rehabilitation
113 works and a rough seismic retrofitting measures by the addition of steel mesh and mortar at the
114 dome and cover, as well as reinforced concrete rings at belfries. The rehabilitation and
115 strengthening works were developed by the authorities without a reliable seismic analysis of the

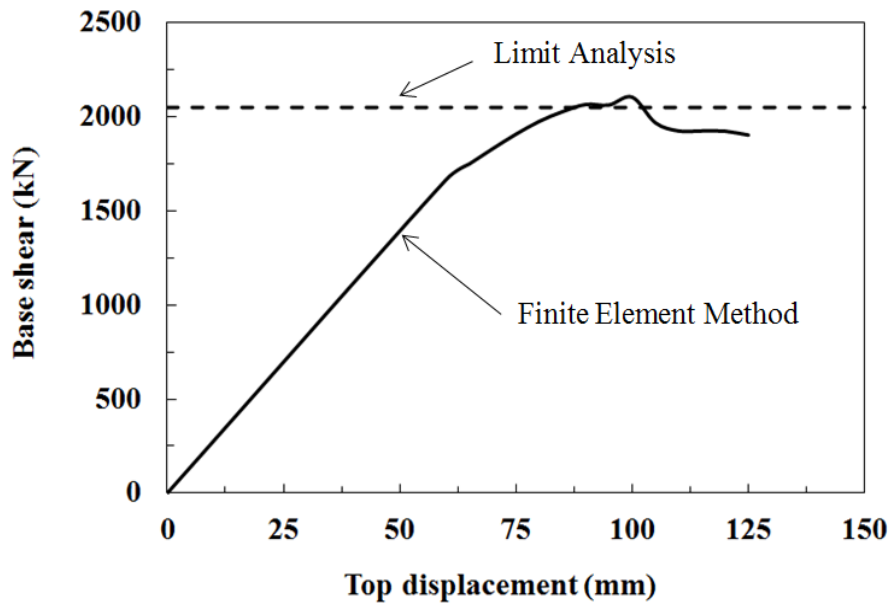
536 Figure 6: Results of the 3DLA for an EQ in -X; (a) failure mechanisms at the Cathedral's main

537 façade at ULS and (b) 3DLA vs. FEM capacity curves

201 Taking into account the aforementioned, it is assumed that for an EQ in the $-X$ direction the main
202 façade including both bell-towers (see Fig. 6a) is completely disconnected from the nave and
203 generates a macro element independent of the rest of the building (Lagomarsino, 1998). Due to
204 the lack of information about the material parameters, we used in the simulations typical values
205 reported in literature. By means of the reports of INAH (2003) and the historical analysis of
206 section 3, it was observed that the façade is formed by brick masonry with lime mortar and both

210 Figure 6a illustrates the failure mechanisms obtained by the 3DLA at the Cathedral's façade rigid
211 block model subjected to lateral loads in the $-X$ direction. It is worth noting the propagation of
212 vertical cracks due to horizontal tensile stresses that led to a disconnection of the left (East) tower
213 from the façade, as well as a combination of in-plane shear and out-of-plane bending cracks at the
214 tower's lower body. 3DLA accurately predicted the observed failure mechanism at the lower
215 body of the tower due to the 2003 EQ. However, 3DLA did not predict any damage at belfry,
216 which was the most important failure mode as observed in 1941 with a total collapse, and did not
217 reproduce the partial damage due to the 2003 EQ (see Figs. 3 and 4). These results are easily
218 explained: Limit Analysis can be seen as a search for the most critical failure mechanism;
219 therefore, it cannot identify partially developed mechanisms. This is also a consequence of that

220 Limit Analysis works only with displacement rates defining the global failure mechanism, and
221 does not consider actual displacements and strains. At ultimate limit state (ULS), the façade rigid
222 blocks model resisted a lateral force of 2050 kN (seismic coefficient of 0.122) as illustrated in the
223 capacity representation of Figure 6b. This seismic coefficient is obtained by the ratio between the
224 resisted horizontal force (base shear) at ULS and the vertical loading, and may be interpreted as
225 the EQ peak ground acceleration (0.122 g) needed for inducing that failure mechanism.
