Preciado, A., Bartoli, G. and Budelmann, H. (2015). "Fundamental aspects on the seismic vulnerability of ancient masonry towers and retrofitting techniques". *Journal of Earthquakes and Structures*, 9(2): pp. 339-352.

Fundamental Aspects on the Seismic Vulnerability of Ancient Masonry Towers and Retrofitting Techniques

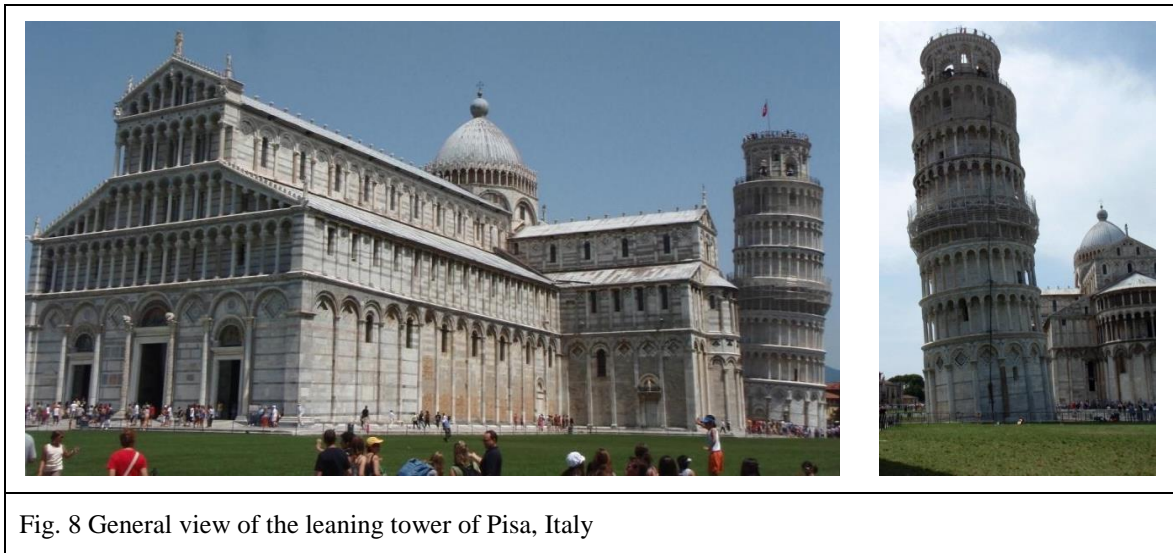
Fig. 8 General view of the leaning tower of Pisa, Italy

Mexico City since decades due to soft soil conditions. The most famous case presented in AMT is the leaning tower of Pisa, Italy. Since its construction in the XII century, it started to lean due to irregularities in the soil conditions, being as a result quite vulnerable to overturning (see Fig. 8).

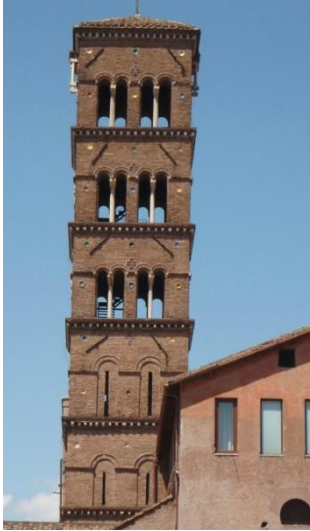
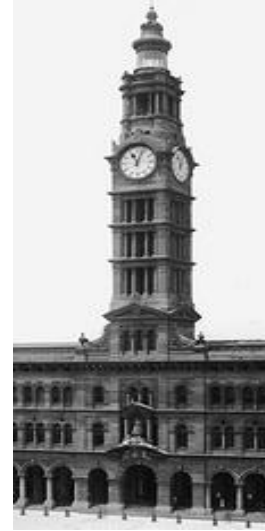
Fig. 1 Historical masonry civic towers; (a) Italian bell towers and (b) Clock tower

Fig. 1 Historical masonry civic towers; (a) Italian bell towers and (b) The General Post Office clock tower in Sydney, Australia

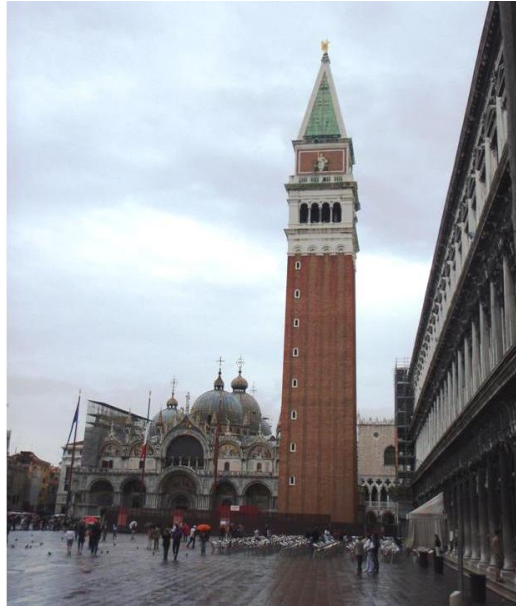
Fig. 6 Replica of the collapsed bell tower of “Piazza San Marco” in Venice, Italy

in Fig. 6), the civic tower of Pavia in 1989 (see Fig. 7) and the bell tower of the church of “St. Maria Magdalena” in Goch, Germany in 1992.

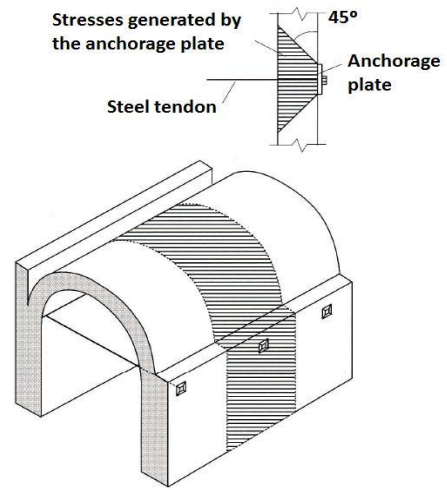
Fig. 14 Presence of horizontal prestressing steel bars in masonry vaulted structures

Horizontal external prestressing (see Fig. 14) has been mainly used in the cultural heritage to provide stability out-of-plane at walls or to reduce the tensile stresses generated by supports opening of vaults, arches and domes (Preciado, 2011). By the other hand, vertical external prestressing has proved to be more suitable to increase the in-plane lateral strength and ductility of masonry walls by providing tensile strength at key locations. The level of improvement strongly depends on the level of the prestressing force, so, the higher the prestressing force the higher the

lateral strength and ductility. Especial careful may be taken into account in order to use this technique in AMT. Firstly, an optimal prestressing level may be designed, due to high prestressing levels could lead to local damage at the top anchorage zone, or a sudden collapse even in static conditions by an exceedance of compressive stresses at the bottom. Moreover, in seismic conditions, the compressed in-plane and out-of-plane toes could fail by crushing, and leading with this, to a brittle failure. If prestressing is used carefully and with an optimal post-tensioning force, this technique may be quite helpful for the EQ protection of cultural heritage, by increasing strength and ductility, transforming the unreinforced masonry element to an energy dissipative structure.
