Seismic vulnerability and failure modes simulation of ancient masonry towers by validated virtual finite element models

Preciado, Adolfo

Preciado, A. (2015). "Seismic vulnerability and failure modes simulation of ancient masonry towers by validated virtual finite element models". *Journal of Engineering Failure Analysis*, 57: pp. 72-87

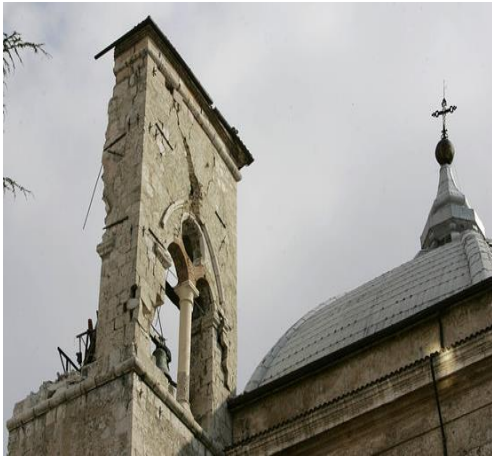
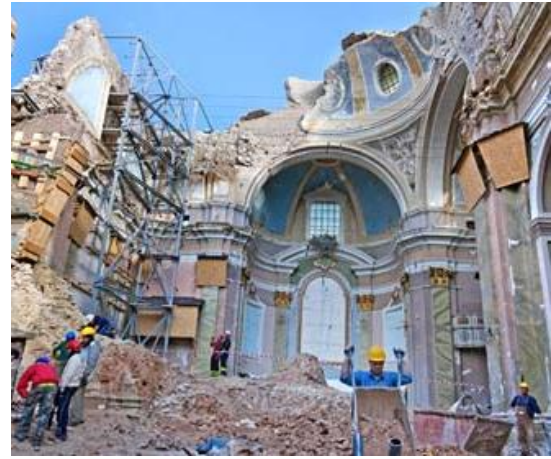
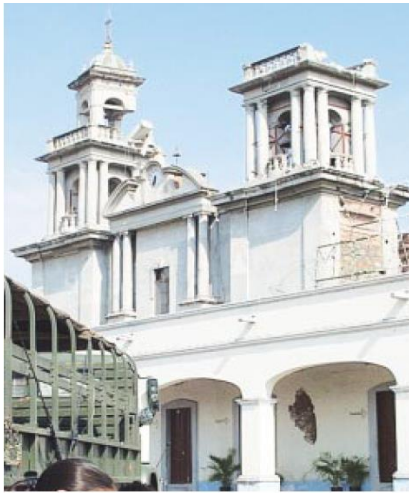
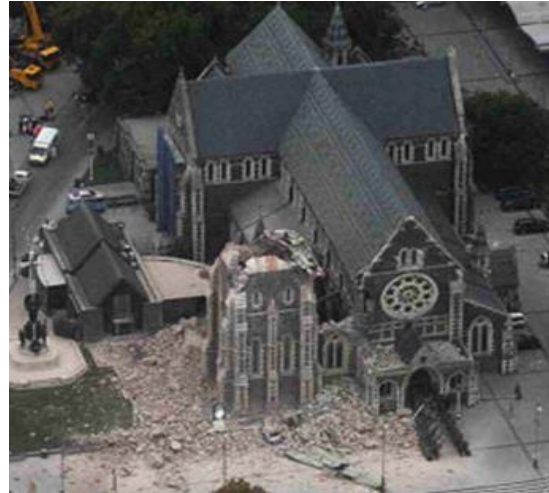
703 Figure 1: Observed EQ damage on cultural heritage; (a) L'Aquila, Italy in 2009 M6.3; (b)

35 intensity. This trend has been observed through centuries and nowadays (Fig. 1) almost after
36 every EQ of considerable intensity (e.g. 2003 M7.5 in Colima, Mexico; 2009 M6.3 in L'Aquila,
37 Italy and 2011 M6.3 in Christchurch, New Zealand). There is a high interest among the nations
38 and scientific community in preserving the cultural heritage of humanity.

166 The occurrence of unexpected and unavoidable events such as EQs has demonstrated that AMT
167 are one of the most vulnerable structural types to suffer strong damage or collapse as depicted in
168 Figure 1. Their protection is a topic of great concern among the scientific community. This
169 concern mainly arises from the observed damages after every considerable EQ and the need and
170 interest to preserve this cultural heritage. Although the recent progress in technology, seismology
171 and EQ engineering, the preservation of these quasi-brittle and massive monuments stills
172 represents a major challenge. Masonry towers in all their uses (bell, clock and medieval towers)
173 are highly vulnerable to suffer strong damage or collapse in EQ conditions, even when subjected
174 to seismic events of low to moderate intensity.

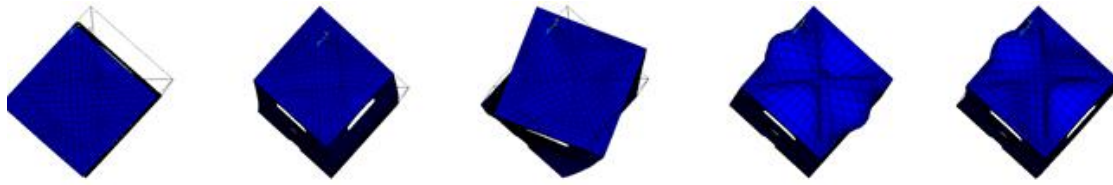
Mode 1

Mode 2
