Vulnerability assessment of churches at Colima by 3D limit analysis models

Orduña, Agustín; Preciado, Adolfo; Galván, Francisco; Araiza, Juan Carlos

Orduña, A., Preciado, A., Galván, F. and Araiza, J.C. (2008). "Vulnerability assessment of churches at Colima by 3D limit analysis models". 6th International Conference on Structural Analysis of Historical Constructions, July 2-4, Bath, UK.

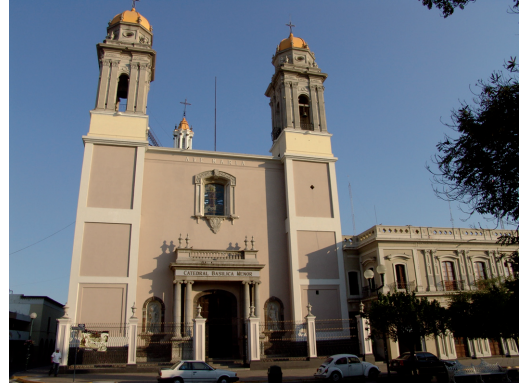
Figure 6. Cathedral "Basilica Menor de Guadalupe" (a) façade; (b) plan view.

The cathedral (Fig. 6) was built in 1889 and is considered the most important historical building in Colima State. This building is larger and more architectonically sophisticated than the chapel "Virgen del Refugio".

The vertical structure of the construction includes a stone masonry foundation, thick masonry walls made of solid clay bricks, and two bell towers made of stone masonry at bottom and clay brick masonry in the upper part. The roof system consists of masonry

vaults, and a clay brick masonry cupola, both supported on arches of the same material. The masonry of the vaults is an interesting case because the pieces are small pots of fired clay. May be the original idea was to achieve a light weight material, compared to solid pieces masonry. The survey after the 2003 earthquake showed extensive cracks in most walls, fairly large pieces of fallen plaster and towers fractured. In the roof system were large and extensive cracks in most vaults and large pieces of fallen plaster.

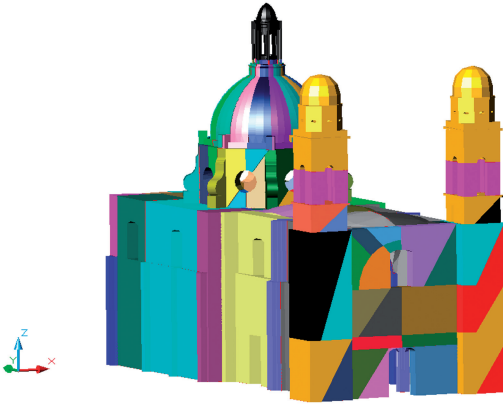
Figure 7. Full model of the cathedral.

A three-dimensional model of the whole building (Fig. 7) was developed taking into account the same considerations that in the first church. Due to the size and sophistication of the Cathedral, the macroblocks were considered in order to analyse only a seismic action on the -X direction by the limit analysis approach. This criterion was assumed after the observed damage post 2003, the historical analysis, and the first evaluation of the building by empirical methods. Besides, this information permitted to identify the part of the building most vulnerable to a seismic action. This was the main façade and the bell towers (Fig. 8).

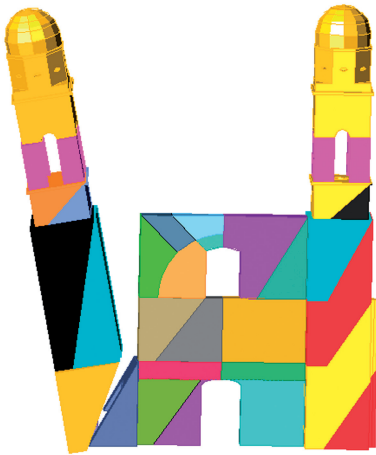
Figure 8. Main façade and bell towers failure mechanism for a seismic action on the $-X$ direction, load factor: 0.12.

The results for the model subject to earthquake in -X direction (Fig. 8) represents the imminent collapse of the north bell tower with a collapse load factor of 0.12. The results obtained in the limit analysis of

this part of the building are consistent with the damage observed. The historical analysis showed that the same bell tower collapsed in a 1941 earthquake with similar magnitude than the 2003 one.
