1ST INTERQUADRENNIAL ICF CONFERENCE
IN MIDDLE EAST AND AFRICA

**Processing, Performance and Failure Analysis of
Engineering Materials**

**SEISMIC BEHAVIOR AND FAILURE MECHANISMS
IDENTIFICATION OF ANCIENT MASONRY TOWERS**

Adolfo PRECIADO-QUIROZ*, Harald BUDELMANN*, Silvio T. SPERBECK,
and Gianni BARTOLI*****

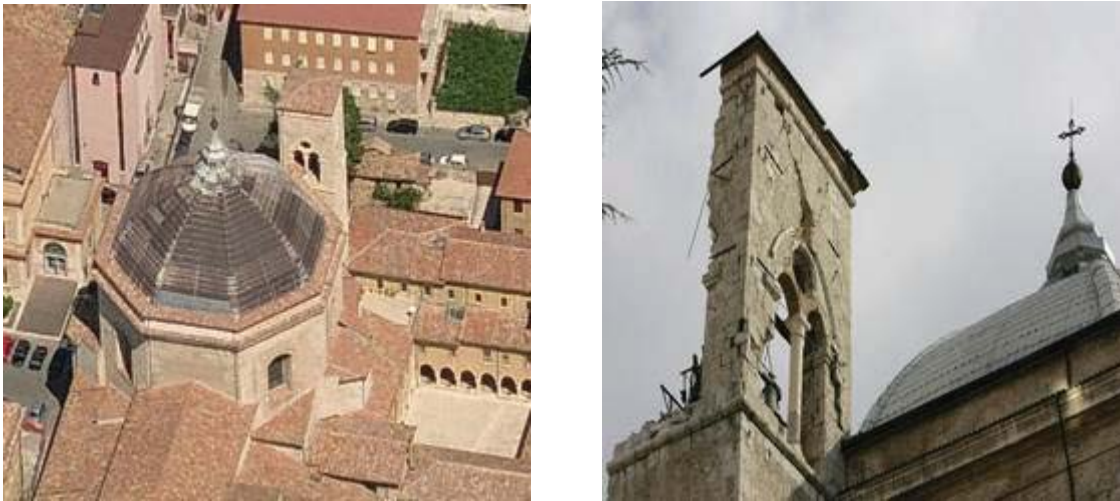
Figure 1 San Bernardino church undamaged and observed damage after the 6.3 magnitude L'Aquila, Italy earthquake on April 6th, 2009 [Bazrafshan, 2009]

Existing ancient masonry towers with different characteristics and functions are distributed all over the world and constitute a relevant part of the architectural and cultural heritage of humanity. These important vertical structures were built either isolated or commonly included in different manners in the urban context, such as built as part of churches, castles, municipal buildings and city walls. Bell and clock towers, also named civic towers, were built quite tall with the important purpose of informing people visually and with sounds by ringing bells and striking clocks about time and extraordinary events such as civil defence or fire alarm, and moreover to call the community to social meetings (see Figure 1).

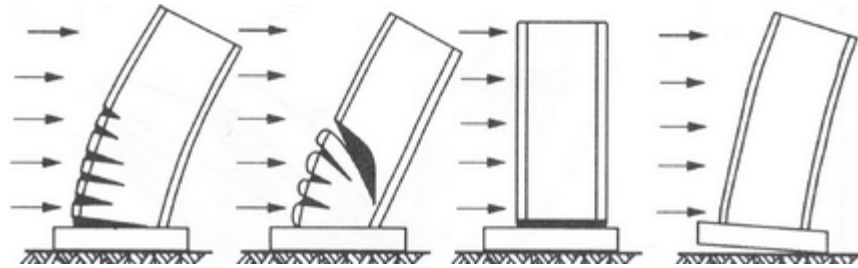
Figure 2 Failure modes of slender masonry structures: flexion; shear; rocking by base uplifting and rocking by foundation uplifting [Bazan and Meli, 2003]

Probably the single most decisive factor affecting the seismic behavior of a wall is its slenderness, commonly expressed in terms of aspect ratio (H/L). High slenderness walls ($H/L \geq 2$) are characterized by a ductile behavior, failing in a predominant flexural mode similar to that of beams. Different to this, in low slenderness or compact walls ($H/L \leq 1$) the factor dominating the seismic performance is shear [Penelis and Kappos, 1997].

NTCDF [2004] and Bazan and Meli [2003], affirm that the seismic behavior of walls differs importantly depending of their slenderness. Compact walls ($H/L \leq 2$) are dominated mainly by shear effects. By the other hand, slender walls ($H/L \geq 2$) behave mainly as cantilever beams with generally low vertical loading, dominating mainly the effect of flexion. If $H/L > 4$, the structure could be considered as excessively slender, being this the case of most of the historical masonry towers (Figure 4). This could cause its failure by flexion, shear, overturning by instability and transmission of elevated vertical loads to the foundation and soil as depicted in Figure 2.

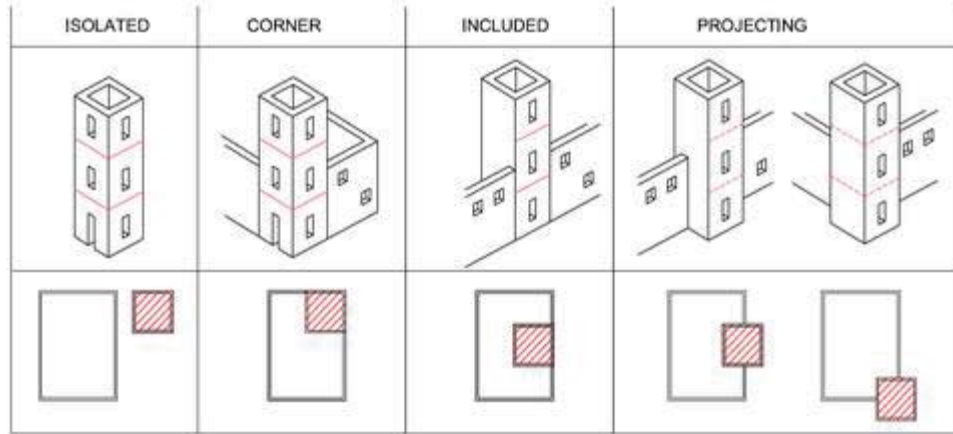
Figure 3 Position of the tower in the urban context [Sepe et al., 2008]

The position of a historical masonry tower in the urban context is a very important aspect that influences the vulnerability of the structure [Sepe et al., 2008]. These boundary conditions (see Figure 3) could strongly modify its seismic behavior and to have big impact in the generation of different failure modes. Non-isolated towers were commonly built as a part of a church or next to another building. The presence of adjacent walls or

façades with different height than the tower and the lack of connection between elements due to the poor tensile strength of masonry could generate during an earthquake a detachment of the different bodies, vibrating independently and hitting between them generating serious damages.

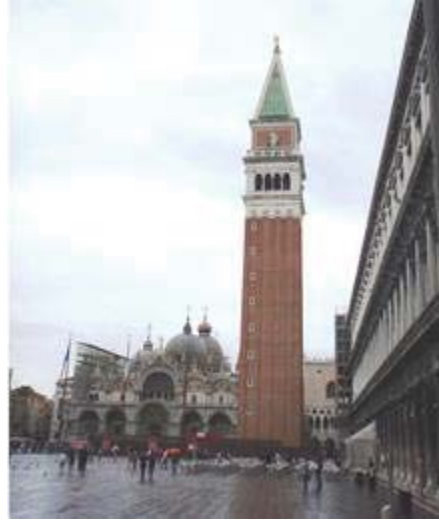
Figure 4 Replica of the collapsed bell tower of “Piazza San Marco” in Venice, Italy

Historical masonry towers are slender structures under high vertical loading. This is due to its height, wall thickness, the presence of a roof system, the high density of masonry and heavy bells, leading to a concentration of high compressive stresses at their base. All these issues and moreover taking into account the deterioration of masonry through the centuries (progressive damage), make the historical masonry towers extremely vulnerable to suffer a sudden collapse by an exceeding of its compressive strength, or in some cases the failure of the foundation or the soil. These sudden collapses have been occurring since centuries ago in this type of structures. The most famous cases are reported e. g. in Binda et al. [1992], Macchi [1993], GES [1993] and Binda [2008]. They correspond to the sudden collapses of the bell tower of “Piazza San Marco”, Venice, in 1902 (a replica was built as depicted in Figure 4), the civic tower of Pavia in 1989 and the bell tower of the church of “St. Maria Magdalena” in Goch, Germany, in 1992.

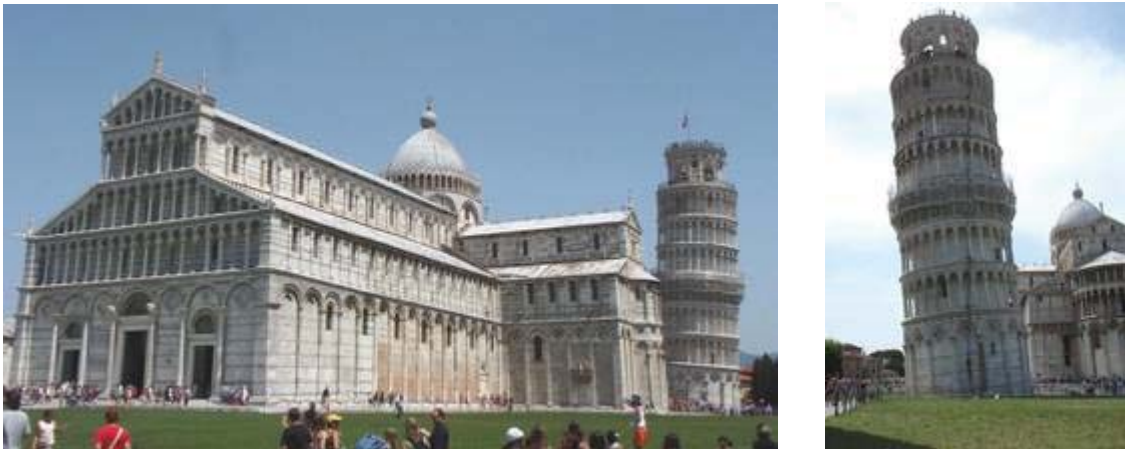
Figure 5 General view of the leaning tower of Pisa, Italy

Another geotechnical issue that depends on the local site effects and the seismic action corresponds to liquefaction and instability conditions by soil settlements. This is the case of the Metropolitan Cathedral of Mexico City that has been presenting since decades important settlements due to the soft soil conditions. The most famous case presented in historical masonry towers corresponds to the leaning tower of Pisa, Italy, as shown in Figure 2.14. It started to incline since its construction in the XII century due to the irregularities in the soil conditions, being with this quite vulnerable to overturning.

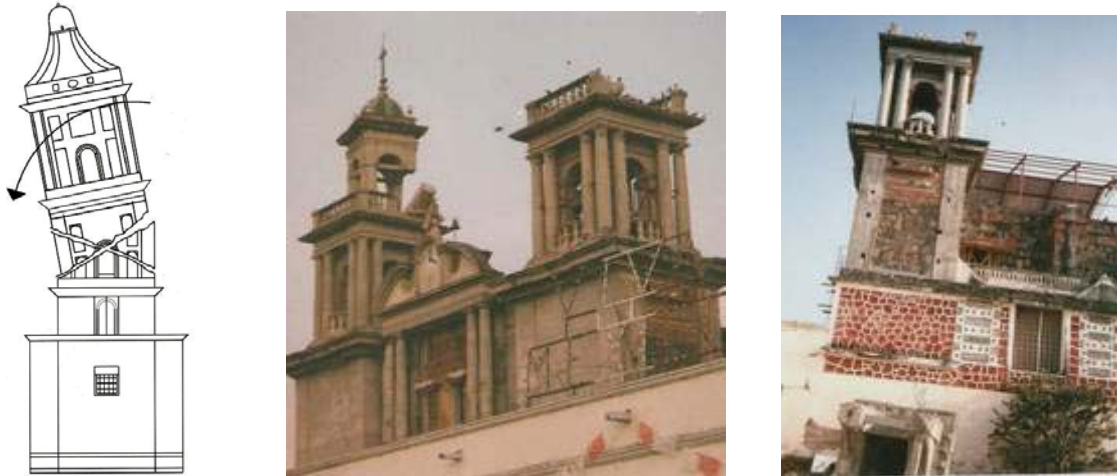
Figure 6 Typical failure mechanisms of bell towers: (Left) [Meli, 1998]; (Right) Effects of the 7.6 magnitude Colima, Mexico earthquake on January 21st, 2003

The excessive slenderness of historical masonry towers ($H/L > 4$) is characterized by a ductile behavior, failing in a predominant flexural mode similar to that of cantilever beams. Due to all these factors and its heavy mass, the lateral vibration at the top of the tower is considerably more amplified than the one of the base, generating with this important horizontal top displacements and inertia forces transmitted in-plane and out-of-plane as a consequence of the earthquake ground shaking. This behavior could cause as previously mentioned different failure mechanisms generated by flexion, shear, base and foundation uplifting due to the transmission of elevated vertical loads or poor soil conditions (see Figure 2). Moreover these poor conditions could generate an amplification of the ground shaking and an excitation very close to the natural frequency of the tower, leading to its failure by the resonance effect. Meli [1998] describes that during an earthquake historical masonry towers present important horizontal top displacements. The flexion generates horizontal cracks but rarely the overturning of the structure. This is due to the alternation of the direction of the movement that causes an

opening and closing effect of these cracks, dissipating with this impact an important part of the energy induced by the earthquake. By the other hand, in bell towers, the presence of large openings at the belfry could increase the vulnerability of the structure, being more frequent its failure by shear.

Due to the strong damage, the belfry could collapse by instability, endangering the adjacent buildings and mainly the people who could be inside or in the surroundings (see Figure 6). Curti et al. [2008] observed in 31 Italian bell towers damaged by the 1976 Friuli earthquakes that the belfry is the most vulnerable part of the tower due to the presence of large openings, leading the pillars to be slender and by the top masses. This amplifies the seismic motion causing critical effects in the higher parts of the tower.

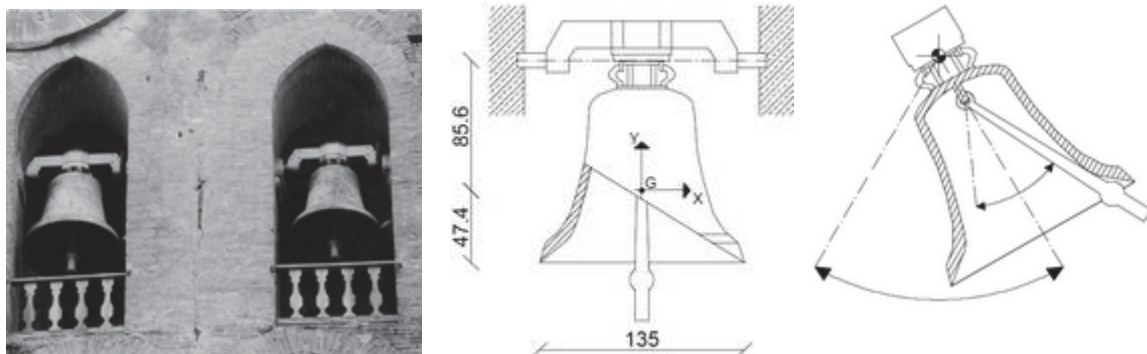
Figure 7 The bell tower of “Matilde” in Pisa, Italy: location of bells at belfry and crack pattern; bell dimensions (in cm) and bell swinging [Beconcini et al., 2001]

The swinging of the heavy bells induces dynamic actions that could cause damage to the tower. By the one hand, this motion generates at the bell's support elevated vertical and horizontal inertia forces that are transmitted to the structure. Considering that most of the towers were built mainly to withstand their vertical loading, results more critical the action of the induced horizontal forces that could generate cracking or the separation of structural elements due to the low tensile strength of masonry (Figure 7). By the other hand, the excitation induced by the swinging of bells could be very close to one of the natural frequencies of the tower, leading to a high dynamic amplification of the structural response by the resonance effect. For more detailed information about the dynamic actions by bells swinging the reader is referred to Beconcini et al. [2001], Bennati et al. [2002] and Ivorra and Pallares [2006].
