Seismic vulnerability enhancement of medieval and masonry bell towers externally prestressed with unbonded smart tendons

Preciado, A., Sperbeck, S. T. and Ramirez-Gaytan, A. (2016). "Seismic vulnerability enhancement of medieval and masonry bell towers externally prestressed with unbonded smart tendons". Journal of Engineering Structures, Vol.122, pp.50-61.

Seismic Vulnerability Enhancement of Medieval and Masonry Bell Towers Externally Prestressed with Unbonded Smart Tendons

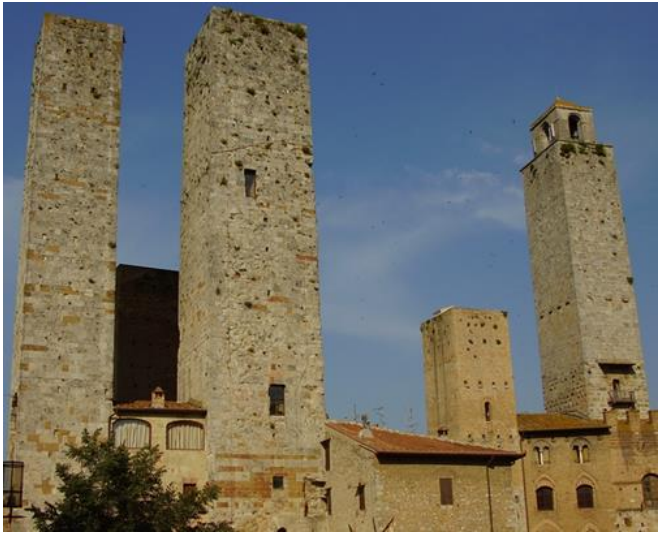
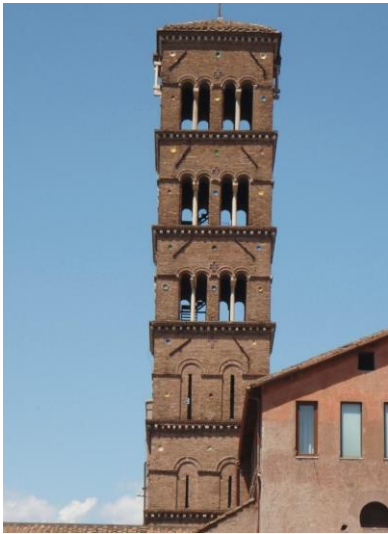
Figure 1: Typical historical masonry towers in Italy; (a) medieval tower and (b) bell tower

General view and FEM models of the medieval and masonry bell towers under study are illustrated in Figure 5. They were selected taking into account common masonry towers with variations in geometry and openings at belfry (see Fig. 1). In following sections, the models are described in detail and initially analyzed by linear analyses and compared against theoretical background. In a subsequent stage, the towers under study are subjected to nonlinear static analyses to assess their seismic behavior and failure modes. Moreover, the towers are retrofitted with a proposed external prestressing device and posttensioning force. The main goal is the achievement of the EQ performance enhancement by providing a better overall behavior of both main groups of towers, bell and medieval, by converting brittle shear failures into ductile ones with higher energy dissipation capability.

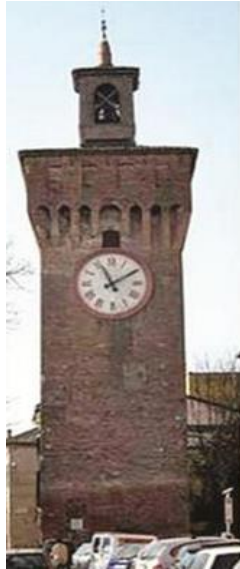
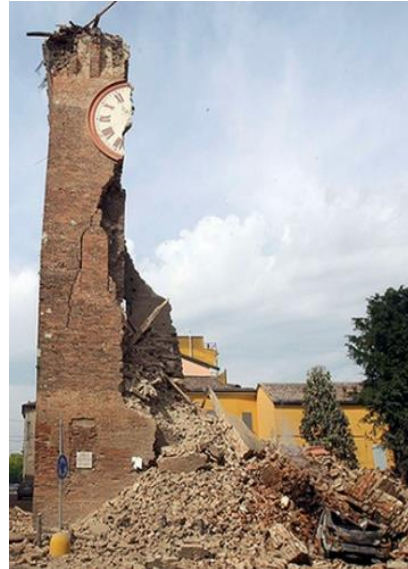
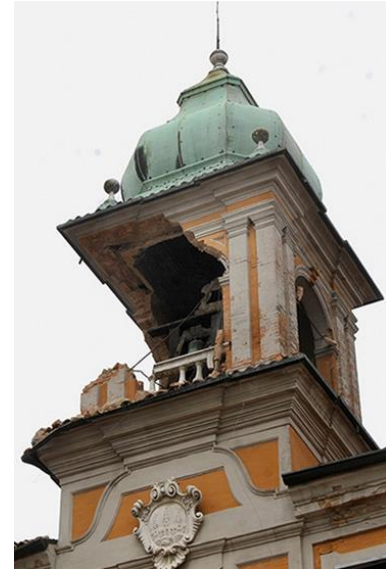
Figure 2: Typical collapses of historical masonry towers under EQ loading; (a) medieval tower (used as clock tower) before and after the EQ and (b) bell tower with large openings at belfry
