Final Report
E-16-604

COMPARATIVE EVALUATION OF WOVEN
GRAPHITE-EPOXY COMPOSITES

Principal Investigators: S. Hanagud (A.E.)
A. Tayebi (Textiles)

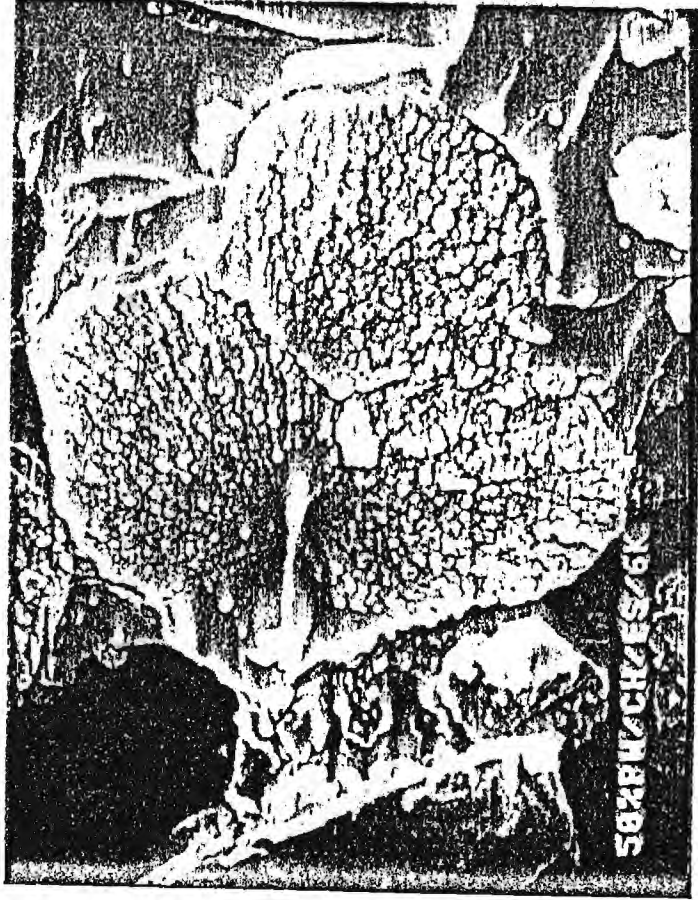
Fig. 19 Fractograph at 6000 X

Fig. 20 Fractograph at 48 X

Fig. 21 Fractograph at 48 X

The figures 19, 20 and 21 is for a composite of 50% resin and plain

weave. This shows a type of propagation of cracks through the fiber bundle. The crack origin is at the junction of two fibers. A change in the direction of propagation at the upper left fiber and the right fiber can be seen. However, at the junction of the lower left fiber and the right fiber, the crack propagates without change of direction.

The figure 20 shows the damage incurred before curing to a complete bundle of fibers. Near the upper edge, many little bumps are seen. These are actually bundle of broken fibers which have been coated with matrix in the curing process. The decrease in strength locally would be severe. The figure 21 shows several partially damaged bundles. The damaged regions do not appear clean and sharp, instead the fibers look as they have been washed down. Also the delamination arrested by the weave pattern in upper left corner around the 0° fiber and following the transverse fiber can be seen in this figure.

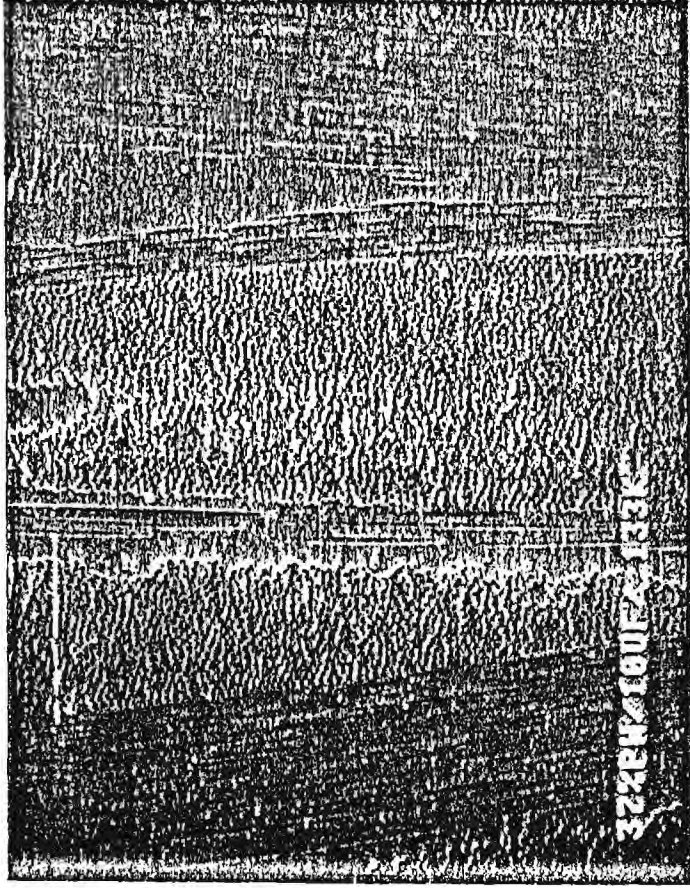
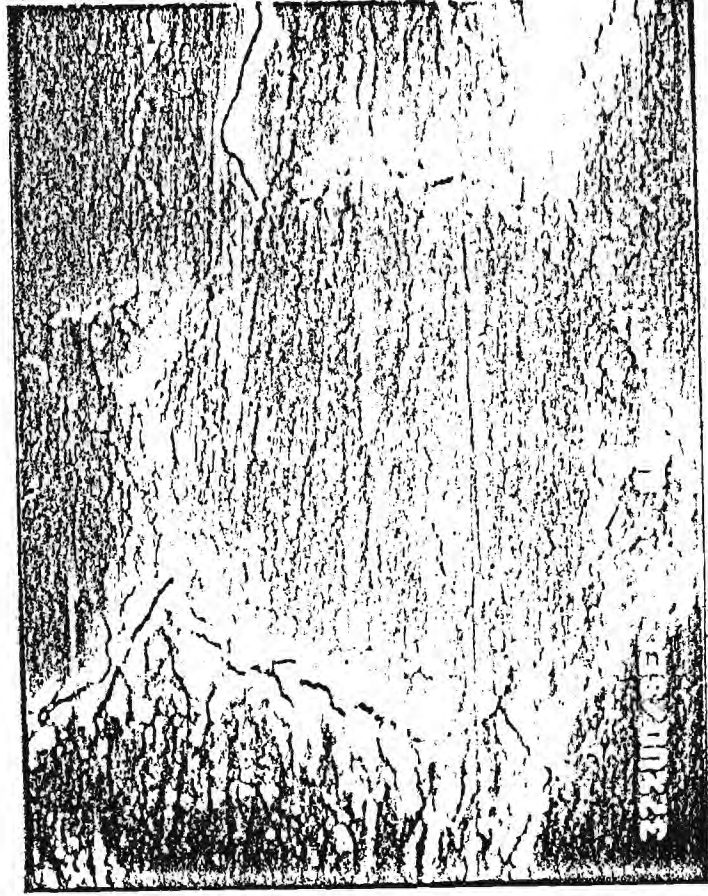
Fig. 25 Photomicrograph at 4700X

Fig. 26 Photomicrograph at 4700 X

Fig. 27 Photomicrograph at 133 X

Fig. 28 Photomicrograph at 9700 X

The figure 25 is a magnified picture of a polished section of a composite specimen of plain weave fabric and 37% resin. The section is at a short distance away from the fracture surface. No unusual fracture pattern is observed. In fact the figure 25 is very similar to the figure 26 which is the magnified picture of polished specimen of an unfractured or virgin specimen. The figures 25 and 26 are at ap-

proximately 5K magnification. The figure 27 is a lower magnification picture of a section from a virgin specimen. The fiber bundles, as they appear in woven composite, can be seen. The figure 28, however, is from a section of failed composite very close to the fracture surface. This picture is from a polished section at a magnification of 9.8K. Some cracks at the fiber-matrix interfaces can be seen. A large number of fibers and matrix can be seen at 1K as shown in the figure 29. This figure can be compared to the figure 30 which shows no such cracks. The figure 30 is, however, from a section of a virgin specimen. In the next few figures, the plain weave fracture surface have been compared to the fracture surface from composites made from unidirectional tapes. The figure 31 shows the view of a cure section with double 0° layer at the center and 90° ply on the outside. This picture can be compared to the figures 16 and 17 of plain weave. The clean appearance of 90° plies can be seen. Also no arrest of any delamination can be seen. The figures 32 and 33 show fractured single fiber. Pre-existing flaws can again be seen at the crack origin in both pictures.

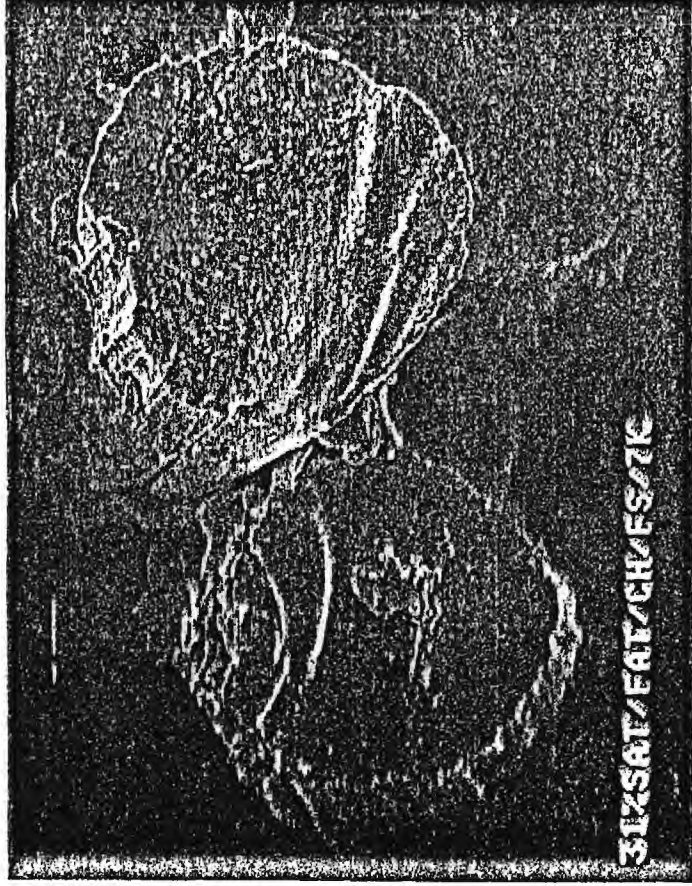
Fig. 37 Fractograph at 7000 X

Fig. 38 Fractograph at 7000 X

Fig. 39 Fractograph at 11000 X

The inspection under S.E.M. is restricted to the area near the fatigue crack origin which was near the hole. The figures 37 to 39 show the fracture pattern of single fiber under magnifications varying from 7K to 11K. The fracture pattern of these fiber are very distinct from the fracture pattern of the fiber under static tensile loading as can be seen in figures 18 and 19. The fracture of these fiber are characterized by a smooth area over substantial part of the fiber. Also no stress concentration such as hole is seen at the crack origin. They appear to be cracks originated by fatigue. However, more tests are needed to confirm the hypothesis. Away from the crack origin standard tensile fracture pattern was observed. The figure 40 shows a number of such unusual fracture pattern. Similar observation on plain weave composites can be seen in figure 41 to 44.
