GEORGIA INSTITUTE OF TECHNOLOGY
OFFICE OF CONTRACT ADMINISTRATION
SPONSORED PROJECT INITIATION

Project Title: A Study of Factors Affecting Crushed Stone Base Course Performance

Project No: E-20-639

Sponsor: Georgia Department of Transportation

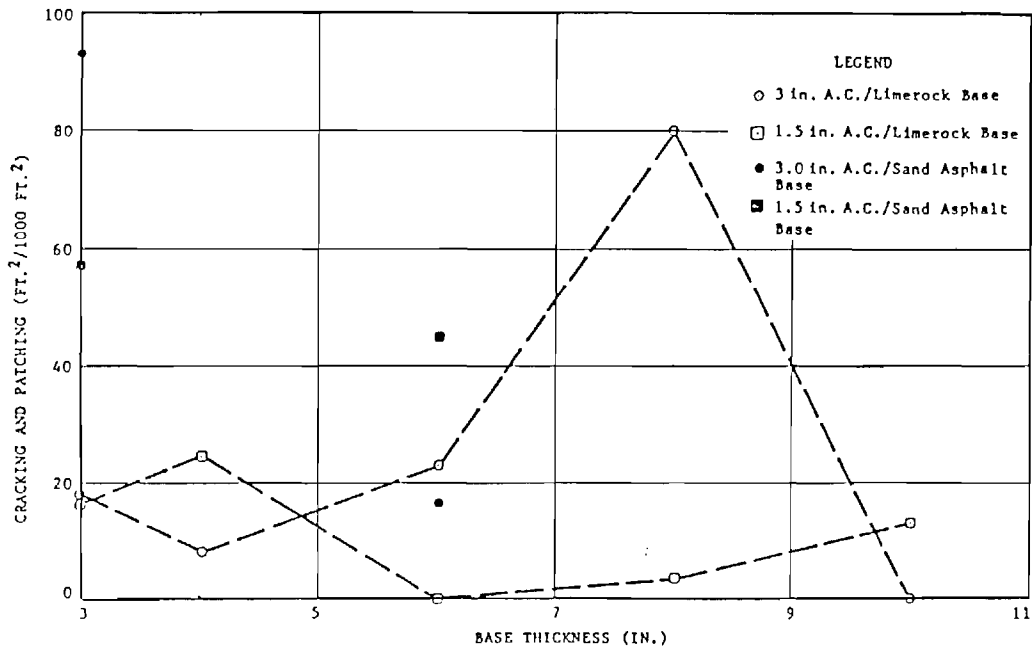
FIGURE 3. MAXIMUM CRACKING AND PATCHING OBSERVED ON LIMEROCK AND SAND ASPHALT SECTIONS AT LAKE WALES [8].

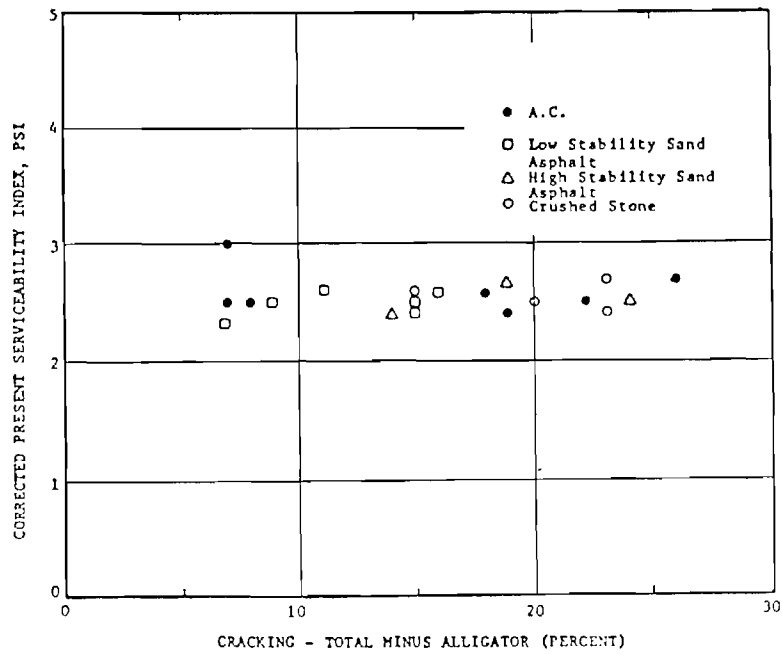
FIGURE 4. EFFECT OF CRACKING ON PRESENT SERVICEABILITY INDEX - COLORADO BASE STUDY [9].

After 12 years of service the PSI values for both the asphalt concrete sections and the granular base/subbase sections were about the same. Also a significant amount of cracking was present in both the bituminous (22%) and granular base (32%) sections. The unstabilized base sections had an average of 0.13 in. (3 mm) of rutting compared to 0.19 in. (48 mm) of rutting in the full-depth bituminous sections. From considerations of cracking, Shook and Kallas [9] recommend base equivalencies of 3.4 to 4.25 for unstabilized base/subbase design for the materials used in the study. Considering the PSI ratings were the same, these ratios are considered too high. Due to the light traffic, the relatively thick granular base sections would very likely have undergone about the same rutting and cracking had a thinner subbase been used. For the light traffic conditions of the study, use of a crushed gravel compacted to 100% of T-180 maximum density would have significantly improved performance. For these conditions considerably higher substitution ratios would be appropriate.

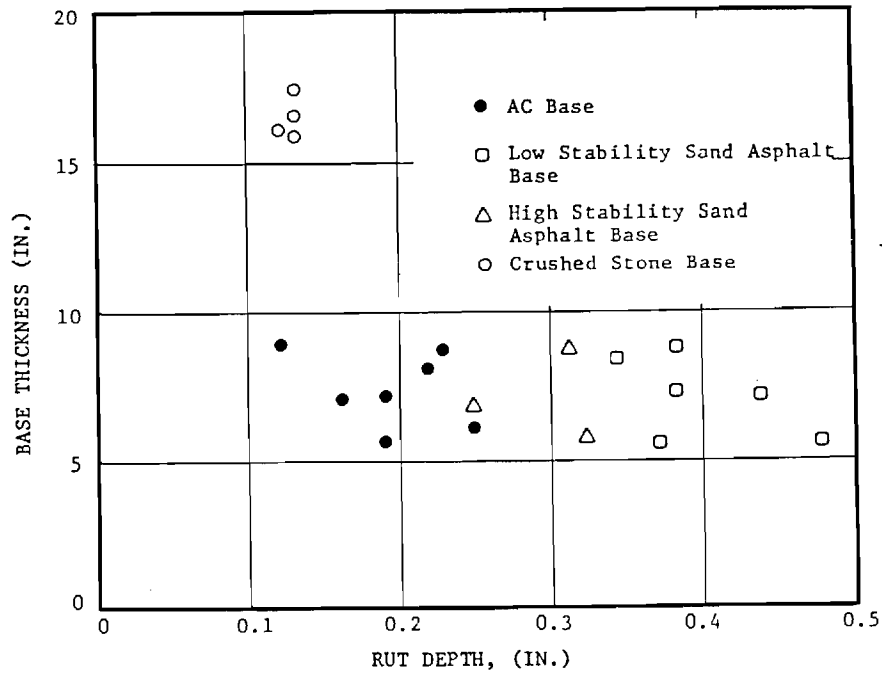
FIGURE 5. INFLUENCE OF BASE TYPE AND THICKNESS ON RUT DEPTH [9].

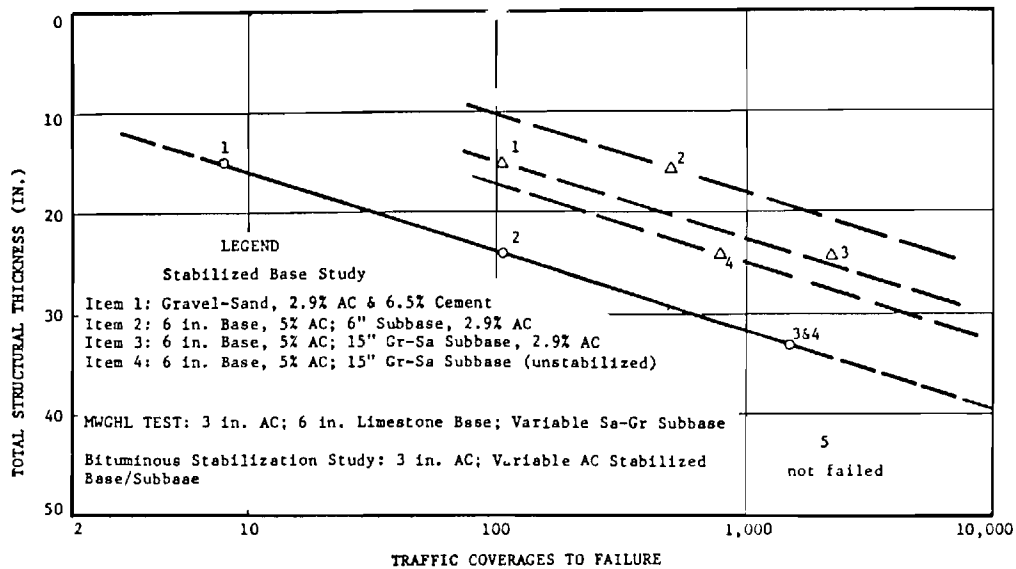
FIGURE 6. EFFECT OF STRUCTURAL THICKNESS AND TYPE CONSTRUCTION ON COVERAGES TO FAILURE - 360,000 LB., 12-WHEEL ASSEMBLY, 100 PSI TIRE PRESSURE [12].

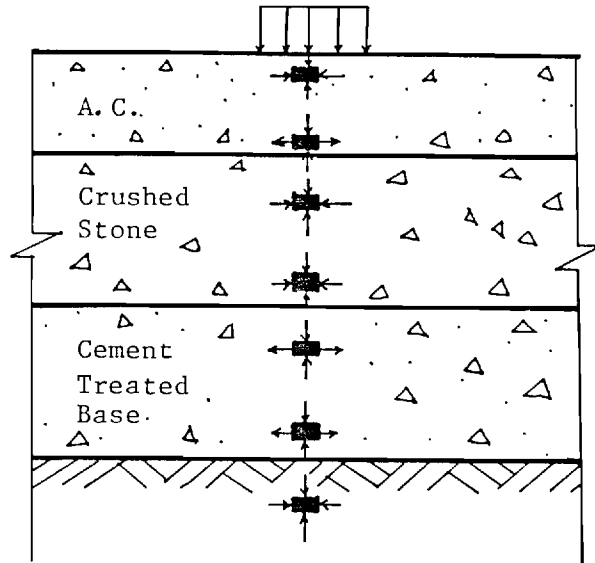
FIGURE 7. STATE OF STRESS IN AN INVERTED SECTION.

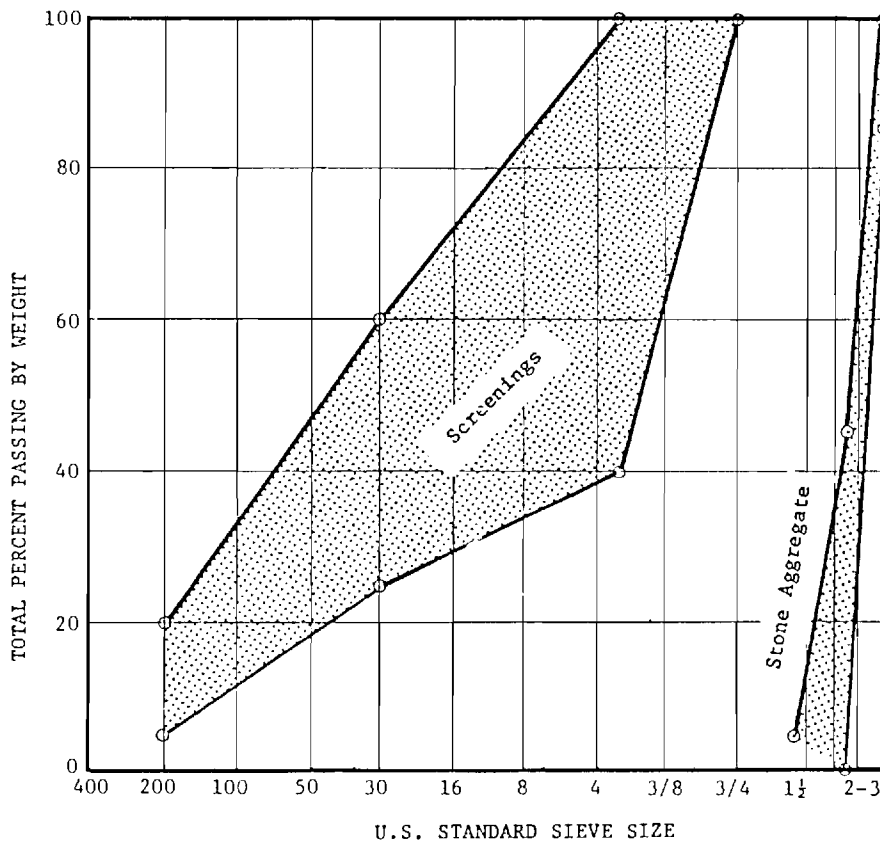
FIGURE 8. GRADATION OF STONE AGGREGATE AND SCREENINGS USED IN NEW JERSEY EXPERIMENTAL ROAD MACADAM [72].

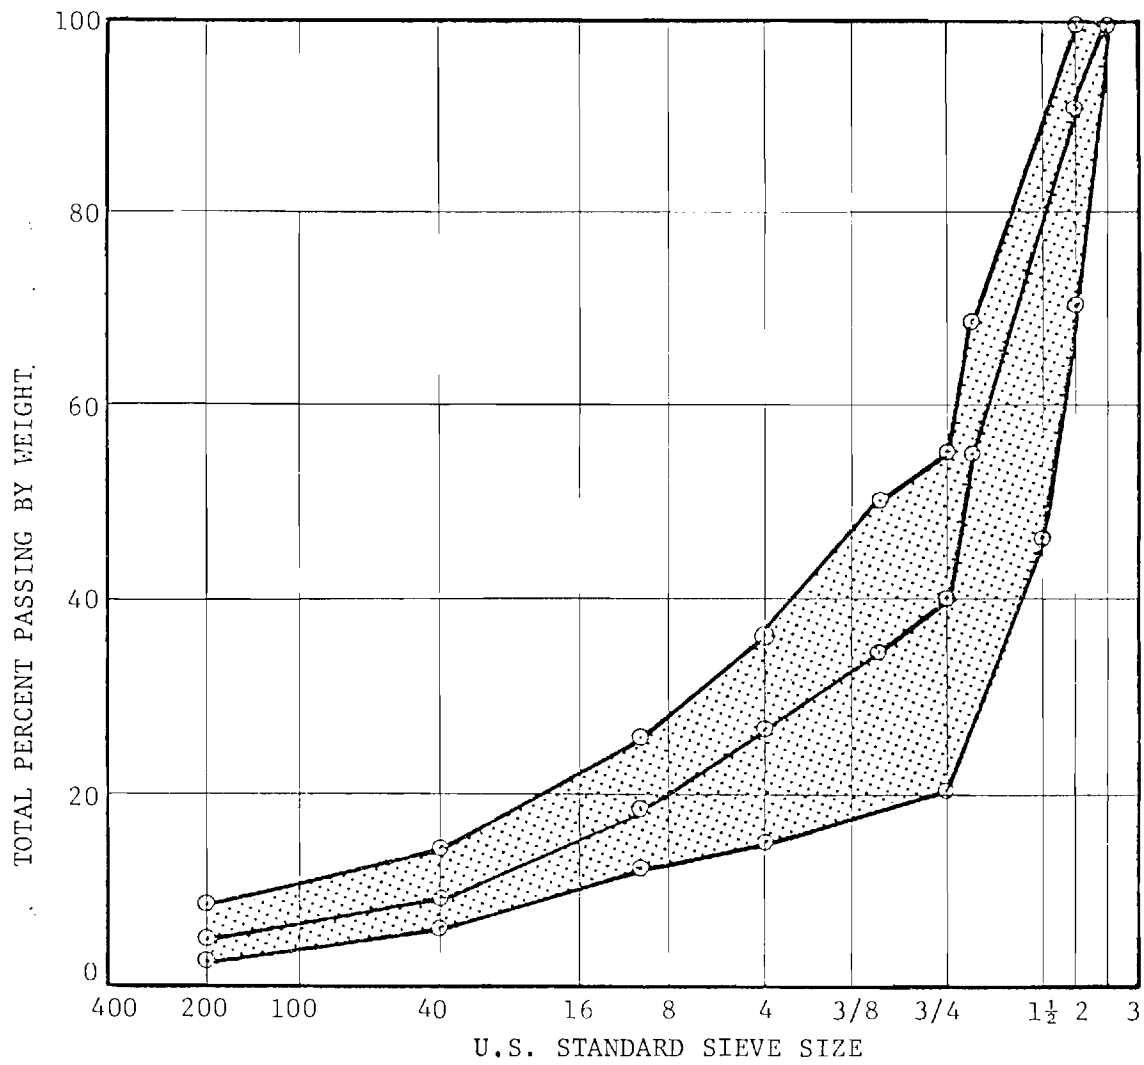
FIGURE 9. EXTREMES AND AVERAGE GRADATION OF DRY BOUND MACADAM USED IN MARYLAND [13].

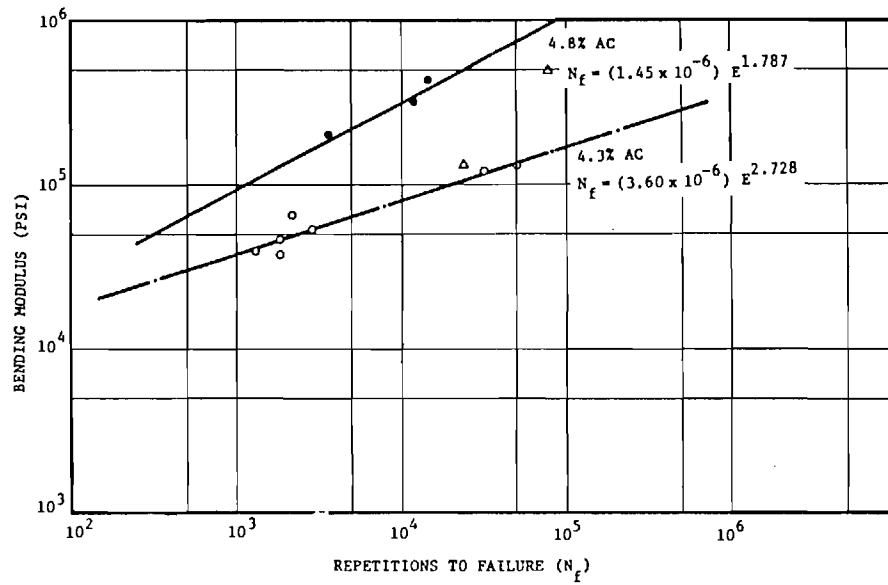
FIGURE 14. B-MODIFIED MIX: REPETITIONS TO FAILURE AS A FUNCTION OF BEAM BENDING MODULUS AND ASPHALT CONTENT.

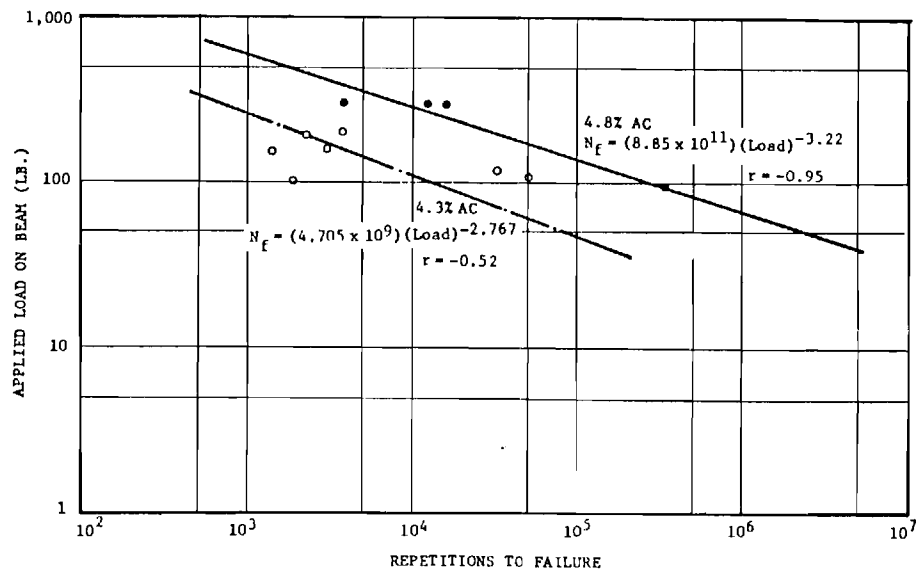
FIGURE 15. B-MODIFIED MIX: REPETITIONS TO FAILURE AS A FUNCTION OF APPLIED LOAD AND ASPHALT CONTENT.

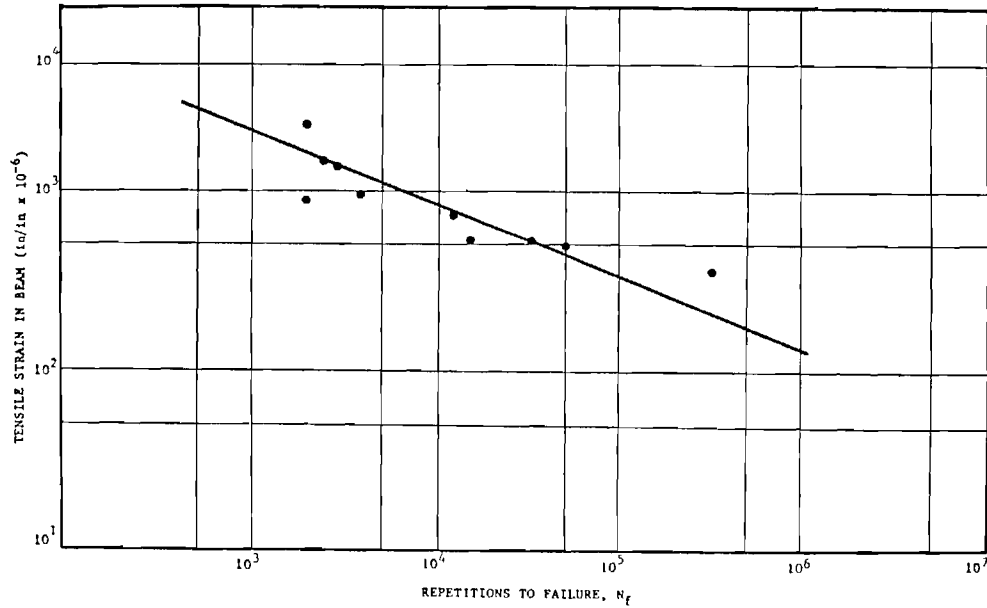
Fig 16: Fatigue Life of Beam as a Function of Tensile Strain (B-Modified Misc.).

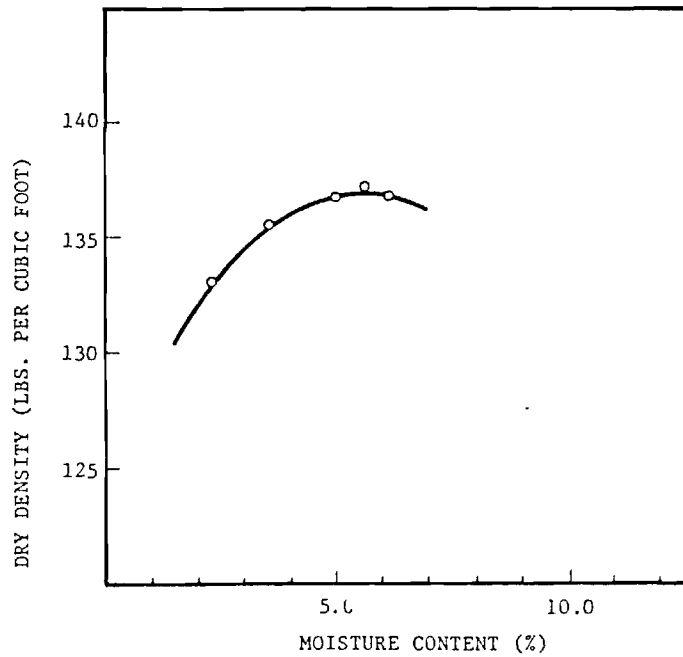
FIGURE 17. MOISTURE-DENSITY CURVE FOR STANDARD BASE COURSE (T-180 COMPACTION).

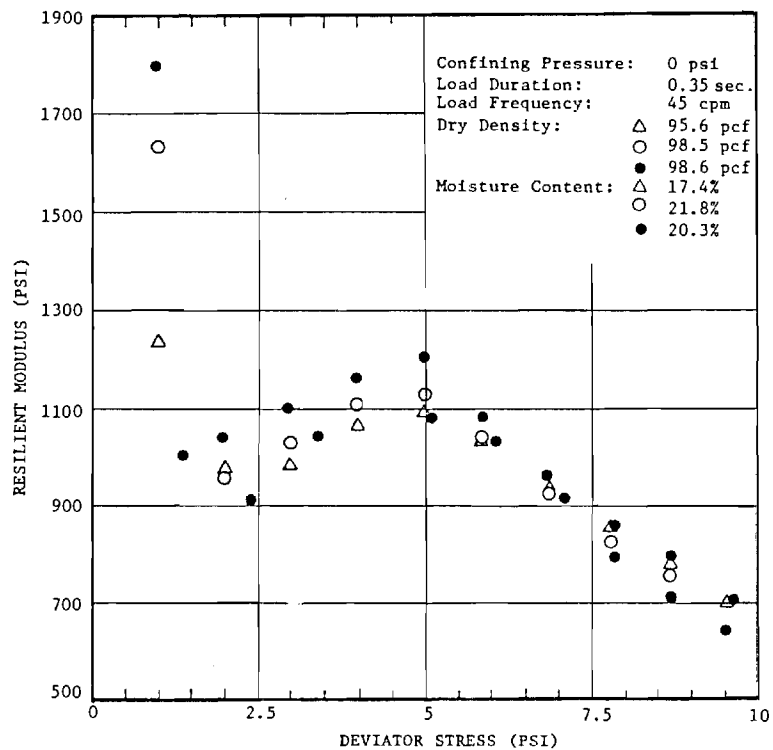
FIGURE 27. INFLUENCE OF DEVIATOR STRESS AND MOISTURE CONTENT ON RESILIENT MODULUS OF MICACEOUS SILTY SAND (CONFINING PRESSURE = 0 PSI).

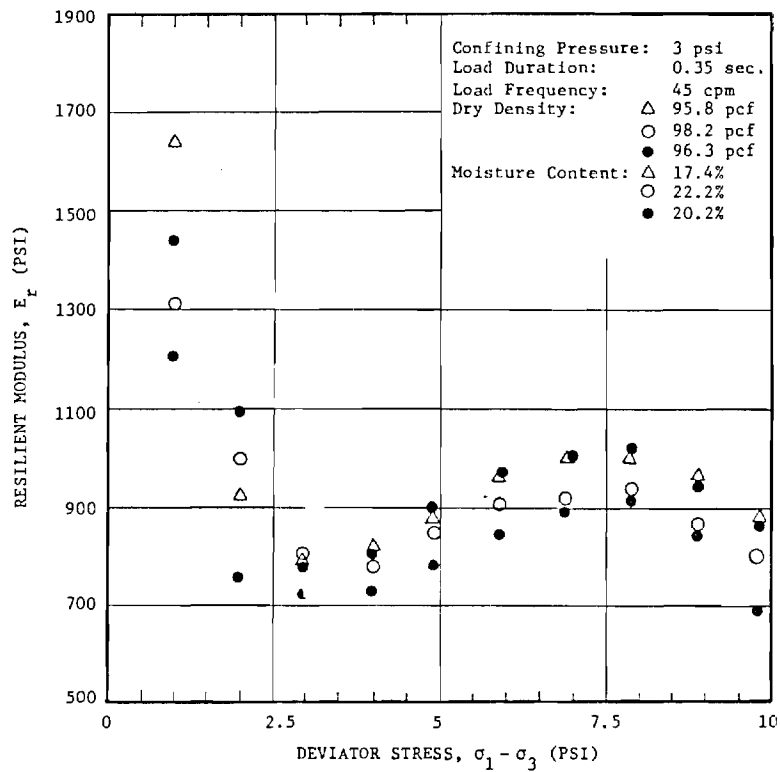
FIGURE 28. INFLUENCE OF DEVIATOR STRESS AND MOISTURE CONTENT ON RESILIENT MODULUS OF MICACEOUS SILTY SAND (CONFINING PRESSURE = 3 PSI).

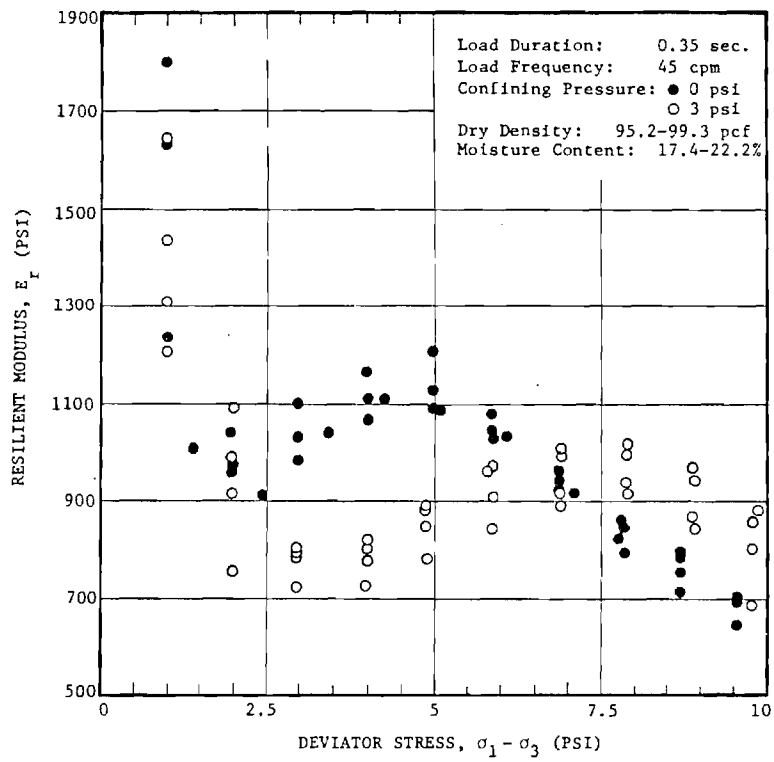
FIGURE 29. INFLUENCE OF DEVIATOR STRESS AND CONFINING PRESSURE ON RESILIENT MODULUS FOR MICACEOUS SILTY SAND - SUMMARY OF ALL RESULTS.

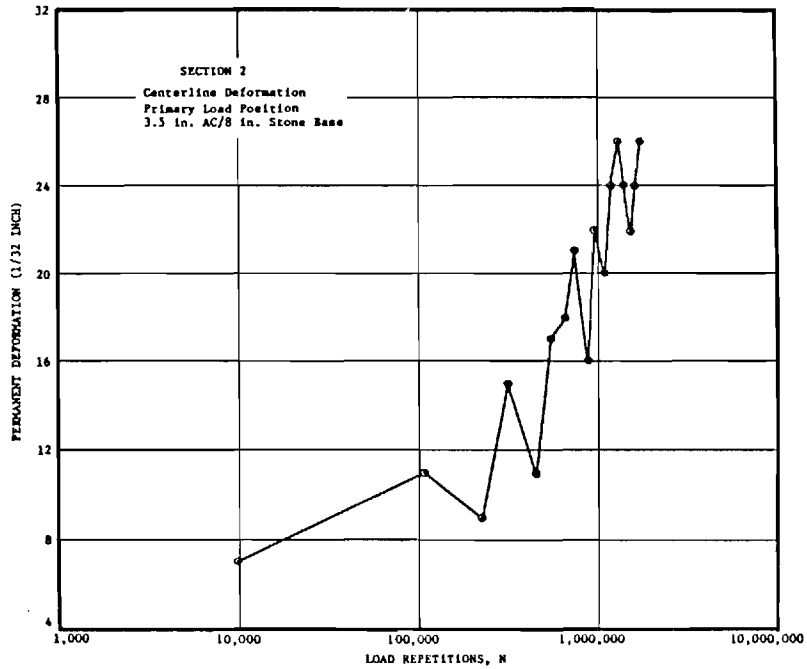
FIGURE 48. VARIATION OF CENTERLINE DEFORMATION WITH NUMBER OF LOAD REPETITIONS - SECTION 2.

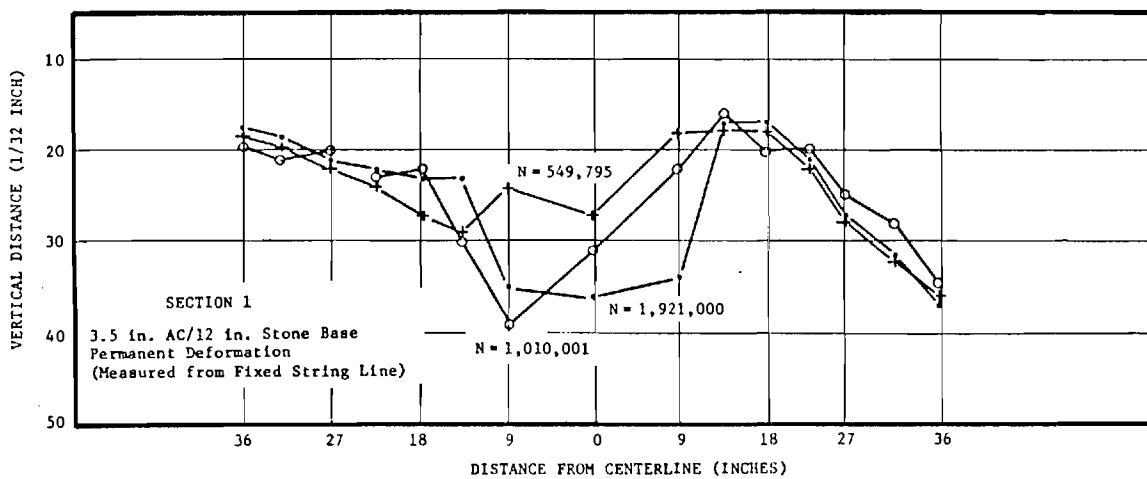
FIGURE 51. VARIATION OF SURFACE PROFILE WITH LOAD REPETITIONS - SECTION 1.

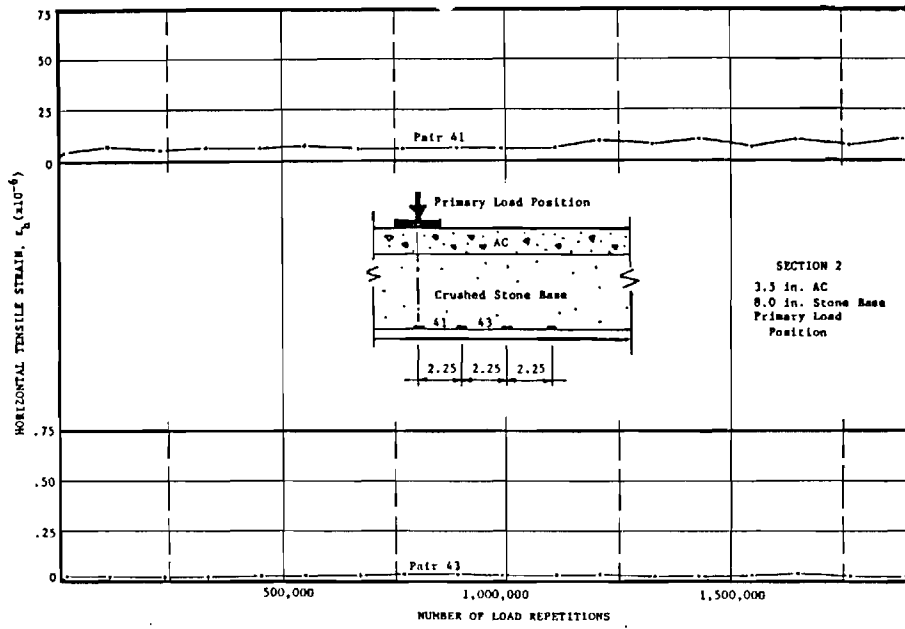
FIGURE 58. VARIATION OF RESILIENT HORIZONTAL STRAIN IN BOTTOM OF CRUSHED STONE BASE WITH NUMBER OF LOAD REPETITIONS - SECTION 2.

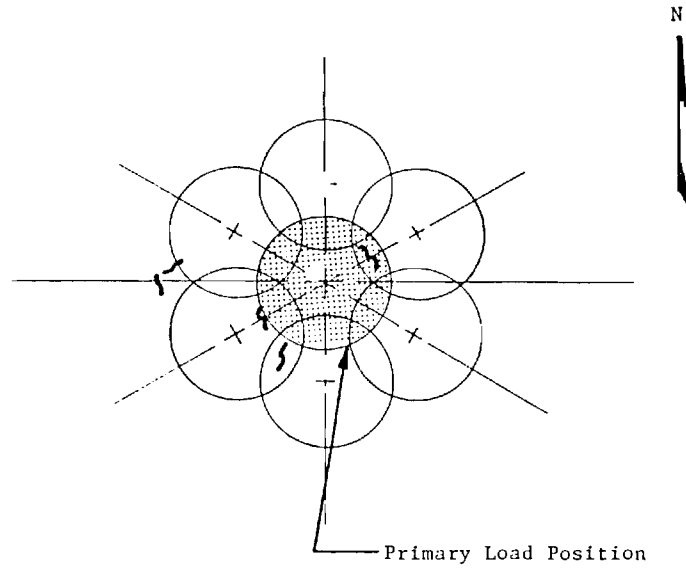
FIGURE 64. CRACK PATTERN IN SECTION 6 AT COMPLETION OF TEST: 6.5 IN. FULL-DEPTH A.C. SECTION.

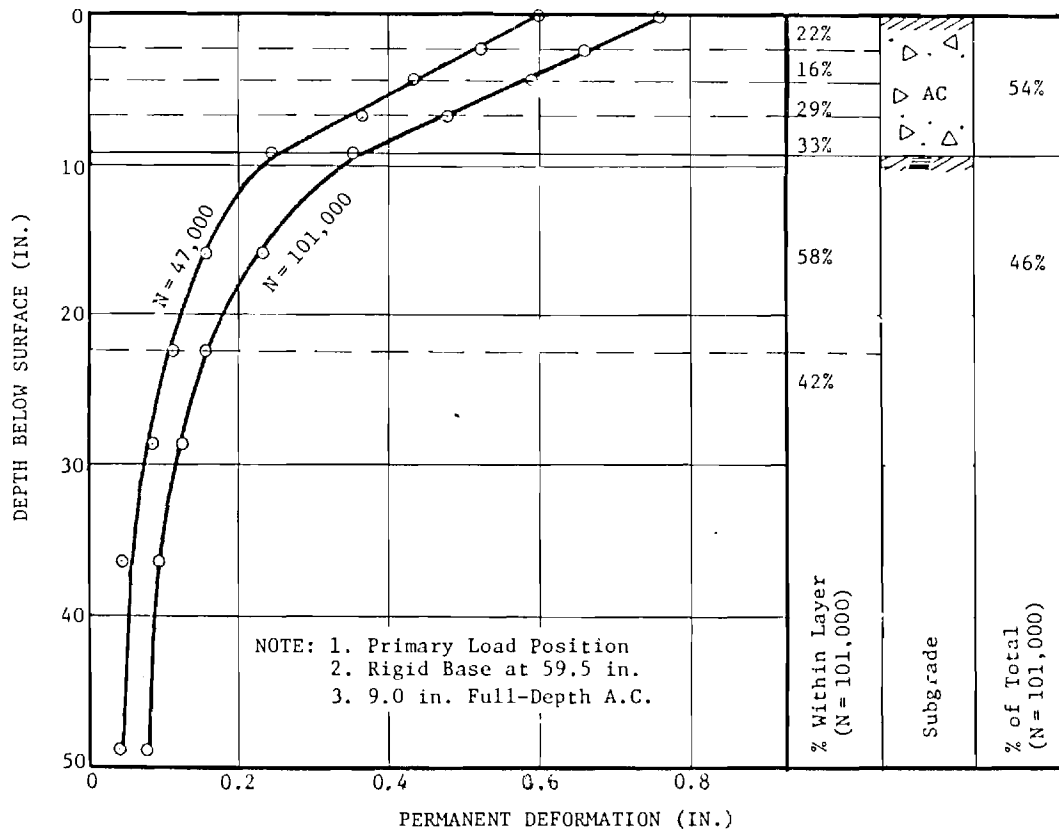
FIGURE 65. DISTRIBUTION OF PERMANENT DEFORMATION WITHIN PAVEMENT STRUCTURE - SECTION 5.

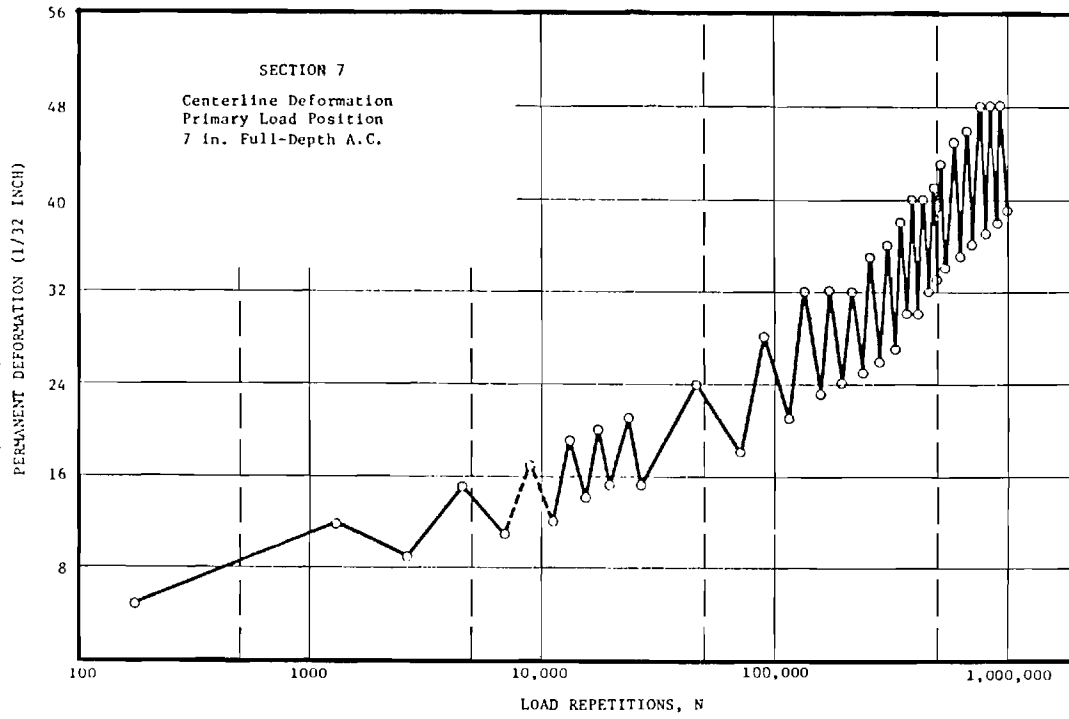
FIGURE 70. VARIATION OF CENTERLINE DEFORMATION WITH NUMBER OF LOAD REPETITIONS - SECTION 7.

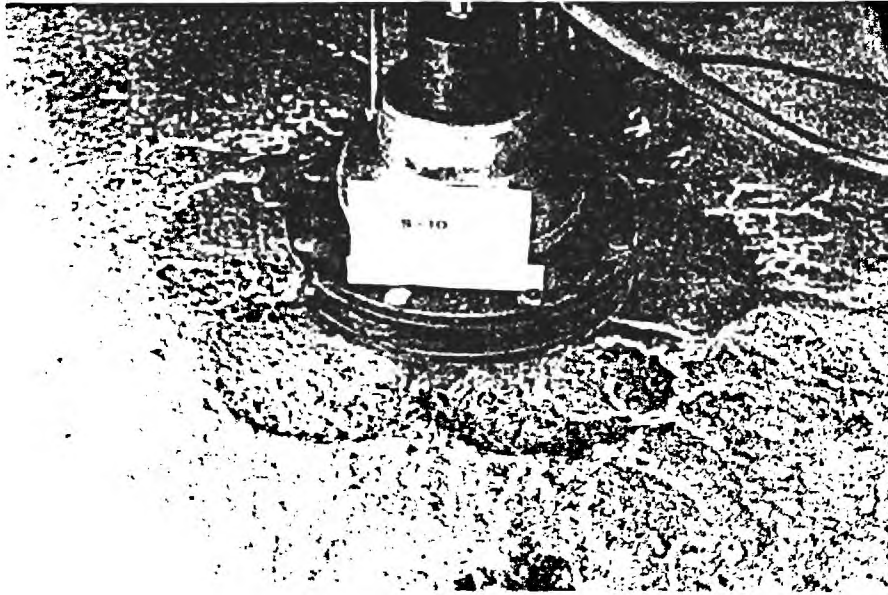
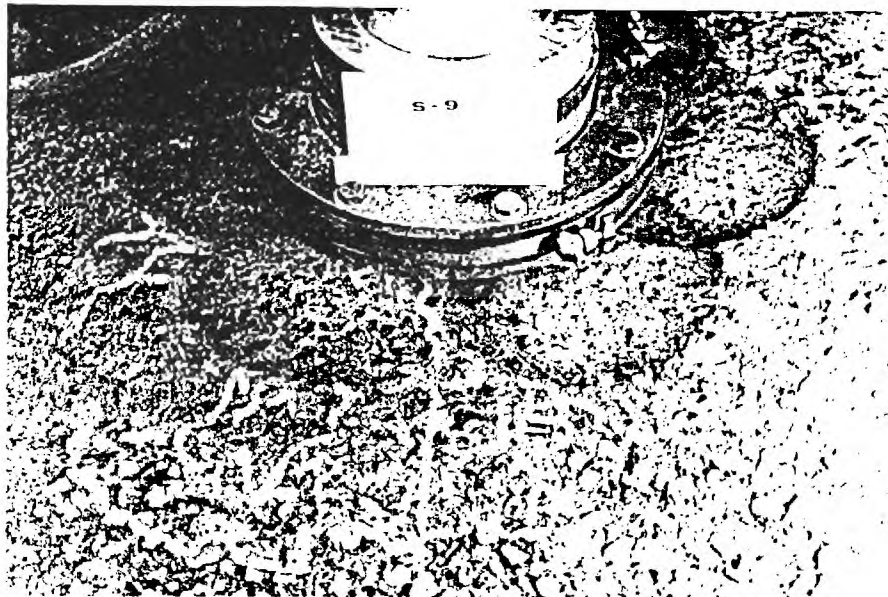
(a) Section 10: 3.5 in./8.0 in. (Fine Gradation)

(b) Section 9: 3.5 in./8.0 in. (Coarse Gradation)

The measured resilient horizontal tensile strain in the bottom of the asphalt concrete beneath the primary load in Section 9 was 270×10^{-6} in./in. and in Section 10 was 390×10^{-6} in./in. Nevertheless, Section 10 which had the higher resilient tensile strain performed better with respect to fatigue than Section 9.

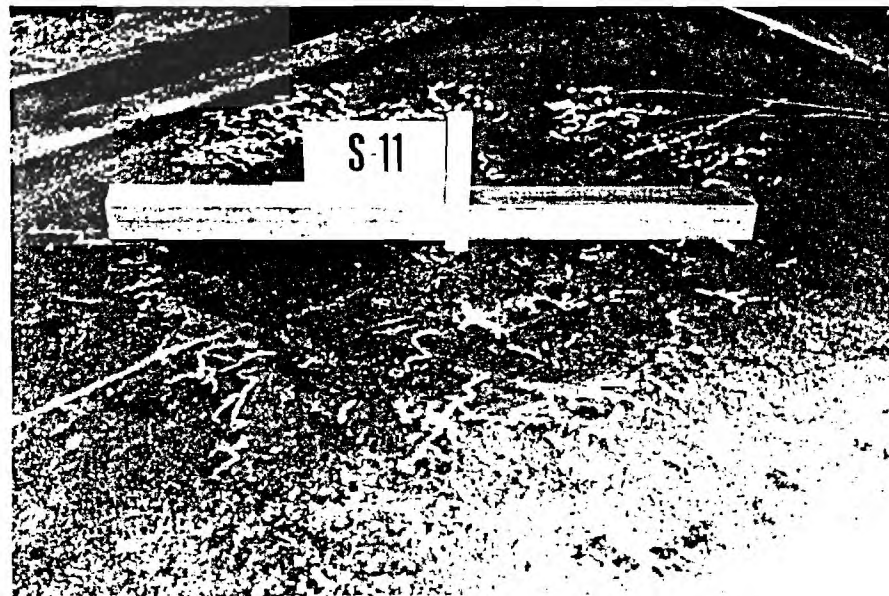
(b) Section 11: 3.5 in. AC/8 in. Stone/6 in. S.C.

FIGURE 98. FATIGUE CRACKING AND SURFACE DEFLECTION PROFILE OF SECTIONS 11 AND 12 AFTER 3.8 MILLION LOAD REPETITIONS.

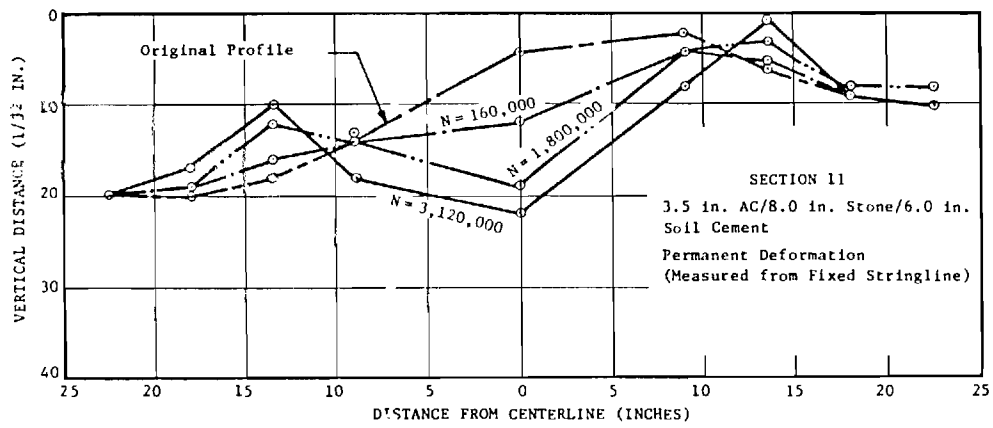
FIGURE 101. VARIATION OF SURFACE PROFILE WITH LOAD REPETITIONS - SECTION 11.

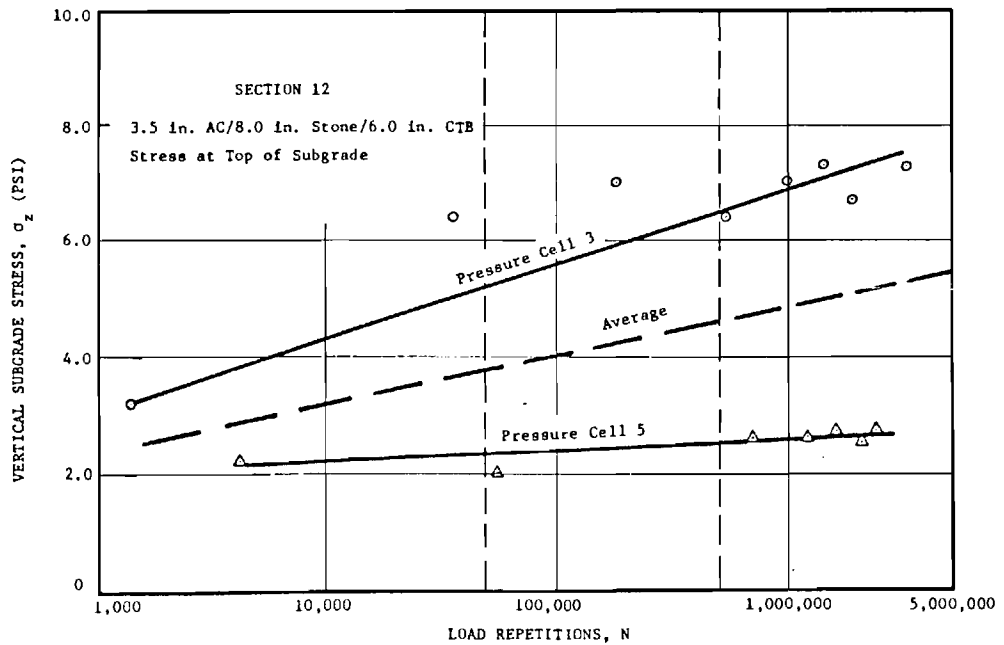
FIGURE 109. VARIATION OF RESILIENT VERTICAL SUBGRADE STRESS BELOW LOAD WITH NUMBER OF LOAD REPETITIONS - SECTION 12.

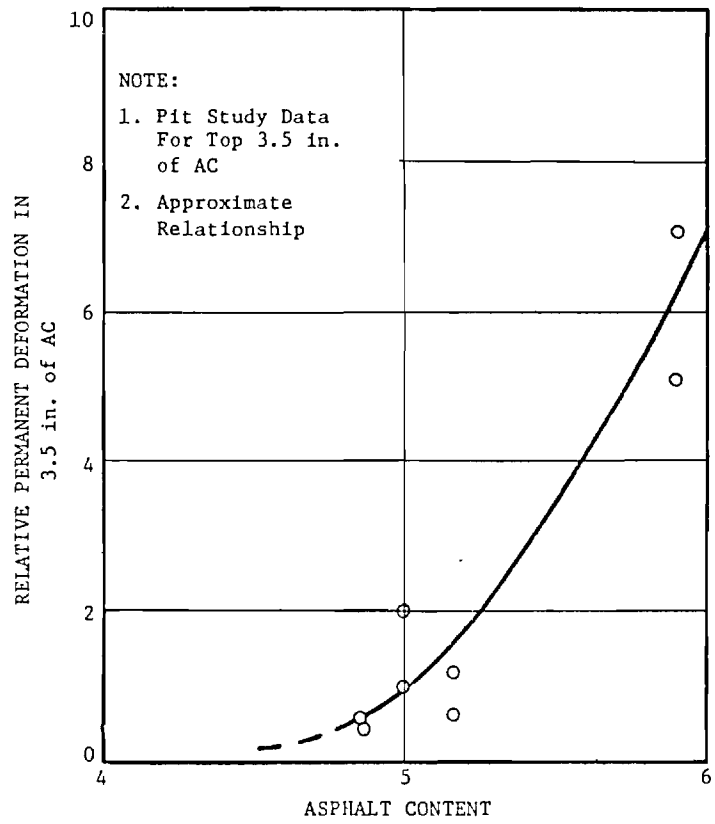
FIGURE 111. APPROXIMATE RELATIVE RUTTING IN ASPHALT CONCRETE AS A FUNCTION OF ASPHALT CONTENT - B AND B-MODIFIED BINDER.

6. Test results indicate an increase in asphalt content from about 5 to 5.25% approximately doubled the rutting in a layer of asphalt concrete.
7. For the reasonably firm sand subgrade investigated, the minimum required structural thickness above the subgrade to limit rutting to about 0.07 to 0.1 in. (1.9-2.5 mm) is about 13 to 15 in. (330-381 mm) for 2 million 6.5 kip (29 kN) loadings. In general however, a safety factor with respect to rutting of 1.25 is recommended as shown in Fig. 117. The standard penetration resistance of the subgrade was about 7 blows per foot (23 blows/meter).

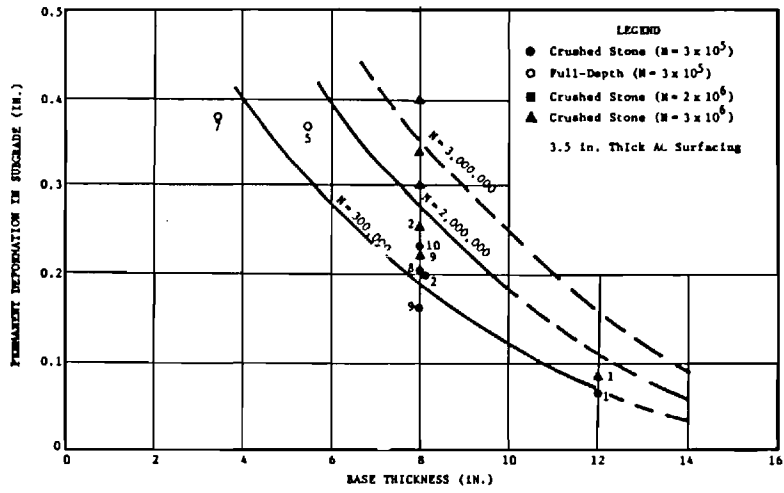
FIGURE 112. EFFECT OF BASE THICKNESS AND NUMBER OF LOAD REPETITIONS ON SUBGRADE RUTTING - CRUSHED STONE BASE AND FULL-DEPTH AC TEST RESULTS.

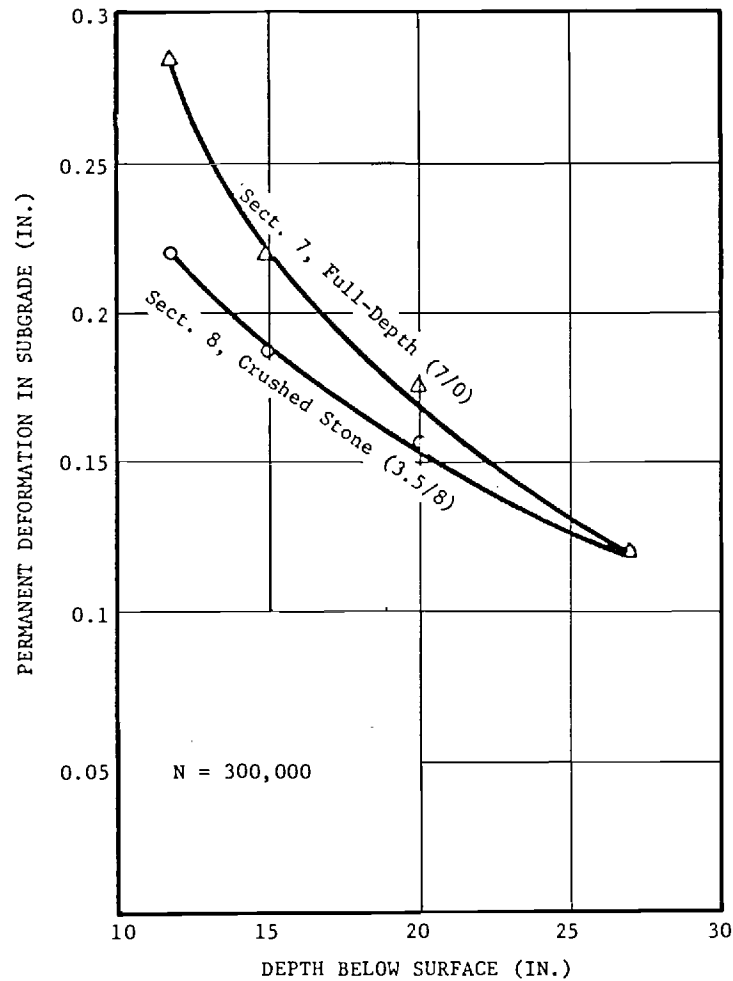
FIGURE 114. COMPARISON OF PERMANENT DEFORMATION IN SUBGRADE OF CRUSHED STONE BASE AND FULL-DEPTH ASPHALT CONCRETE SECTIONS - 300,000 LOAD REPETITIONS.

9. The crushed stone base sections were just as effective inch for inch as the full-depth asphalt concrete sections in reducing subgrade rutting.
10. For the conditions of the tests, 1.6 in. (46 mm) of crushed stone replaced 1.0 in. (25 mm) of asphalt concrete base. Refer to Chapter VI for a discussion of these results.

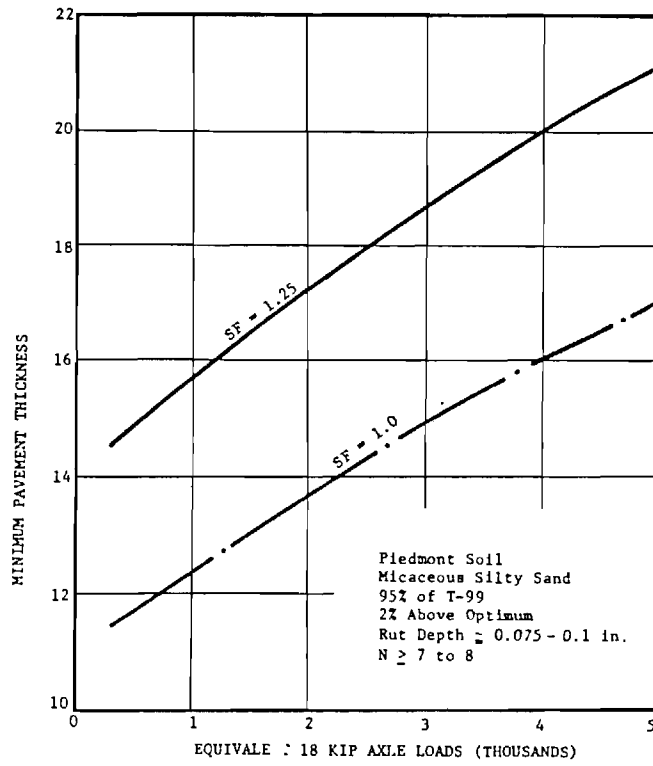
FIGURE 117. MINIMUM TOTAL PAVEMENT THICKNESS TO LIMIT SUBGRADE RUTTING.

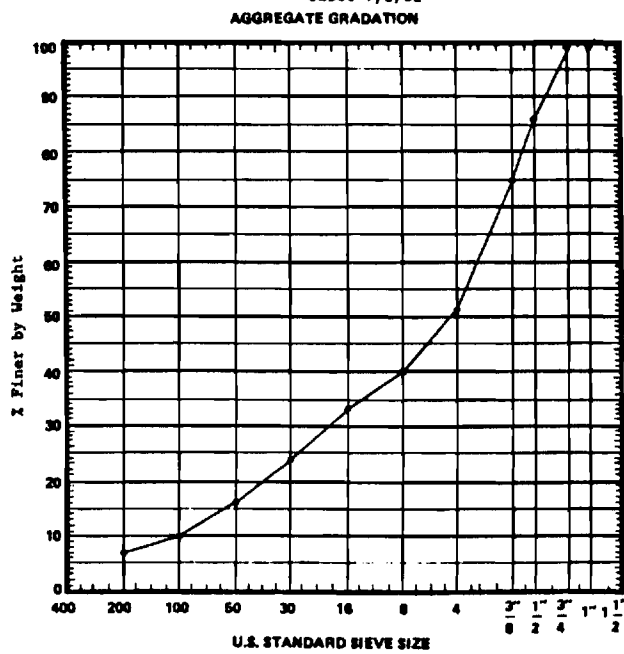
FIGURE 13. ASPHALT CONCRETE B-MIX DESIGN APPLICABLE TO SECTIONS 11 AND 12.

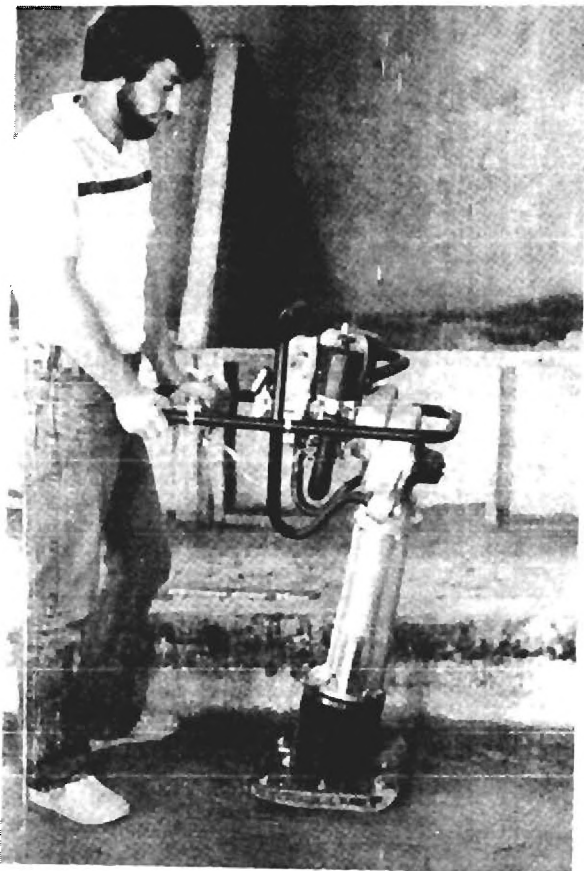
FIGURE 34. WACKER COMPACTOR USED TO OBTAIN 98% OF T-99 IN SILTY SAND SUBGRADE.

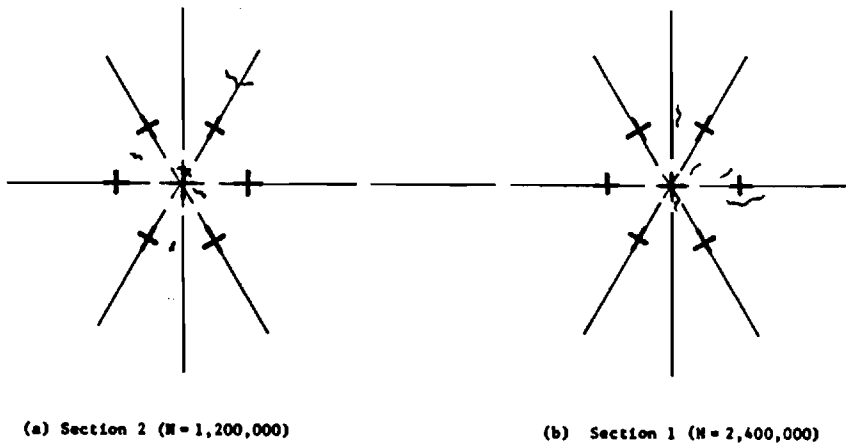
FIGURE 47. SURFACE CRACKING OBSERVED IN TEST SECTIONS 1 AND 2 AT INDICATED NUMBER OF LOAD REPETITIONS.

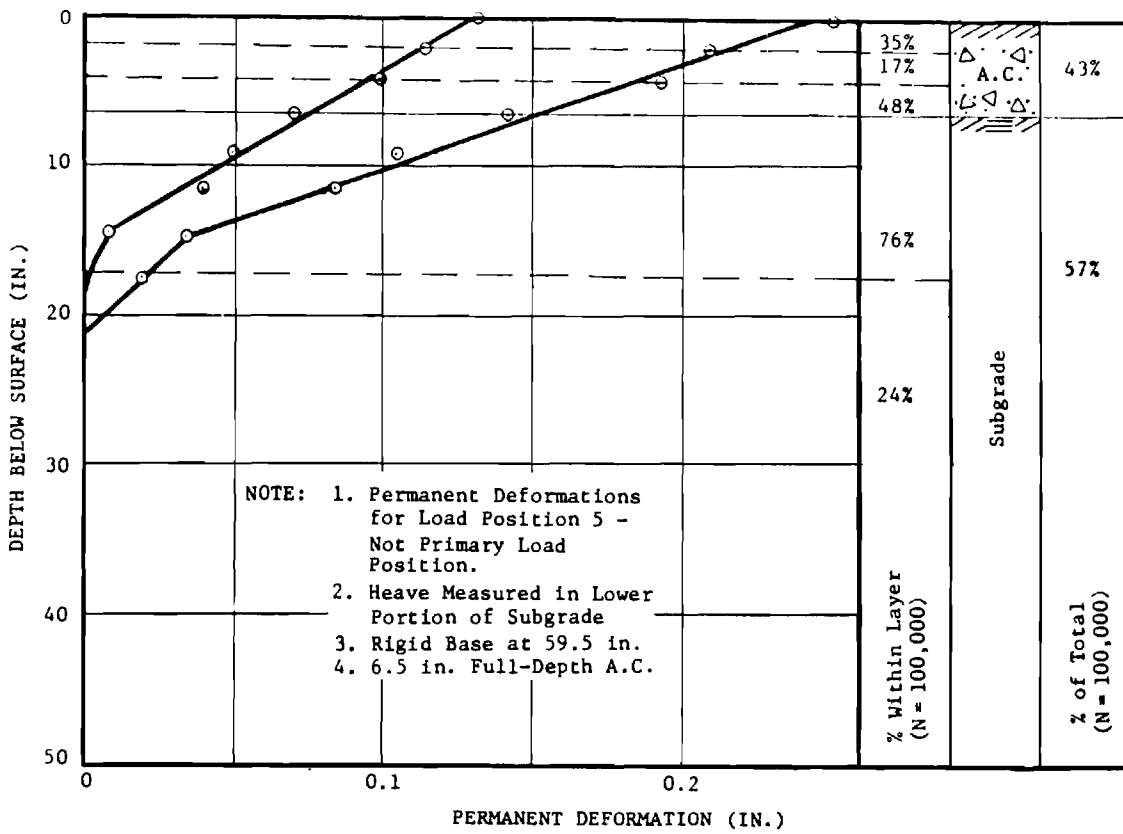
FIGURE 63. DISTRIBUTION OF PERMANENT DEFORMATION WITHIN PAVEMENT STRUCTURE - SECTION 6.

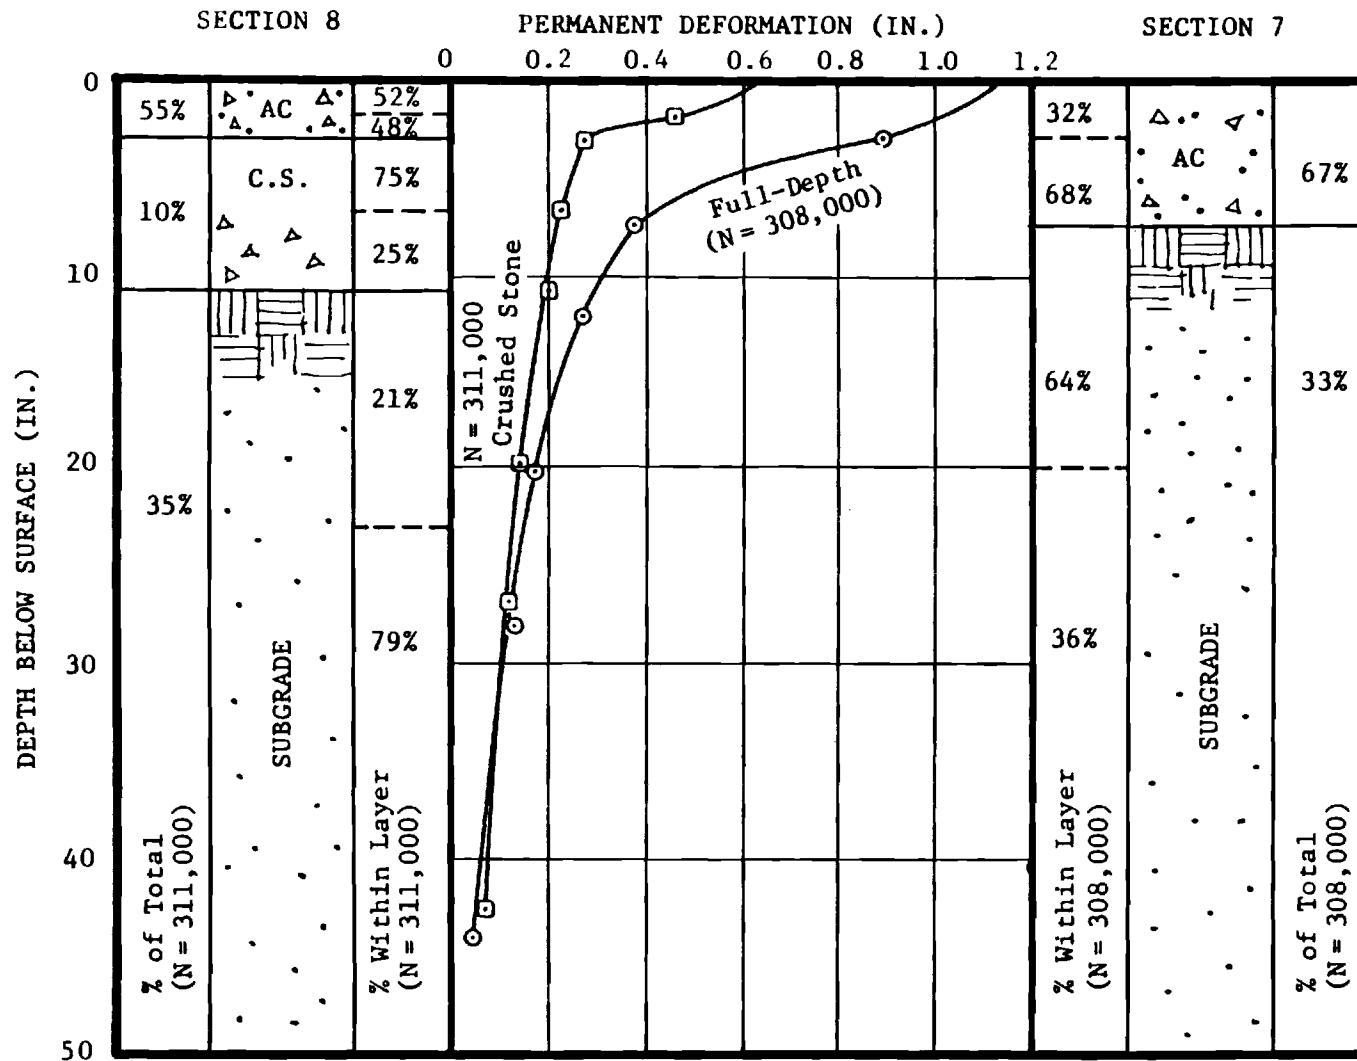
FIGURE 74. COMPARISON OF DISTRIBUTION OF PERMANENT DEFORMATION IN FULL-DEPTH SECTION 7 AND CRUSHED STONE SECTION 8.
