GEORGIA INSTITUTE OF TECHNOLOGY
OFFICE OF CONTRACT ADMINISTRATION
SPONSORED PROJECT INITIATION

Project Title: A Study of Factors Affecting Crushed Stone Base Course Performance

Project No: E-20-639

Sponsor: Georgia Department of Transportation

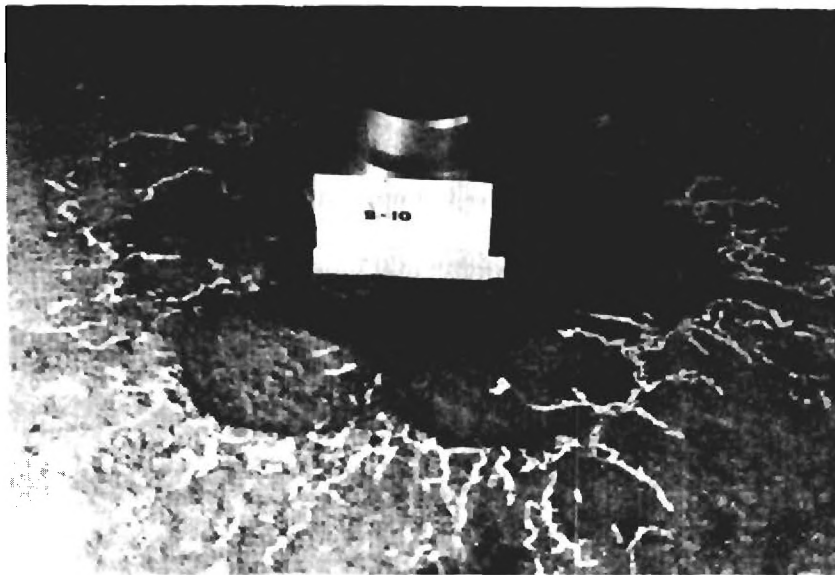
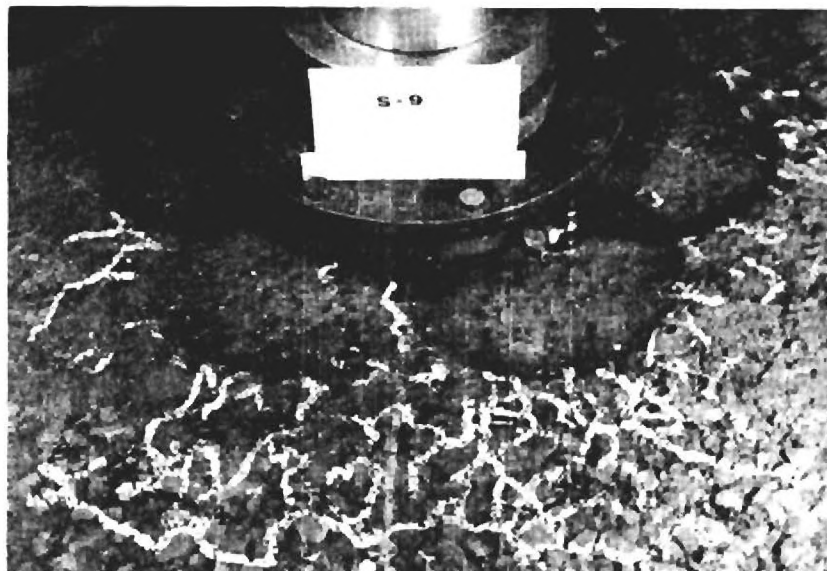
(a) Section 10: 3.5 in. A.C./8.0 in. Stone (Fine Gradation)

(b) Section 9: 3.5 in. A.C./8.0 in. Stone (Coarse Gradation)

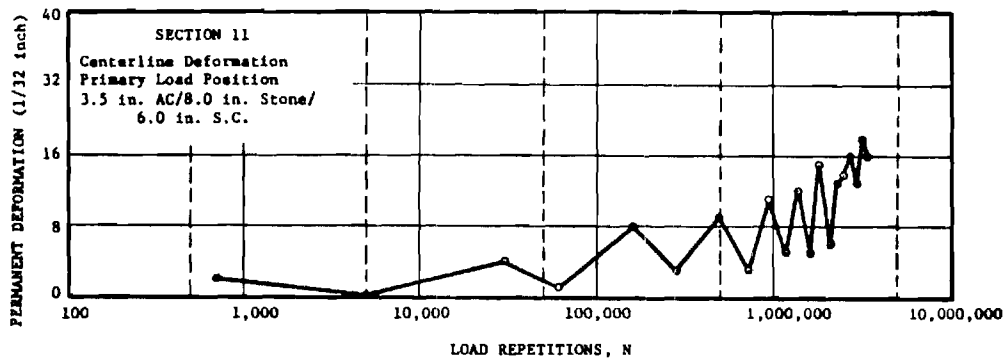
FIGURE 93. VARIATION OF CENTERLINE DEFORMATION WITH NUMBER OF LOAD REPETITIONS - SECTION 11 .

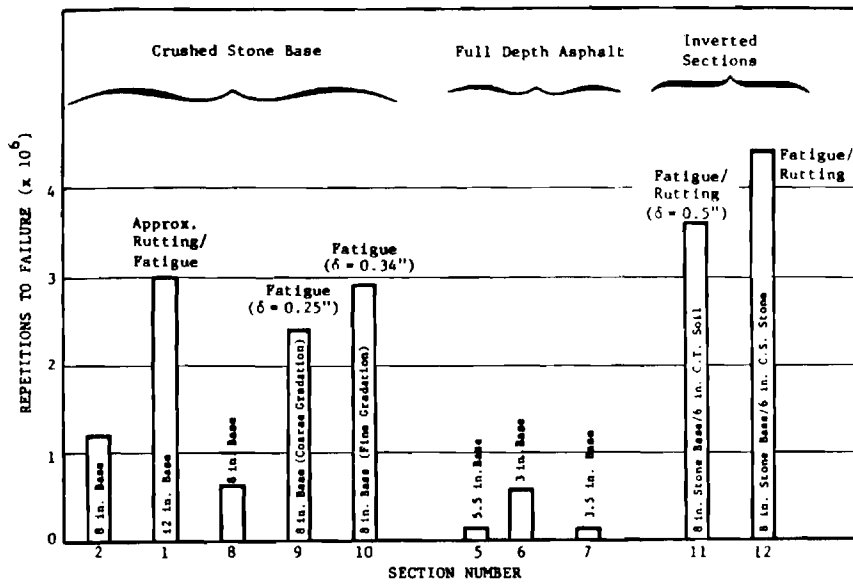
FIGURE 104. SUMMARY OF TEST SECTION RESULTS.

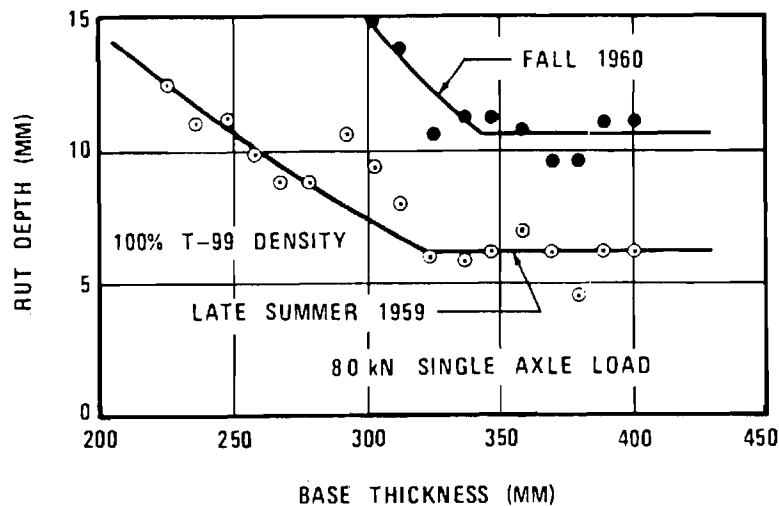
FIGURE 114. RUT DEPTH AS A FUNCTION OF BASE THICKNESS FROM AASHTO ROAD TEST.
