Project Title: *Research Initiation - Strengthening of Reinforced Concrete Columns for Earthquake Resistance*

Project No: *E-20-613*

Project Director: *Dr. Lawrence F. Kahn*

Sponsor: *National Science Foundation*

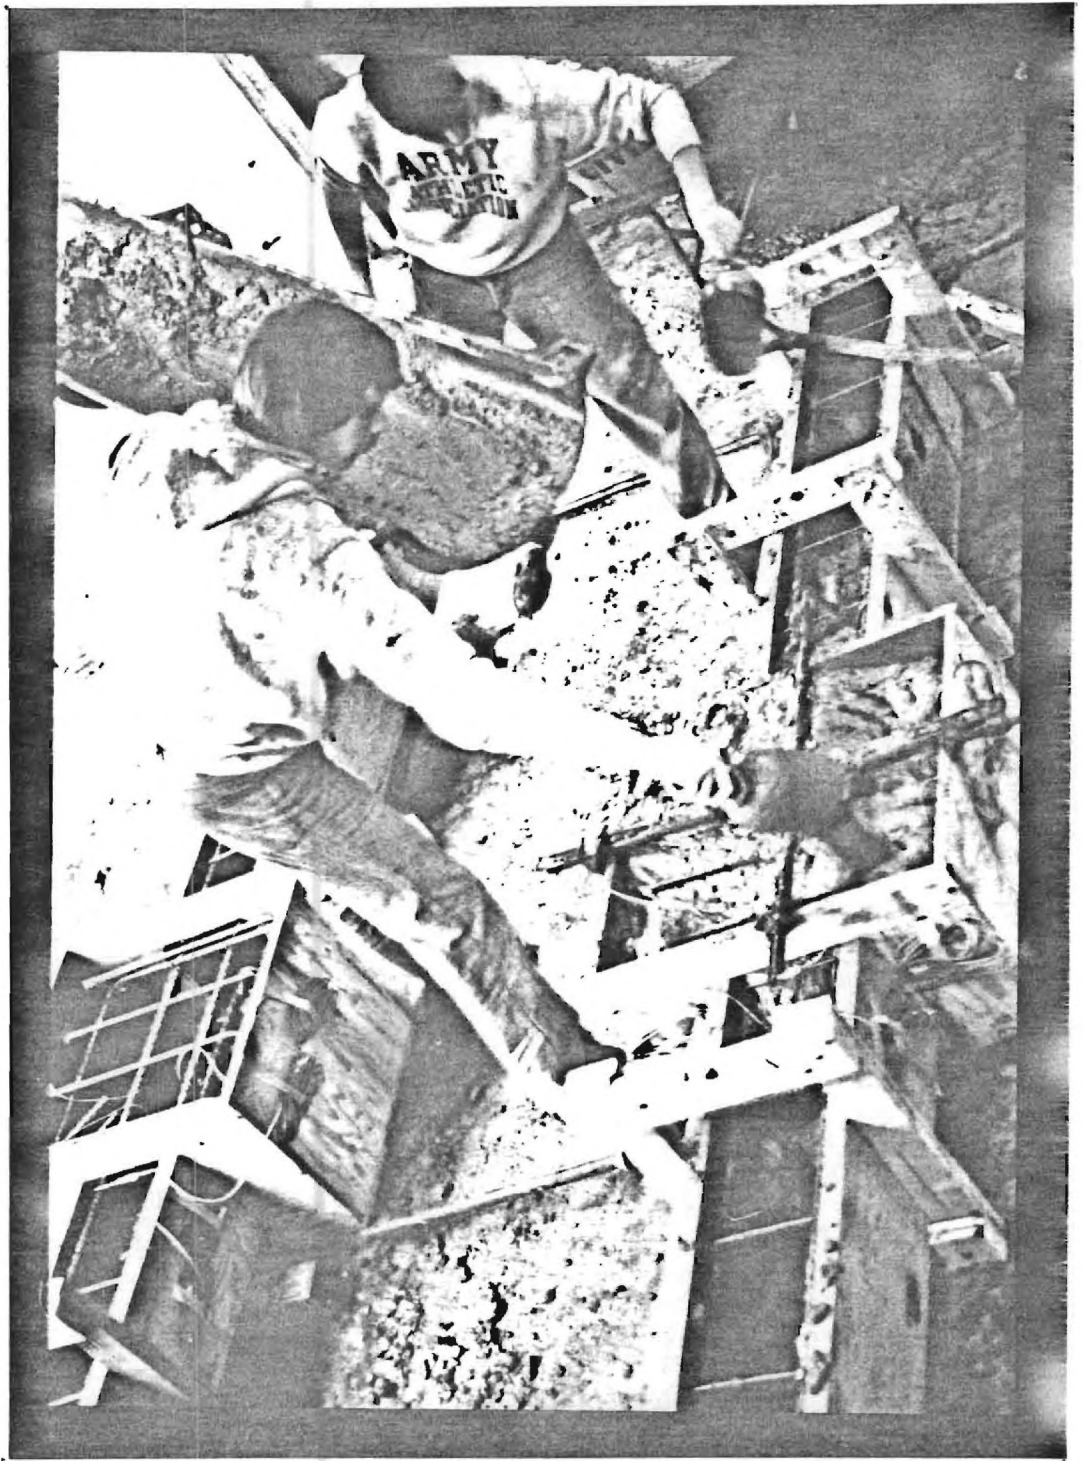
Figure 3. Casting columns in horizontal position with ready-mix concrete.

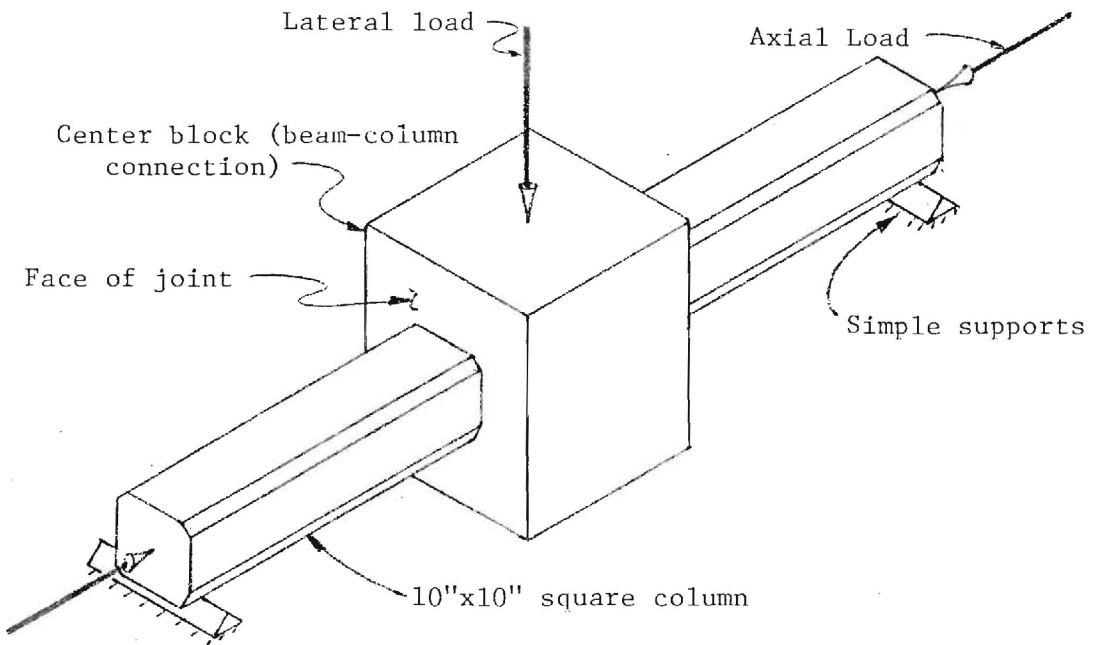
Figure 2.1 Column test specimen under axial load and flexed in single curvature.

In order to model this weak column - stiff girder connection and to provide a P- $\Delta$  effect, a model like that shown in Figure 2.1 was selected. The large center block represents the stiff girder connection. With a constant axial load, the specimen was flexed in single curvature by applying a lateral load at the center block. The P- $\Delta$  moment was generated by the difference in the line of action of the axial force and

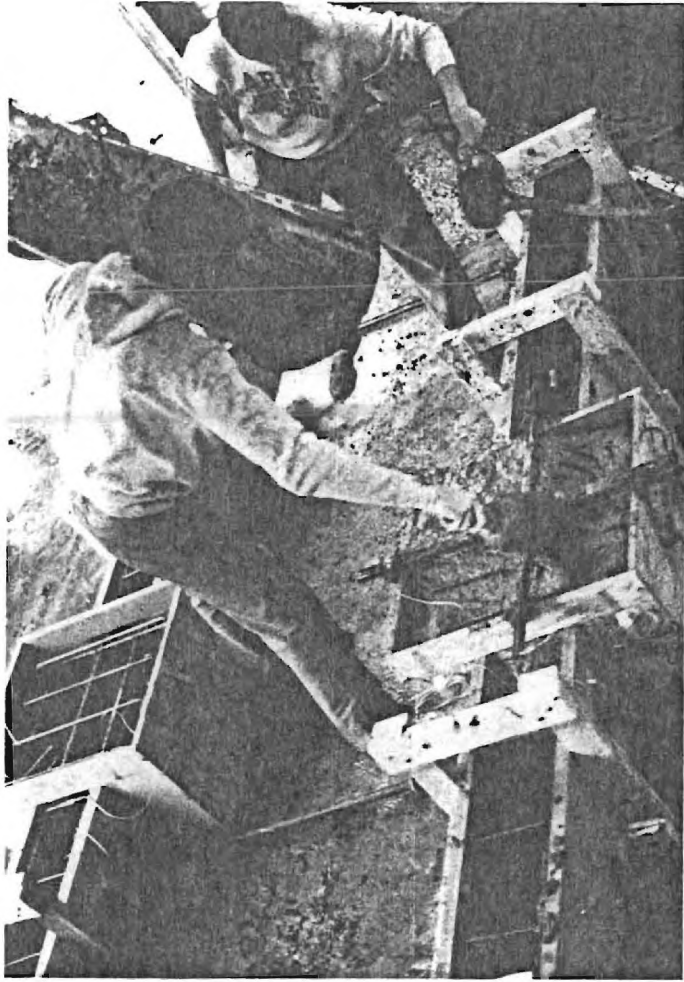
Figure 2.6 Casting column specimens.

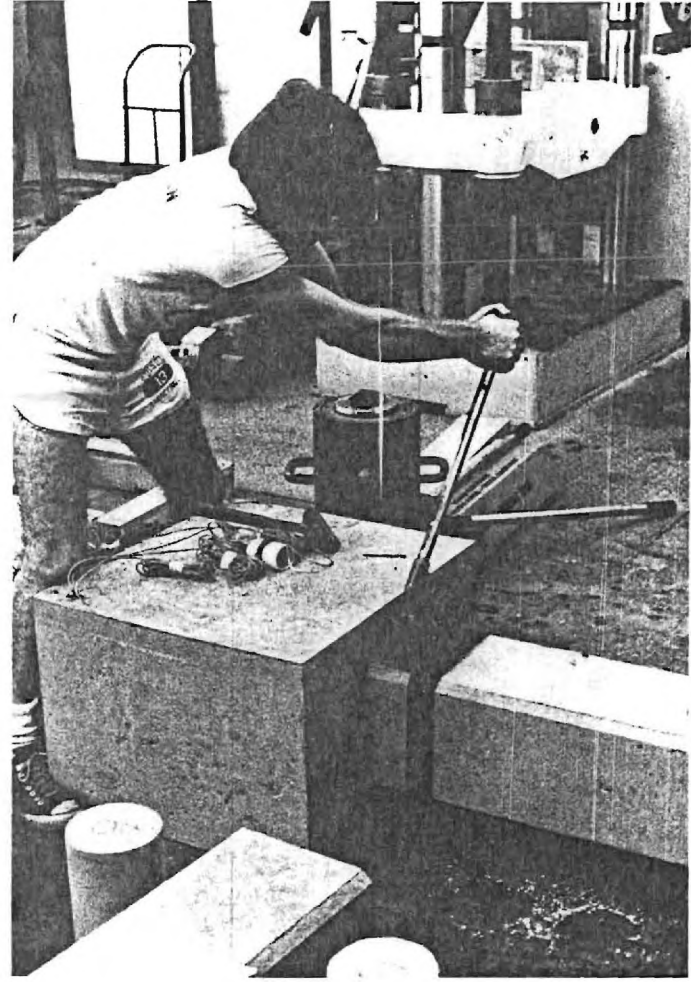
Figure 2.7 Tightening banding around Specimen 2.

Specimens 2,3 and 4 were strengthened using different techniques after the columns had cured for a minimum of one month. Specimen 2 was strengthened by hooping the column with 2-in. wide and 0.045-in. thick steel strapping bands; such bands are used typically for packaging. Figure 2.7 shows the first band being tightened around the column using a lever device; one end of the band was fixed in the base of the device while the other was secured in a spindle. The spindle was rotated by the lever, and the band, thus, was tensioned. One free end of the band was lapped over the hoop and was secured with two metal clips (figure 2.8) by crimping the clips with special pliers. As the lever device removed, the tension in the band was released. As the band

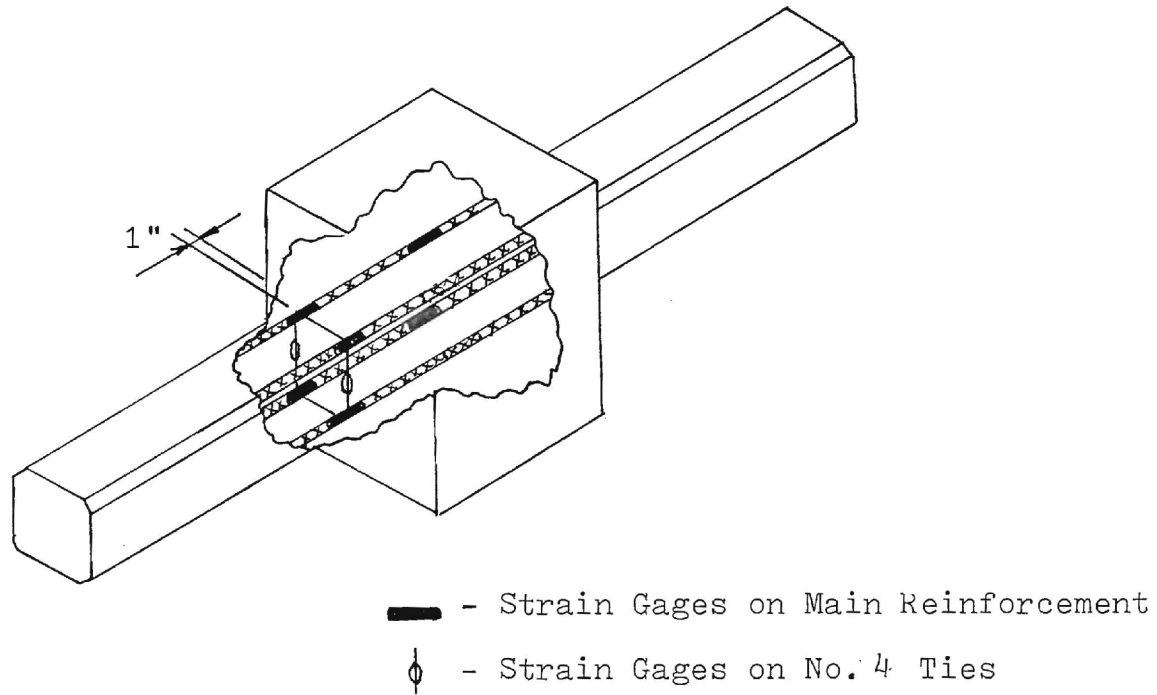
Figure 2.14 - Strain Gage Locations within the Specimen

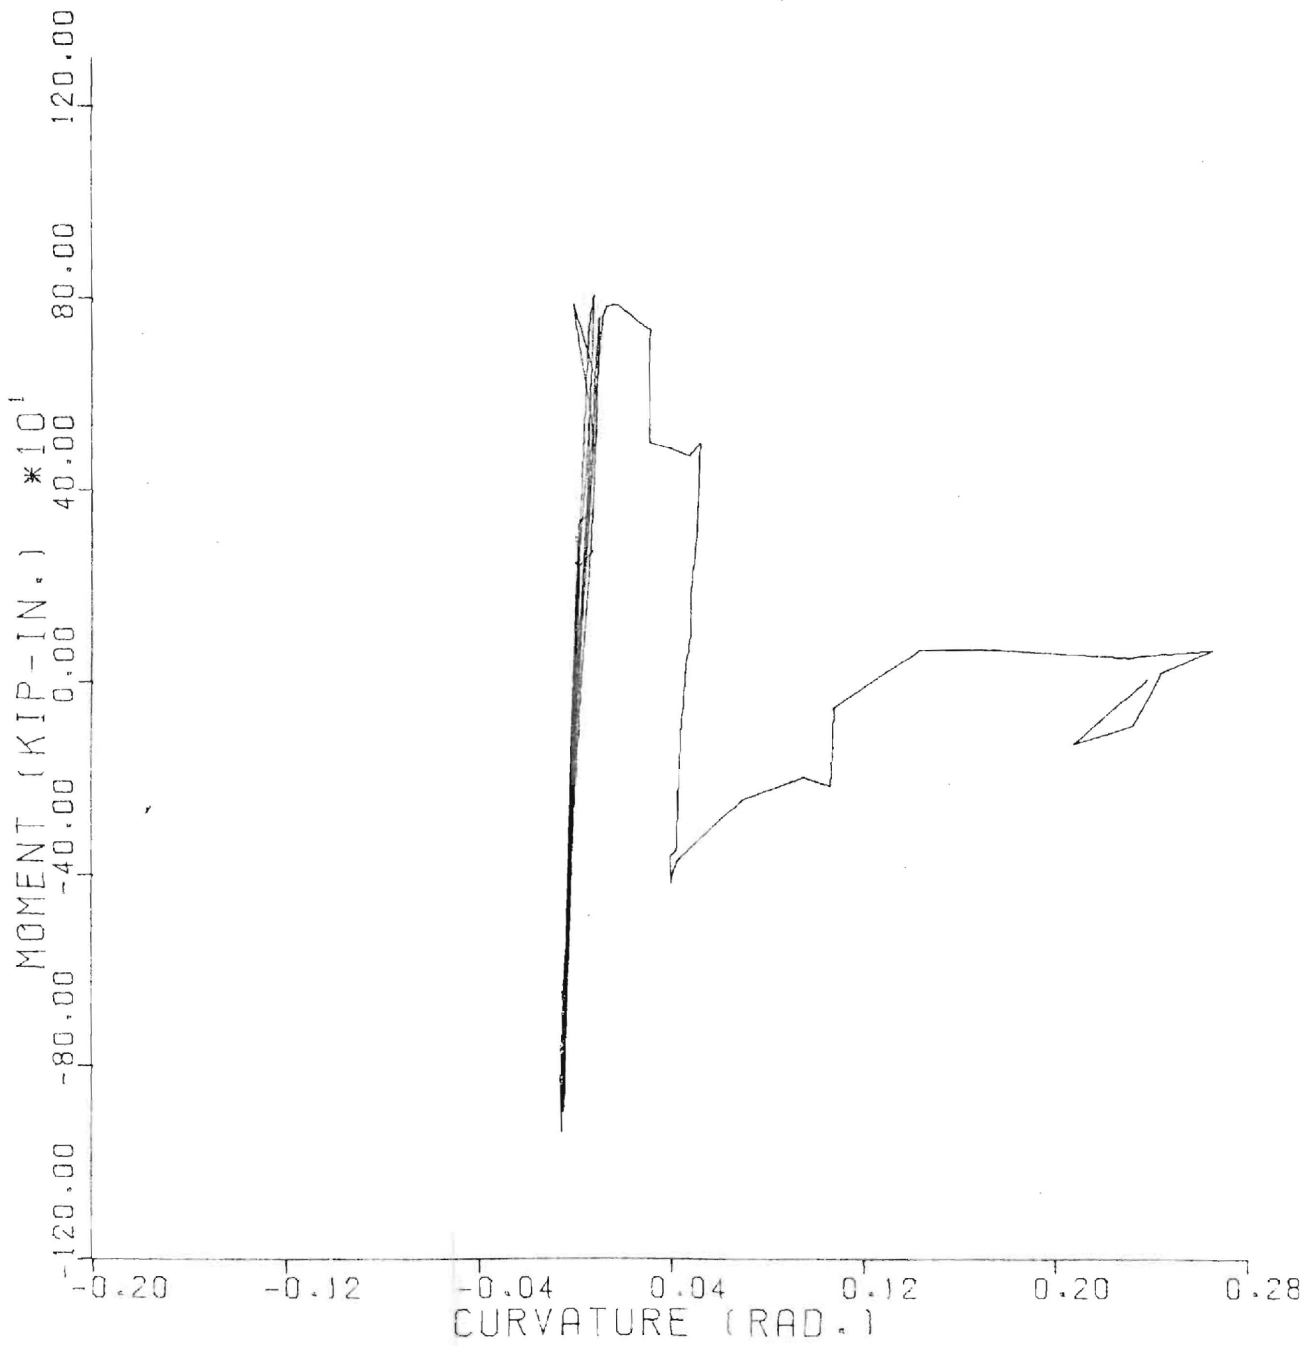
Figure 3.13 Specimen 1, moment-curvature response.

A rough experimental measure of column curvature was determined by the lateral deflection gages at the column-joint face and at 10 in. from that face. The difference in the deflection measurements were divided by the 10-in. distance between gages to yield an average rotation over the 10-in. space which included the maximum column moment and plastic hinge region. The moment at the joint face was calculated as the sum of the shear times the distance from the support to the joint face and the axial force times the lateral deflection at the joint face. Plots of these calculated moment-curvature relations are shown in Figure 3.13 through 3.16 for Specimens 1 through 4 respectively.

plot for Specimen 1 shows almost immediate failure at curvatures beyond the elastic range. The most important observation in the plots for Specimens 2, 3 and 4 is that the moment continued to increase at curvatures between 0.02 radian and 0.04 radian during the first cycle to the maximum deflection. This increasing moment corresponds to the decreasing lateral load at large deflections mentioned in Section 3.1 above. Although the P- $\Delta$  effect was evident, the moment capacity of the columns was stable and slightly increasing.

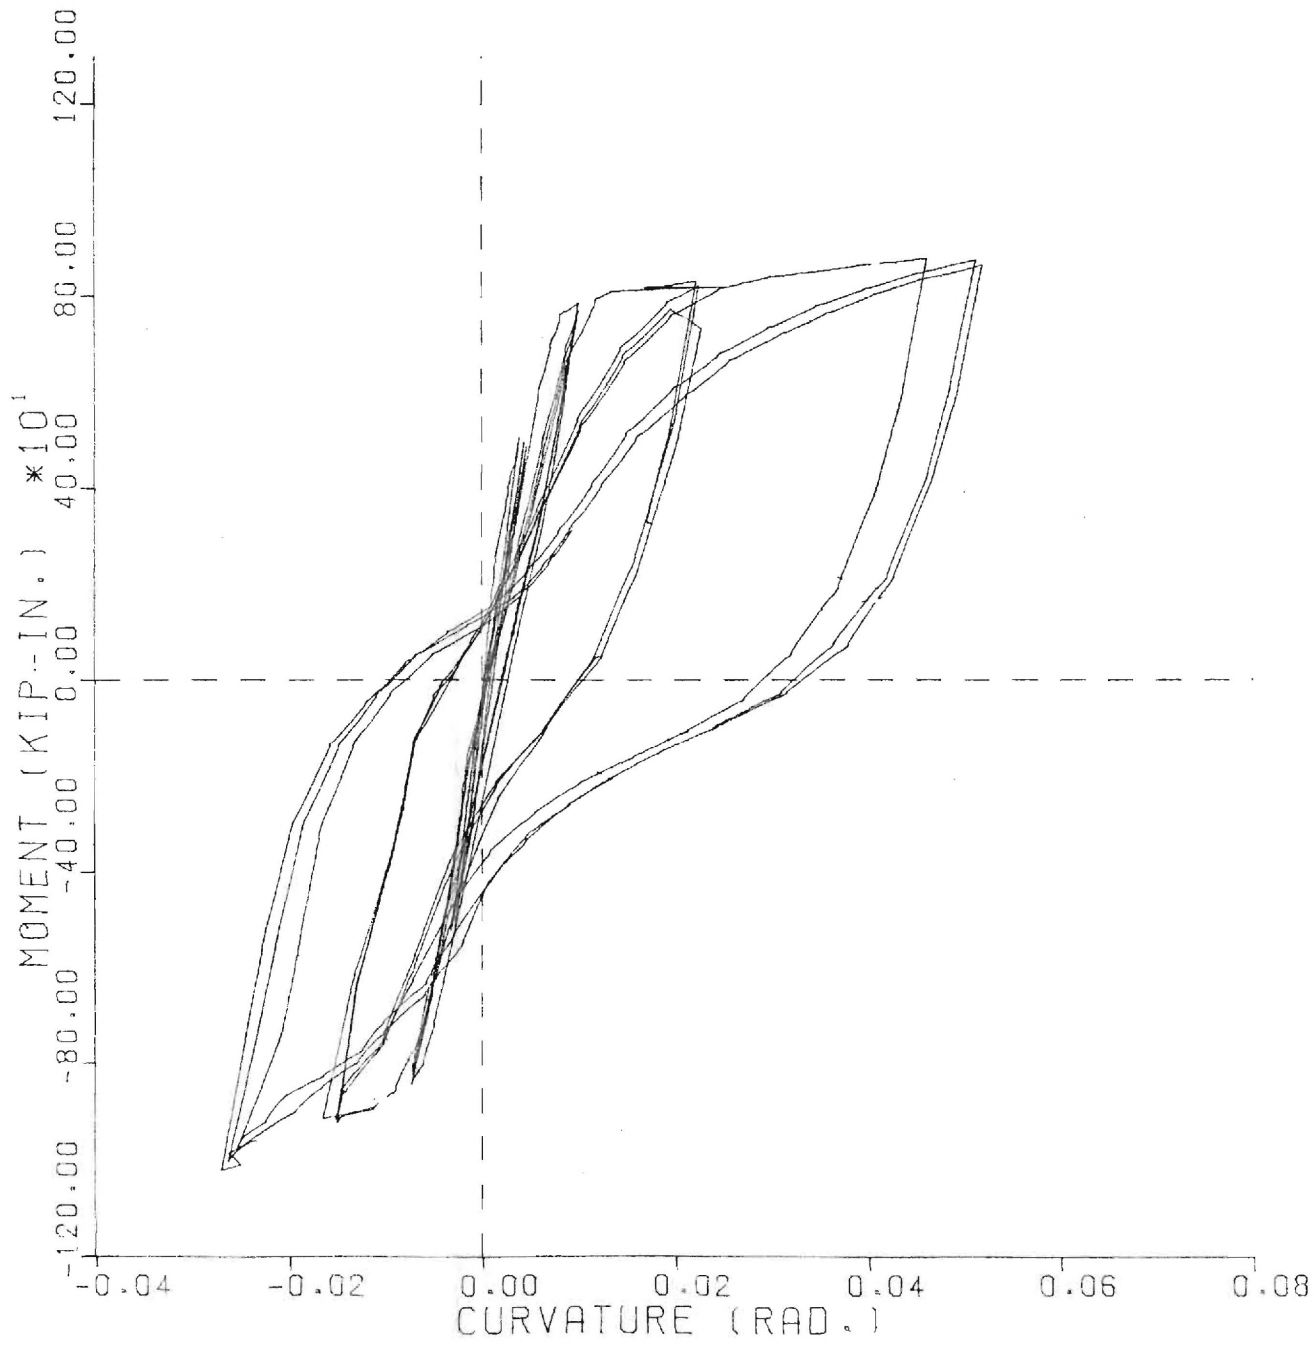
Figure 3.15 Specimen 3, moment-curvature response.

For Specimens 2, 3 and 4 these moment-curvature diagrams closely resembled the load-deflection curves, and were typical for reinforced concrete members dominated by flexural response. The moment-curvature

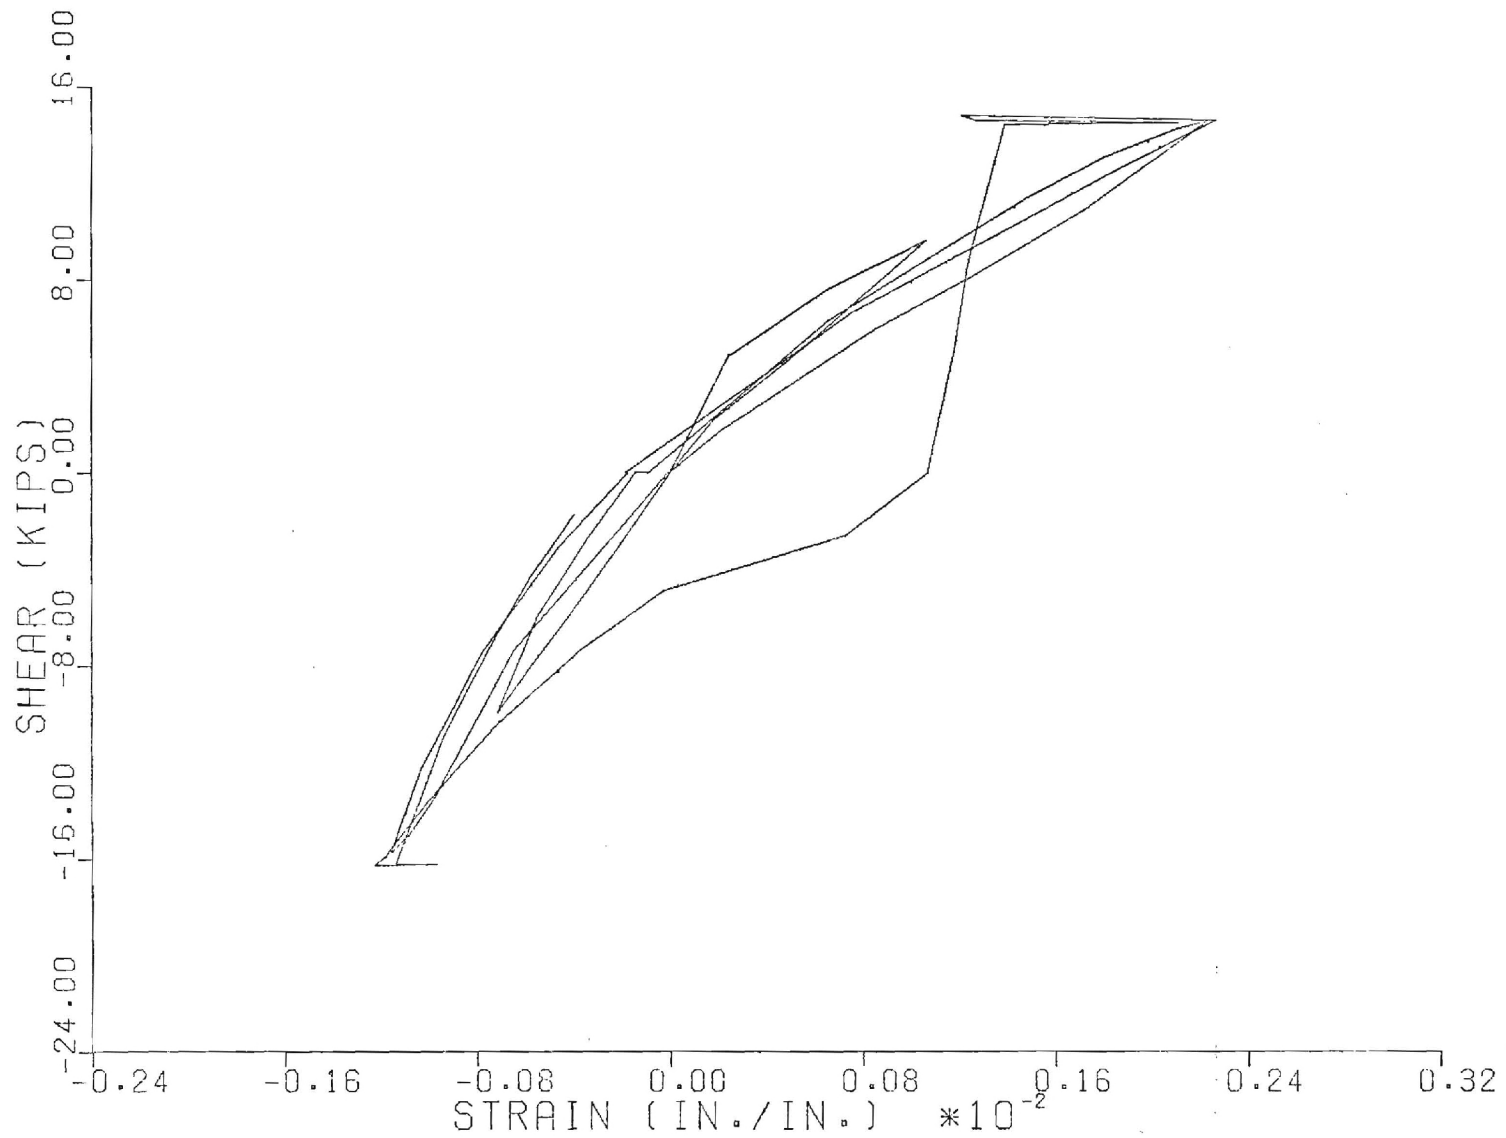
Figure 3.19 Specimen 3, average strain on bottom No. 7 bars, 1-in. from joint for deflection cycles 1, 4, and 7.

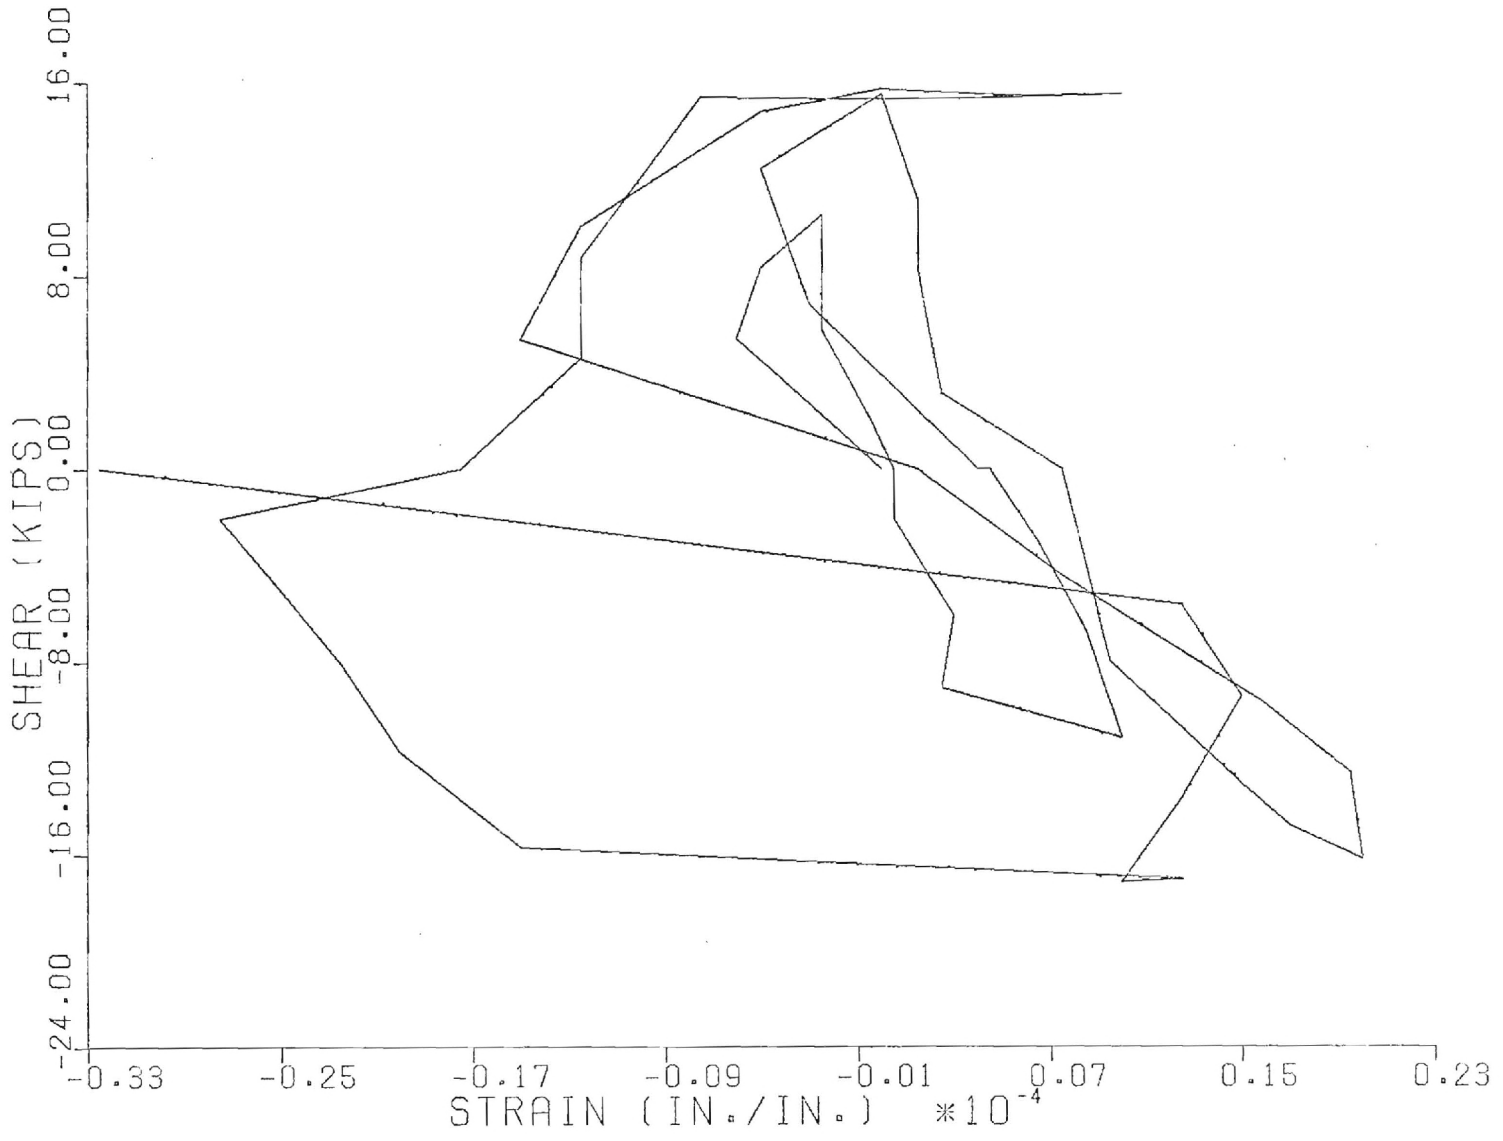
Figure 3.22 Specimen 4, strain on U-clamp next to joint for deflection cycles 1, 4, and 7.

strain in the first U-clamp. Observations of the second U-clamp and bolt did not indicate any yielding. The second clamp had added flexibility across the crack because of the bending of the outstanding legs. The bending of these legs reduced the stiffness and effective confining capacity of the clamp.

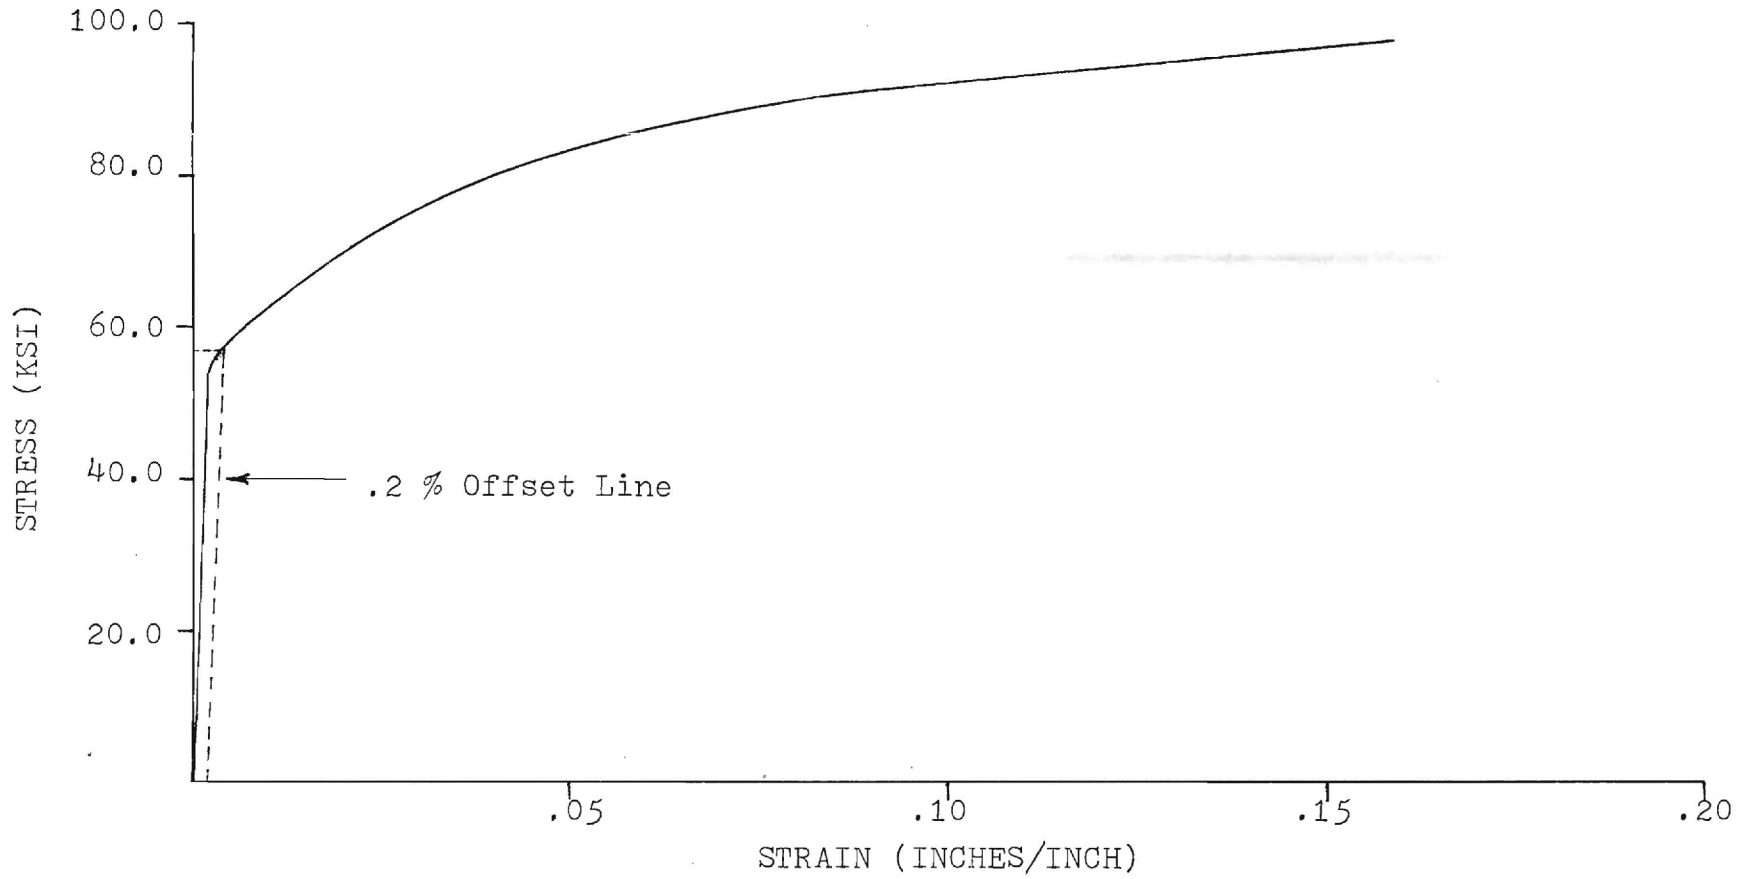
Figure A.1 - Average Stress-Strain Curve for No. 7 Reinforcing Steel Bar

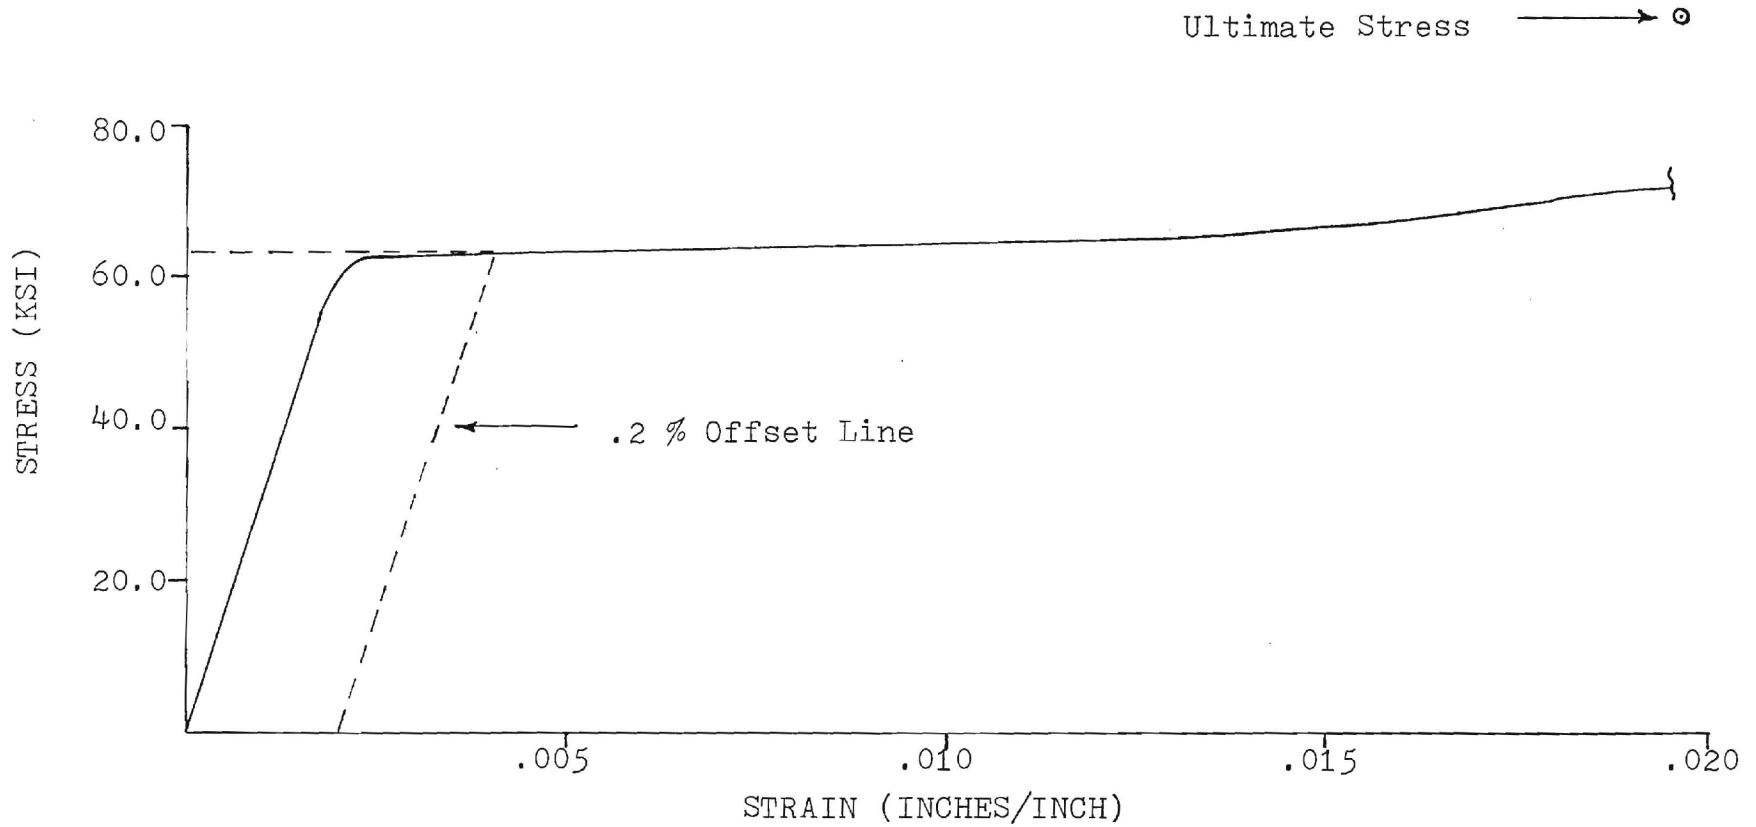
Figure A.5 - Average Stress-Strain Curve for No. 3 Reinforcing Steel Bar

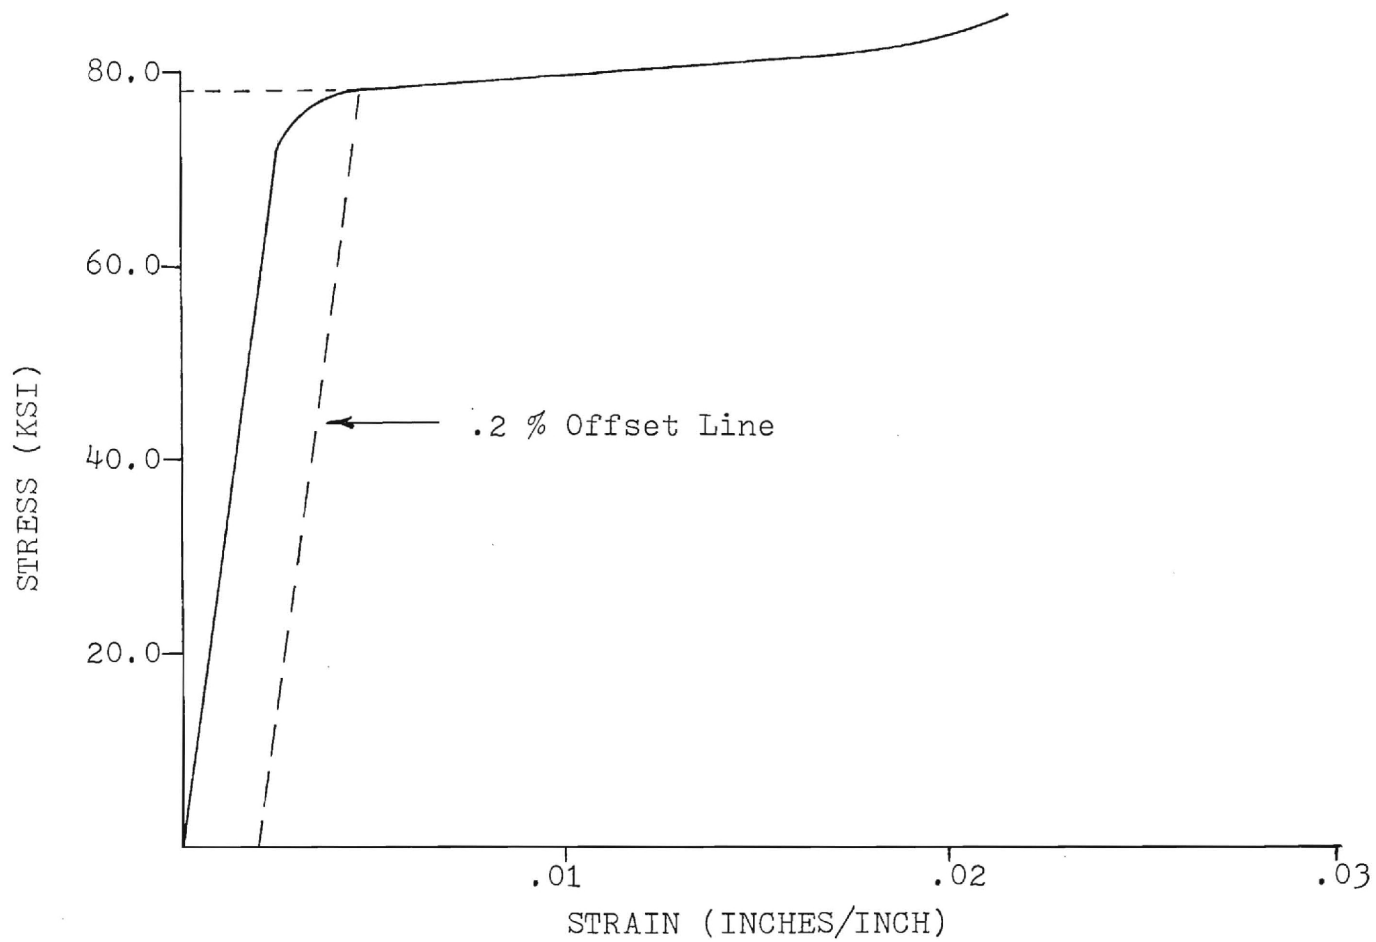
Figure A.7 - Average Stress-Strain Curve for No. 2 Reinforcing Tie

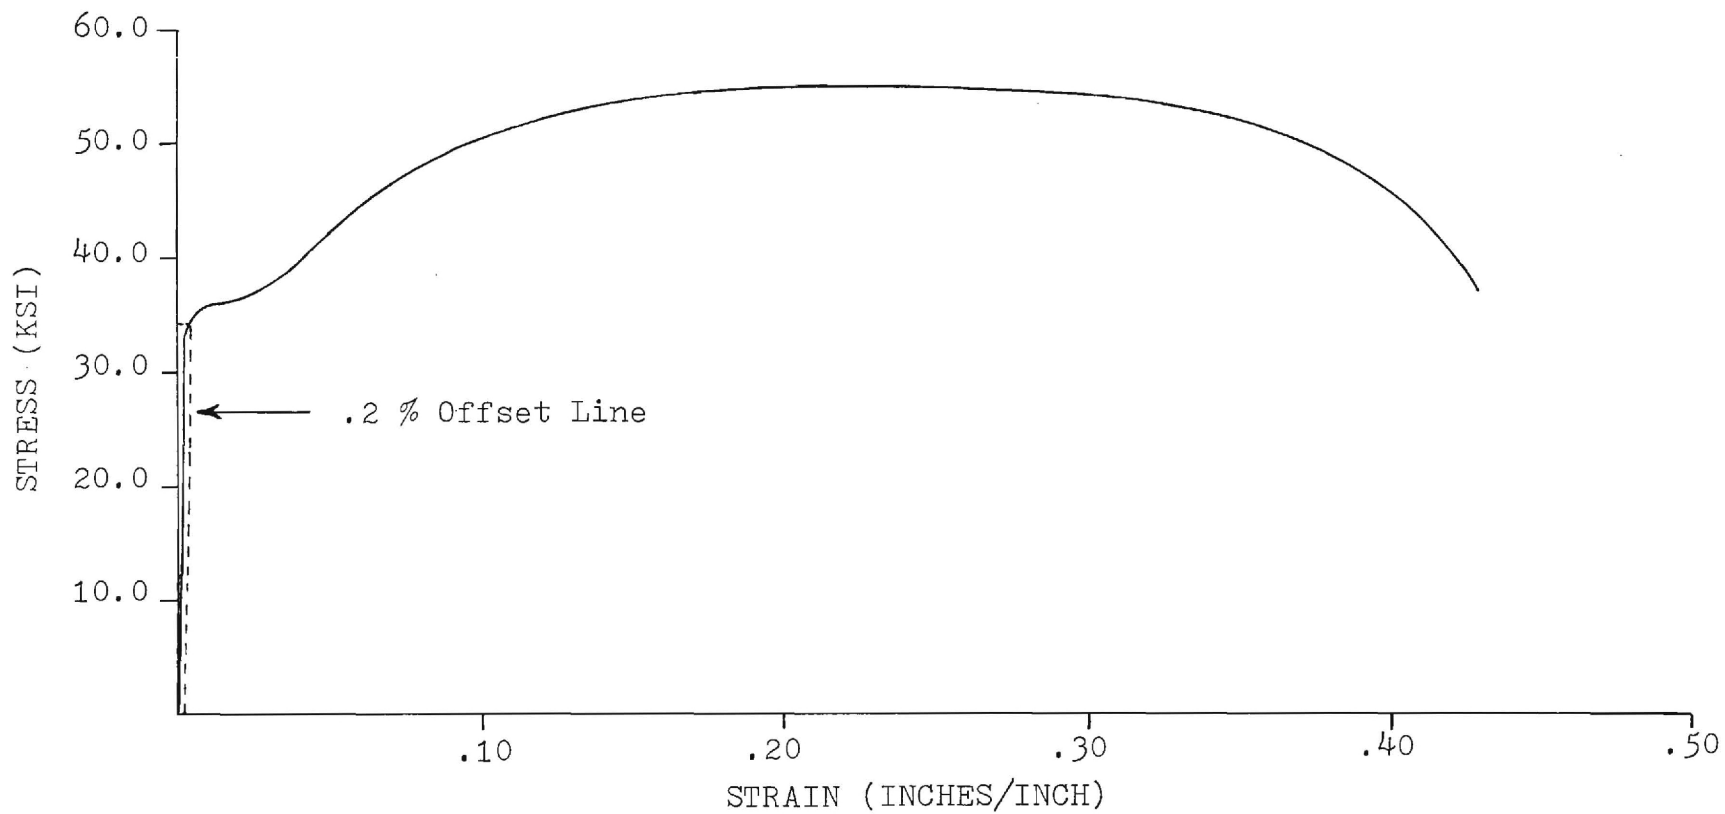
Figure A.17 - Average Stress-Strain Curve for 3 x 5 x 5/16 inch Angle

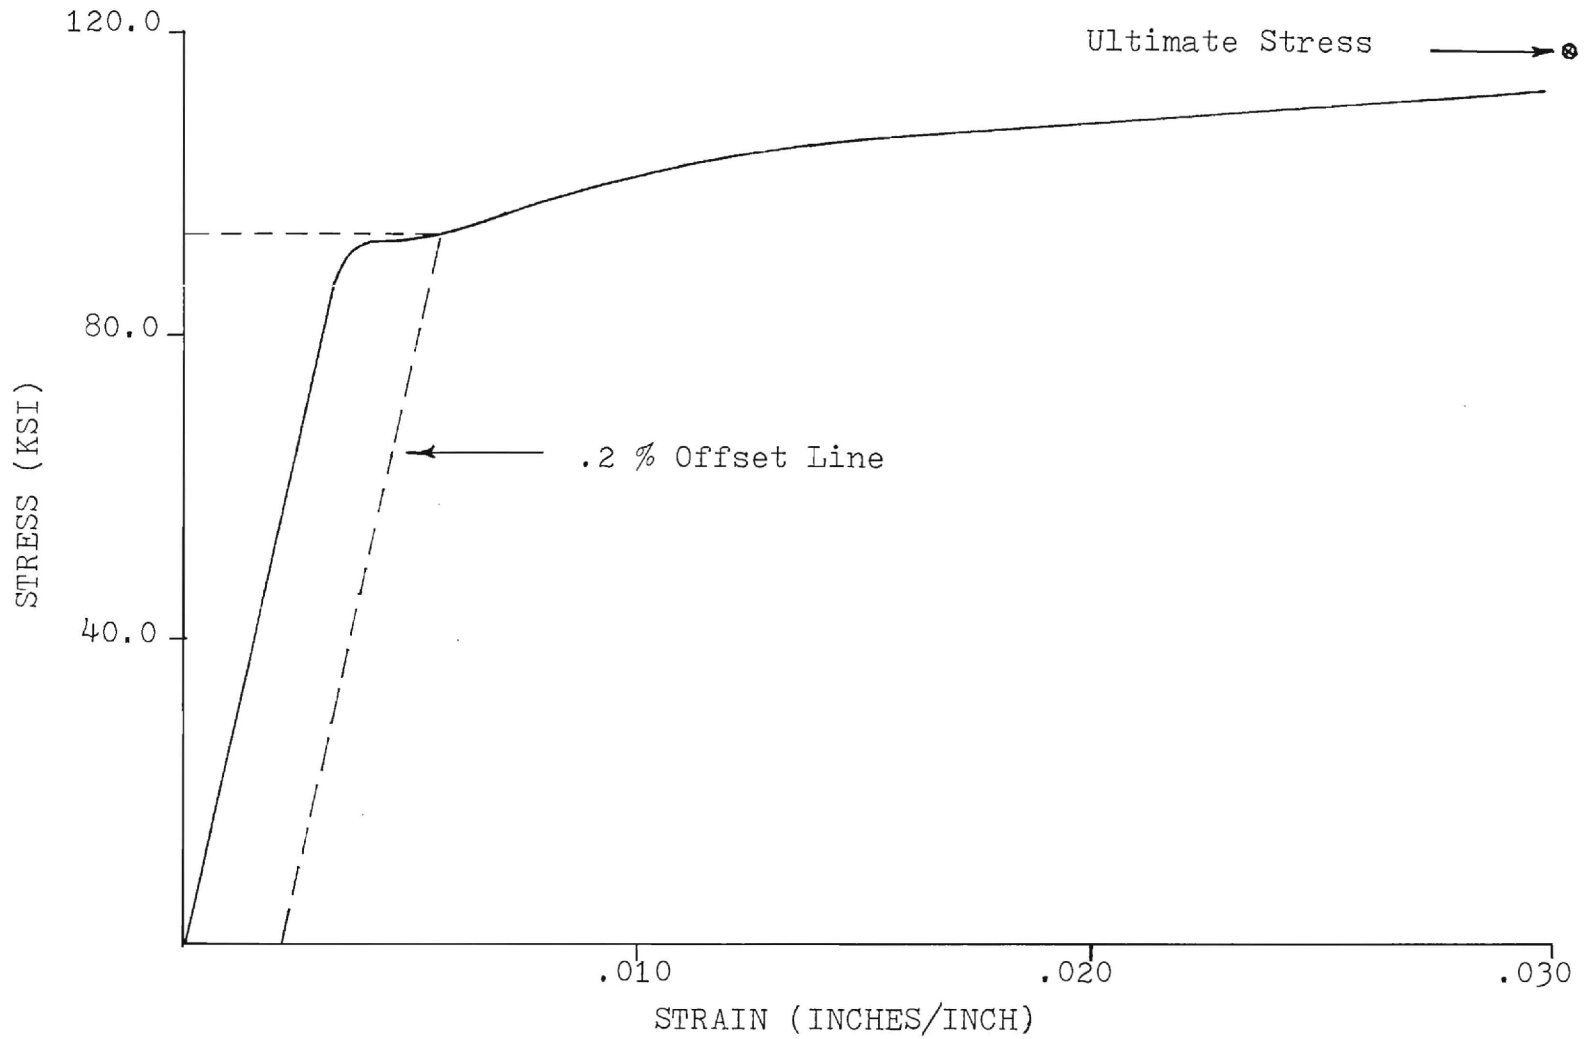
Figure A.20 - Average Stress-Strain Curve for Packaging Band

technique, were tested in a Tinius-Olsen Universal Testing Machine and strain was automatically plotted using the identical LVDT arrangement previously mentioned. Gage marks were not used. The specimens exhibited classical necking configurations shown in Figure A.18. Yield lines developed diagonally across the necked area. The rupture is shown in Figure A.19. The average stress-strain curve, plotted from the load-strain graphs, is shown in Figure A.20.
