Platt, S, Erandi, I, Jayasinghe, C, Jayasinghe, T, Maskell, D, Ranasinghe, G & Walker, P 2020, 'Improving the lateral load resistance of vernacular masonry walls subject to flooding', *ICE Construction Materials*.  
<https://doi.org/10.1680/jcoma.20.00004>

**Improving the lateral load resistance of vernacular masonry walls subject to flooding**

Low rise vernacular masonry buildings are vulnerable to damage from extreme flooding. This paper presents findings from a study based in Sri Lanka assessing the structural resilience of non-engineered single storey houses constructed with either fired clay brickwork and cement block masonry walls. A structural survey of flood damaged houses enabled characterisation of masonry materials, and development of proposals to improve the lateral load capacity of masonry walls. The structural survey revealed that a combination of low-quality masonry units and variable thickness of mortar beds may have contributed to flexural failure due to the hydrostatic pressures during flood events. An experimental programme investigated the impact of differing masonry units and mortar thickness on masonry properties under dry and saturated conditions. A simple

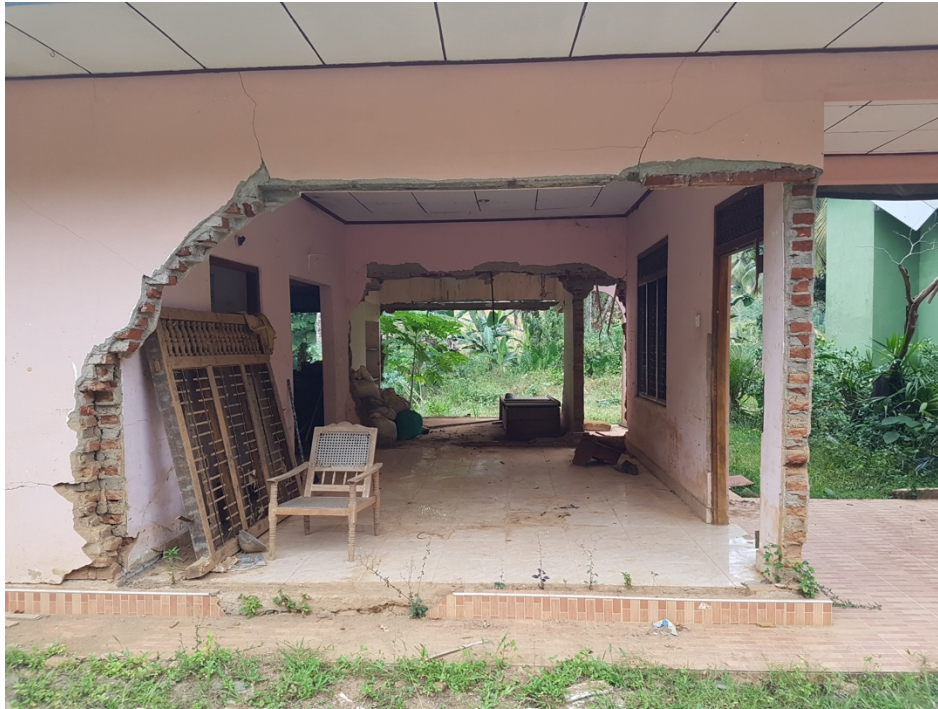
Figure 1. Flood damaged masonry house, Sri Lanka, 2017

15  
16 There are differing approaches to reducing the impact of flooding that broadly involve  
17 improving either resistance or resilience. Houses that are flood resistant prevent  
18 flooding of the space, and therefore allow operation to continue largely unaffected  
19 during and after the event. However, flood resilient buildings allow flood waters to enter  
20 the house without causing permanent damage, thus maintaining structural integrity, and  
21 allowing normal use to resume once the flood waters have receded. Many of the  
22 vernacular low-rise houses in Sri Lanka, and elsewhere, are neither flood resistant nor  
23 resilient, as seen from the typical damage in the 2016 and 2017 floods (Figure 1).

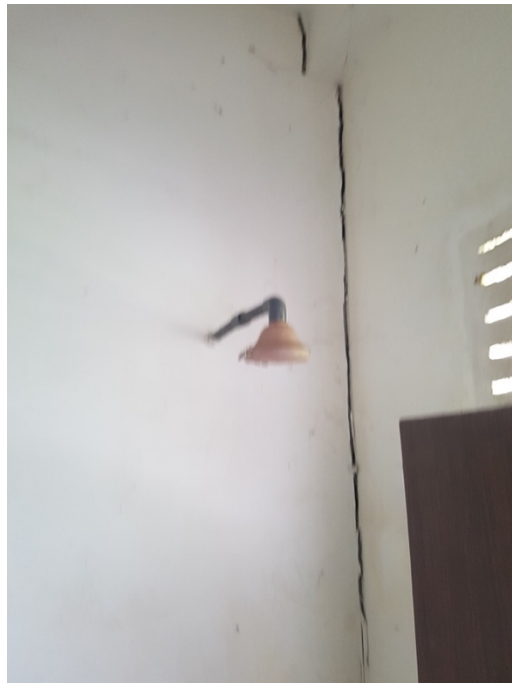
Figure 2. Cracking between adjoining walls

90 In 83% of buildings surveyed in the flood affected regions, the flood waters reached at  
91 least 2 metres high. Damage to masonry walls and buildings from the flooding  
92 characterised during the field survey included: cracking/failure between adjoining walls  
93 (Figure 2); cracking along solid walls (Figure 3); cracking/failure around openings  
94 (Figure 4); and total wall collapse (Figure 5).

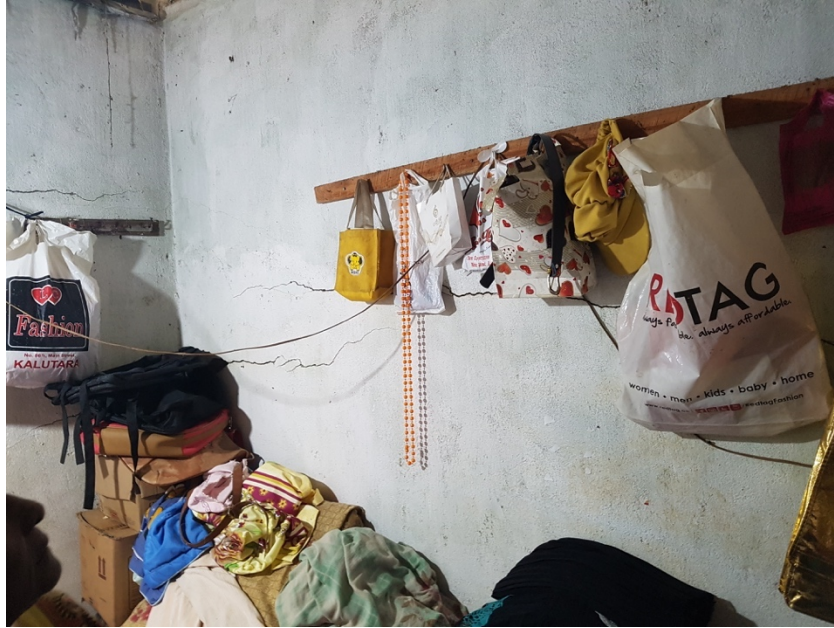
Figure 3. Cracking in solid wall

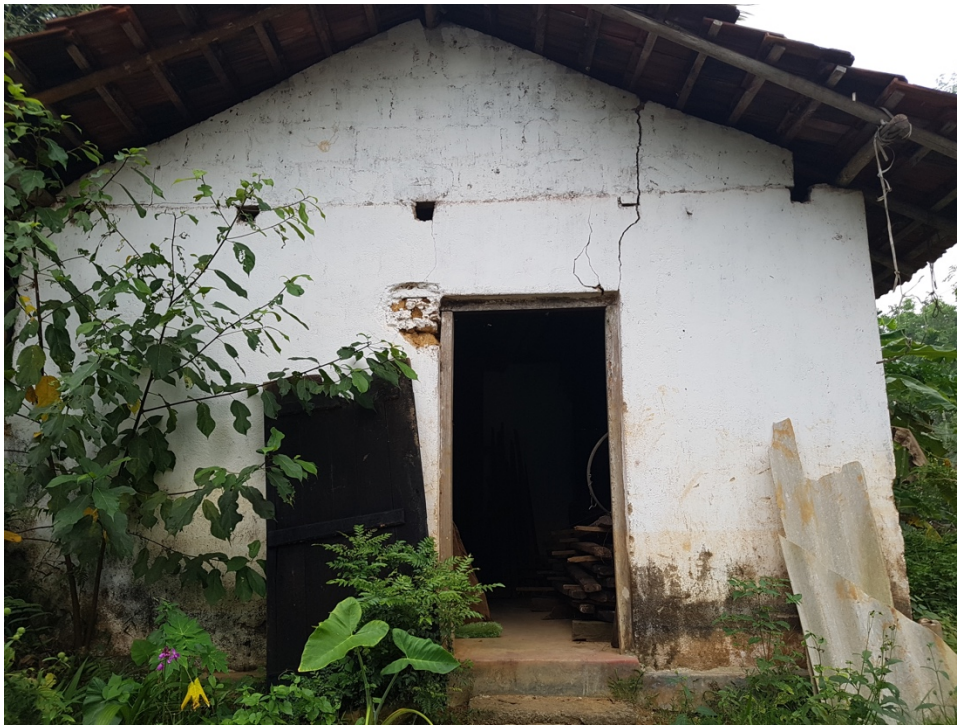
Figure 4. Cracking around opening

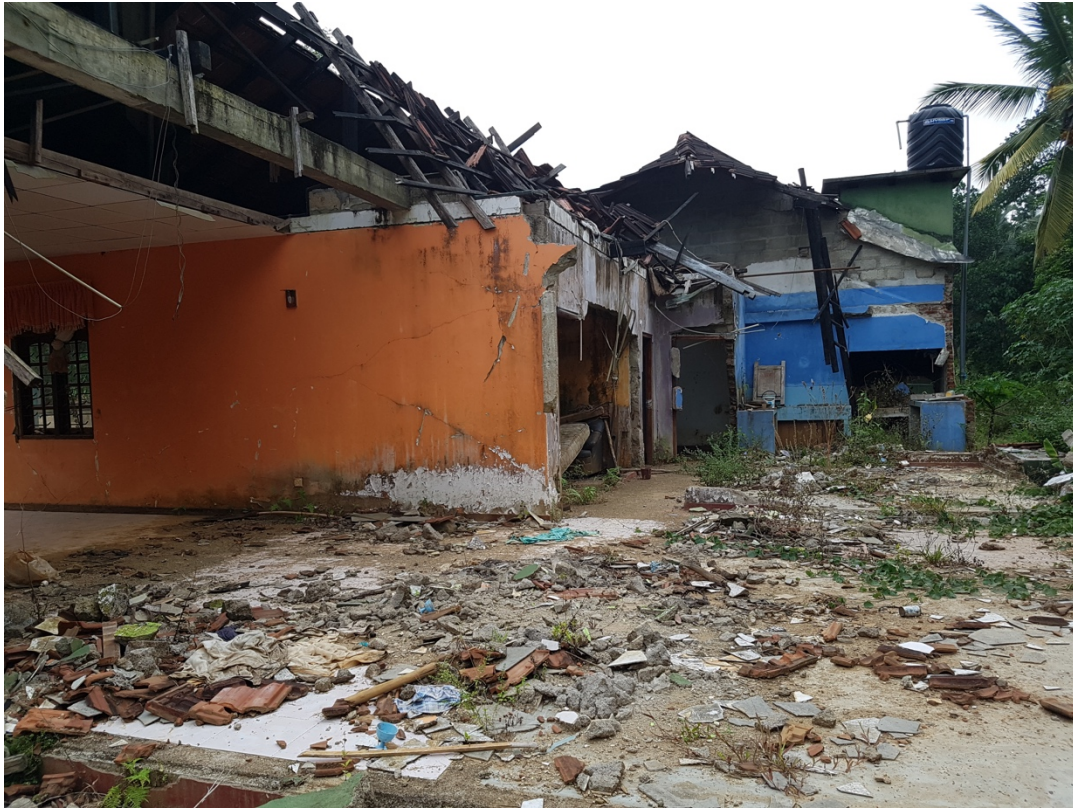
Figure 5. Total wall collapse

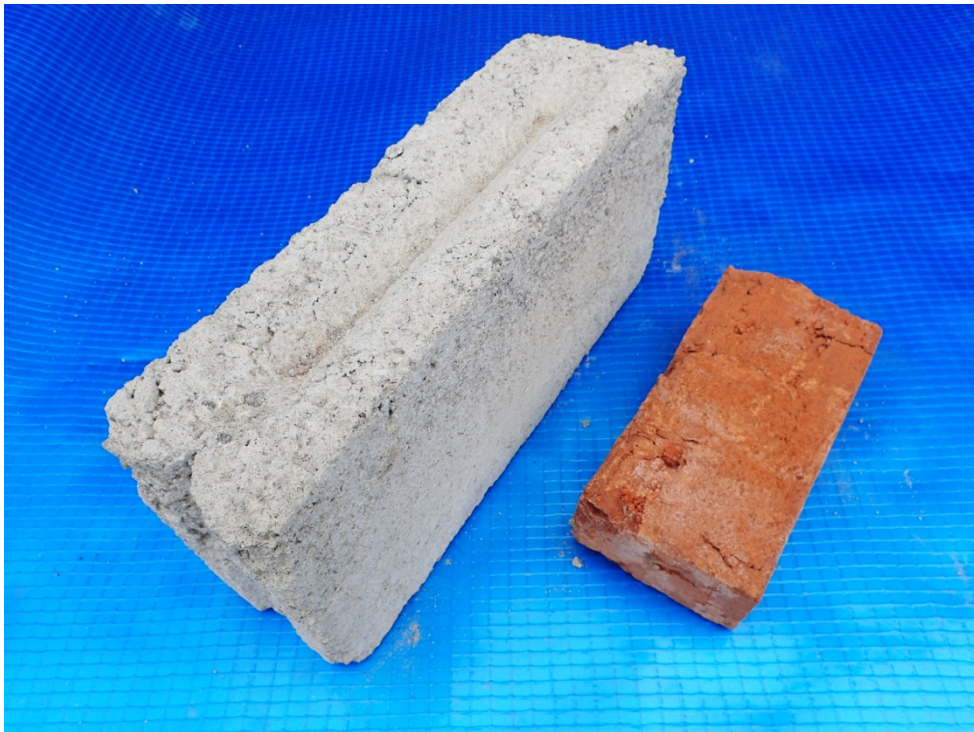
Figure 6. Masonry units

139 the constituents generally comprise cement, sand, and quarry dust. The nominal  
140 dimensions of the cement blocks were 400 mm (length) 100 mm (width) x 200 mm  
141 (height). The fired clay brick and cement blocks used are shown in Figure 6.  
142

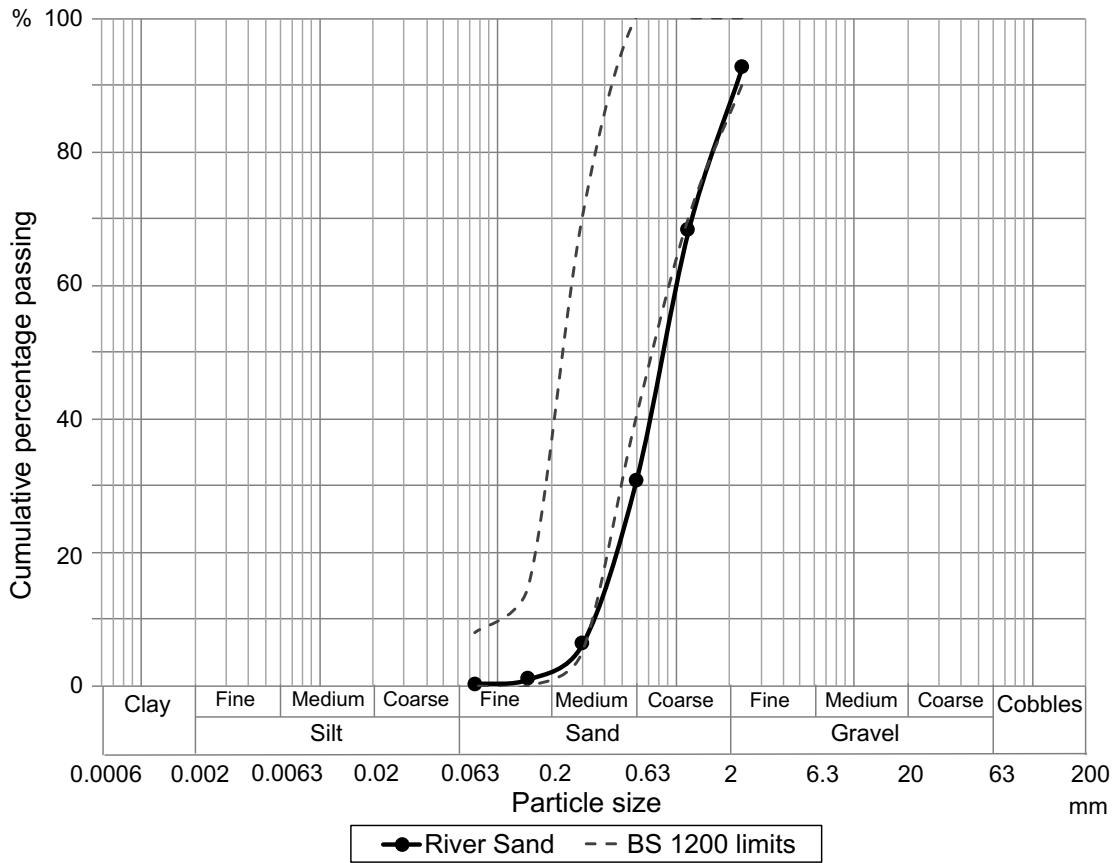
Figure 7. Sand composition related to BS1200 requirements

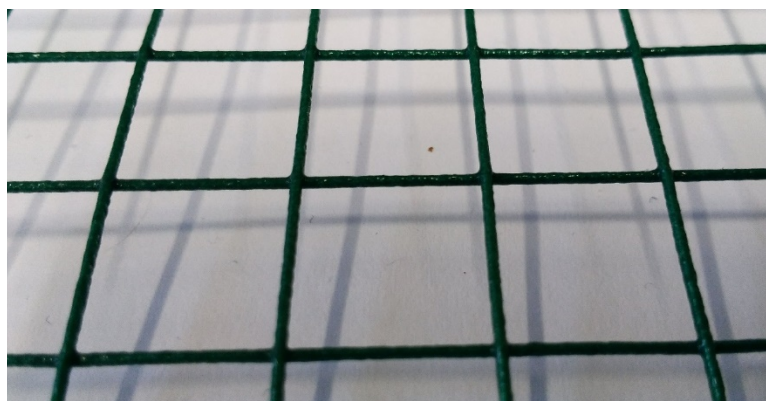
Figure 8. PVC coated welded wire mesh

191 A PVC coated galvanised mild steel wire mesh, (widely available from local hardware  
192 stores and building merchants) was selected (Figure 8). The square mesh,  
193 manufactured in Sri Lanka, is comprised of 0.81 mm diameter wires spaced at 12.5 mm  
194 openings. Normally used as a lightweight material for a variety of domestic uses, it was  
195 selected for its low cost, ease of handling, and readily availability throughout Sri Lanka.  
196 Welded wire mesh products tend to be orthotropic due to their production process  
197 where the longitudinal wires (machine direction - *md*) are under tension as the cross  
198 wires (cross machine direction - *cmd*) are welded in place.

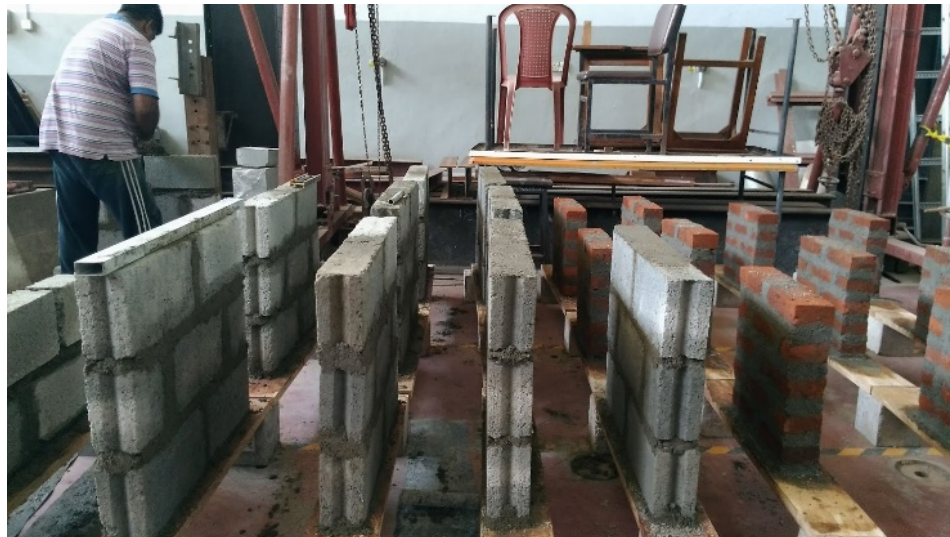
Figure 9. Masonry prism construction

264 Two unit wide stack bonded wall panels were built to establish the compressive strength  
 265 of the cement block and fired clay brick masonry (Figure 9). The fired clay brick panels  
 266 were five courses high, whilst the cement blocks were three units high.

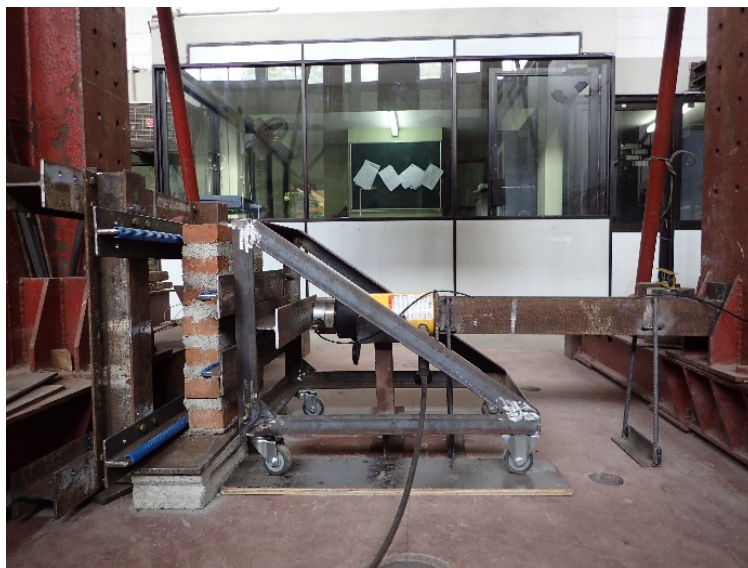
Figure 10. Parallel to bed joint flexural test

270 The vertical compression testing was undertaken in accordance with  
271 BS EN 1052- 1- 1999. The walls were loaded at a rate of 0.09 N/mm<sup>2</sup>/min with all  
272 failures occurring within 15 minutes.  
273  
274 Flexural strength was determined in accordance with BS EN 1053-2:1999 for both  
275 parallel and perpendicular to the bed joint. For parallel flexure the panels of burnt clay  
276 bricks were of length equivalent to two units and the height equivalent to seven courses.  
277 For the cement blocks, the length was equivalent to 1.5 units long and the height was  
278 equivalent to three courses. After the completion of each panel, further units were  
279 stacked on top to provide a precompression load approximately equal to  
280  $2.5 \times 10^{-3}$  N/mm<sup>2</sup>. The panels were tested under four-point loading laterally, as shown  
281 in Figure 10, in accordance with BS EN 1052-2:1999. Lateral loading was applied at a

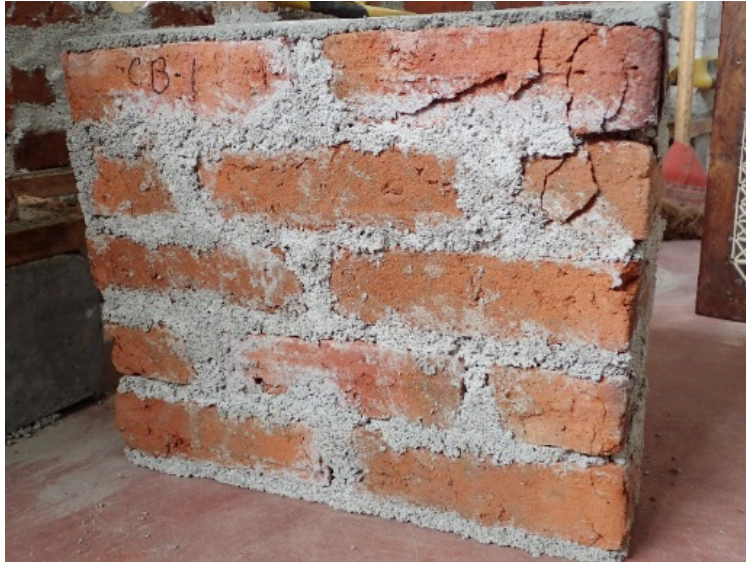
Figure 11. Brickwork prism failure in compression tests

337 The compressive strength properties of the cement blockwork and fired clay brickwork  
 338 prisms are presented in Table 4. The average mortar compressive ( $f_m$ ) and flexural ( $f_{mt}$ )  
 339 strengths are also included. Tests were only completed under air-dry conditions. The  
 340 characteristic compressive strength has been calculated in accordance with  
 341 BS EN 1052-1:1999. Failure of the wall panels in compression was preceded by vertical  
 342 cracking of masonry units prior crushing of the materials (Figure 11).

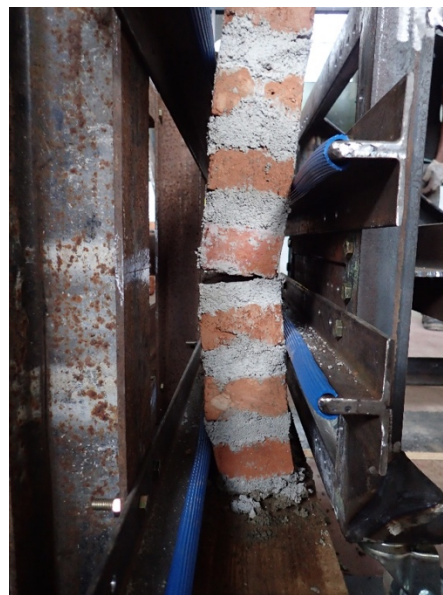
373 Figure 12. Parallel bed joint flexural test failure

357 The results for flexural strength parallel to bed joints are summarised in Table 5. The  
358 average mortar compressive ( $f_m$ ) and flexural ( $f_{mt}$ ) strengths are also included. A  
359 representative failure mode in testing is shown in Figure 12 with failures most commonly  
360 at the interface between the mortar and unit. Therefore, it is expected that the bond  
361 strengths are consistently lower than the flexural strengths of the mortar (Table 4). In

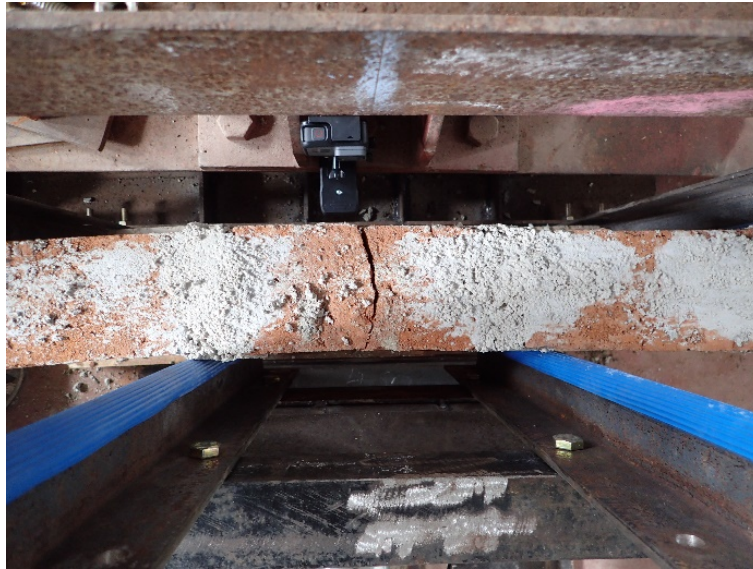
Figure 13. Perpendicular to bed joint flexural test failure

389 Typical failure in testing is shown in Figure 13, with cracking observed at joint interfaces

399 The results of the retrofitted panel tests, average of five repeat tests, are presented in  
400 Table 7. The average mortar and plaster compressive ( $f_m$ ) and flexural ( $f_{mt}$ ) strengths  
401 are also included in Table 7. Rather than flexural strength, the failure load resistance of  
402 each specimen is presented. The panels failed in flexure, with horizontal cracking  
403 observed at the masonry unit-mortar joint interfaces but also through the masonry units  
404 (Figure 13).

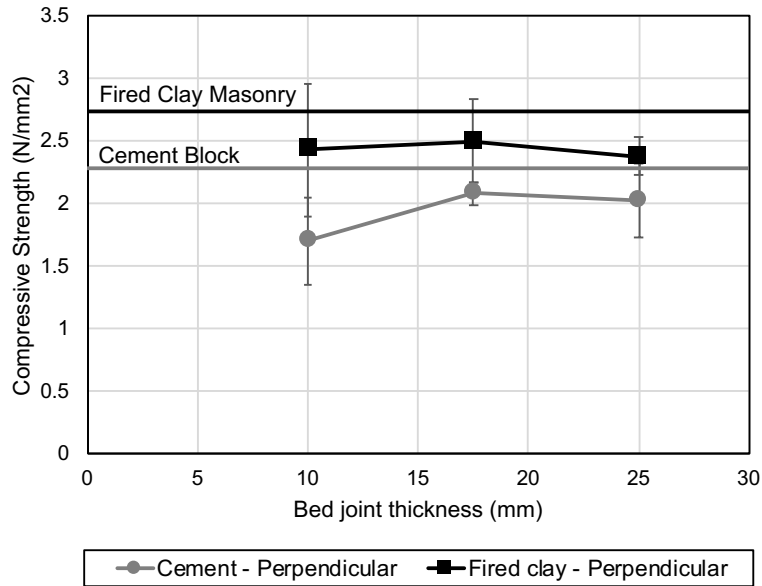
Figure 14. Influence of mortar thickness of compressive strength of masonry panels.

In general the compressive strength of masonry can be expected to decrease with increasing mortar joint thickness. Figure 14 (the error bars represent 95% confidence interval) shows that this behaviour has not been observed here. While there is an apparent peak in both compressive and flexural strength (Figure 14) at 17.5mm for all masonry units, there is no statistically significant difference, based on the two-sided 't-test' with a p-value of  $<0.05$ , between the respective results for a given mortar thickness. The relative high strength of the mortar compared to the unit strengths is the most likely explanation.

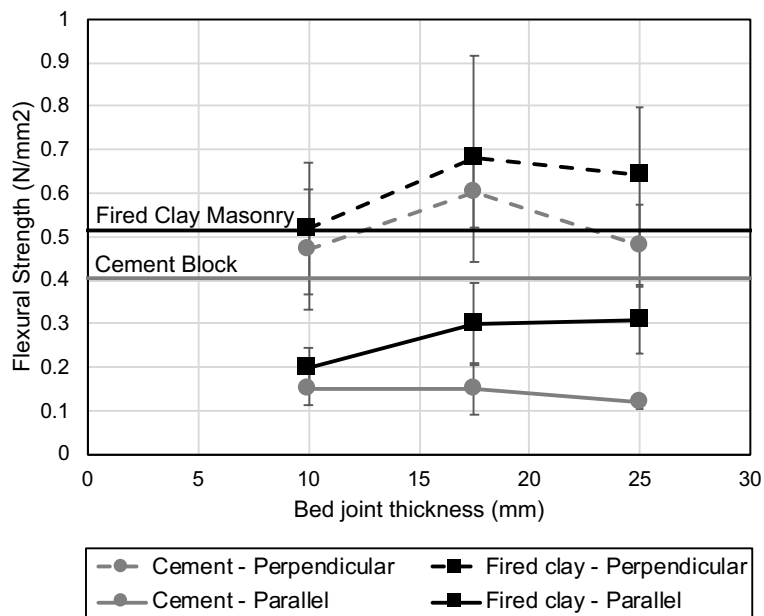
Figure 15. Influence of mortar thickness of flexural strength of masonry panels.

However, the limiting factor, as observed in Figure 15 is the interface between the mortar and the masonry unit under parallel flexure which is the focus of the retrofitting.

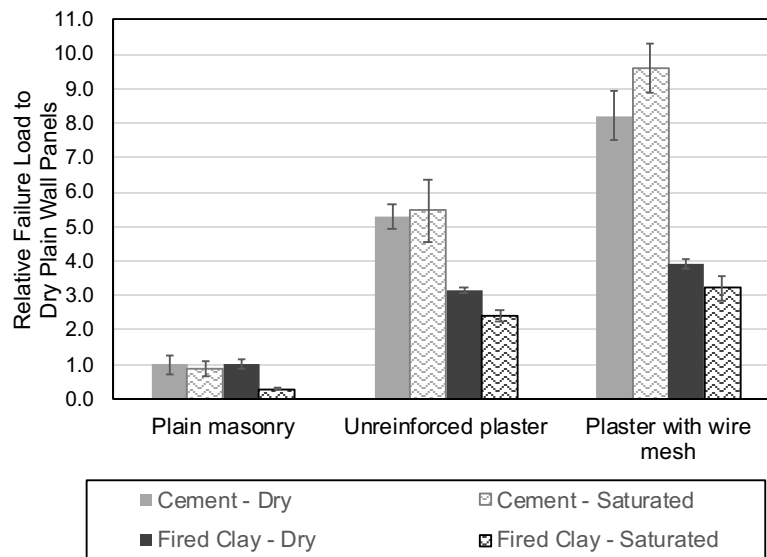
Figure 16. Relative Failure Loads of the wall panels compared to the Dry Plain Walls

The plaster coatings significantly increased flexural capacity compared to the plain masonry, with further 25% and 55% enhancement from the inclusion of the mesh reinforcement in cement block panels and fired clay masonry, as observed in Figure 16 (with error bars representing normalised confidence intervals). The unreinforced plaster significantly increased the failure load, which is not solely attributed to the increased thickness of the material. The increase can be attributed to the additional tensile capacity provided by the plaster but also the continuity that the plaster provided over the mortar joints, the point of failure in the unplastered masonry panels. The additional enhancement in the panels with mesh reinforced plaster indicates that the mesh acted as a tensile reinforcement.
