## Experimental test on a fibre-reinforced scaled cross vault subjected to in-plane shear displacements at the springings

# **Experimental test on a fibre-reinforced scaled cross vault subjected to in-plane shear displacements at the springings**

## **Abstract**

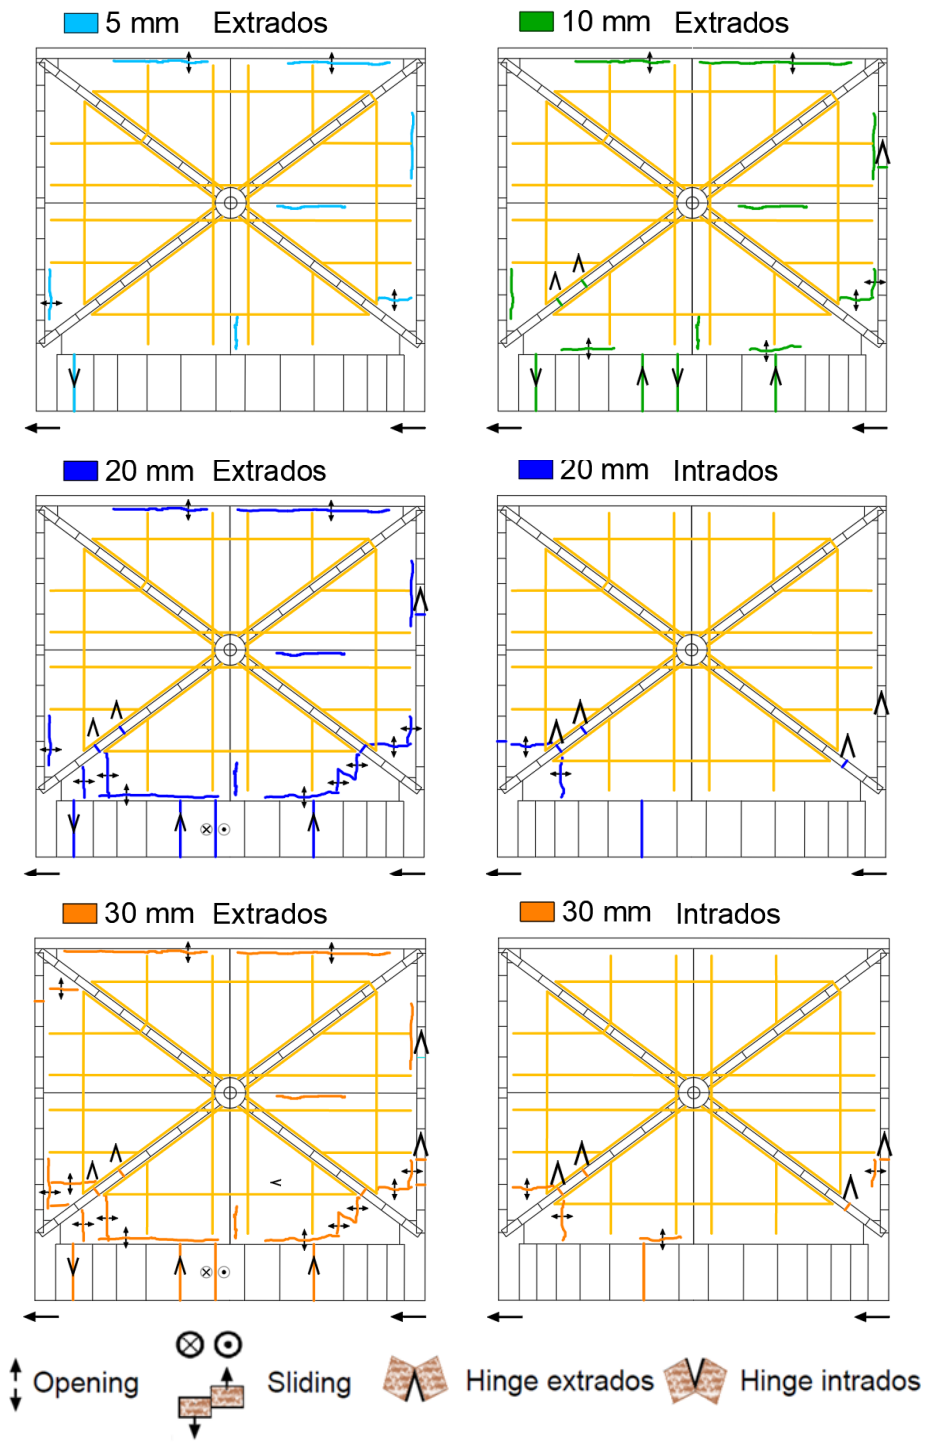
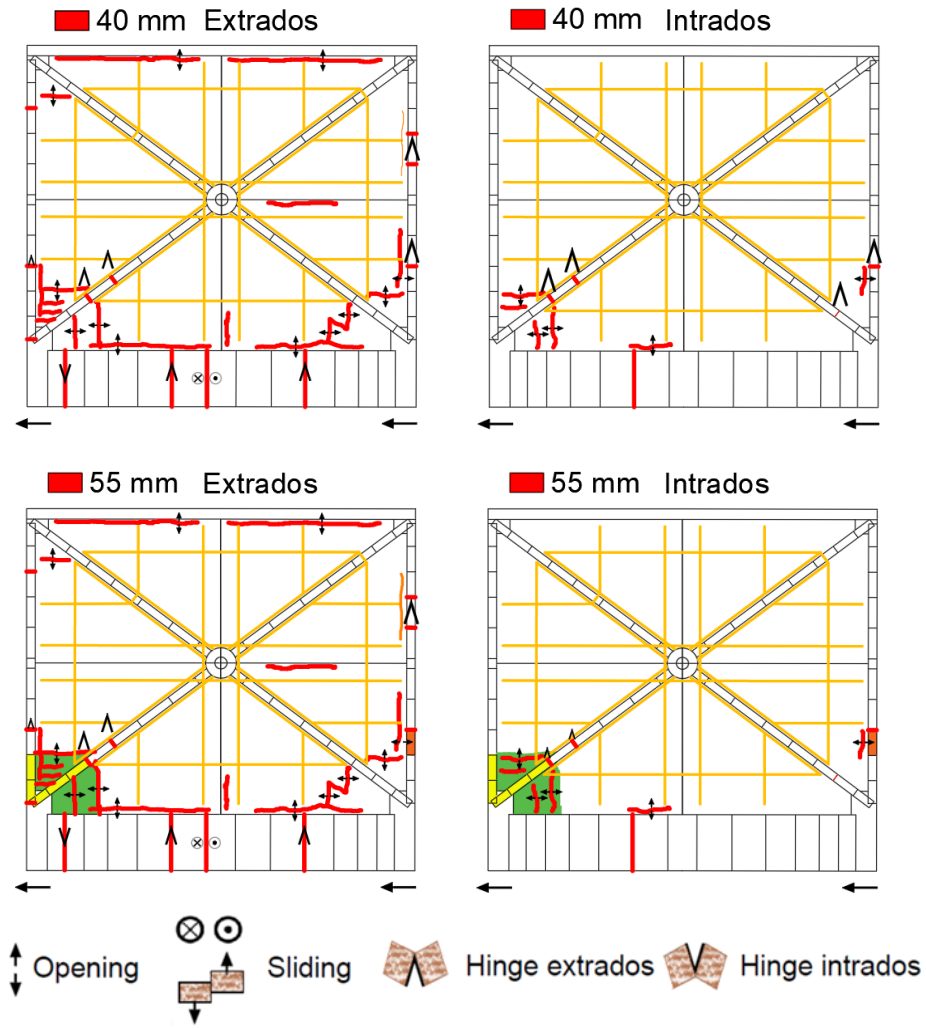
*Fig. 4: Crack pattern evolution and collapse condition.*

The crack pattern was observed on the extrados and the intrados after every spreading increment. In order to simplify the comprehension of the cracks' development, different colours are used for each step and thicker lines are adopted to represent the width of each crack (Figure 4). The detailed description of the cracking pattern is as follows:

Figures 1b and 4 compare the crack patterns of the vaults in the unreinforced and reinforced configurations. It is clear that, in the unreinforced model, the cracks are almost uniformly distributed over the vault surface, whilst, in the reinforced one, the cracks developed only in the corner areas and no cracks occurred in the central portion of the vault where the fibres were placed.

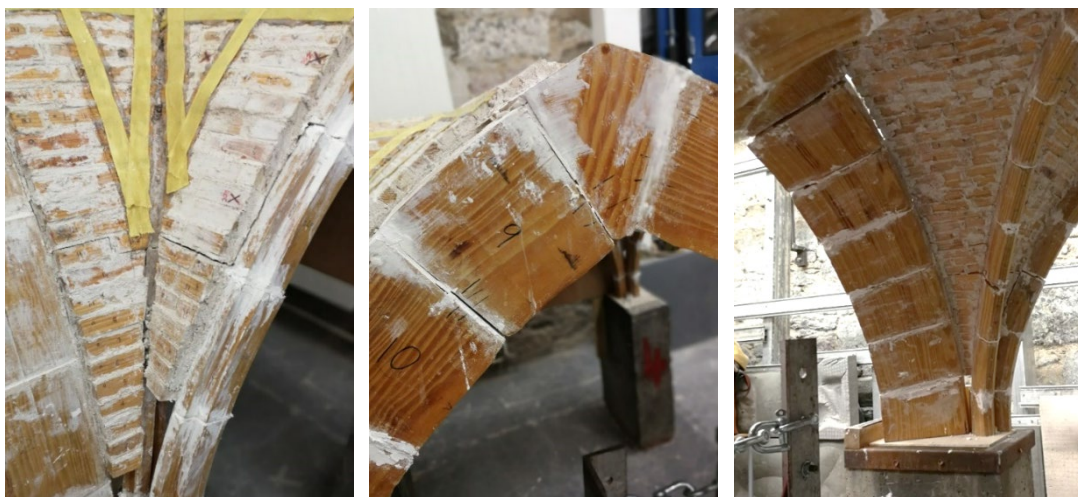
**Fig. 5:** (a) Extrados cracks in the corner area close to pier 2. (b) Downwards sliding of the voussoir at the left of the keystone of nave arch 1-2. (c) Intrados cracks in the corner area close to pier 1. (d) Undamaged strengthened portion of the vault (webs B and C). (e) Collapse of the unreinforced corner area around pier 1. (f) Collapse of one voussoir of the transverse arch 2-3.

- at 20 mm, small cracks appeared at the extrados in both corner areas close to the sliding piers 1 and 2 (Figure 5a). The first cracks appeared at the intrados in web B and C close to the rib 1-3 where the fibre-bands ends. One of the existing extrados cracks in the left-hand side of the nave arch 1-2 increased until one voussoir started to slide downwards with respect to the adjacent one (Figure 5b);

- at 40mm, the detachment between the lower voussoir of the nave arch 1-2 and pier 1 increased. The cracks in the unreinforced corner areas increased both in their width and in their number. Although the central reinforced part of the vault was completely undamaged, the failure

mechanism of the model started forming, defined by the dislocation of the voussoir of the nave arch 1-2 and the hinge on the intrados of the diagonal rib 1-3 (Figure 5c);

- for the successive displacement stages (45 and 50 mm) more damage occurred, especially in the unreinforced corner areas, but still the central strengthened portion of the vault remained undamaged (Figure 5d);
- at 55 mm, i.e. the last stage before collapse of the whole vault, the unreinforced corner area around pier 1 (webs B and C) started to collapse, involving voussoirs of the transverse arch 1-4 and the diagonal rib 1-3 (Figure 5e). In addition, one voussoir of the transverse arch 2-3 fell down (Figure 5f).

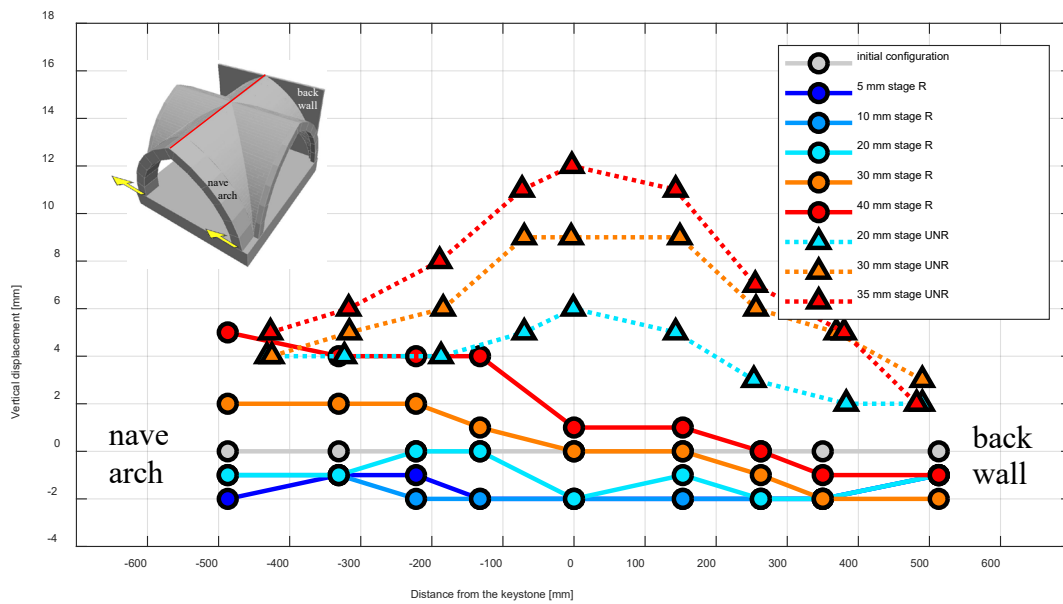
*Fig.6: Comparison of the vertical deflections of the transverse ridge for the unreinforced and reinforced models.*

Figure 6 shows the vertical deflections of the transverse ridge with respect to the initial horizontal configuration (R - solid lines and UNR - dotted lines). In the reinforced case, after an initial general downward settlement of maximum 2 mm at the 5 mm, 10 mm and 20 mm stages of shear displacement, the global behaviour looks quite asymmetrical for the 30 mm and 40 mm stages. The points close to the back wall show small downward deflections, whilst the points close to the nave arch show large upward displacements up to 2 mm at the 30 mm stage and 5 mm at the 40 mm stage. The front portion, where the imposed shear-displacement is applied, lifts up.

The comparison of the two models, indicates that in the unreinforced case the behaviour is basically symmetrical across the ridge and the maximum deflection is reached at the keystone (around 12 mm). On the contrary, in the reinforced case the behaviour is almost asymmetrical and the most significant

deflection, although much less here (6 mm, i.e. half of the UNR maximum), is reached by the point on the nave arch.

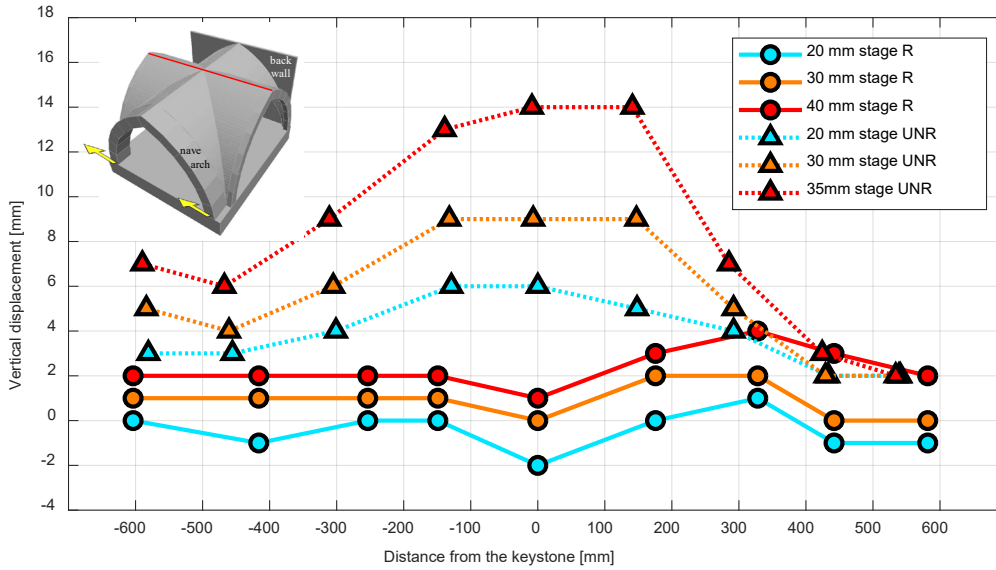
*Fig. 7: Comparison of the vertical displacements of the longitudinal ridge for the unreinforced and reinforced models.*

Figure 7 shows the vertical deflections of the longitudinal ridge with respect to the initial horizontal configuration at selected displacement stages. In the reinforced case, as already observed for the transverse ridge, also the longitudinal ridge displays an initial downward displacement (again up to 2 mm) at the first stages (up to the 20 mm stage) and does not show a constant trend during all stages. At the 30 mm and 40 mm stages, the longitudinal ridge slightly rises; the maximum value is about 4 mm. It is evident that the displacements of the reinforced model are smaller than in the unreinforced model. The latter shows a clear symmetrical uplift of the central portion of the vault, up to 14 mm, whilst the former an upward movement of its portion closer to the transverse arch 2-3 around 2 – 4 mm.

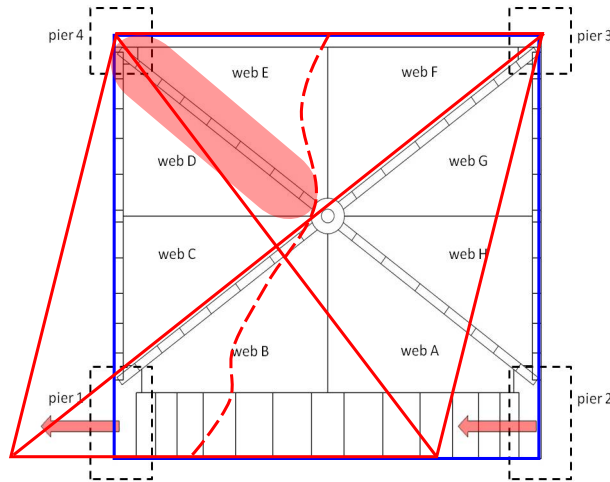
**Fig. 9:** Interpretation of the strut opposition provided by diagonal rib 2-4.

It is important to study also the horizontal displacements of the transverse ridge with respect to the initial horizontal configuration, as a more direct effect of the in-plane shear displacement (Fig. 8). In general, the ridge seems to follow the imposed shear movement with larger displacement of the points close to the nave arch, up to 20-25 mm at the 30 mm and 40 mm stages, as expected due to the fact that this area is spreading. The recorded values of the displacements indicate that, at the first stages of shear movement (5 and 10 mm), the displacement of the transverse ridge is larger than the one imposed at the springings, whilst at the last stages (20, 30 and 40 mm) the displacement at the top is of the same order of magnitude as the imposed one at the bottom. The deformed shape clearly displays a hump, which is most probably due to the opposition provided by the compressed diagonal rib 2-4 and the surrounding webs D and E (Figure 9).

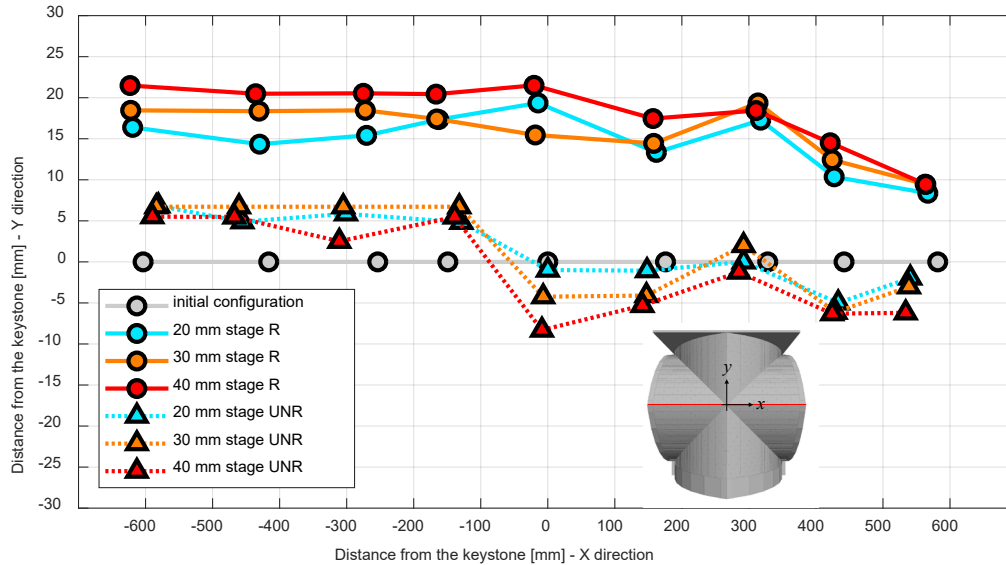
*Fig. 11: Comparison of the horizontal displacements of the longitudinal ridge for the unreinforced and reinforced models.*

Figure 11 shows the horizontal displacements of the longitudinal ridge at selected shear displacement stages. In the reinforced case, the deformed shape consists of a roughly uniform translation towards the back wall. In more detail, the left portion of the longitudinal ridge moves slightly more than the right portion, maybe due to the fact that webs D and E are compressed and thus may shorten in plan. This last observation is also consistent with the hump characterising the deformed shape of the transverse ridge, detailed in Figure 9. The comparison of the two models indicate that in the unreinforced case the lower stiffness of the vault allows larger deformations to happen, so the left portion of the ridge moves towards the back wall and the right one opposite, with high concentration of strain and damage around the key-stone. On the contrary, in the reinforced case, the higher stiffness of the vault provided by the fibres make the ridge move together towards the back wall.

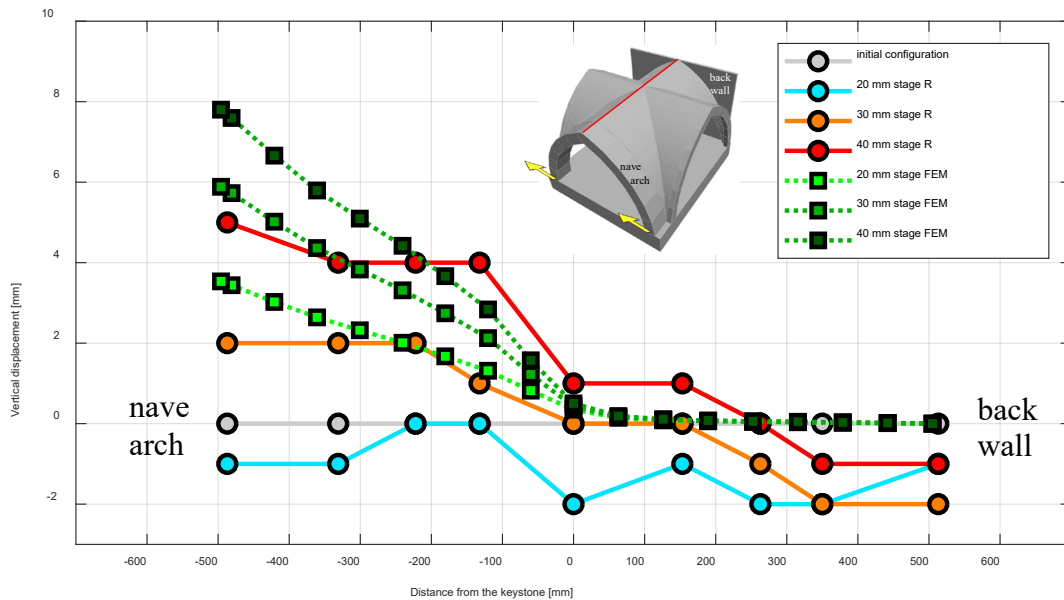
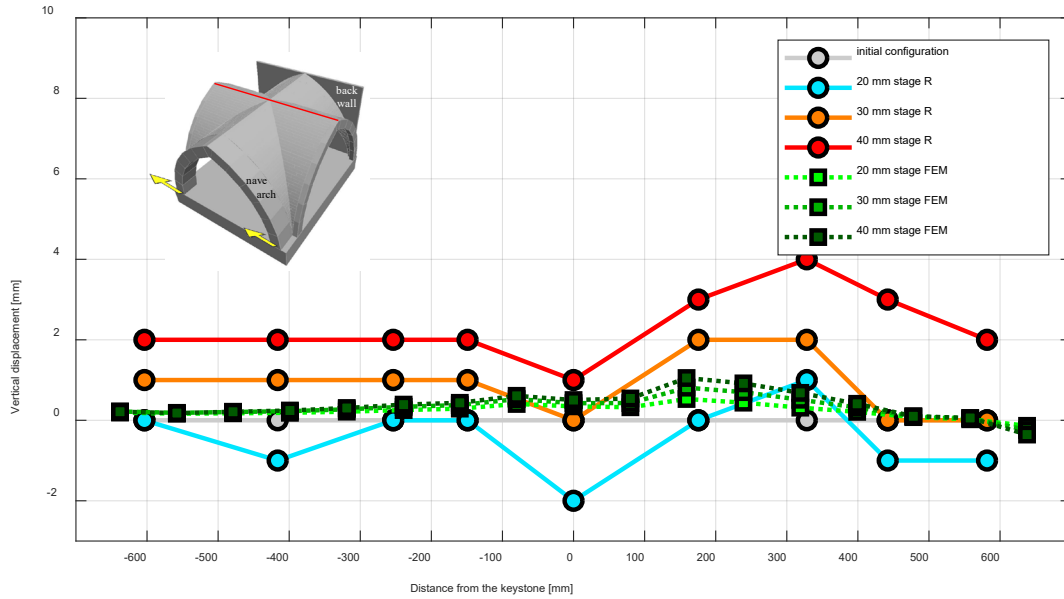
**Fig. 14:** Vertical displacements of (a) the transverse ridge and (b) the longitudinal ridge for the reinforced model: FEM numerical and experimental results.

- for large shear displacement stages (e.g. 30 and 40 mm), the qualitative response (upward movement of the points close to the nave arch) and the order of magnitude (around 5 mm) of the vertical displacements of the transverse ridge are well captured (Figure 14a). The vertical movements of the points close the back wall receive the effects of the boundary conditions (fixed restraints on the back perimeter arch, as per Figure 12), whilst the real vault experienced small downward movements;

- for large shear displacement stages (e.g. 30 and 40 mm), the qualitative response (upward movement) of the longitudinal ridge is captured (Figure 14b). From a quantitative point of view, due to the relatively small values of these displacements, this numerical model is not able to provide the order of magnitude;

- as it could be easily expected due to the unavoidable randomness of the real vault response to small displacement action, for the 20 mm stage, the numerical model cannot reproduce the experimental response at that stage but does simulate the qualitative response at larger displacements for both the transverse ridge and the longitudinal ridge.

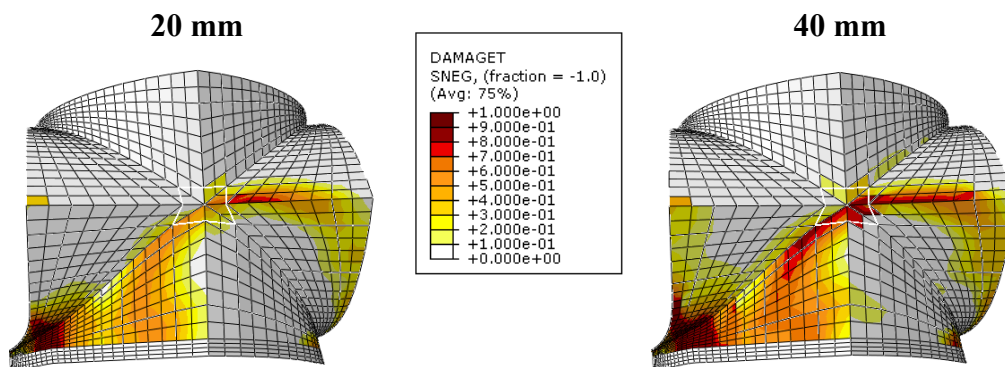
**Fig. 15:** Non-linear static damage contour plots in the FEM model.

The non-linear analysis using the Concrete Damage Plasticity model allows the tension damage variable (DAMAGET) contour plots to be obtained for the different shear displacement applied. Two illustrative plots are reported in Figure 15. The numerical results are in good agreement with the damage detected in the corner areas, capturing the damage occurred in the unreinforced lower part of the left front webs, as highlighted in Figure 5e. However, the numerical model indicates damages along the longitudinal ridge close to the key-stone that were not observed in the physical test. This may be due to the size and the shape of the shell elements near the keystone, that create a singular point characterised by sharp edges that may provoke stress concentrations in the numerical model. In the real vault model, the keystone is characterised by smooth curvatures (compare Fig. 2b with Fig. 12a).
