JCATI Base Plate

Abstract: Students of the Mechanical Engineering Technology (MET) program at Central Washington University have contributed to an ongoing Carbon Fiber Recycler project funded by the Joint Center for Aerospace Technology Innovation (JCATI). The goal of this project was to modify the existing recycling system to produce a higher success rate of recycled carbon composite material. This report focuses on increasing the rigidity of the crushing gears so that the deflection occurring among the components during operation was below 0.005 inches to ensure proper operating conditions. The operating speed of the crushing gears was 2.5 rpm with a crushing load of 10,500 pounds. A base plate design ensured the rigidity of all components operating on a singular plane. Flat plate analysis was conducted to determine the thickness of the plate required of ASTM A36 Steel to produce a deflection less than the required value. Plate models run in Autodesk Nastran provided stress and deflection results used to confirm green sheet calculations and assembly modifications. Testing consisted of using dial indicators to determine deflections at various locations of the base plate and confi

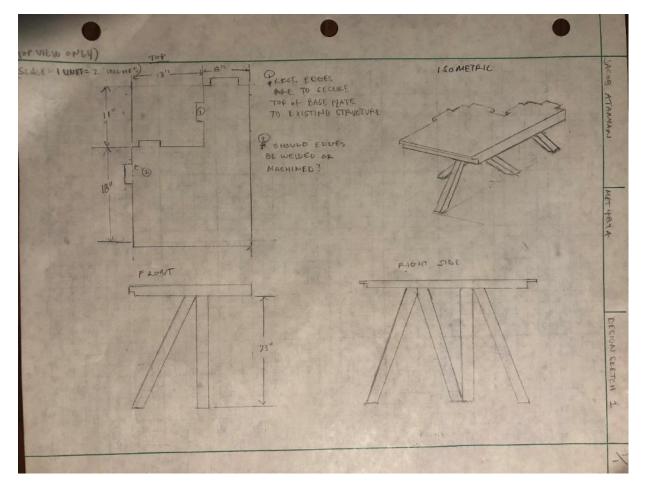
Figure 1 shows the original design intent for a base plate connecting the three recycling components mentioned in the approach. The rectangular notched edges of the plate are incorporated to attach the baseplate to the existing foundation. Design of the supports would be further analyzed.

Figure 1: Base Plate Sketch

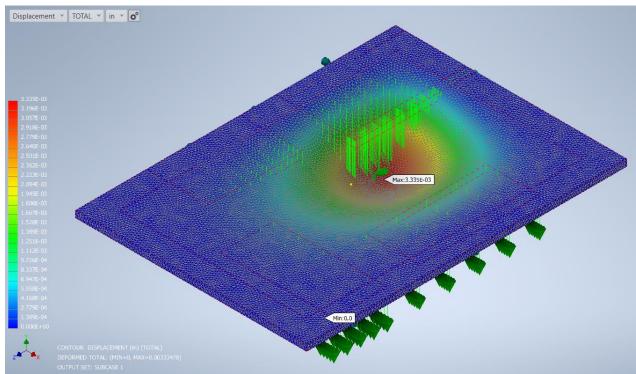
A model of part 20-002 was ran in Nastran to determine the maximum deflection as a result of a radial load acting in the plate area of 5253 lb. The deflection came to be 0.003335 inches with a linear mesh of 0.3 inches (refer to Figure 2). This value was checked using the deflection equation found in MARKS': $y_{max} = k_1 * PR^2/(Et^3)$ where P = 477.5 lbs [1]. Calculations found in Appendix A11.1. The value of P was found from the radial load distributed across the side length of the crushing housing per inch. This equation resulted in in a deflection of 0.00365 inches and error of 8.7% compared to the Nastran model. The new safety factor was F.S. = 1.4. Consulting the project mentors, a decision was made to discard the truss assembly. The plate alone would fulfill the requirement of staying under 0.005 inches of deflection.

Figure 2: Nastran Model Showing Plate Deflection

The base plate design process went through several different designs until a final design was decided on. Analyses 4, 6, and 11 were the most important in determining geometry of the base plate. These analyses found the following design parameters:

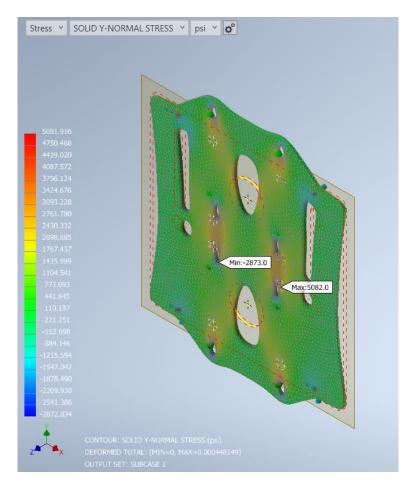
A final finite element analysis was conducted to determine if any significant side plate deflection would occur in the existing crushing housing assembly. A Nastran model confirmed the side plate would absorb the load from the crushing gears. The stress of 5082 psi, shown in Figure 3, is well below the yield of ASTM A36 Steel. Green sheet calculations confirmed a stress of 5059 psi, 0.45% error to the Nastran model. Maximum deflection occurred was well below the requirement at 0.0004 inches, refer to Figure 4. This analysis confirmed the safety of the side plate and the reason for focus on parts external to the crushing housing causing displacements greater than 0.005 inches during operation.

Figure 3: Side Plate Y-Normal Stress

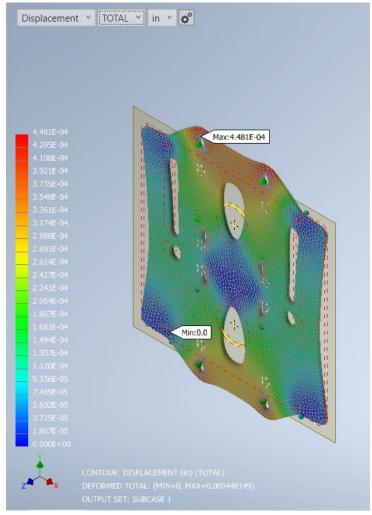
Figure 4: Maximum Side Plate Deflection

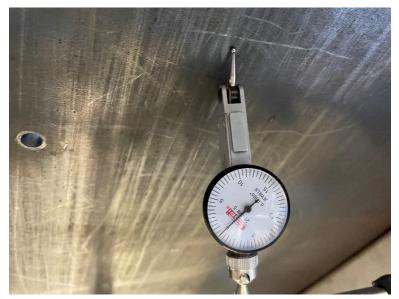
Figure 9: Zero Indicator

Adjust the position of the arm so that the tip of the dial indicator will be pressed against the base of the plate. The dial should be pressured a full revolution from its initial position at 0.0 inches. Data recorded from this position will tell the magnitude and direction of plate deflection. Refer to Figure 5.

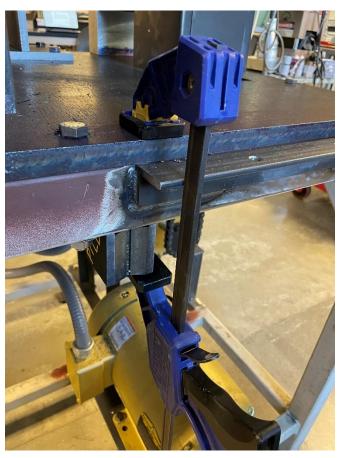
6) Clamp the base of the indicator to the table to ensure a secure location as shown in Figure 6.

Figure 10: Clamp From Underneath

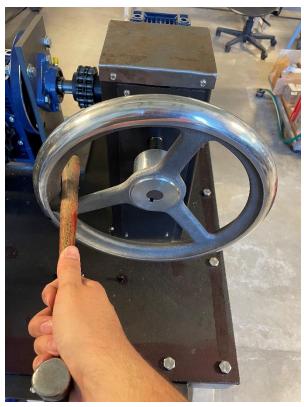
Figure 11: Manual Driver

- 7) Get a good view of the dial indicator.
- 8) Have another person manually operate the recycling system with the driving wheel turning counterclockwise, as in Figure 7, while watching the deflection indicator.

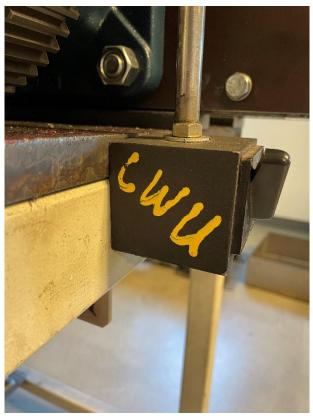
Figure 13: Magnet Position

- 10) Document deflection results on test sheet. Turn the driving wheel clockwise to feed the carbon fiber out of the crushing wheels and set up the next test location.
- 11) Change the location of the dial indicator to the front of the side wall housing. Set the magnetic base to the side of the supporting table as shown in Figure 9.

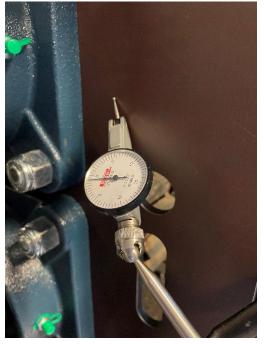
Figure 15: SW Top Front

14) Reset the dial indicator as in Step 12, but in line with the top shaft as in Figure 11.

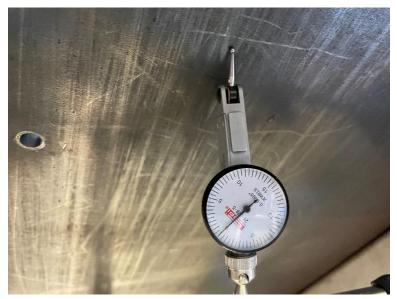
Figure 22: Zero Indicator

5) Adjust the position of the arm so that the tip of the dial indicator will be pressed against the base of the plate. The dial should be pressured a full revolution from its initial position at 0.0 inches. Data recorded from this position will tell the magnitude and direction of plate deflection. Refer to Figure 18.

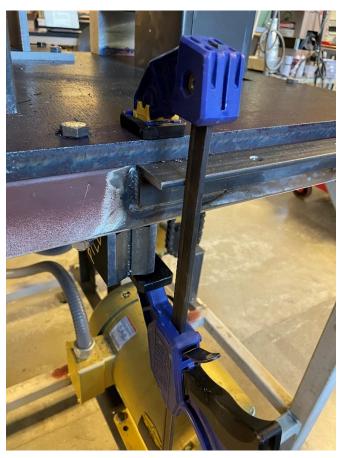
6) Clamp the base of the indicator to the table to ensure a secure location as shown in Figure 19.

Figure 23: Clamp From Underneath

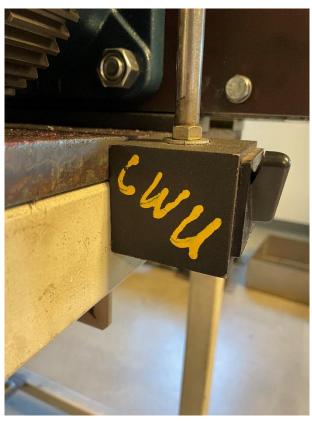
- 10) Document deflection results on test sheet. Turn the driving wheel clockwise to feed the carbon fiber out of the crushing wheels and set up the next test location.
- 11) Change the location of the dial indicator to the front of the side wall housing. Set the magnetic base to the side of the supporting table as shown in Figure 22.

Figure 26: Magnet Position

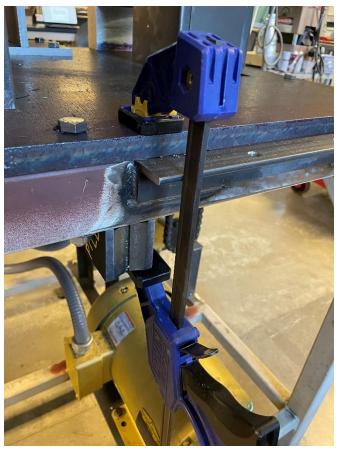
6) Clamp the base of the indicator to the table to ensure a secure location as shown in Figure 33.

Figure 35: Clamp From Underneath

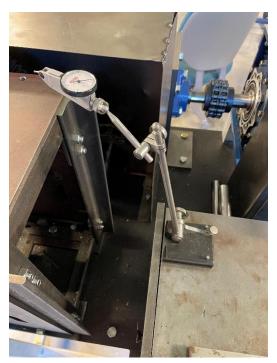
Figure 34: Location For Top Side Wall

7) Set the second dial indicator base to the top of the shredder housing as in Figure 34. Use a c-clamp to secure the base as in Figure 35.

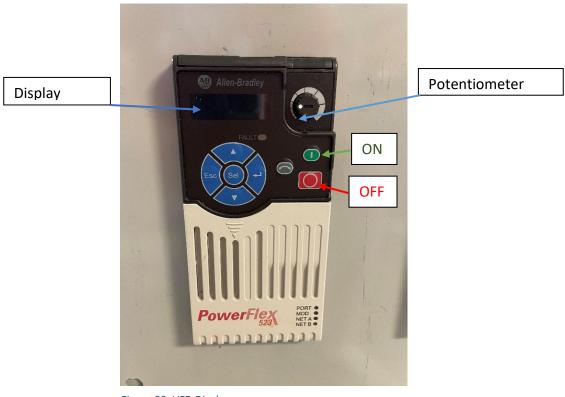
10) Turn on the VFD pressing the green button. Make sure the potentiometer is set to zero. Refer to Figure 39.

Figure 39: VFD Display

11) Adjust the potentiometer to a desired rpm read from the display screen. Refer to Figure 39.
