**ARCHAEOLOGICAL MONITORING OF THE DEMOLITION OF A
HISTORIC CISTERN UNASSOCIATED WITH THE STEGMAN
BUILDING, BROWNSVILLE, CAMERON COUNTY, TEXAS**

FINAL LETTER REPORT (Redacted)

Raba Kistner Environmental, Inc. (RKEI) was contracted by Muñoz & Company (CLIENT) to conduct archaeological monitoring associated with the proposed partial demolition of a historic cistern located within the footprint but under the floor of the historic Stegman Building, in Brownsville's Historic Downtown District, Cameron County, Texas.

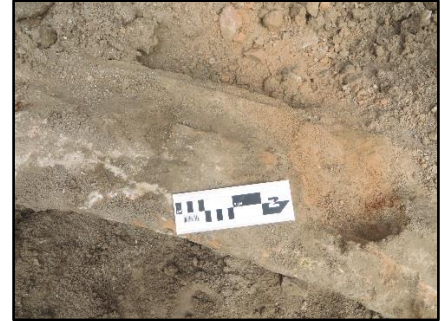
Figure 13. Top of the eastern wall of the cistern, indicating width of brick and mortar.

Since the top of the cistern was removed in the 1910s, it is difficult to determine the type of cistern on the property. The remnant of the cistern that RKEI observed exhibited straight walls with no slope. The cistern has an outer diameter of 4.8 meters (13 feet) and a depth of 1.85 meters (6 feet). The cistern is constructed of local, buff-colored brick, and its walls are least three courses thick (**Figure 14**). The brick is held together with thick mortar and the inside of the feature is mortar-coated.

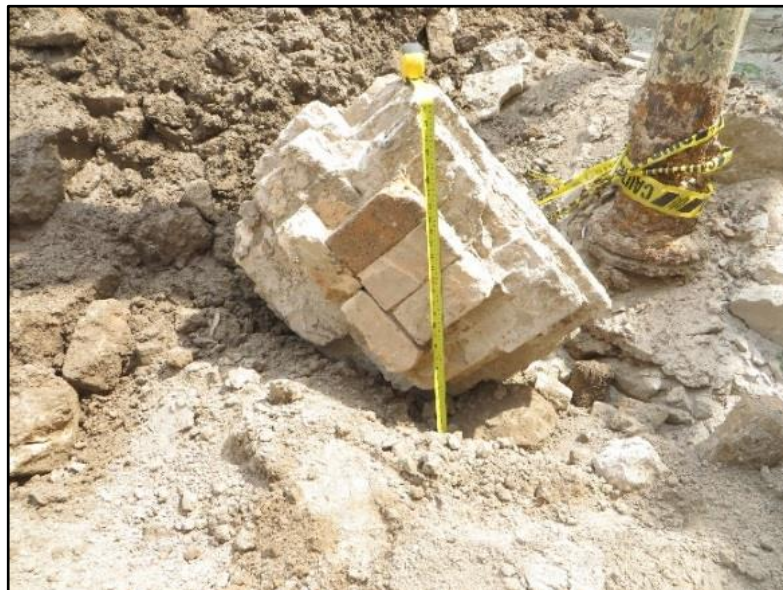
Figure 14. A portion of the removed brick and mortar, 75 cm in length.

The yellow and buff colored, lime based bricks used to construct the features may date to the 1870s. The earliest brick in Brownsville was most likely imported from Matamoros, or locations just north of the river. Matamoros bricks were often yellow in color due to the calcium in local clay deposits (Arreola and Curtis 1993:160-161). Buff colored bricks were popular, locally made bricks. These durable bricks are noted as the preferred construction material of B.G. Stegman for his buildings on Levee Street and Washington Street (*Brownsville Daily Herald* 1911: 10). By 1870, there were four local brick manufacturers in Brownsville, producing 690,000 bricks per year. However, by 1880, the only manufacturer in town was Louis Kowalski (Cook 1998).
