## Archaeological Monitoring of South Alamo Street Improvements, Pereida Street to César Chávez Boulevard, San Antonio, Bexar County, Texas

Texas Antiquities Permit No. 8563

*Prepared by:*  
Center for Archaeological Research  
The University of Texas at San Antonio  
One UTSA Circle  
San Antonio, Texas 78249  
Archaeological Report, No. 474

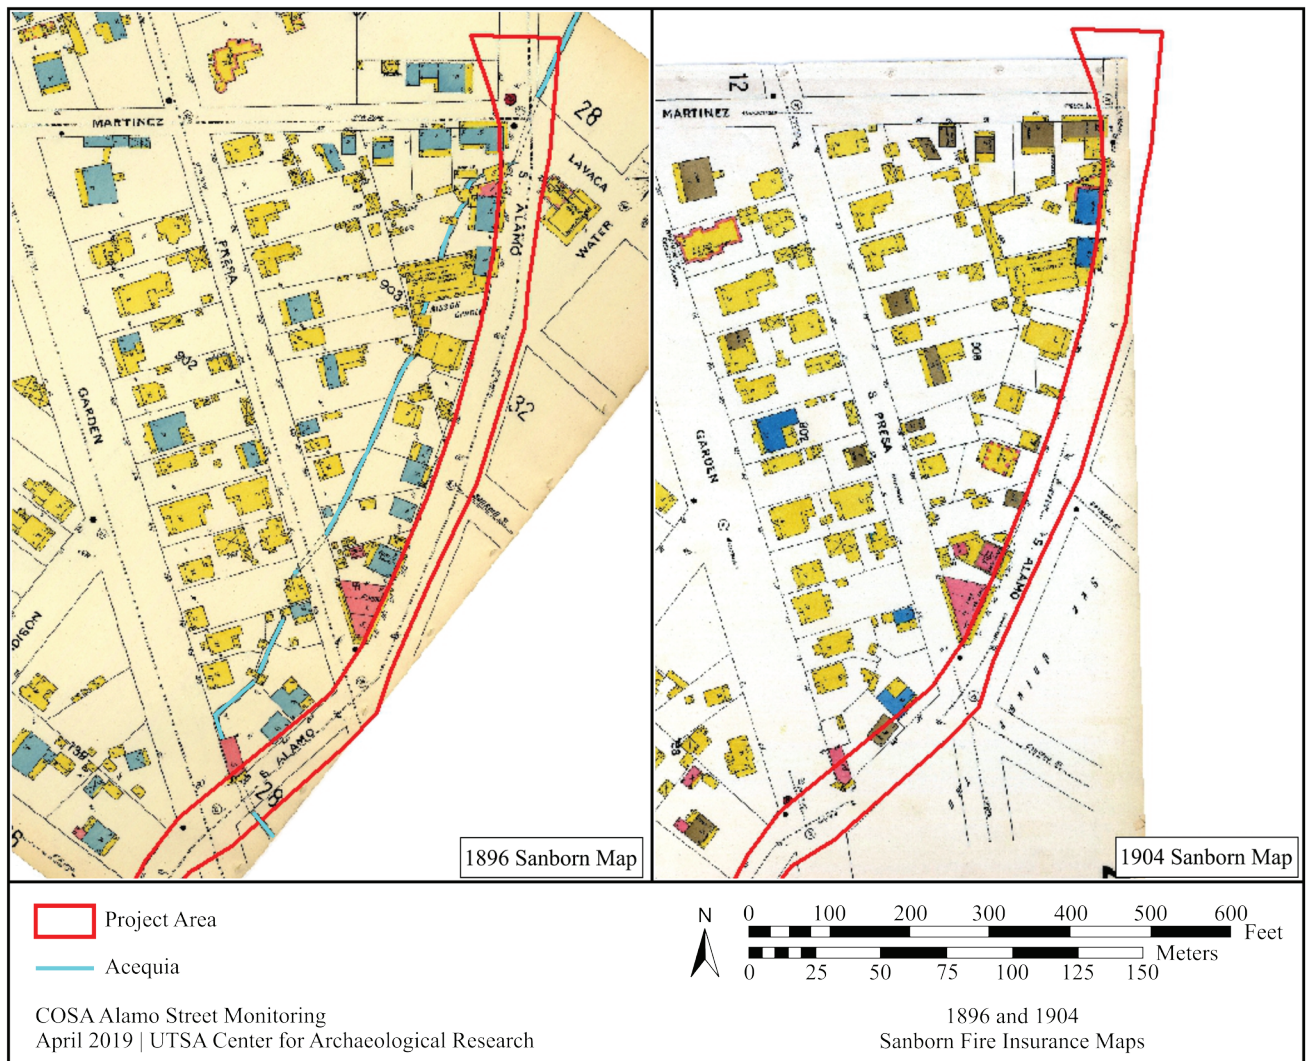
Figure 2-1. The 1896 Sanborn map shows the acequia as still present west of the project area, and by 1904, the acequia has disappeared from the map. Acequia highlighted in blue.

In 2016, a branch of the *acequia* was encountered north of the project area near Martínez Street, near the area depicted on the Sanborn maps (Figure 2-1; Galindo 2017). This branch was not stone-lined, in contrast with the portion of the *acequia* documented during the course of this project.

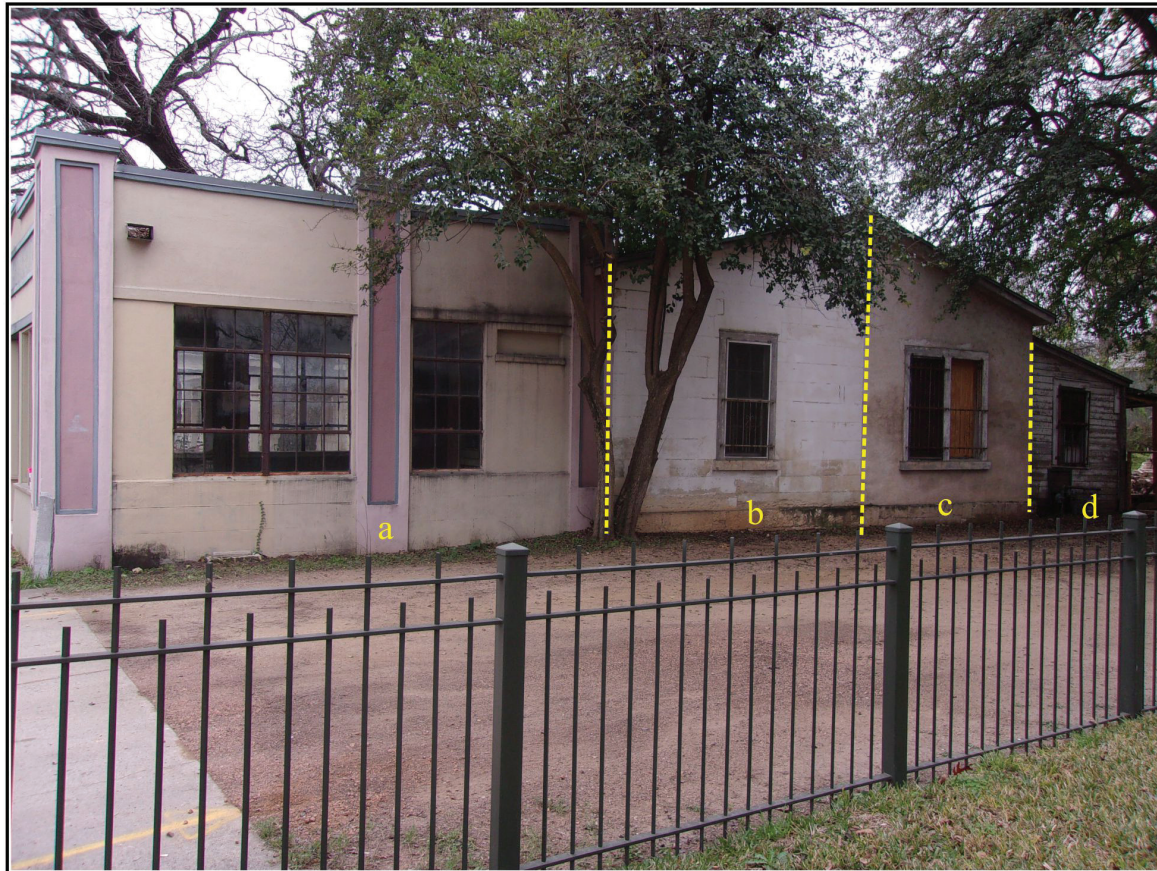
Figure 3-2. 1009 S. Alamo Street. Yellow delineates separate construction episodes. Section *b* appears to be original limestone construction; *a*, *c*, and *d* are likely later additions.

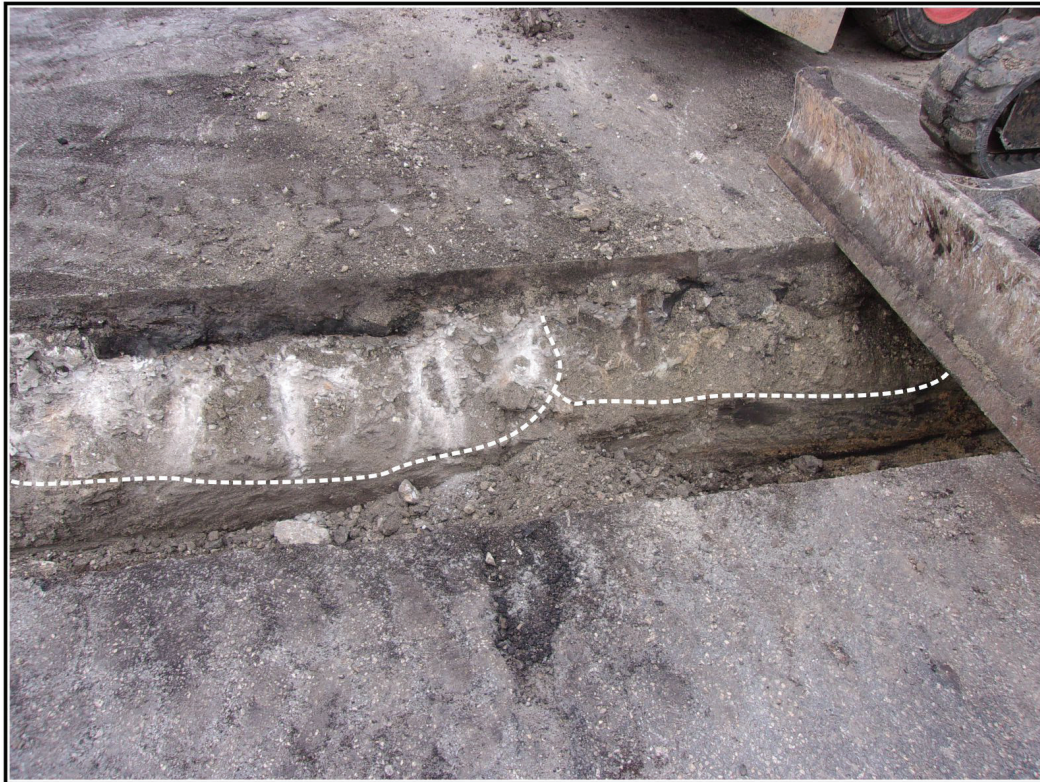
Figure 4-2. Trench profile depicting previous road layers and road base associated with multiple street modifications. Dotted white lines to the left show old concrete, to the right show layer of road base.

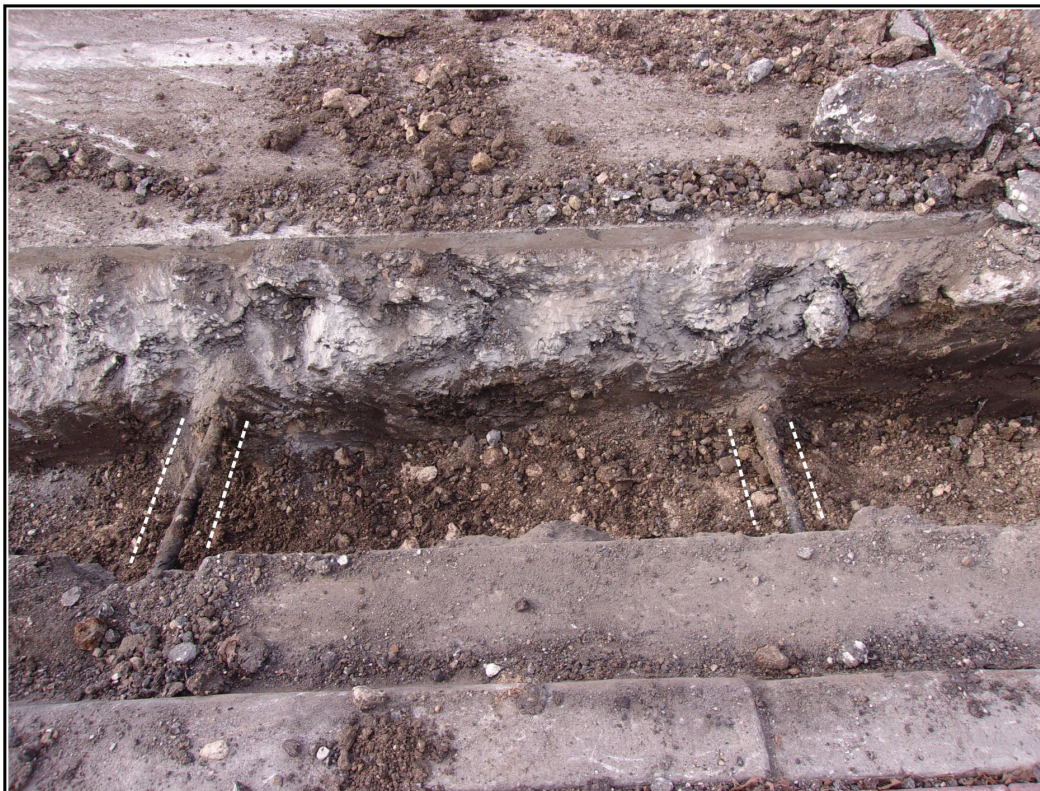
Figure 4-3. Utility pipes within monitored trench. Dotted white lines illustrate pipes.

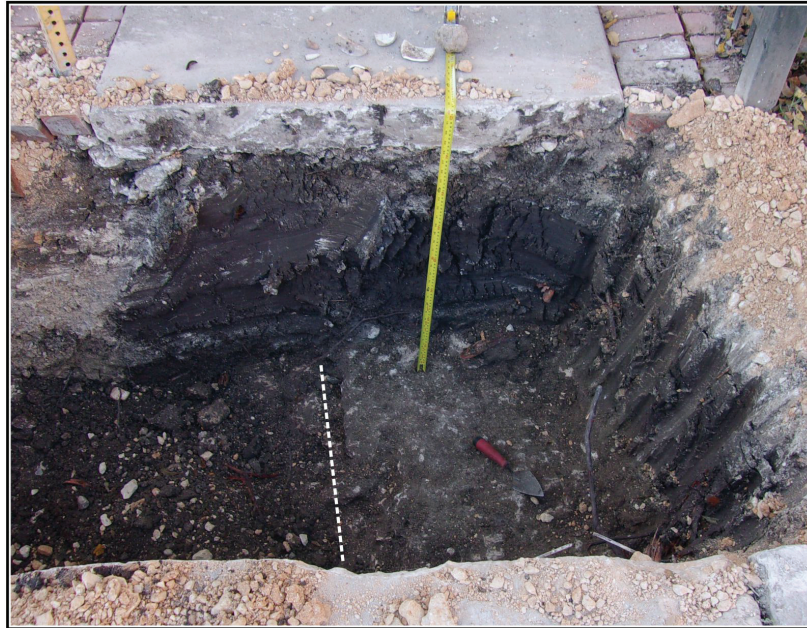
Figure 4-6. Site 41BX8 (Feature 1), facing south. Top of acequia wall (edge of feature) marked in white. The northern, southern, and western edges of the feature extend outside the boundaries of the utility excavation.

this project. Site 41BX8 has previously been determined to be eligible for inclusion on the National Register of Historic Places (NRHP), and it is designated as a Historic American Engineering Record and a Recorded Texas Historic Landmark (THC 2019). CAR recommends the intact section of 41BX8 documented during the course of this project is eligible for inclusion to the NRHP and designation as a State Antiquities Landmark (SAL). Avoidance of any impact to this site is recommended.

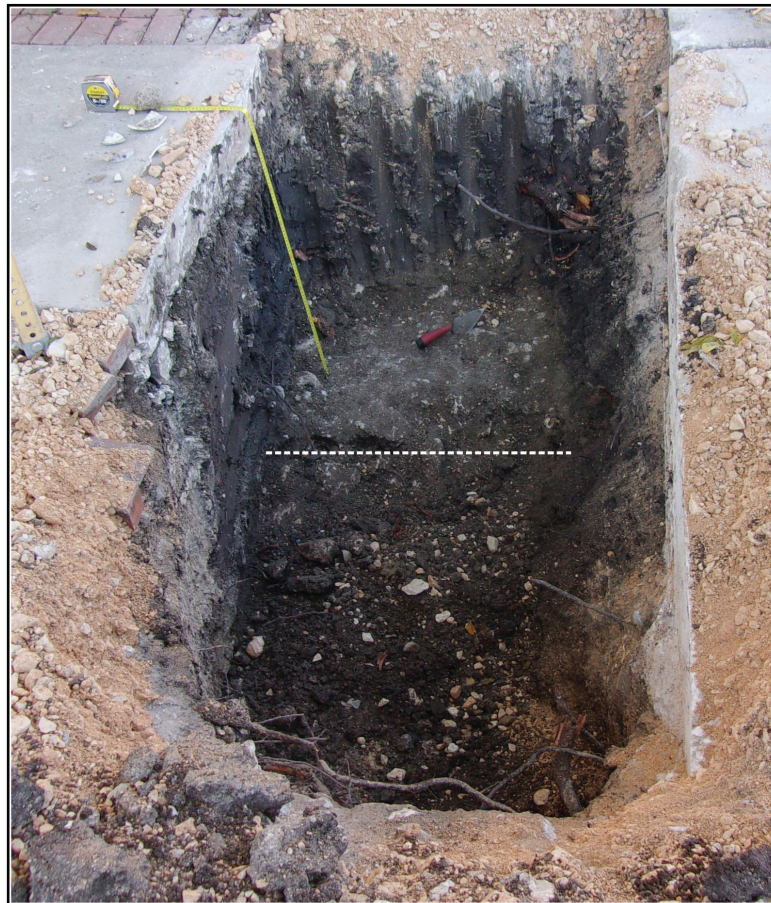
Figure 4-7. Site 41BX8 (Feature 1), facing west. Top of acequia wall, (edge of feature) marked in white. The northern, southern, and western edges of the feature extend outside the boundaries of the utility excavation.

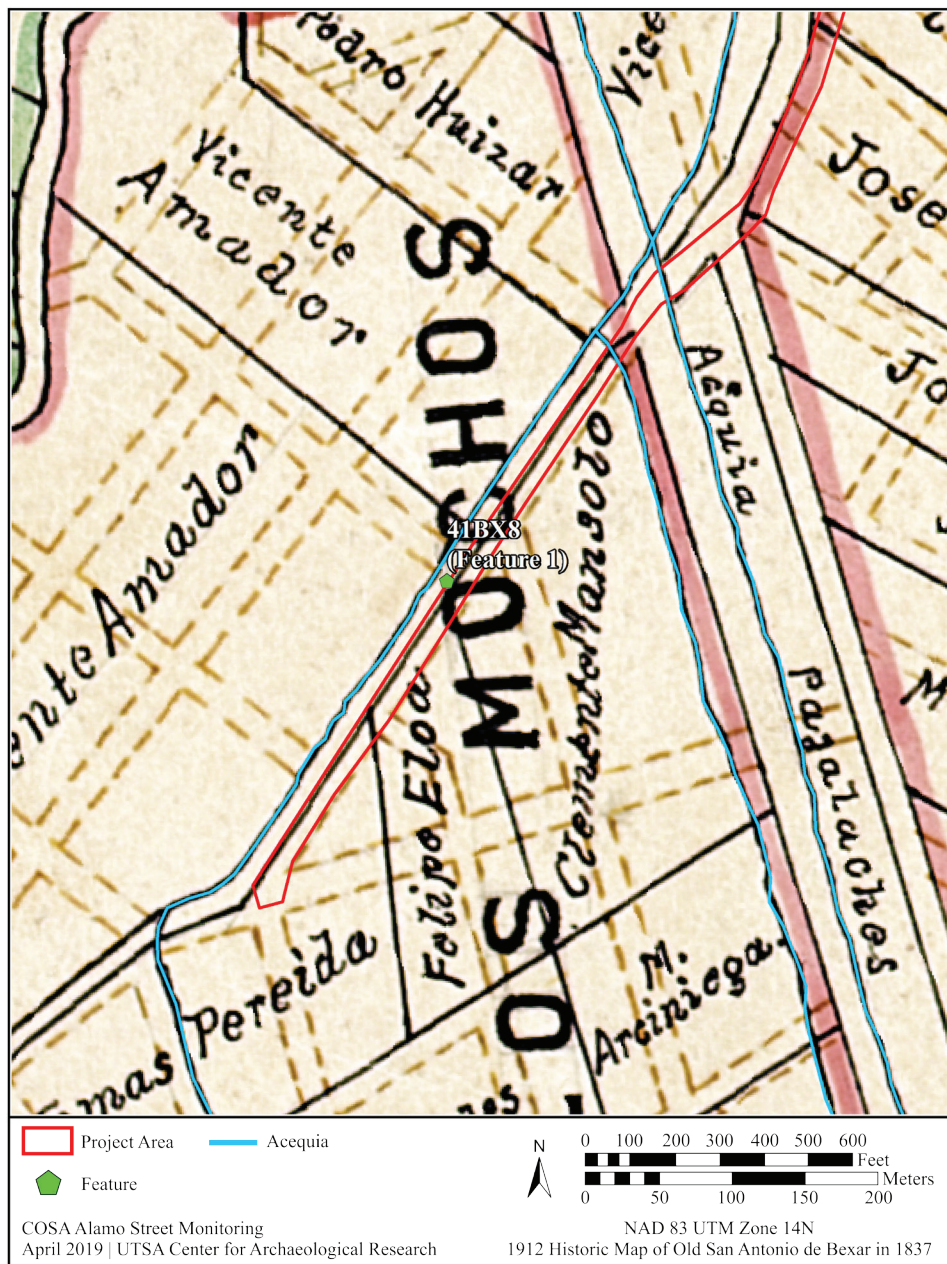
Figure 4-8. Site 41BX8 (Feature 1) location on Rullman (1912) map. Note discrepancy the location of Feature 1 and the path of the acequia depicted on the Rullman map.

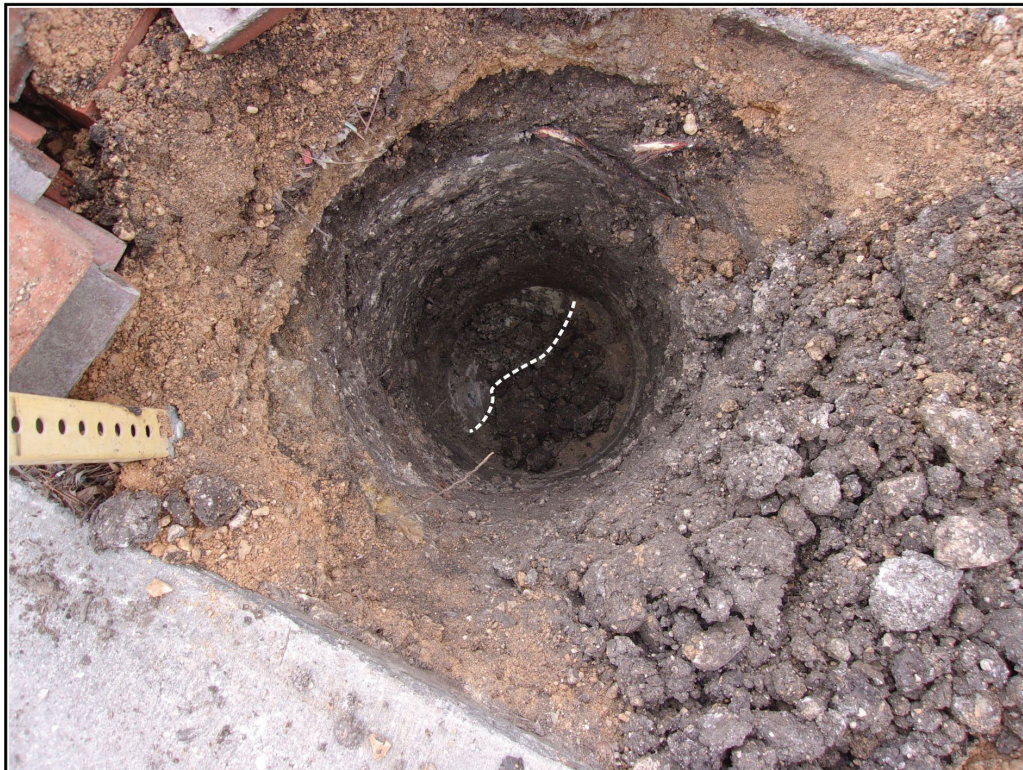
and directed that boring continue past the limestone obstruction (Figure 4-10). The only artifacts recovered from this borehole were a few red brick fragments.

Figure 4-10. Borehole near acequia. Limestone obstruction at the bottom marked in white. Feature extends into the north (upper left) portion of the borehole wall.

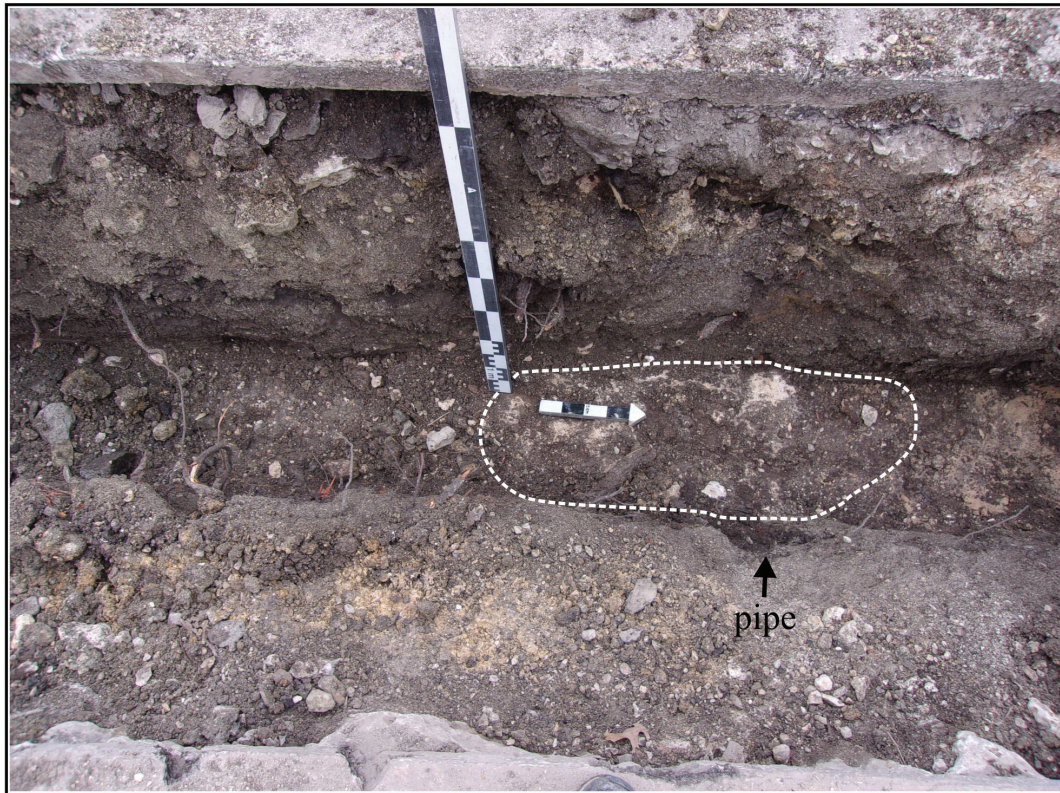
Figure 4-12. Site 41BX2287 (Feature 3), rough limestone blocks with mortar. Feature marked in white. Note intrusion by pipe.

Site 41BX2287 (Feature 3) is of unknown age and has no associated artifacts. It has been impacted by prior disturbance and appears to be out of context. The data recovered from this limited investigation suggests that the site is not significant. Site 41BX2288 was identified by two limestone blocks (Features 4 and 5). No artifacts are associated with these two features. Site 41BX2289 (Feature 6) consists of the remains of a wooden post and some associated yellow brick fragments. The site appears to have limited research value and is not significant. These three sites are not recommended as eligible for inclusion on the NRHP or for listing as a SAL.

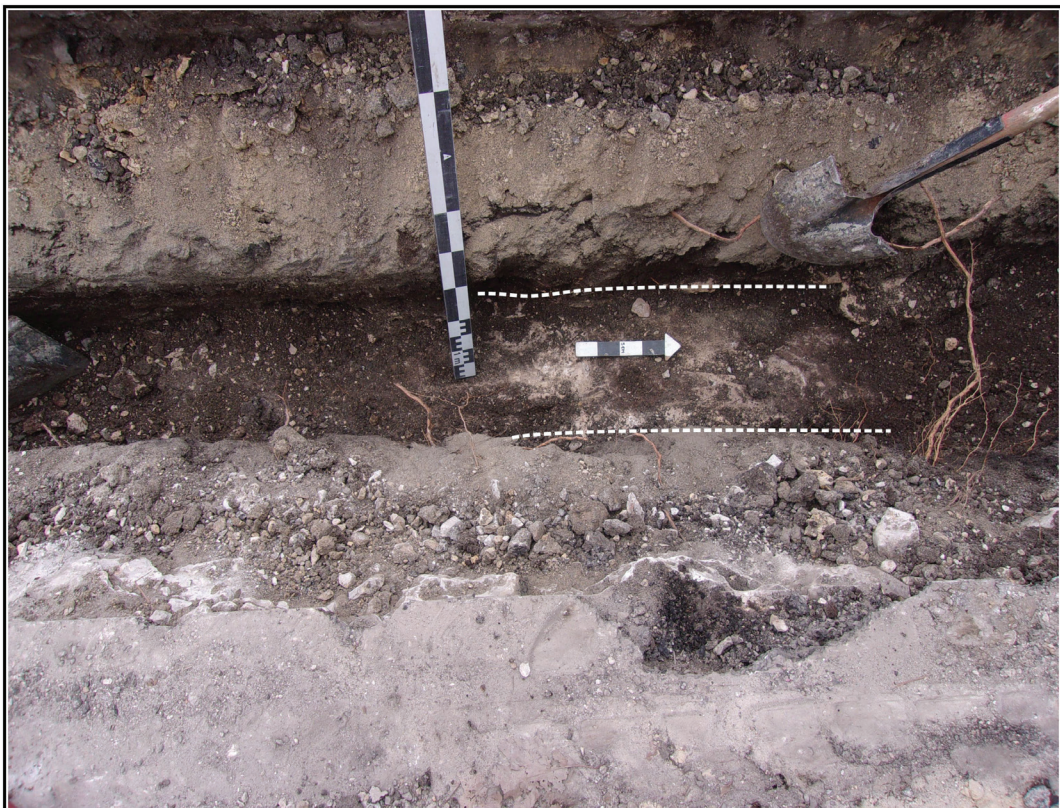
Figure 4-13. Site 41BX2288 (Feature 4), rough limestone block. Feature marked in white.

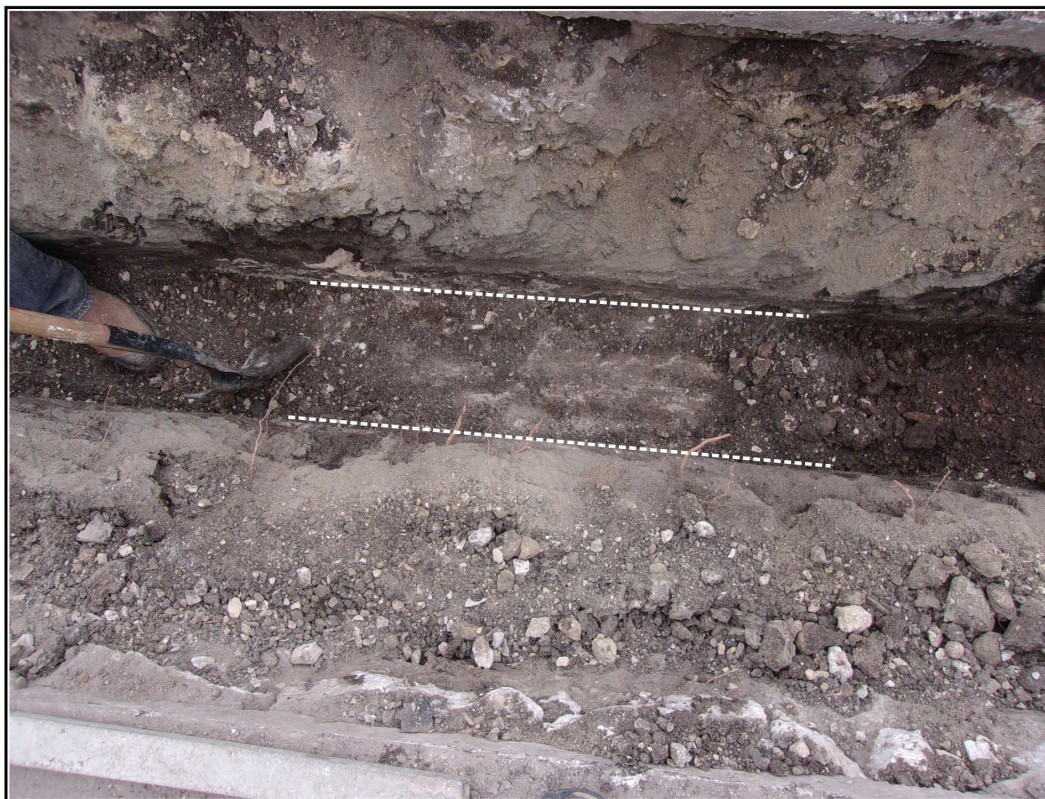
Figure 4-14. Site 41BX2288 (Feature 5), rough limestone block. Feature marked in white.

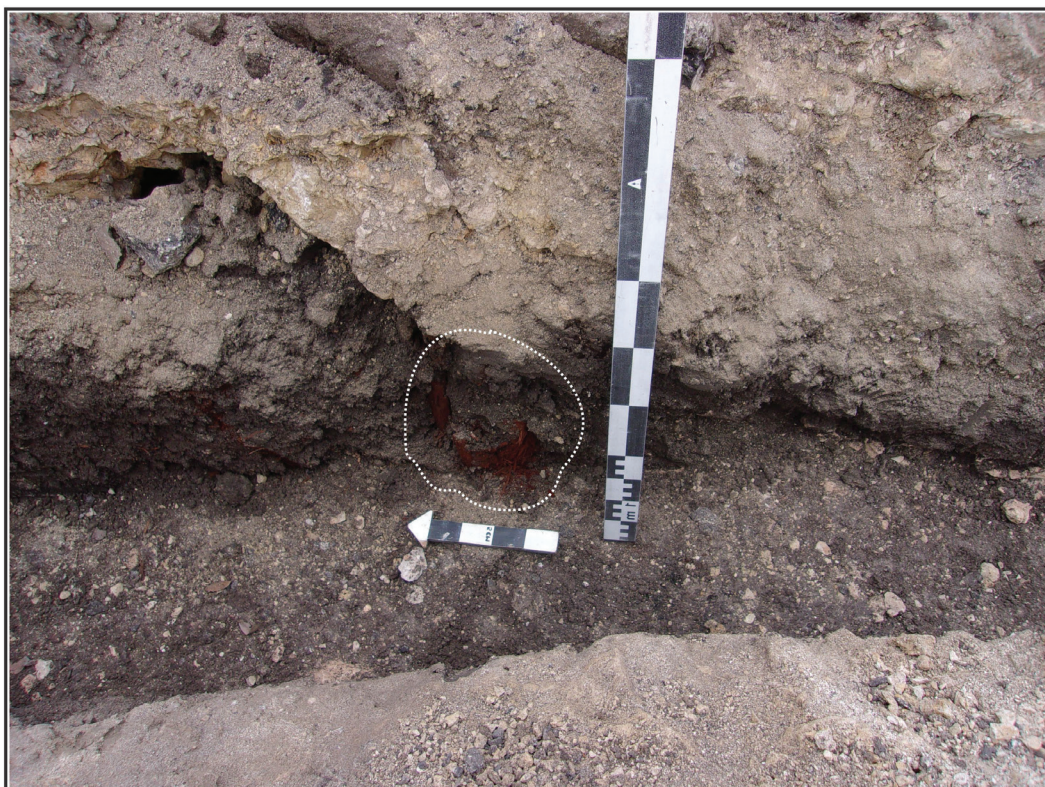
Site 41BX2289 is a previously unrecorded site consisting of the base of a wooden post (Feature 6) uncovered within the electrical conduit trench on the east side of S. Alamo Street just north of the intersection with Cedar Street (Figure 4-18). The feature was identified at 65 cmbs. The post was about 25 cm wide, and the wood appeared untreated. The narrow diameter of the post suggests that it is not a utility pole but,

Figure 4-15. Site 41BX2289 (Feature 6), wooden post. Feature marked in white.

potentially, a signpost or boundary marking. Two complete yellow bricks with no markings were found within the trench prior to encountering the feature, and yellow brick fragments were found in the backfill associated with the feature.

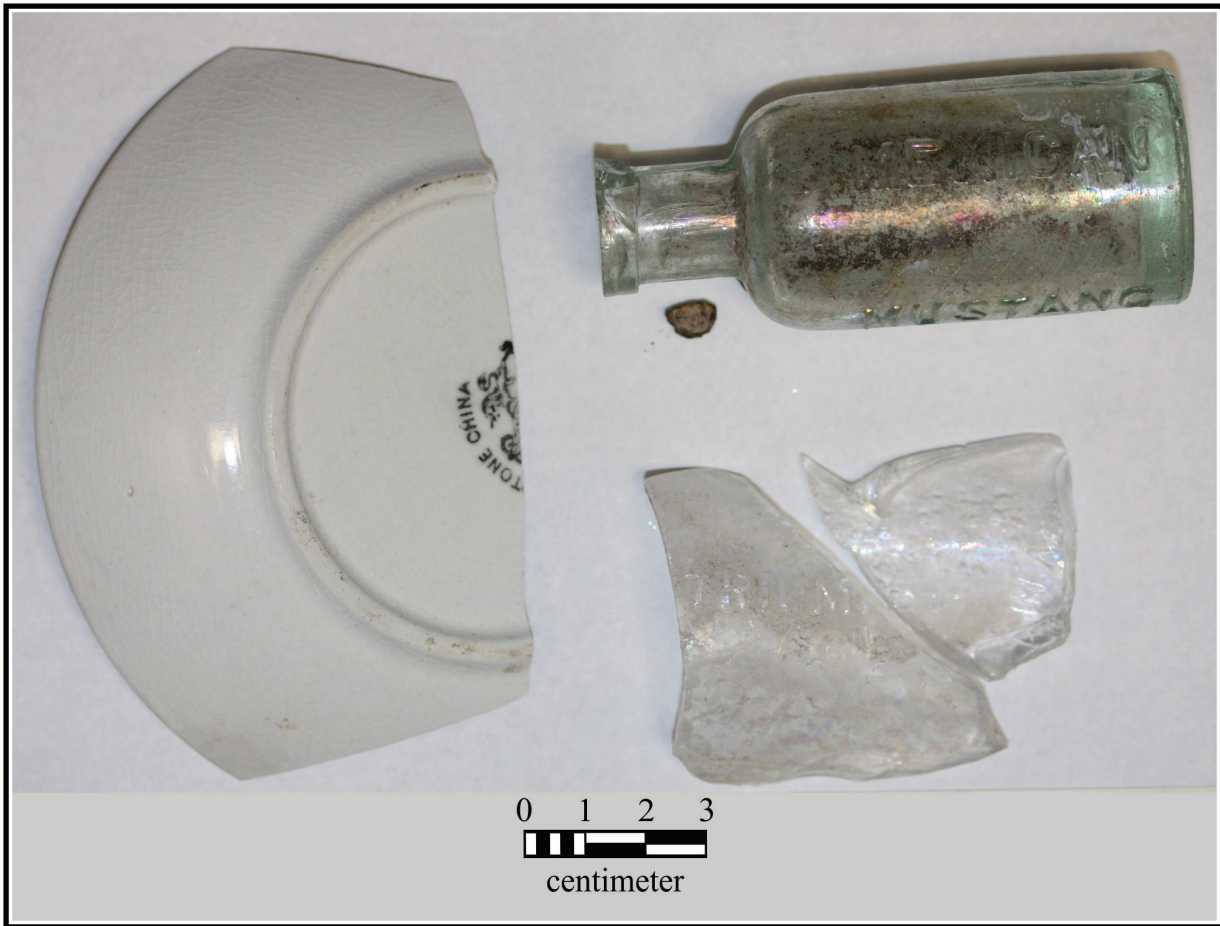
Figure 4-16. Diagnostic artifacts recovered from 41BX8 (Feature 1). Ironstone plate (left), aqua medicine bottle with cork piece (top right), and clear embossed glass (bottom right).

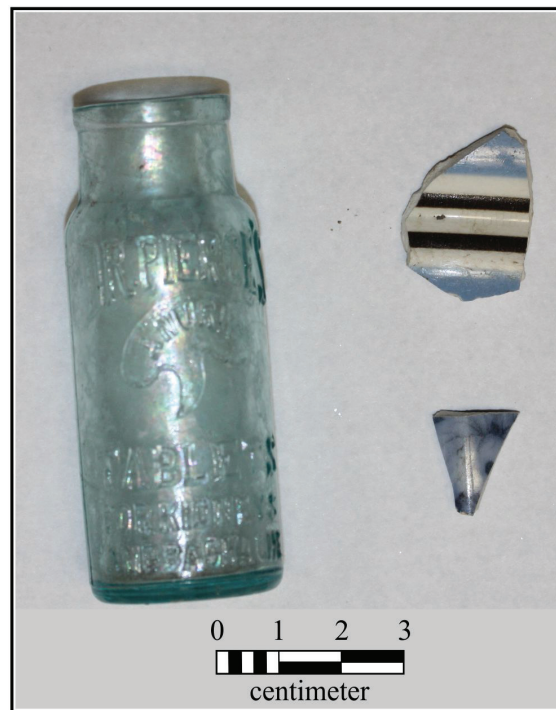
Figure 4-18. Artifacts recovered from the vicinity of the Beauregard Street intersection. Aqua medicine bottle (left), annular ware (top right), and flow blue (bottom right).

Historical Medical Artifacts 2019; Figure 4-18). This bottle appears to have been manufactured in a cup-bottom mold and has a tooled finish.
