INTENSIVE CULTURAL RESOURCES SURVEY FOR THE CANYON WEST WATER SUPPLY LINE, TRAVIS AND BURNET COUNTIES, TEXAS

February 2020

Final Report

Texas Historical Commission
TAC Permit # 8514

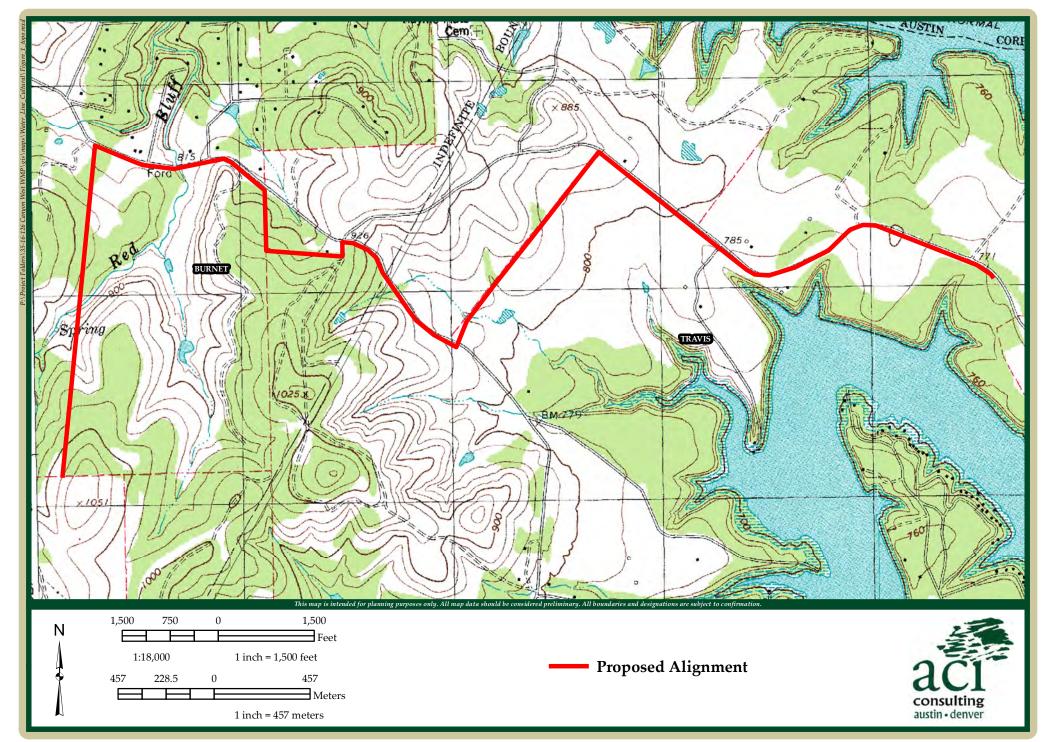
Figure 1: USGS 7.5-minute Topographic Map: Pace Bend

The project is located between Lake Travis and the Pedernales River, also crossing Red Bluff Creek and smaller tributaries. The proposed alignment is located within the Pace Bend (1986) U.S. Geologic Survey (USGS) 7.5-minute topographic quadrangle (see Figure 1). The proposed alignment transects variable topography of hills and gently sloping areas that range in elevation from approximately 1,020 feet above mean sea level (MSL) to 780 feet above MSL. The western portion of the proposed alignment generally drains north to Lake Travis and the eastern portion of the proposed alignment generally drains west or south to Lake Travis. The area is in the Edwards Plateau ecoregion, specifically the savanna.

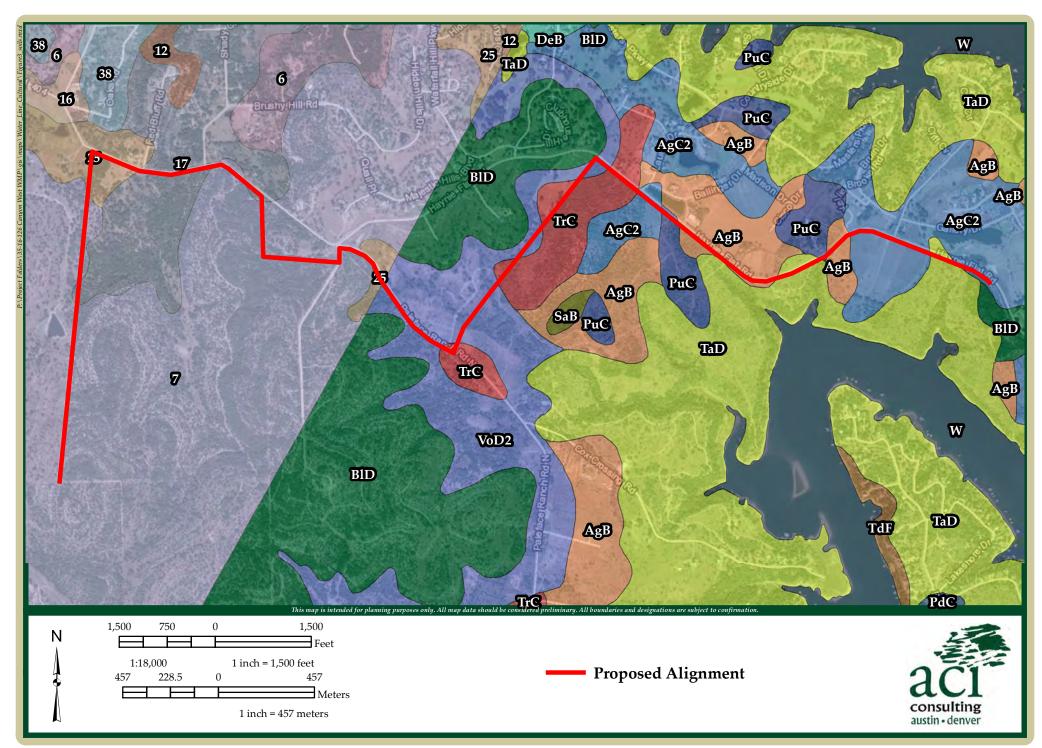
Figure 3: Soils

According to the United States Department of Agriculture (USDA) Natural Resource Conservation Service (NRCS) Web Soil Survey (2018), 10 soil map units occur within the proposed alignment (Figure 3). The majority of the soils within the project area have been previously determined to have a low probability to contain archeological sites according to the Potential Archeological Liability Maps (PALM) model, including Bracket, Hensley, Altoga, Real, Purves, and Tarrant (Abbott 2013). Travis and Volente have a low to moderate probability to contain archeological sites. Krum has a moderate to high probability to contain archeological sites. According to the Hybrid Austin District PALM model, the majority of the alignment is mapped as low to negligible potential for cultural resources (Abbott and Pletka 2015) (Figure 4). However, there are small sections along the alignment that are mapped as high potential. These areas can be found near the Pedernales River and one pocket is located in the middle of the alignment in a flat forested area.

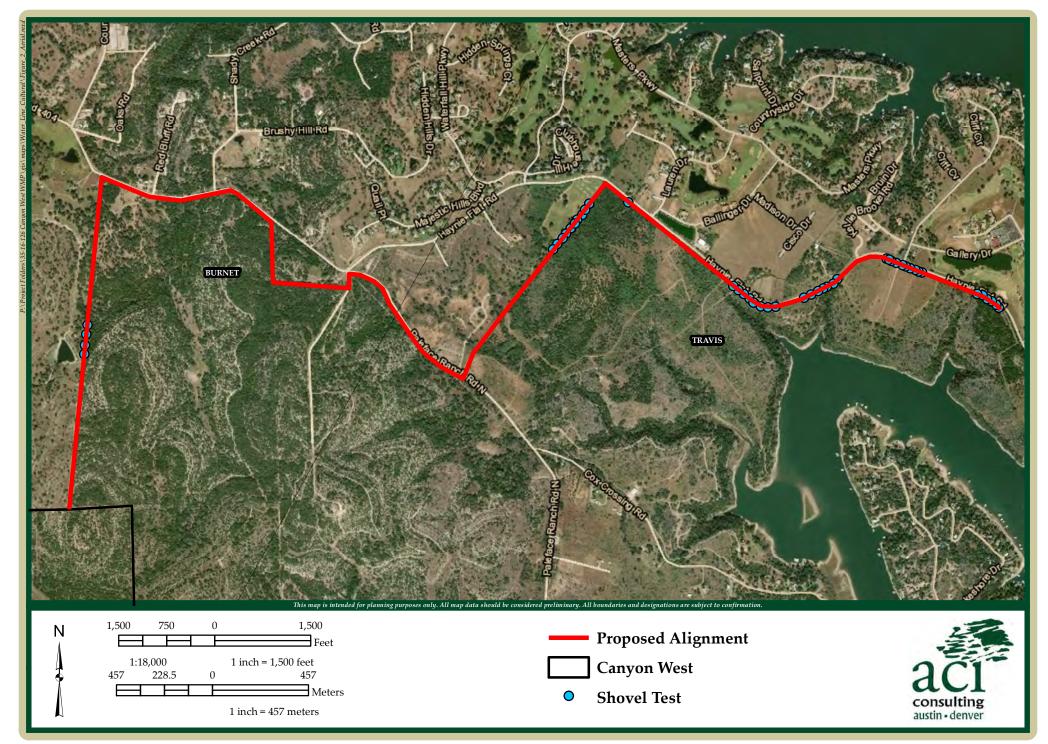
Canyon West Water Supply Line Figure 6: Field Results

The proposed alignment is located within agricultural-use land. The survey began at the east end of the alignment within previously recorded site 41TV539. Six shovel tests were conducted in 30m intervals within the known site boundary and pedestrian surveyed (Figure 7). Shovel tests were conducted to depths of 30 cm until clay and the bottom of Holocene deposits were reached. All shovel tests were negative. Two cores and two lithic flakes were recovered from the surface (Figure 8). A two-track road and a surface water line run through the site and further agricultural activities could account for the lack of recovered artifacts (Figure 9). Due to lack of diagnostics and poor contextual integrity, 41TV539 is not recommended for listing on the NRHP, and the portion of the site within the APE would not contribute to the site's eligibility were it to later be determined eligible.

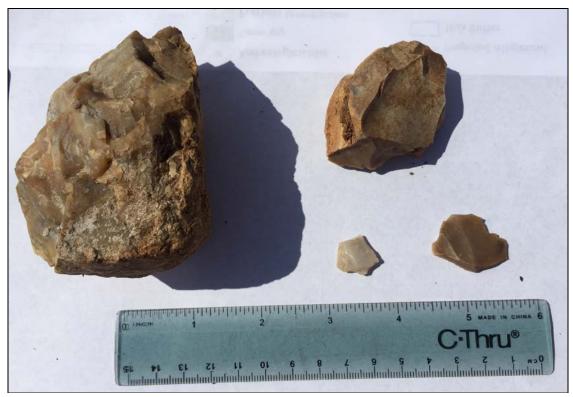
Figure 8. Recovered artifacts from surface of 41TV539

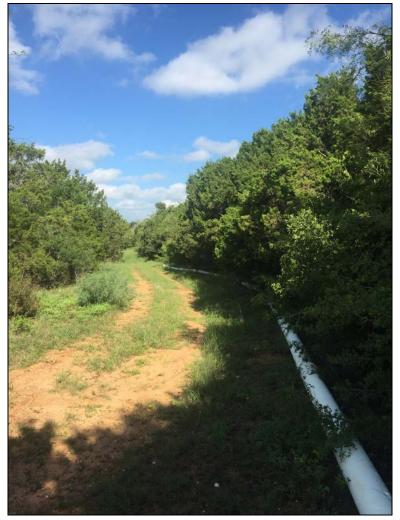
Figure 9. Overview of 41TV539, facing west

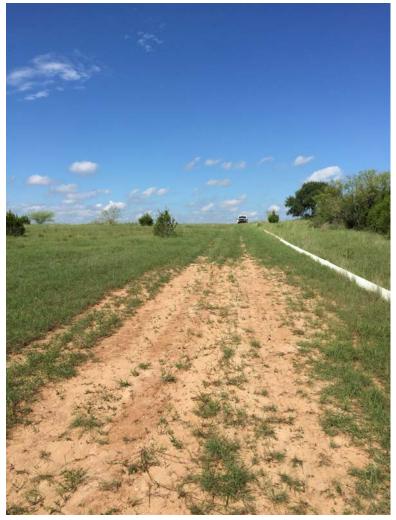
Figure 11. 41TV2501 site overview towards rise, showing GSV, facing west

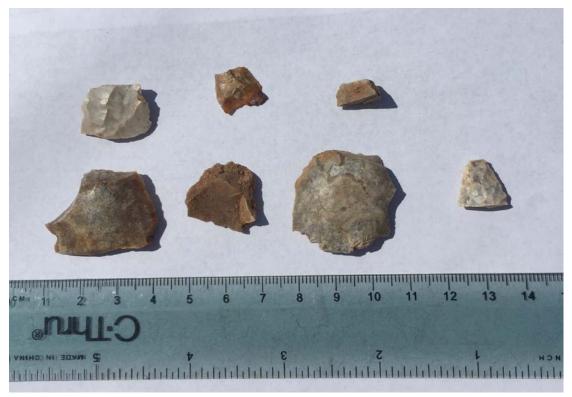
Figure 12. Recovered artifacts from surface of 41TV2501

Observed material included chert flakes and utilized flakes. The site was shovel tested until double negatives were reached to the east and west. The positive shovel tests extended the known site boundary to the east and west by a total of 70m, for an approximate east-west width of 120m. Due to the constraints of the APE, it is unknown how far south the site may extend. Haynie Flat Road bounds the site to the north. Due to lack of diagnostics and high level of erosion, 41TV2501 is not recommended for listing on the NRHP, and the portion of the sites within the APE would not contribute to the site's eligibility were it to later be determined eligible.

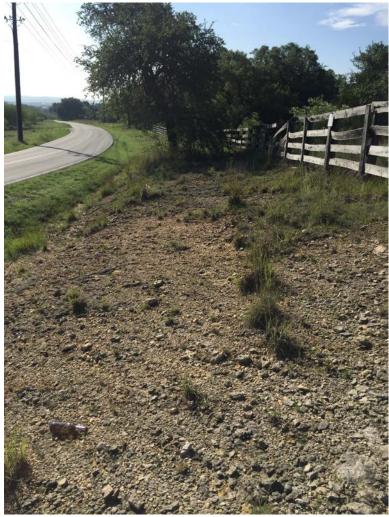
Four previously determined HPAs intersect the alignment which were shovel tested in 30m intervals. A fifth HPA also intersects the alignment but lacked soils. Throughout the remainder of the alignment, ground surface visibility ranged from 30 to 90% and many areas included exposed limestone outcroppings (Figures 13-15). While chert material was located, no cultural materials were recovered outside of the two previously recorded sites.

Figure 13. GSV along Paleface Ranch Road, facing southeast

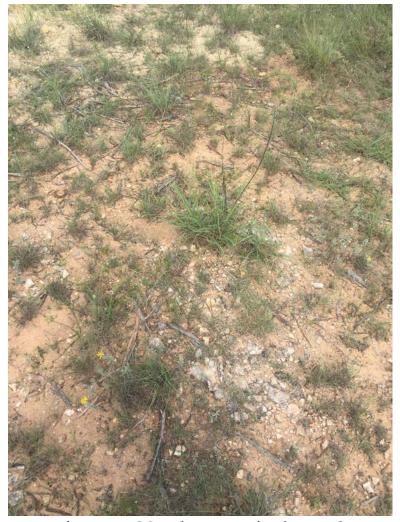
Figure 14. GSV along Haynie Flat Road

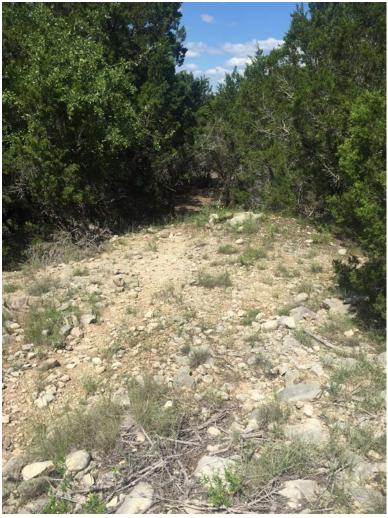
Figure 15. GSV and overview of HPA along western portion of APE, facing north towards a spring
