Coastal Zone Management Problems: RI Coastal Lagoons and Barriers

Coastal Zone Management Problems:
RI Coastal Lagoons and Barriers

Virginia Lee and Jon C. Boothroyd
University of Rhode Island

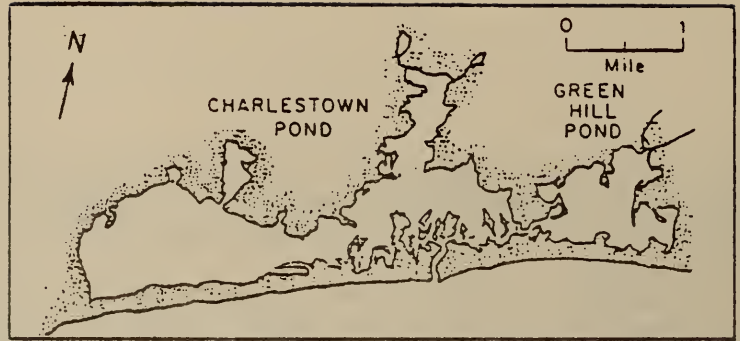
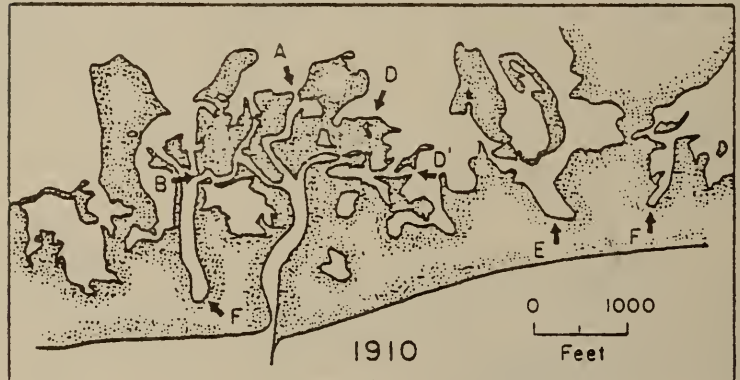
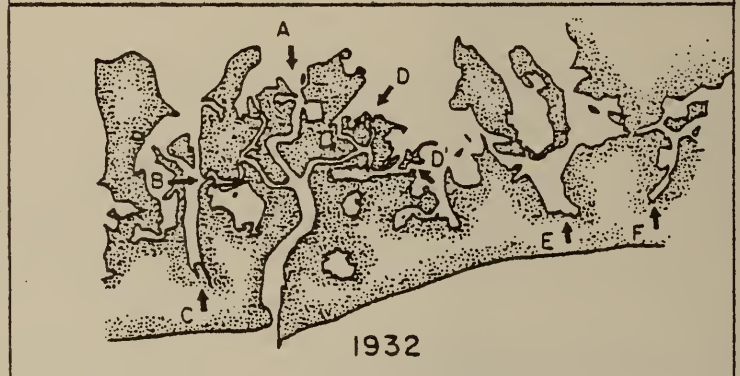
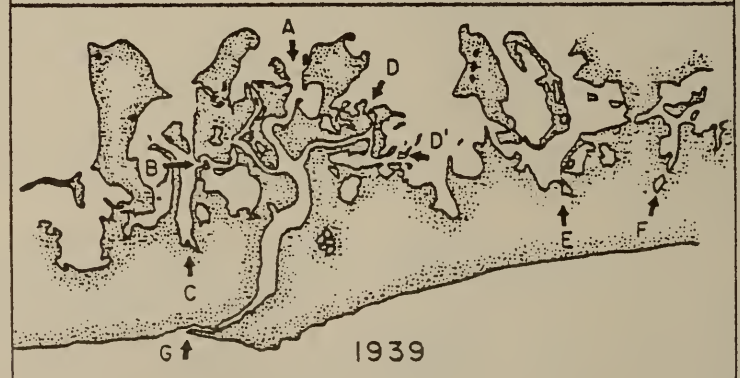
Figure 2.

Maps of Charlestown and Green Hill ponds showing changes in the breachway and major tidal delta channels over time.

Attempts to reinforce the breachway to make a permanent connection to the sea started at least 100 years ago. In the late 1800s, when Narragansett Bay supported an enormous oyster fishery, the state looked to Charlestown and Green Hill Ponds as a steady source of oyster seed to be transplanted to the commercial beds in the Bay. Even though the oysters spawned produgiously in the ponds, it was thought that the set would grow better if the ponds were flushed with more seawater. So in 1881, the state paid for the Charlestown breachway to be reinforced with a rock wall on the west side and leased out sections of the pond for oyster culture (Figure 2).

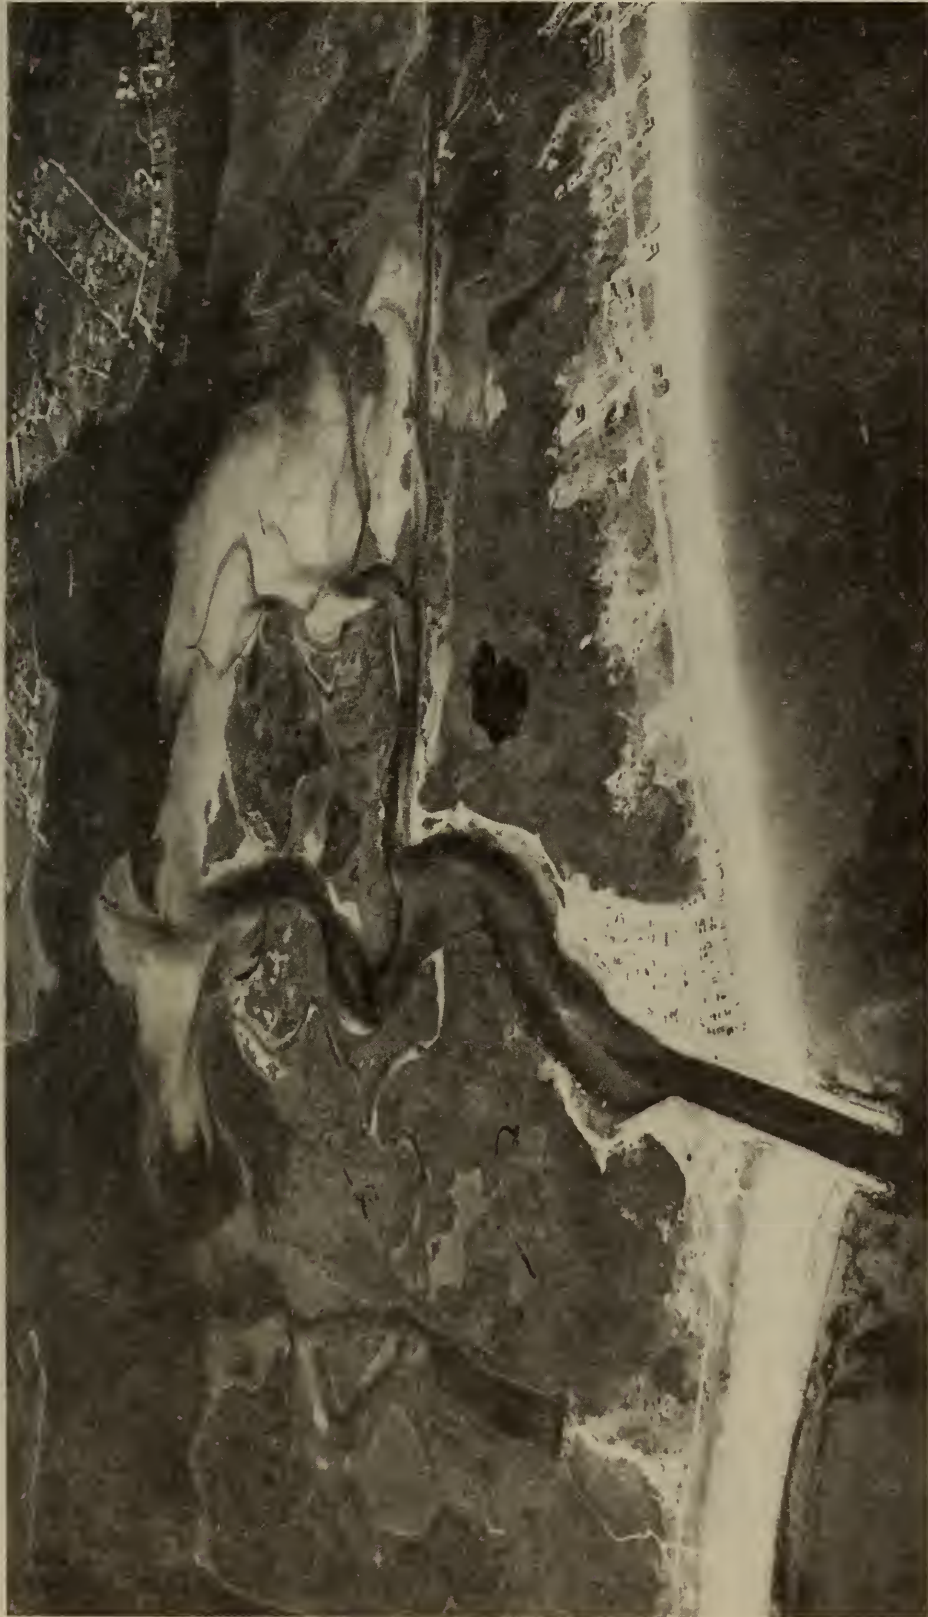
Figure 3. Photograph of the Ninigret Pond flood tidal delta and adjacent barrier spits. Photo taken June 28, 1981 by Jon Boothroyd.
